NASA Technical Memorandum 85722

INVESTIGATION OF FUSELAGE ACOUSTIC TREATMENT  
FOR A TWIN-ENGINE TURBOPROP AIRCRAFT  
IN FLIGHT AND LABORATORY TESTS

JOHN S. MIXSON , ROBERT L. O'NEAL , AND  
FERDINAND W. GROSVELD

JANUARY 1984

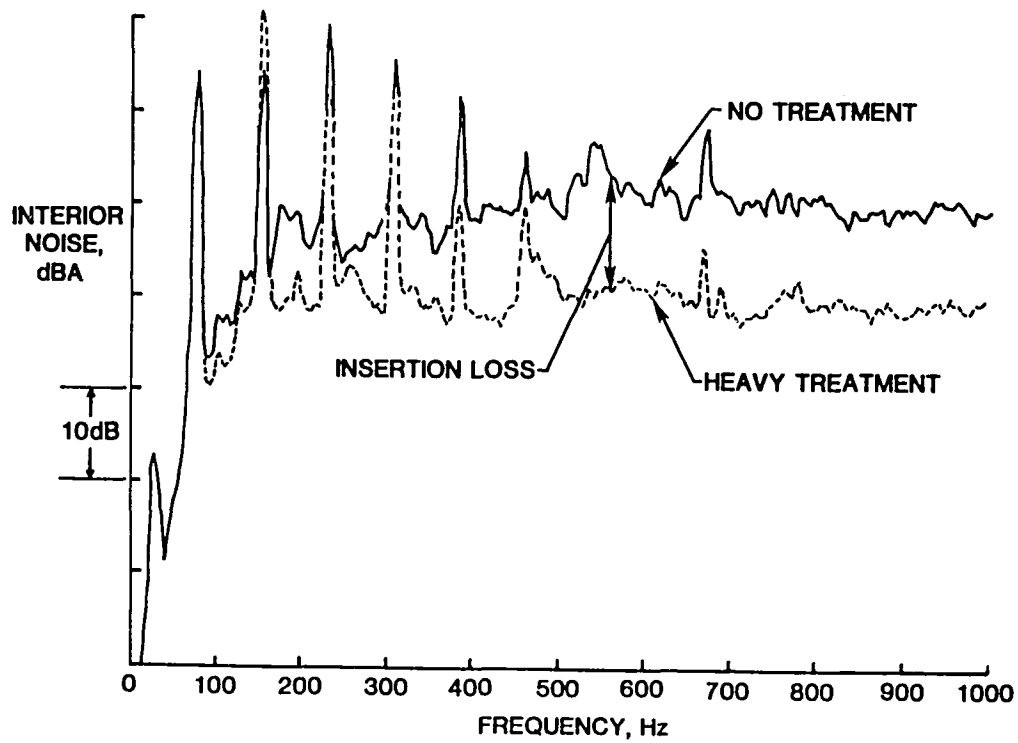
Figure 5.- Cabin noise measured in flight at position 2 for two treatments.

For this report, initial data analyses considered narrowband spectra of A-weighted noise level such as shown in Figure 5. The two spectra in figure 5 were measured in two separate flights, each flight having a different sidewall treatment. The microphones were installed at fixed positions and flight conditions were carefully established in an attempt to maintain the same test conditions for both flights, so that the difference in level between the two spectra would result only from the difference in treatment. For this study, then, the treatments are characterized by their insertion loss, which is defined as the reduction of noise level that results from the insertion of the treatment when all other factors are held constant. Insertion loss was determined graphically, as indicated in figure 5, and is a function of frequency, microphone position, initial configuration, and final treatment. Note that insertion loss is positive when the treatment reduces the level, but can also be negative, as it is at the 150 Hz tone in figure 5.

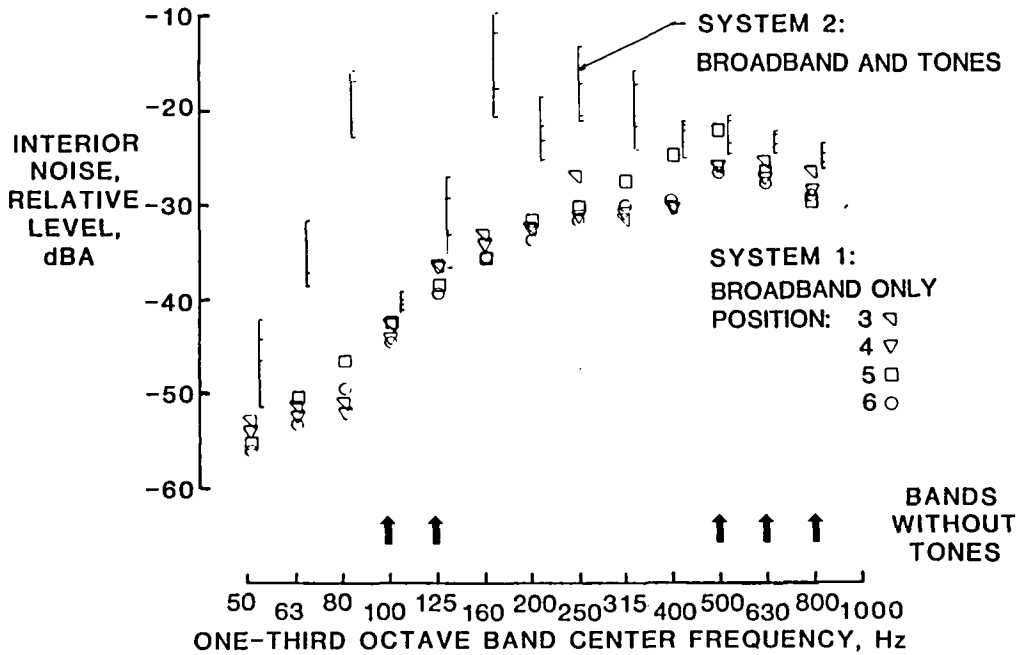
Figure 11.- Interior noise in flight from two measuring systems, cabin with 695A treatment.

Cabin noise spectra from the two measurement systems are shown in figure 11 for the 695A treatment. The measurements with each system were made on separate flights; but with nominally the same test conditions. In the bands without tones system 2 shows noise levels that are about 3.5 db higher. For this treatment configuration also, the propeller tones dominate only the 80 Hz and 160 to 315 Hz bands, but in this case the levels are substantially higher than the boundary layer noise levels in the 400 to 800 Hz bands. This suggests that additional noise reduction is required in the propeller dominated bands.

Insertion loss of the treatment was determined in one-third octave bands using the data shown in figures 10 and 11. For the broadband - only data (the symbols for system 1) the noise level "treated" (fig. 11) was subtracted from the "untreated" level (fig. 10) for each cabin position. For the broadband plus propeller (system 2) the noise levels were averaged over cabin position before subtracting. The resulting insertion loss is shown in figure 12. This figure shows that in the frequency bands below 500 Hz the treatment provides less insertion loss for the total noise (propeller and broadband) than for the broadband component alone. The data of figure 12 and insertion loss of the 2 inches of fiberglass vs bare treatment are compared with laboratory data in a later section of this paper.

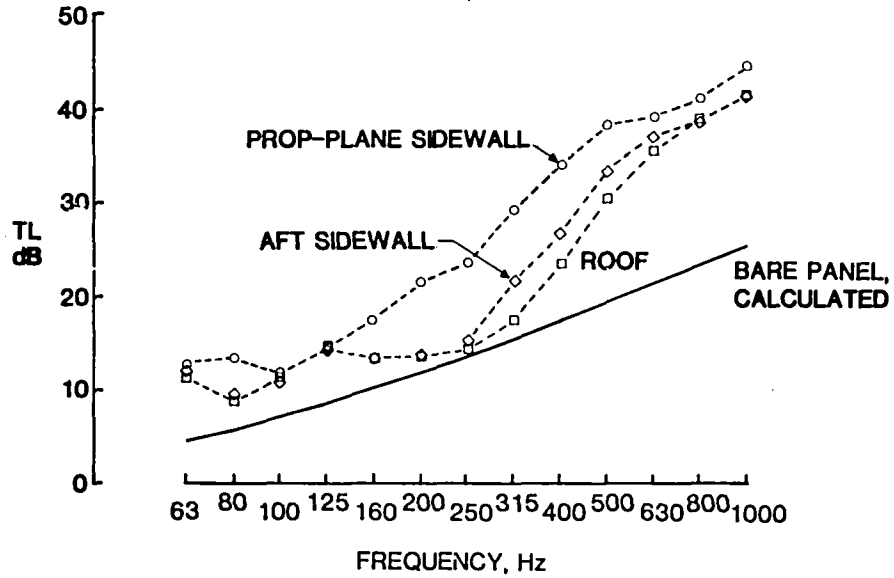
Figure 18.- Transmission loss of panel and acoustic treatment measured in the lab.

Laboratory results from five configurations were used for comparison with flight results. Transmission loss for four configurations is shown in figure 18. For the bare structure the T L was calculated from field incidence mass law. These values were used instead of measured data because the measured T L exhibited several "dips" that are thought to be associated with the boundary conditions of the panel in the lab setup, and would not be expected to occur on the aircraft. When damping tape was applied to the skin panels the "dips" disappeared and the TL followed the mass law for mass of skin plus damping tape (ref. 3). The curve labeled "roof" in figure 18 is intended to represent the roof region in figure 3, "aft sidewall" the region aft of station 154.5 in figure 3, and "prop-plane sidewall" the region between stations 78 and 154.5. The treatment elements described in Table I were arranged for these configurations as shown in figure 17. The TL of the fifth configuration, "2 inches of fiberglass," was determined from tests

and the TL values of the different regions are taken from figure 18. For this calculation the windows are ignored, so there is an implicit assumption that each window has the same TL as the adjacent wall. Windows are discussed further in a later section of this paper.

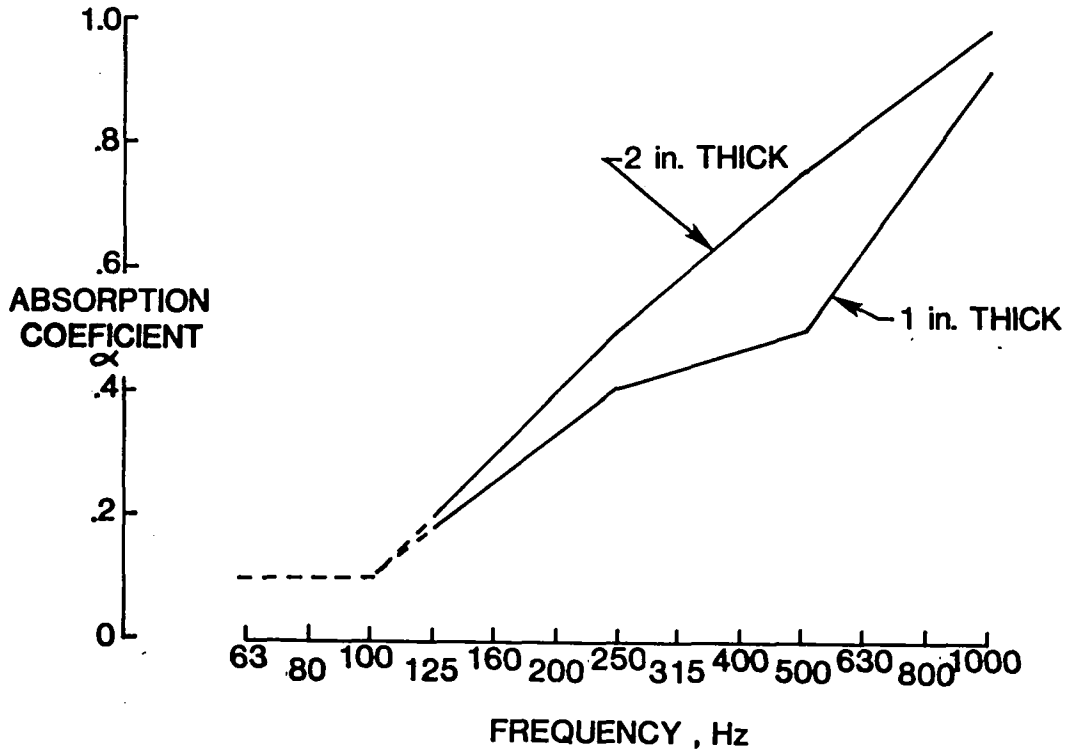
Figure 19.- Absorption coefficients of fiberglass used in calculating insertion loss. Data from reference 5.

For untreated surfaces  $\alpha_i$  is taken as 0.1 based on data presented in reference 4, therefore the bare aircraft has  $\alpha_e = 0.1$ . For treated surfaces the absorption was determined by the thickness of the fiberglass layer exposed to the cabin interior and backed by either a vinyl septum, the noise barrier, or the sidewall structure. The absorption values used for the fiberglass are shown in figure 19. These values, taken from reference 5, were determined by the manufacturers using standardized test facilities and procedures. As an approximate check, the absorption values of the fiberglass blankets used in this study were measured in the receiving room. The values were acceptably close to values presented in reference 5 for a test setup similar to the one used here.

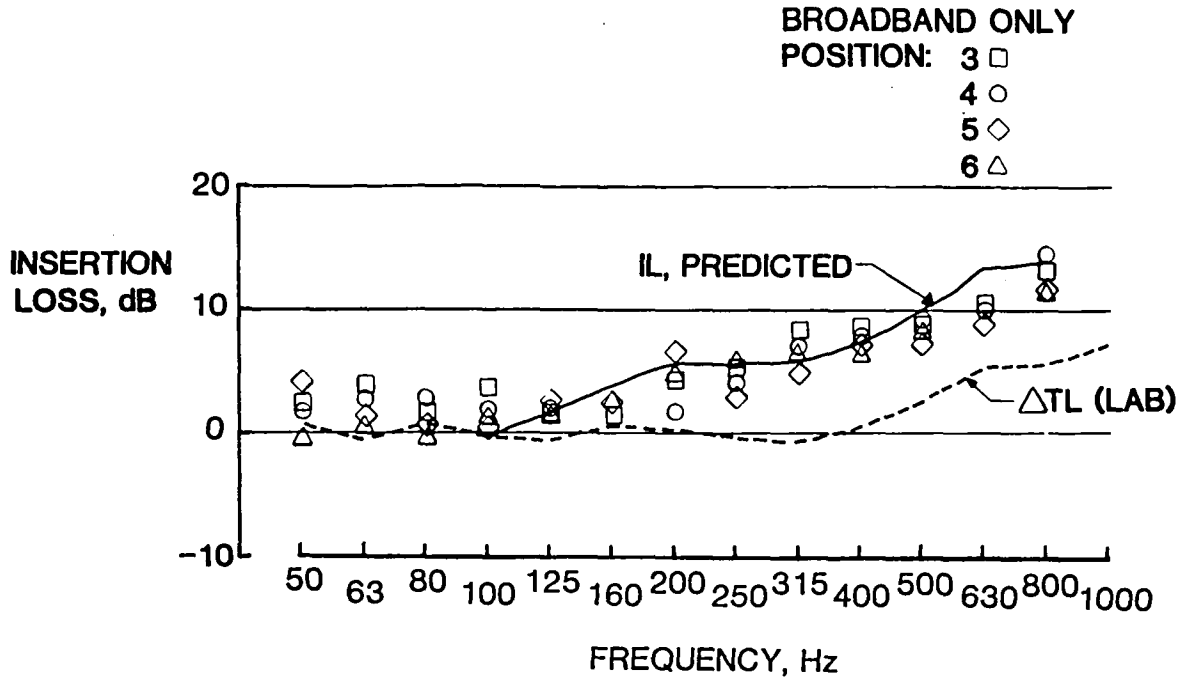
Figure 20.- Insertion loss of 2 in. of fiberglass relative to no treatment, comparison of predictions with flights data.

using the panel with damping tape applied. The change of TL was determined by comparison of results with and without the fiberglass present. As shown in figure 20, the fiberglass provides increased TL only above 400 Hz. The values above 400 Hz are felt to be within 2 dB of values appropriate for use when the fiberglass is added to the bare panel (as in the aircraft).

Insertion loss of the 2 inches of fiberglass treatment compared to no treatment was predicted using lab results, and the comparison with measured flight insertion loss is shown in figure 20. The flight data is presented for four positions at mid and aft cabin, and was determined for the broadband (boundary layer)

component only, as described previously. Agreement between predicted and measured results is shown to be good at frequencies above 100 Hz. Below 100 Hz the flight data may be inaccurate due to the difficulty of graphically fitting a curve to the steeply sloping narrow band spectra at these frequencies (fig. 9). In the important frequency range of 160 to 400 Hz where the highest A-weighted noise components occur, figures 5 and 11, the contribution of TL is seen to be negligible, while the absorption results in insertion loss values from 2 to 8 dB.

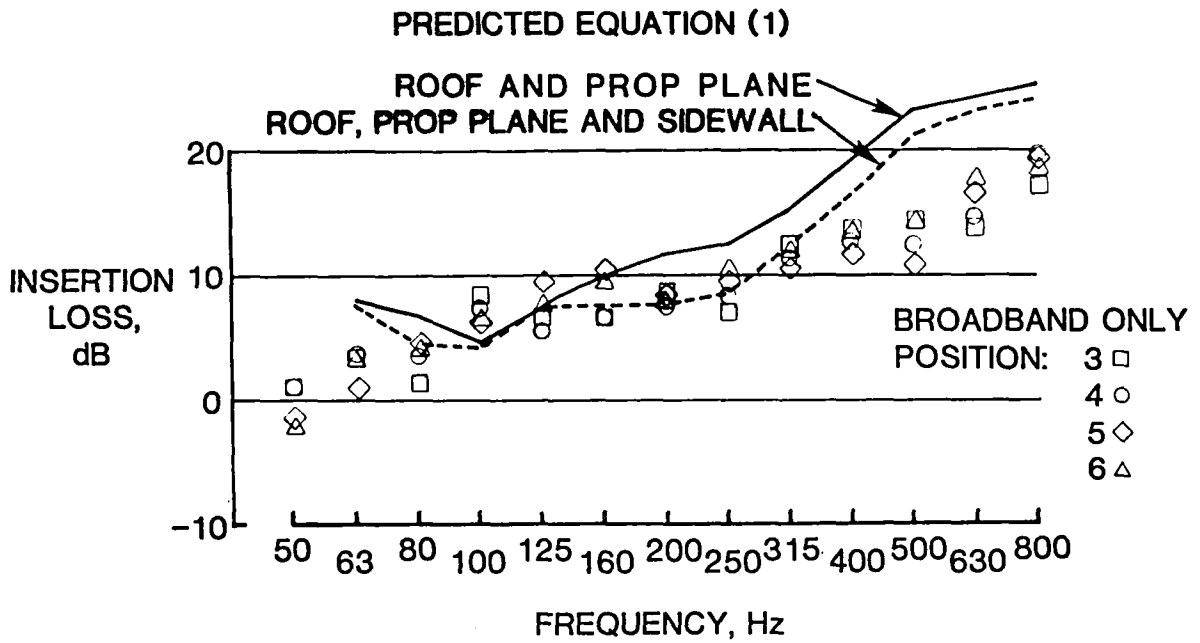
Figure 21.- Insertion loss of 695A treatment relative to no treatment, comparison of predictions with flight data.

Predicted insertion loss for the 695A treatment compared to no treatment is compared with flight results in figure 21. Predicted values are given for two cases, one including only roof and prop plane TL in the effective TL, and the second including aft sidewall in addition. Predictions were made for both cases with the thought that cabin absorption might restrict the noise that enters at the rear of the cabin from reaching the more forward positions 3 and 4. However, the flight data shows that the Insertion loss is about the same for all four cabin locations. The predicted insertion loss including roof, prop plane and aft sidewall TL is seen to be in good agreement with the flight data at frequencies from 125 Hz to 315 Hz. The overprediction at frequencies below 100 Hz is thought to result from boundary condition stiffness of the panel in its facility mounting. The reason for the overprediction at frequencies above 400 Hz has not been determined, but may be due to flanking acoustic transmission through lightly treated sidewall locations, or through windows.

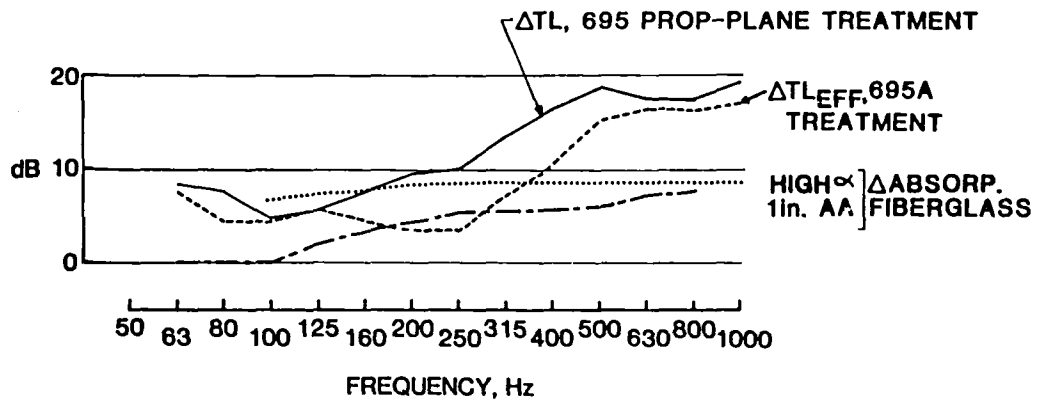
Figure 22.- Component contribution to insertion loss of acoustic treatment.

Possible approaches to improved treatment are illustrated in figure 22. The absorption associated with the 695A treatment as tested here is indicated by the dot-dash line labeled "1 in. AA." Reference 5 indicates that substantially larger values of absorption can be obtained by using fiberglass of a different type or larger thickness. Using the higher absorption values from reference 5 the  $\Delta$ ABS contribution has been estimated and is shown as the dotted line labeled "High  $\alpha$ ".

Increases of 3 to 4 dB are shown at frequencies from 160 to 400 Hz. In order to obtain cabin noise reductions from this approach the fiberglass must be exposed (in the acoustic sense) to the cabin interior, and not covered with an acoustic barrier such as a vinyl layer or a trim panel.

The contribution of the increased effective TL of the 695A treatment is shown by the dashed line. This curve indicates the effective  $\Delta TL$  when the TL contributions of roof, aft sidewall, and prop-plane sidewalls are combined using equation (1) and the individual TL value from figure 18. Increased  $\Delta TL$  could be obtained by extending the prop-plane treatment forward and aft so that its larger  $\Delta TL$  contribution, indicated by the solid line, would not be reduced by flanking transmission through the more lightly treated forward and aft sidewalls. Other treatment approaches are also possible.
