Article

Landsat-8 Thermal Infrared Sensor (TIRS) Vicarious Radiometric Calibration

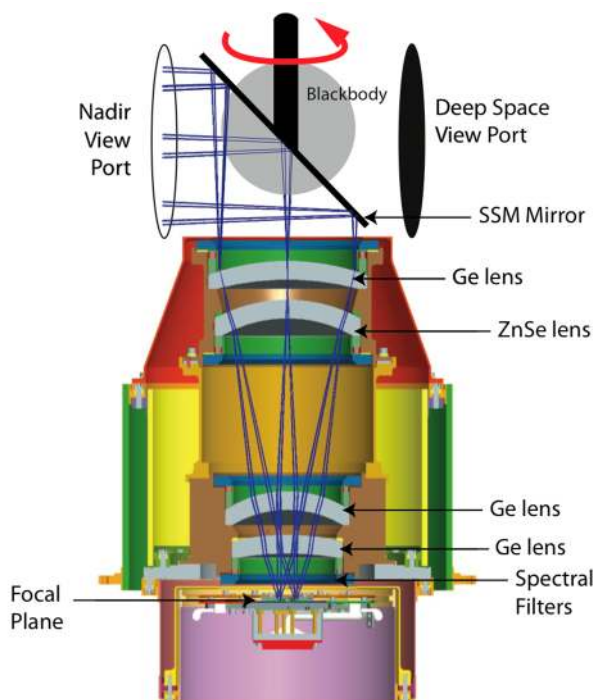
Figure 1. TIRS optical diagram. The SSM mirror rotates between the nadir viewport, blackbody and deep space viewport to provide calibration at least once an orbit.

The instrument features a four-element refractive optics telescope, with three germanium (Ge) elements and one zinc selenide (ZnSe) element, which directs the incoming energy onto the focal plane (Figure 1). A flat mirror at the front of the telescope, the Scene Select Mechanism (SSM), switches the field of view between the earth and the two internal calibration positions for view of deep space and the on-board blackbody.

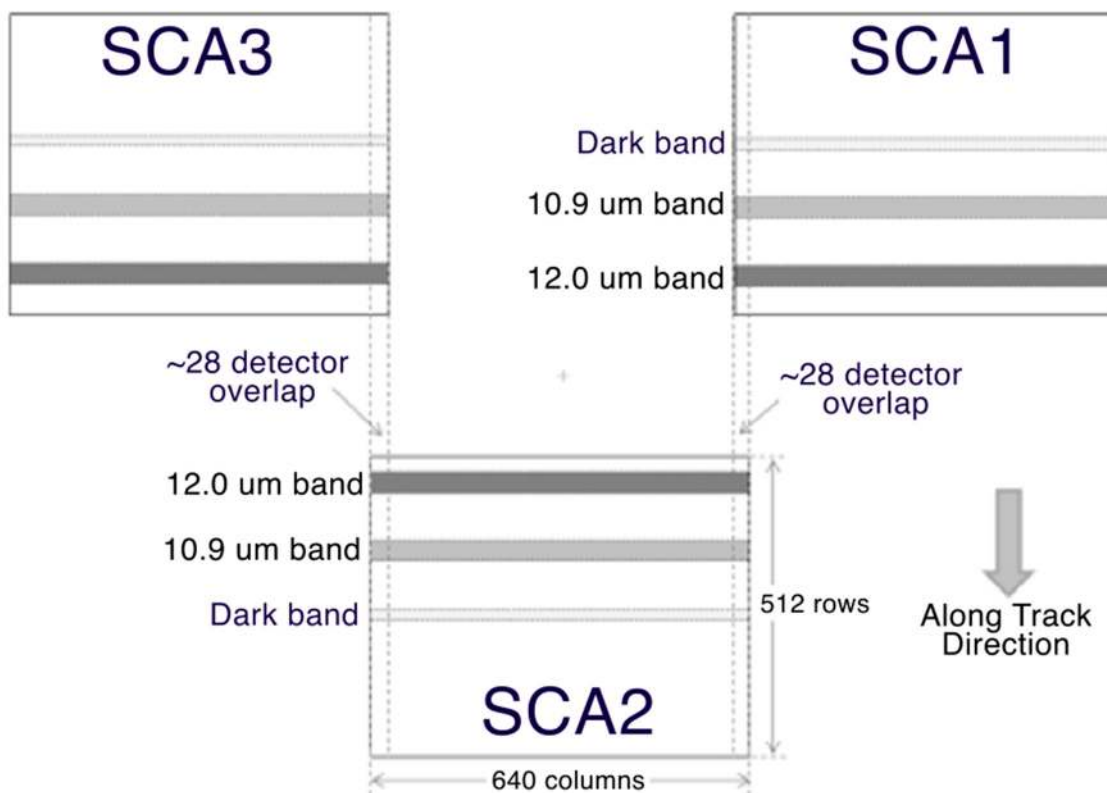
Figure 2. TIRS focal plane diagram. The areas of the three SCAs covered by the spectral filters are indicated, along with the region on each SCA used to measure the dark signal.

The pushbroom focal plane consists of three separate Sensor Chip Assemblies (SCAs), each 512 \times 640 pixels. Figure 2 shows the layout of the chips on the focal plane; two SCAs are slightly offset from the third in the along-track direction by about 300 rows in Band 10 and 200 rows in Band 11. The SCAs overlap in the across-track direction by 28 pixels. The temperature of the focal plane is controlled by the cryocooler to \sim 40 K and maintained to within \pm 0.01 K [9]. The spectral interference filters lay on top of the SCAs, covering about 30 rows of the 512-row chip. Of these 30 rows, only one row per-band is read out to generate the standard image product. A second row per-band is designated as backup, in case a detector in the primary row fails. Several rows outside of the spectral filter are completely blocked from incoming energy and are used to characterize the internal instrument dark signal.

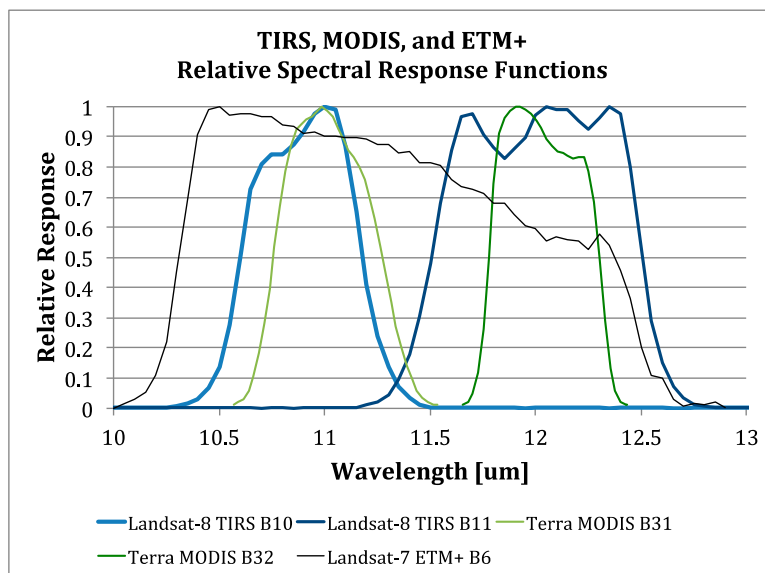
Figure 3. The relative spectral responses (RSR) of the TIRS bands (B10 and 11). Also shown for comparison are the RSRs of ETM+ band (B6) and the equivalent MODIS bands (B31 and 32). The TIRS and ETM+ RSRs are band-average but the MODIS RSRs are each for a specific detector (detector 5 in both cases).

The spectral interference filters were designed to provide the optimal band combination for use in a split-window atmospheric correction algorithm [11]. Figure 3 shows the final band-average TIRS relative spectral responses (RSRs) for each band.

The three sensors, TIRS, ETM+ and MODIS, cover the same spectral regions but don't have identical RSRs (Figure 3). Sensor reaching radiance can be converted to top-of-atmosphere brightness temperature using the Planck function.

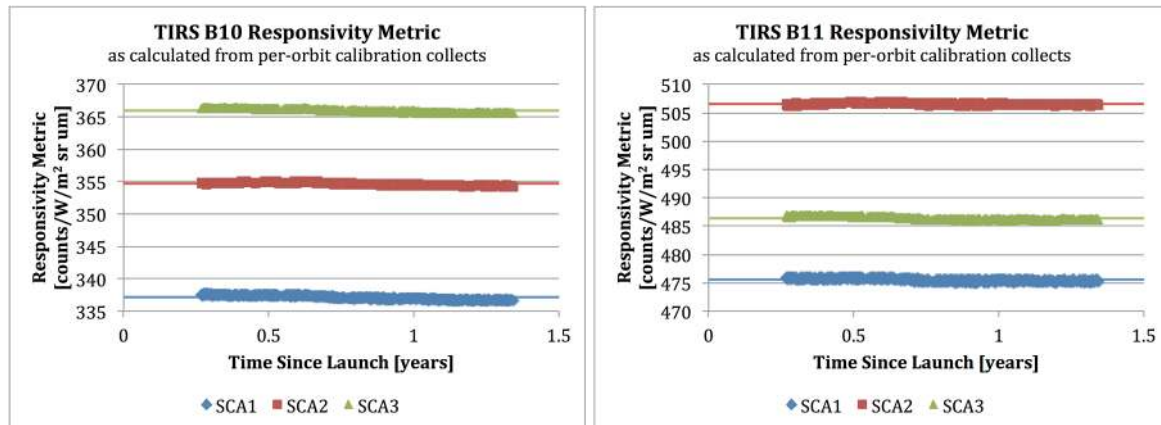
Figure 4. The SCA-average per-calibration sequence responsivity metric for both TIRS bands along with the per-SCA lifetime average. Based on this and other metrics, the TIRS instrument is internally stable.

where Q_{BB} is the bias-subtracted, linearized digital counts extracted from the blackbody image, Q_0 is the instrument offset which incorporates instrument and electronic biases, L_{BB} is the spectral radiance of the blackbody as converted from the monitor thermistor readout and L_{space} is the spectral radiance of deep space, assuming a 4 K background. The metric is calculated per-SCA since all detectors on a single SCA share electronics. Note that this is not the actual gain equation. Instrument gain and bias are covered in detail in [12]. Since launch, the SCA-average metric may have a slowly decreasing trend (maximum of $-0.28\%/year \pm 0.005\%/year$ in the worst case) but the total variability over the lifetime is still only 0.08% (1σ) for the worst case (Figure 4).

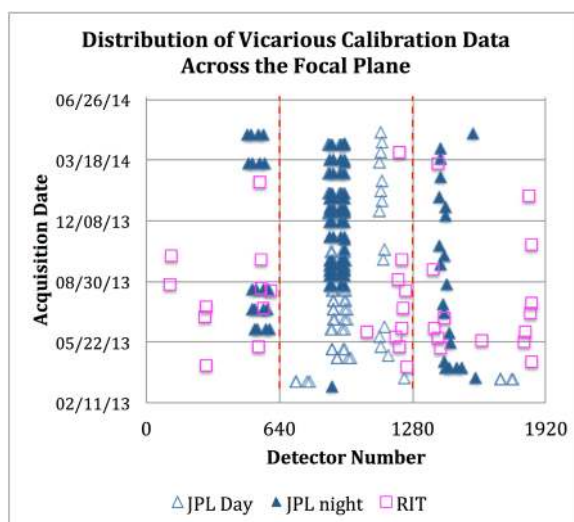
Figure 5. Distribution of vicarious calibration data across the TIRS focal plane. Dashed red lines indicate the boundaries between SCAs; SCA1 consists of detectors 1–640, SCA2 contains detectors 641–1280, and SCA3 is detectors 1281–1920. Note that all the JPL day data since April 2013 falls in SCA2 and for most of the night acquisitions, the satellite has been pointed such that Tahoe falls in SCA2. The RIT acquisitions are based on eight different buoys and are distributed across the focal plane.

angle. As the lakes naturally fall in SCA2 during the day acquisitions, the JPL data are heavily concentrated in SCA2 (Figure 5).

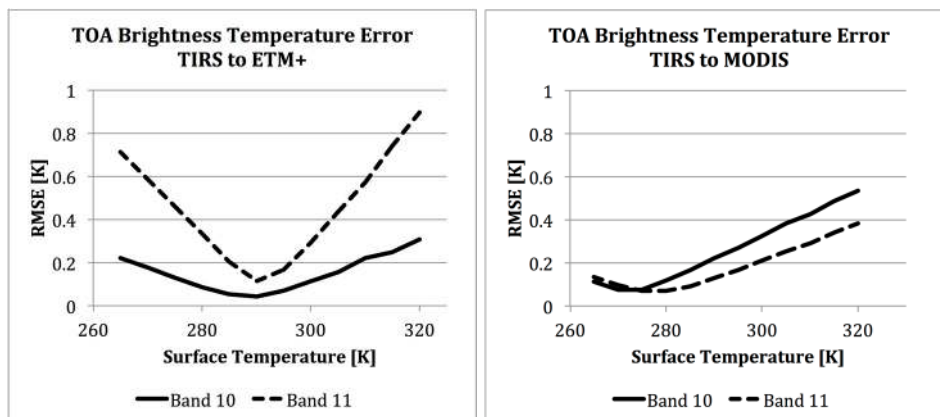
Figure 6. The estimated root-mean-squared error (RMSE) error in comparing the ETM+ (left) or MODIS (right) to TIRS brightness temperatures over a range of surface temperatures and through a variety of atmosphere types. The largest errors are due to less likely conditions, *i.e.*, a very warm surface in a very cold atmosphere.

A study simulating the difference between spectral radiance and brightness temperature was performed to verify the ability to compare data between two different calibrated sensors. Using MODTRAN to perform the radiometric propagation, four North American Regional Reanalysis (NARR) atmospheres [19] were processed to test the difference between brightness temperature for ETM+ or MODIS and the TIRS bands. The NARR atmospheres were selected to cover a wide range of atmospheric conditions, from hot and dry to cold and wet. When compared in terms of apparent temperature, Landsat-7 Band 6 temperatures and Landsat-8 Band 10 or 11 temperatures over water should agree to within ± 0.5 K for most realistic conditions and within ± 1 K for extreme conditions (e.g., very warm moist air over very cold water) (Figure 6). The agreements are better between MODIS Band 31 and TIRS Band 10 and MODIS Band 32 and TIRS Band 11, where even the worst cases should be within ± 0.5 K.

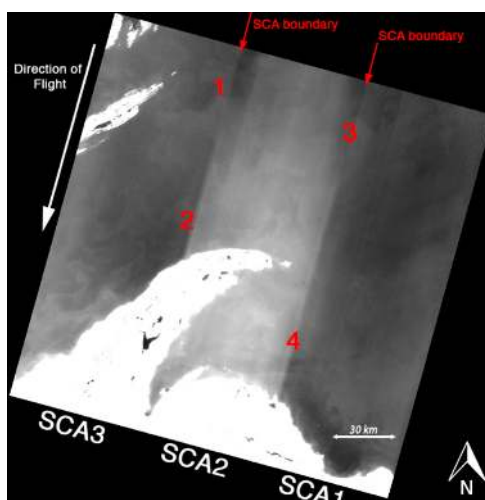
Figure 7. TIRS Band 11 image of Lake Superior (47.5N, 88W) illustrating the discontinuities between the Sensor Chip Assemblies (SCAs) and time-varying nature of the difference. The edges of the SCAs are clearly defined (red arrows) and the differences between the SCAs change from north to south in the image. In a stable system, even with a calibration error, the differences between the SCAs should remain constant for the length of the lake. However, in this example, SCA3 is warmer than SCA2 by 0.2 K at the region marked 1 but is cooler by 0.8 K at region 2. SCA1 is warmer than SCA2 by 0.2 K at region 3 but cooler than SCA2 by 0.7 K at region 4.

The first hint that there was a problem with TIRS was in the discontinuity between SCAs over what should be a uniform target. It was clear from the images that the overlap between adjacent SCAs was not smooth, manifesting itself as a discrete step in the image (Figure 7). Also, the difference appeared to change over time, as the satellite traveled through space. In Figure 7, this is apparent as at the top of the lake, SCA3 is warmer than SCA2 but further south in the image, closer to the peninsula, the contrast flips and SCA2 is warmer.

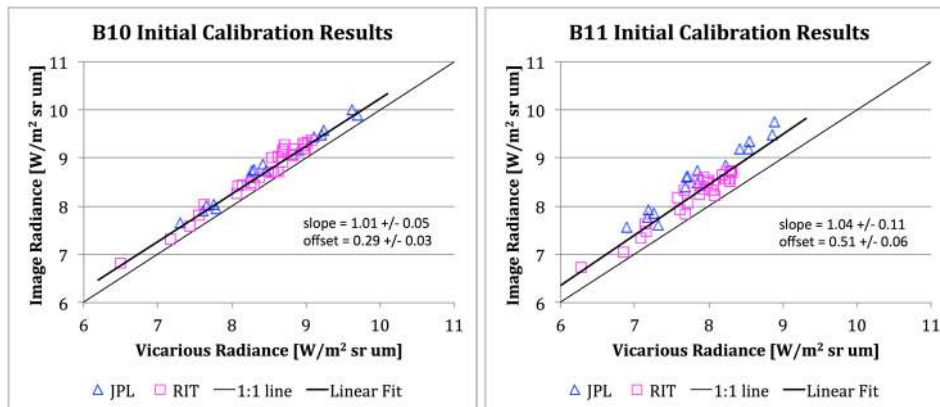
Figure 9. The initial vicarious calibration results for both TIRS bands, based on the day JPL and RIT buoy data. If the instrument were perfectly calibrated, the data would fall scattered about the 1:1 line. All results for both bands are above the 1:1 line indicating that the instrument is predicting too high.

The initial calibration error was calculated in November 2013, based on all the available daytime buoy data from JPL and RIT. The TOA-predicted radiance (vicarious radiance) was compared to the TIRS estimated radiance (image radiance) point for point. The data were spread amongst all three SCAs, though all of the JPL data falls on SCA2. All data from both teams and the three SCAs were treated as one data set and the slope and offset were assessed to determine the calibration error (Figure 9). The slope of the trend was not statistically significant, indicating that there was not likely an error in the calibration gain. However, the data were all above the 1:1 line, indicating that the instrument is predicting a radiance that is too high. This bias error was calculated as the average difference between the vicarious radiance and the TIRS image radiance for all data points for each band.

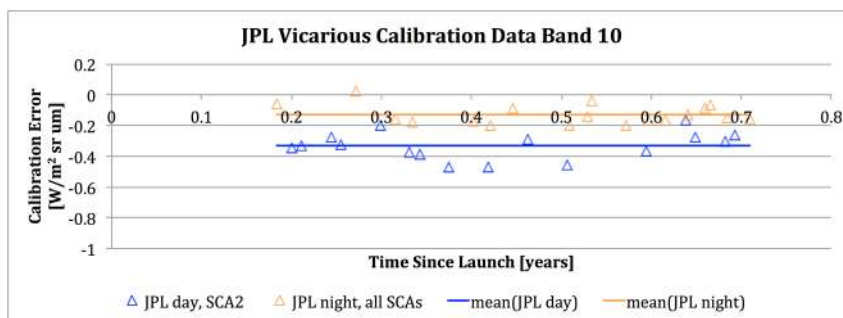
Figure 10. The initial vicarious calibration results for Band 10, based on the JPL data only, displayed as difference between the predicted vicarious radiance minus the image radiance. The data are split into the day and night series. There is a statistically significant difference between the day and night results so only the results for the day data were used to calculate the bias error.

Figure 10 and Table 2 show the calculated calibration error for just the JPL data, broken down by day and night, for all data acquired before November 2013. This difference between day and night acquisitions is also thought to be an effect of the stray light; the solar loading results in the temperature difference between our water targets and the land being greater during the day than at night. Since there is a statistically significant difference between night and day populations and Landsat primarily acquires data during the day, it was decided to determine the bias error from just the day population of data.

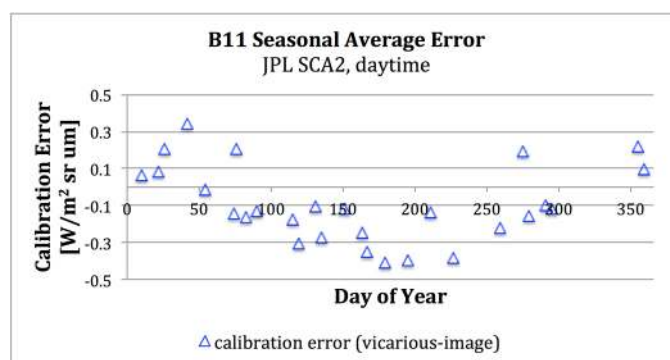
Figure 11. Seasonal effect of the residual bias error for the Band 11 JPL data (includes both Lake Tahoe and Salton Sea). Data are plotted versus day of year so the change in the residual error over the year is apparent.

Figure 11 shows the residual bias error over the year for the JPL day data. The out-of-field surround is very consistent for both the JPL targets: the dataset only includes Lake Tahoe and Salton Sea data and the water bodies are consistently on the same place on the focal plane. Therefore, the surfaces from which the out-of-field contribution is originating are always the same (barring the presence of clouds or snow).

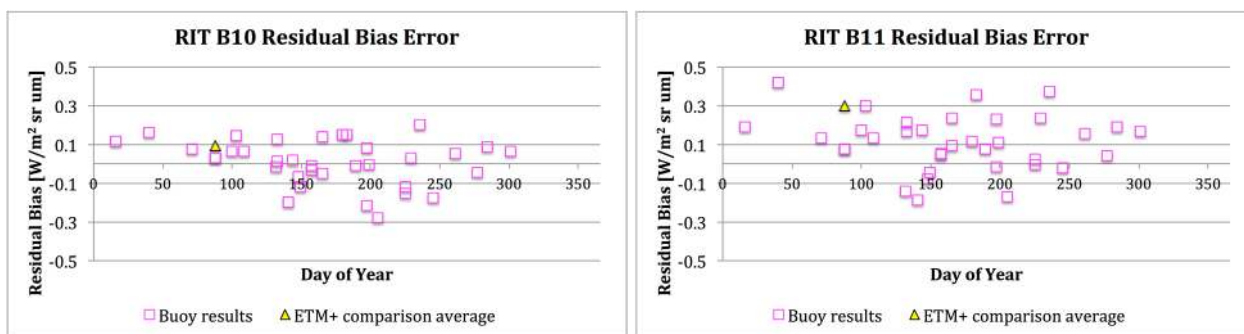
Figure 12. Seasonal effect of the residual bias error for the RIT data, including the average error for the ETM+ comparison. Data are plotted versus day of year but the seasonal effect is not as apparent in the RIT data as in the JPL data (Figure 11). The ETM+ comparison data point sits within the residual errors of the buoy data.

Figure 12 shows the residual error for the buoy data over day of year. The ETM+ comparison has been added as a single point and it falls within the distribution of data for that time of year.

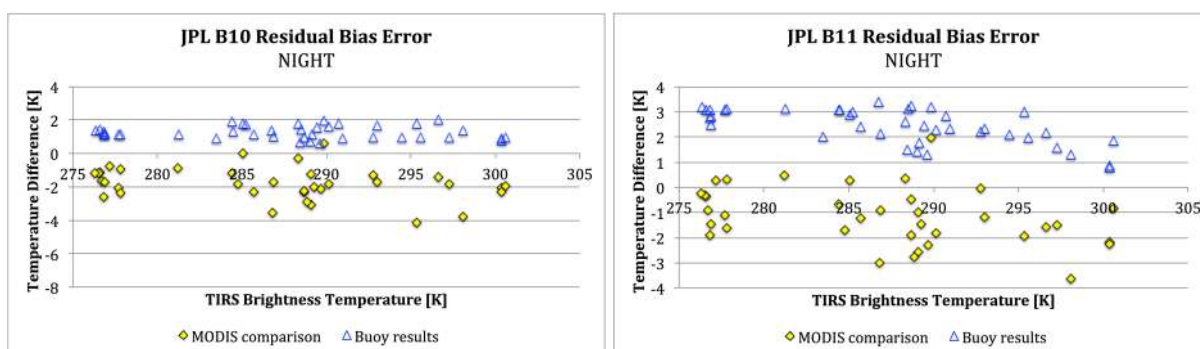
Figure 13. JPL buoy and MODIS comparison results plotted versus target brightness temperature. The trends do not overlap but they both indicate that the residual error is not dependent on target temperature. The trend in the Band 11 data is a function of the seasonal effect of the stray light.

The JPL MODIS to TIRS comparison illustrates how the biases are different day and night, how there is more scatter in the day than night data and how there is more scatter with Landsat-8 band 11 than with Landsat-8 band 10. The fact that there is a larger scatter than with the buoy comparisons can be attributed to mismatch in the acquisition times between the two sensors (Figure 13) and highlights why these sensor-to-sensor comparisons do not provide a substitute for validation against in-situ data. As noted in the introduction, the next step in this analysis will be to derive the surface skin temperature from the MODIS data and use that in a similar manner to the way the buoy data are used to remove the RSR differences.

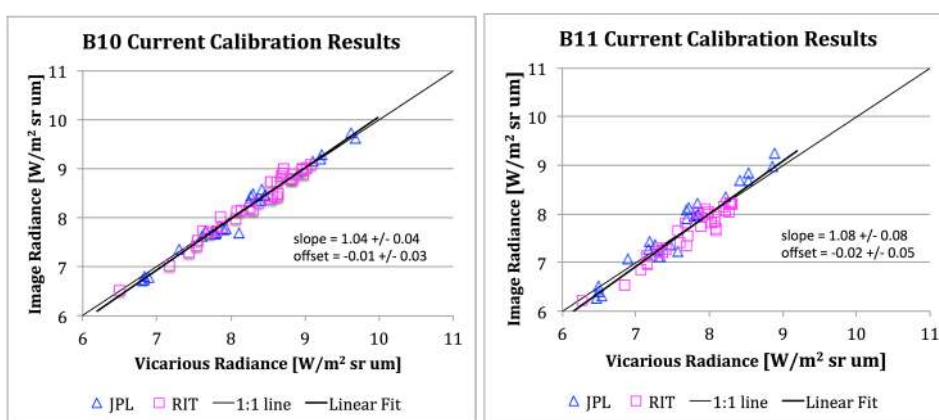
Figure 14. Current vicarious calibration results for the two TIRS bands, including both RIT and JPL data for all SCAs, but only displaying day data. The data are scattered about the 1:1 line, indicating that the residual error has been removed. Neither the slope nor the offset is statistically significant.

on the collected dataset now does not have a statistically significant bias error (Figures 14 and 15 and Table 4).

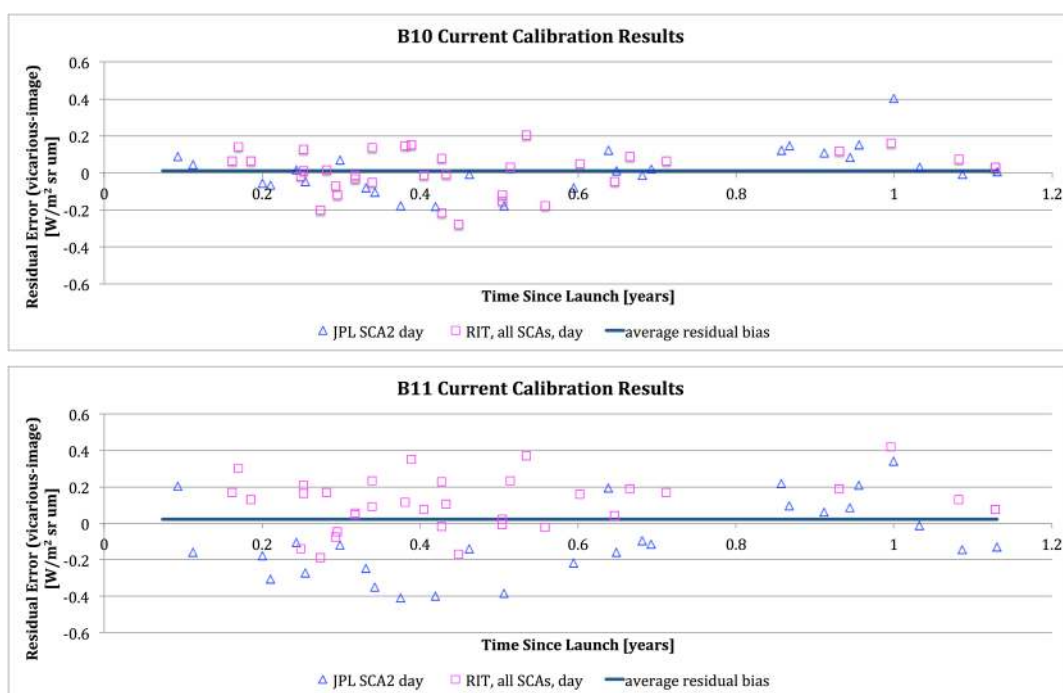
Figure 15. Current vicarious calibration results for the two TIRS bands over time. The residual difference between the vicarious radiance and the image radiance is scattered about the zero axis.
