Light Unmanned Aerial Vehicles (UAVs) for Cooperative Inspection of PV Plants

Abstract—After a fast photovoltaic (PV) expansion in the past decade supported by many governments in Europe, in this postincentive era, one of the most significant open issues in the PV sector is to find appropriate inspection methods to evaluate real PV plant performance and failures. In this context, PV modules are surely the key components affecting the overall system performance; therefore, there is a main concern about the occurrence of any kind of failure in PV modules. This paper aims to propose a novel concept for monitoring PV plants by using light unmanned aerial vehicles (UAVs) or systems (UASs) during their operation and maintenance. The main objectives of this study are to explore and evaluate the use of different UAV technologies and to propose a reliable, cost-effective, and time-saving method for the inspection of PV plants. In this research, different UAVs were employed to inspect a PV array field. For this purpose, some thermal imaging cameras and a visual camera were chosen as monitoring tools to suitably scan PV modules. The first results show that the procedure of utilizing UAV was

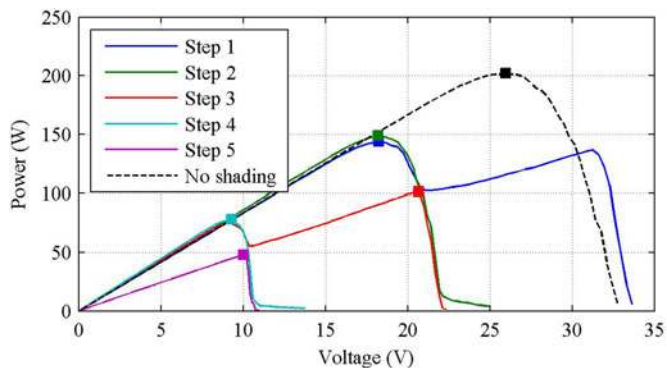
Fig. 2. P - V characteristic of multiple diagonal steps shadowing effects on the same module (from [15]).

When the solar cells are subjected to shadowing, they may operate reversely as loads, as shown in Fig. 2. Therefore, in this case, the solar cells consume energy instead of generating it [15]. In addition, sufficient protection can prevent hot spots

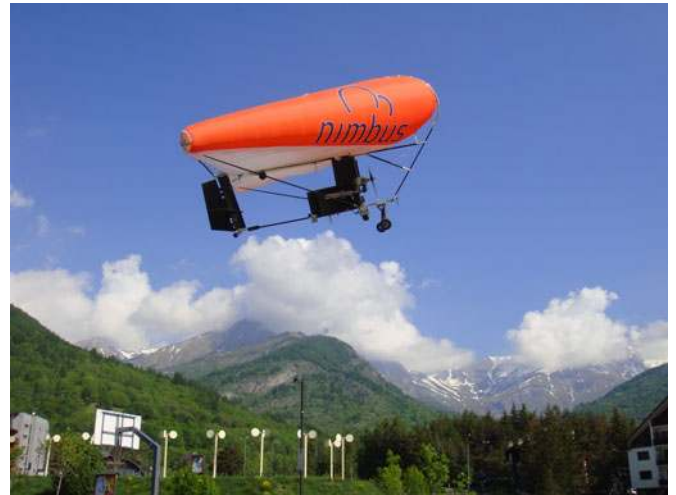
Fig. 4. Nimbus EosXi UAV platform.

In this investigation, two different UASs have been employed to inspect the PV modules' conditions: Nimbus EosXi UAV (see Fig. 4) for a first analysis and Nimbus PLP6 (see Fig. 5) for an in-depth analysis and detailed information about the plant. Both of them can be classified in the *light UAS* segment. In fact, the use of UAVs can reduce the monitoring cost much more than the other methods. Inspection by this method will be fast and it can save monitoring time. Therefore, this method can be appropriate for small and large PV array fields to find out PV modules' degradation and other failures. However, the early recognition of defects can prevent extending PV modules' degradation and wasting energy. The key aspects of UAV application in PV module monitoring include flexibility, fast detection of a large PV array field, and cost-effectiveness.

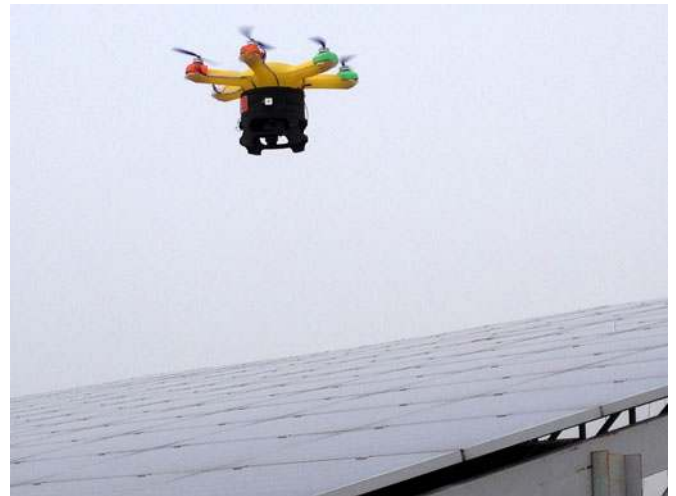
Fig. 5. Nimbus PLP6 during PV monitoring operation.

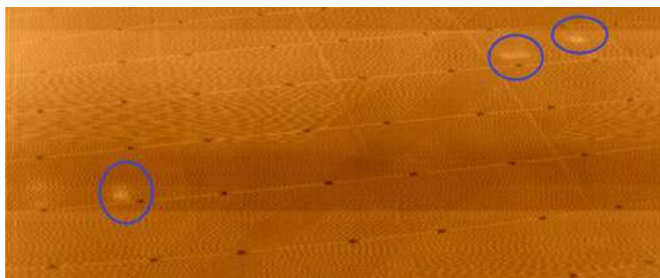
Fig. 6. Different hot areas captured by a thermal camera.

First of all, a preliminary analysis was made using the bigger Nimbus EosXi UAV platform for an overall view of the plant. Figs. 6–8 have been captured by a MicroCAM 640 thermal camera.

As shown in Fig. 6, some defective points have been detected in different areas of the PV field. Depending on their shape and location, these hot spots and hot areas can highlight different faults. Usually, if an entire module is warmer than usual, as partially shown in Fig. 1 (taken by a Fluke Ti 25 thermal camera), then some interconnection problems can be envisaged. On the other hand, if single cells or strings of cells are showing up as a hot spot or a warmer "patchwork pattern," as shown in Fig. 7, the reason can usually be found either in defective bypass diodes, internal short-circuits, or in a cell mismatch, as well as due to snail trails phenomenon. Sometimes, shadowing and cracks in cells show up as hot spots (see Fig. 8) or polygonal patches in the thermal image. The temperature rise of a cell (or part of it) indicates a defective cell or shadowing.

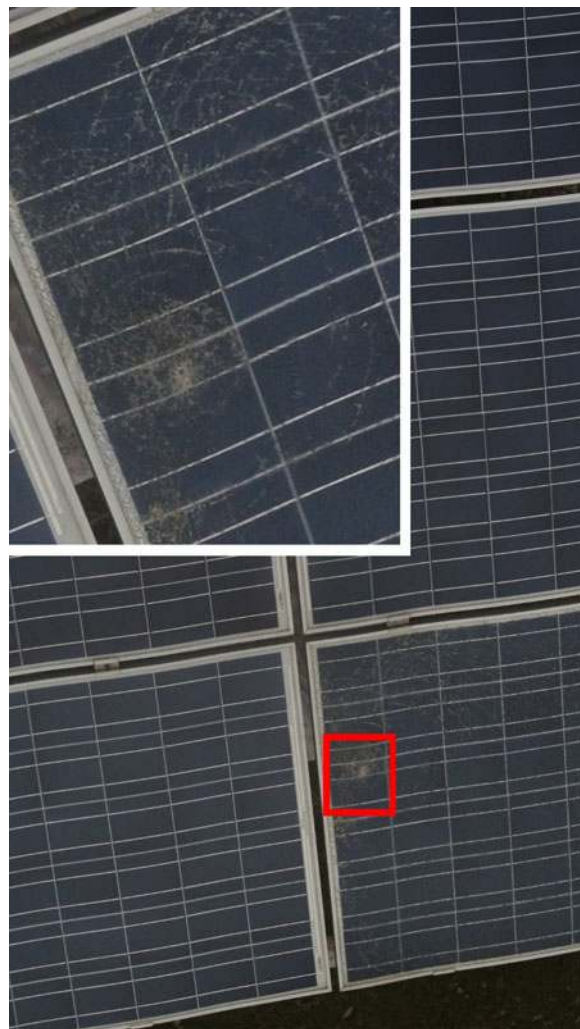
Fig. 9. Picture captured by a Nikon1-v1 camera with inlet detail of a particular shock-defect.

However, the distance between the PV array and the UAV in this case did not allow the accurate identification of additional information on the type of problem that was causing the overheating of some cells. The use of the second type of UAV allows us to get closer to the shelter and, consequently, to the modules. In this case, we performed a second analysis using a different sensor, namely a camera in the visible range. Figs. 9 and 10 show some of the results obtained. First picture shows that the defect detected by the thermal analysis is because of breaking of the glass (a mechanical shock). The second picture shows the snail trail phenomenon.
