5. Materials and Techniques for Spacecraft* Static Charge Control

L.J. Amore and A.E. Eagles
General Electric Company
Space Division
Valley Forge, Pennsylvania

An overview of the design, development, fabrication, and testing of transparent conductive coatings and conductive lattices deposited or formed on high resistivity spacecraft dielectric materials to obtain control static charge buildup on spacecraft external surfaces is presented.

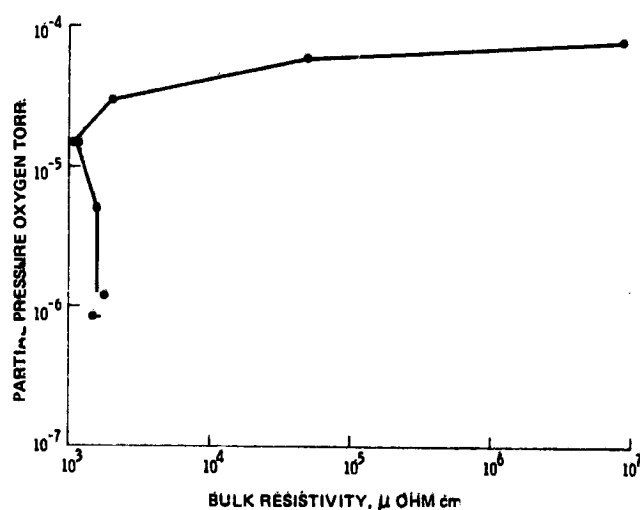
The electrical conductivity of sputtered ITO films decrease as the partial pressure of oxygen rises beyond 1×10^{-5} as can be seen in Figure 3. This data was taken from measurements using RF diode sputtered films of ITO on microsheet substrates. Recent results using magnetron sputtering where the glass surface is cool during deposition have also supported the ITO coatings dependence on partial pressure of oxygen.

Figure 3. Resistivity of Sputtered Indium Oxide/Tin Oxide Films

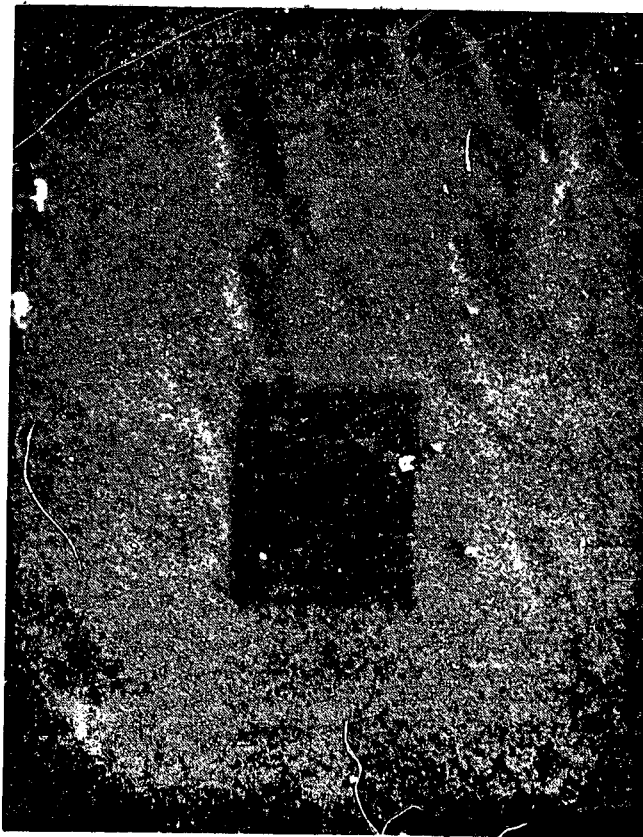
Surface characteristics of Kapton and ITO coated Kapton were observed with an electron microscope at 10,000X (see Figures 4, 5, and 6). Figure 4 reveals a uniform Kapton surface with no evidence of imperfections. Figure 6 reveals a surface that underwent severe flexing (180° bend) with subsequent micro-fracturing of the film. This defect did not affect the conductivity of the film under electron beam bombardment as will be described later.

Figure 4. Uncoated Kapton Surface (at 10,000X)

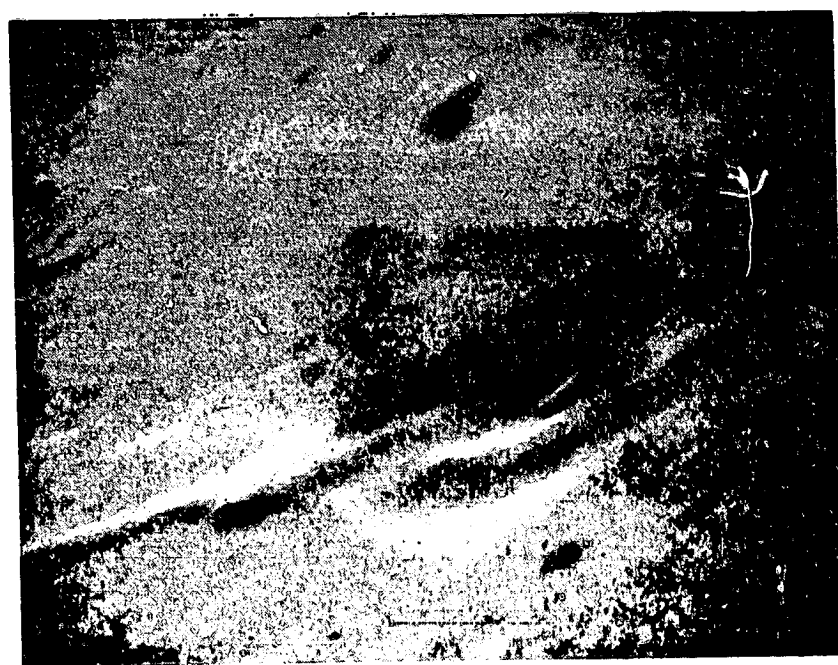
Figure 5. Kapton Coated with 500 Å of ITO (at 10,000X)

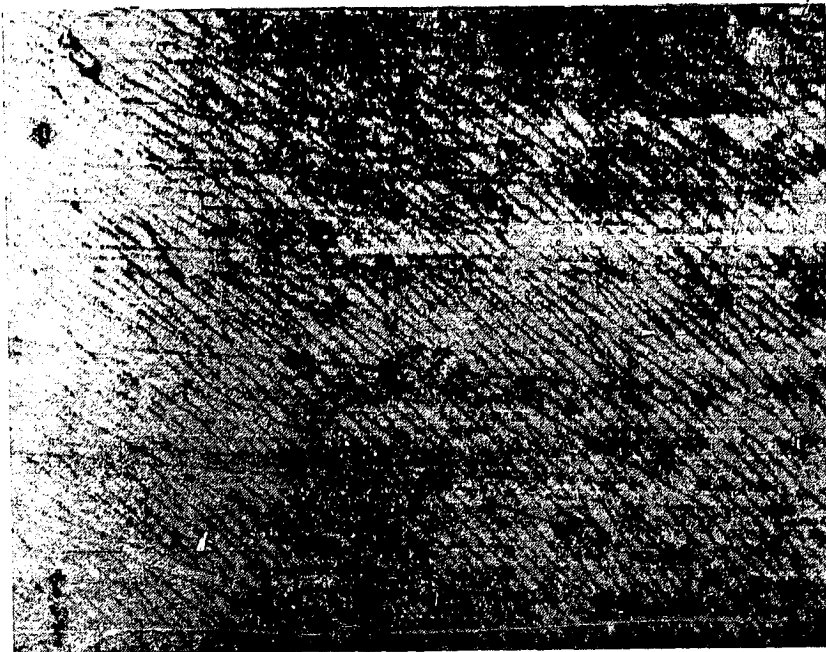
Figure 18b. FEP/ITO After Electron Irradiation at the Central Region of the Electron Beam. Electron etched craze lines appear on the FEP-Teflon surface, together with fabrication die lines, under the transparent semi-conductor (200X)

Micrographs of ITO (250 Å) coated FEP Teflon after electron beam irradiation are shown in Figure 18b indicating "electron-etched" cracking and crazing. These craze-cracks (due to large applied anisotropic stress or tensile force) run along parallel direction of stretch lines to which the material was subject (that is, longitudinal drawing or pulling and radial blowing), as is evidence by the micrograph of the unexposed spacecraft material (Figure 18a) and less evident outside the electron beam irradiation area (Figure 18c). The stretch lines correspond to the direction of molecular orientation, preferentially, since the polymer under the coating has less strength perpendicular to the direction of orientation. Crystallization occurs along these oriented molecules.

Within these imperfections and voids intrapped gas is ionized by electron beam charging. Local temperatures rise, chemical reactions occur and stress is created, as in the case of chemical or vapor etching.
