Mechanical behaviour of thermoplastic composites spot-welded and mechanically fastened joints

A preliminary comparison

Composites Part B: Engineering

Mechanical Behaviour of Thermoplastic Composites Spot-Welded and Mechanically Fastened Joints: A Preliminary Comparison

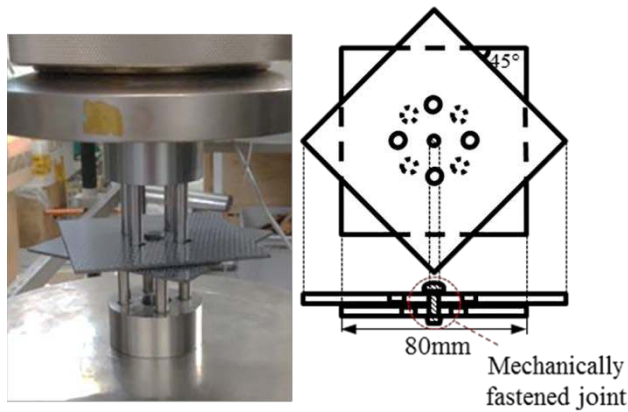
Fig. 2. Loading fixture and specimen configurations for PT tests: (a) spot-welded specimen; (b) mechanically fastened specimen.

The out-of-plane performance of both welded and mechanically fastened joints was evaluated with pull-through (PT) tests following ASTM D7332-09 [26]. Specimens consisting of two square composite plates assembled with either a spot weld or a mechanical fastener were placed in between a pair of loading fixtures (see Fig. 2). The size of the composite plates is shown in Fig. 2. To accommodate the test fixture, four holes were drilled on each plate prior to the assembly and the top plate was joined at a 45° angle with respect to the bottom one. A compressive load was applied on the fixture with a Zwick/Roell 250kN universal testing machine, which resulted in a tensile force on the joints. Specimens were loaded with a crosshead displacement rate of 0.5 mm/min and the tests were stopped following the 30% load drop principle as well. Five specimens were tested for both types of joints.

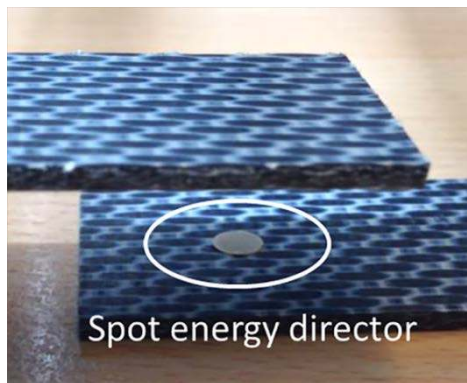
Fig. 5. Spot energy director fixed on composite adherend prior to welding process.

Spot flat energy directors, made of a neat resin film, were used to create the spot-welded joints in this study, as shown in Fig. 5. To keep consistent with the pin diameter of the mechanical fasteners, 4 mm-diameter-circular energy directors (EDs) were used, as cut from the PEEK film with a nominal thickness of 0.25 mm. Prior to the welding process, the spot EDs were manually fixed on the bottom adherend with a Rinco handheld ultrasonic welder. The ED melted, flowed and created a bigger spot-welded joint (approximately 10mm in diameter) during the welding process, which will be illustrated in detail in Section 3.1.

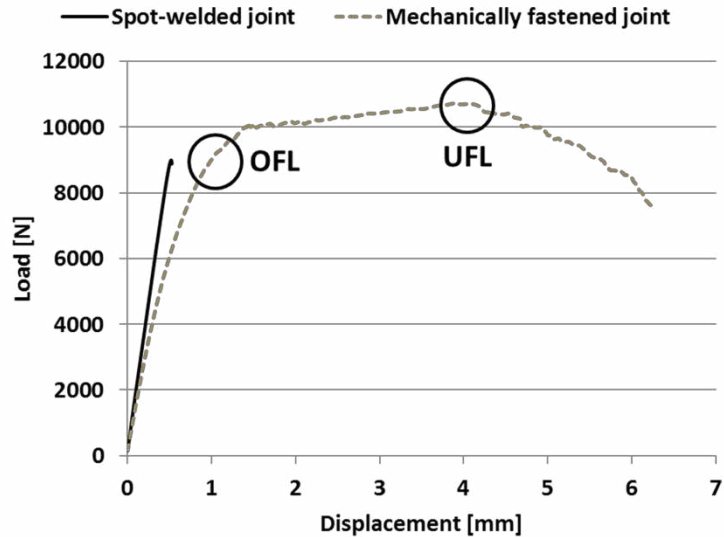
Fig. 7. Comparison of representative Load-displacement curves between spot-welded (solid line) and mechanically fastened (dashed line) joints in DLS tests. The left and right circles indicate the onset and ultimate failure, respectively. The data are adopted from [31].

A comparison of representative DLS L-D curves between the spot-welded and mechanically fastened joints is summarized in Fig. 7. The black solid line corresponding to the spot-welded specimen exhibits a linear behaviour with a continuous load increase and no obvious reduction of the joint stiffness observed until ultimate failure. On the contrary, the loading history of mechanically fastened specimen with a HL10V6 fastener (the grey dashed line) shows different stages, which is in good agreement with the study in [20]. Basically, four different stages can be observed from the L-D curve: (1) the load linearly increases in the initial period until the obvious slope/stiffness alternation. Although the load transfer mechanisms are different in this stage, due to the very small change of the stiffness, the first two stages illustrated in [20] are regarded as one stage; (2) the joint stiffness keeps on decreasing while the load continues to increase due to the presence of bearing damage; (3) the load almost keeps constant until the maximum point (UFL), illustrating the joint slowly losing load-carrying capability with the evolution of bearing damage; (4) the load has a continuous drop which indicates the ultimate failure of the joint.

Fig. 7. Comparison of representative Load-displacement curves between spot-welded (solid line) and mechanically fastened (dashed line) joints in DLS tests. The left and right circles indicate the onset and ultimate failure, respectively. The data are adopted from [31].

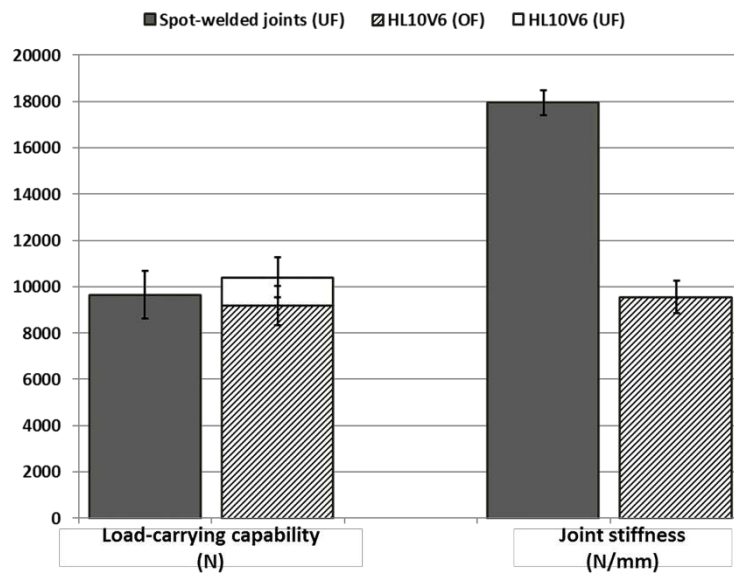
Fig. 8. Comparison of in-plane mechanical (shear) performance for both types of joints in DLS tests. (OF: onset failure, UF: ultimate failure) The error bars indicate the standard deviation.

Table 1 lists the average OFL, UFL and JS of both types of joints, accompanied by the corresponding coefficient of variation (COV) in the parentheses. Since the welded specimens failed immediately after the maximum load was reached, only UFL was represented. As mentioned in Section

2.1, the OFL of mechanically fastened joints, which is more important in the structural design rather than the UFL [23], was calculated by using bilinear approximation. It is notable that the OFL of both types of joints in DLS tests are within the same range, which is also indicated by the bar graph in Fig. 8. The variation of the load-carrying capability of both types of joints are within standard deviation, which is displayed by the error bars. In contrast, the averaged stiffness of spot-welded joints is reported to be substantially higher, by 88%, than the mechanically fastened specimens. In addition, the COV is lower for the spot-welded joints.

Fig. 8. Comparison of in-plane mechanical (shear) performance for both types of joints in DLS tests. (OF: onset failure, UF: ultimate failure) The error bars indicate the standard deviation.

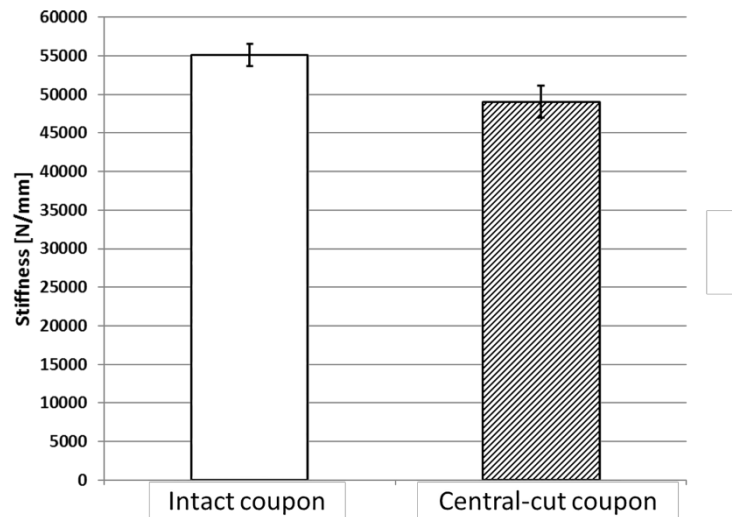
Fig. 9. Comparison of stiffness between intact and central-cut coupon in tensile test.

To figure out the main cause for the stiffness reduction in the mechanically fastened joints, tensile tests were carried out on CF/PEEK composites coupons with and without the central hole. Fig. 9 shows the experimental results. It can be noted that, compared to intact composite coupons, the stiffness reduction of central-cut coupon (approximately 12%) is not as significant as the stiffness difference observed in DLS tests. Therefore, the stiffness degradation observed in the mechanically fastened joints is likely induced by the concentrated pin-load applied on the interior of the circumference of the bolted hole during the DLS tests.

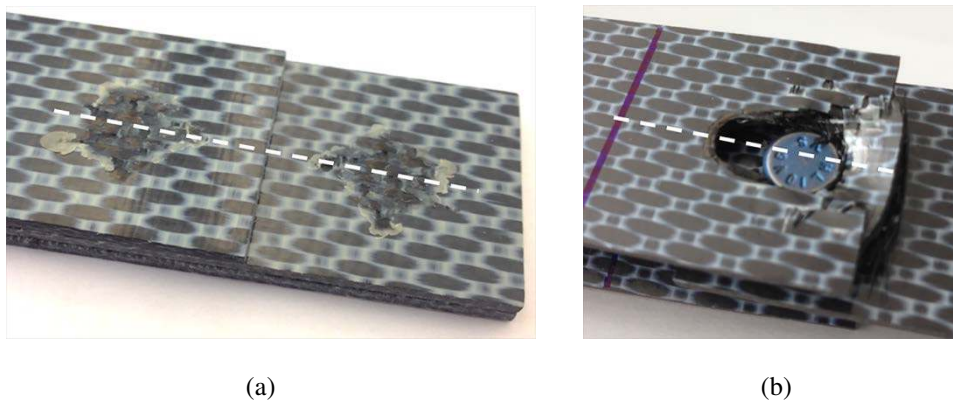
Fig. 17. Central-cut of both welded (a) and mechanically fastened (b) specimens along the dashed lines for the cross-sectional microscopy.

A combination of ultrasonic C-scan and cross-sectional microscopy was used to assess the internal damage in both the welded and the mechanically fastened joints. To characterize the through-the-thickness damage utilizing a microscope, some selected specimens were cross-sectioned through the central line of the overlap, parallel to the apparent fibre orientation, as indicated in Fig. 17. Afterwards, the sectioned specimens were embedded in epoxy and polished. The experimental results are separately shown based on DLS and PT tests.
