Microstructural Alterations Associated With Friction Drilling of Steel, Aluminum, and Titanium

Scott F. Miller, Peter J. Blau, and Albert J. Shih

Friction drilling, also called thermal drilling, is a novel sheet metal hole-making process. The process involves forcing a rotating, pointed tool through a sheet metal workpiece. The frictional heating at the interface between the tool and workpiece enables the softening, deformation, and displacement of work-material and creates a bushing surrounding the hole without generating chip or waste material. The bushing can be threaded and provides the structural support for joining devices to the sheet metal. The research characterizes the microstructures and indentation hardness changes in the friction drilling of carbon steel, alloy steel, aluminum, and titanium. It is shown that materials with different compositions and thermal properties affect the selection of friction drilling process parameters, the surface morphology of the bore, and the development of a highly deformed layer adjacent to the bore surface.

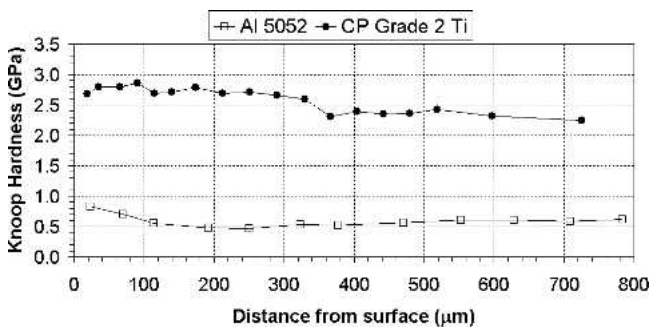
Fig. 12 Knoop microindentation subsurface hardness profile of the friction-drilled bore for Al 5052 and CP Ti (0.245 N force used)

Figure 12 compares the subsurface Knoop hardness versus depth profiles of the aluminum and titanium sheet. For titanium, the highly-deformed swirled regions, like those shown in Fig. 10 had Knoop microindentation hardness values ranging from about

2.6 to 3.5 GPa, while the granular regions just below the swirled region had hardness values of about 2.2 GPa. For aluminum, due to its high thermal conductivity, the reduction of hardness is gradual and deep (over 200 μm) into the workpiece.
