**MODEL PREDICTIONS OF WIND  
AND TURBULENCE PROFILES  
ASSOCIATED WITH AN ENSEMBLE  
OF AIRCRAFT ACCIDENTS**

*G. G. Williamson, W. S. Lewellen,  
and M. E. Teske*

AERONAUTICAL RESEARCH ASSOCIATES OF PRINCETON, INC.

NATIONAL AERONAUTICS AND SPACE ADMINISTRATION • WASHINGTON D. C. • JULY 1977

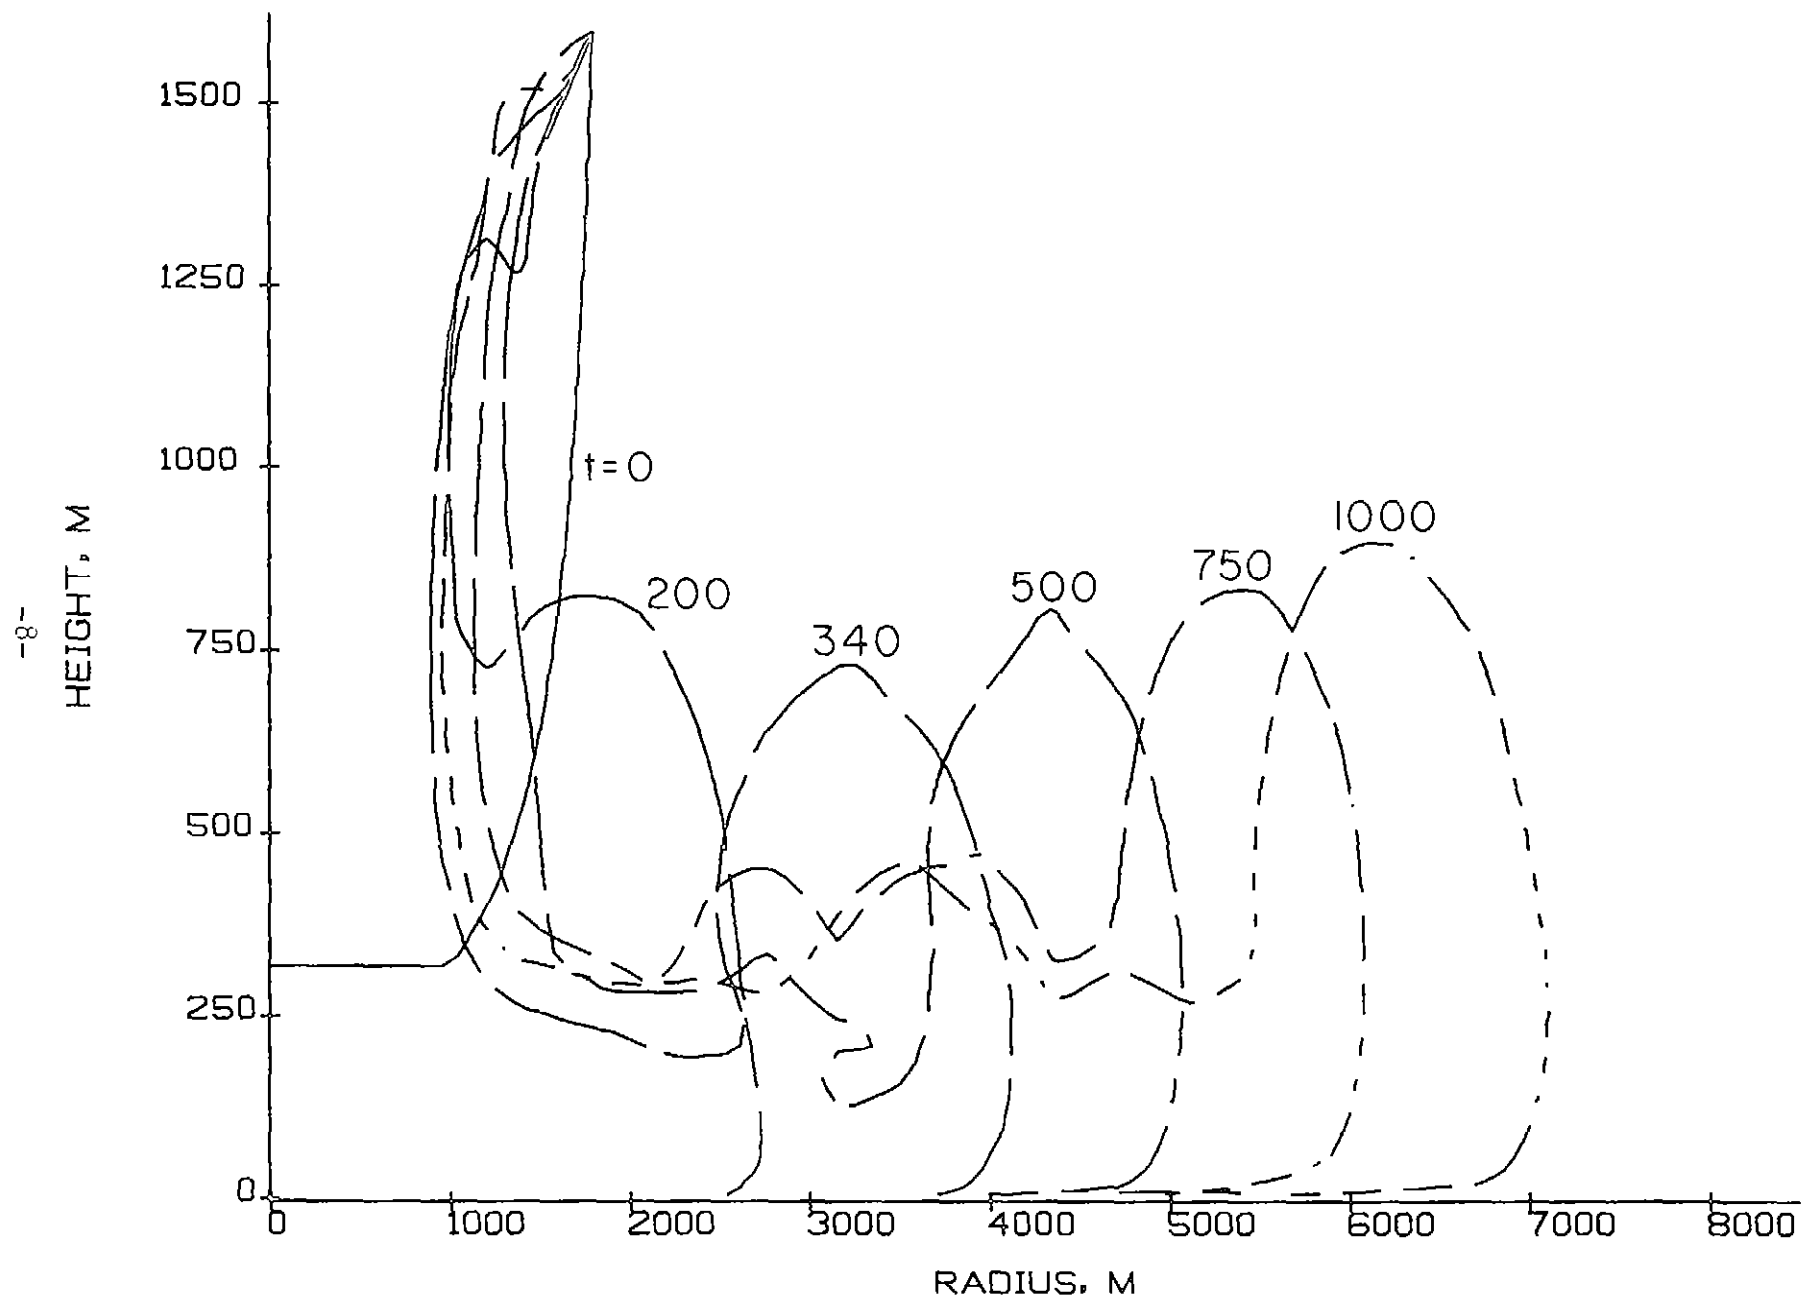
Figure 2.3.1. Growth of axisymmetric gust front as illustrated by the  $T=-200$  contour at  $t = 0, 200, 340, 500, 750, 1000$  sec.

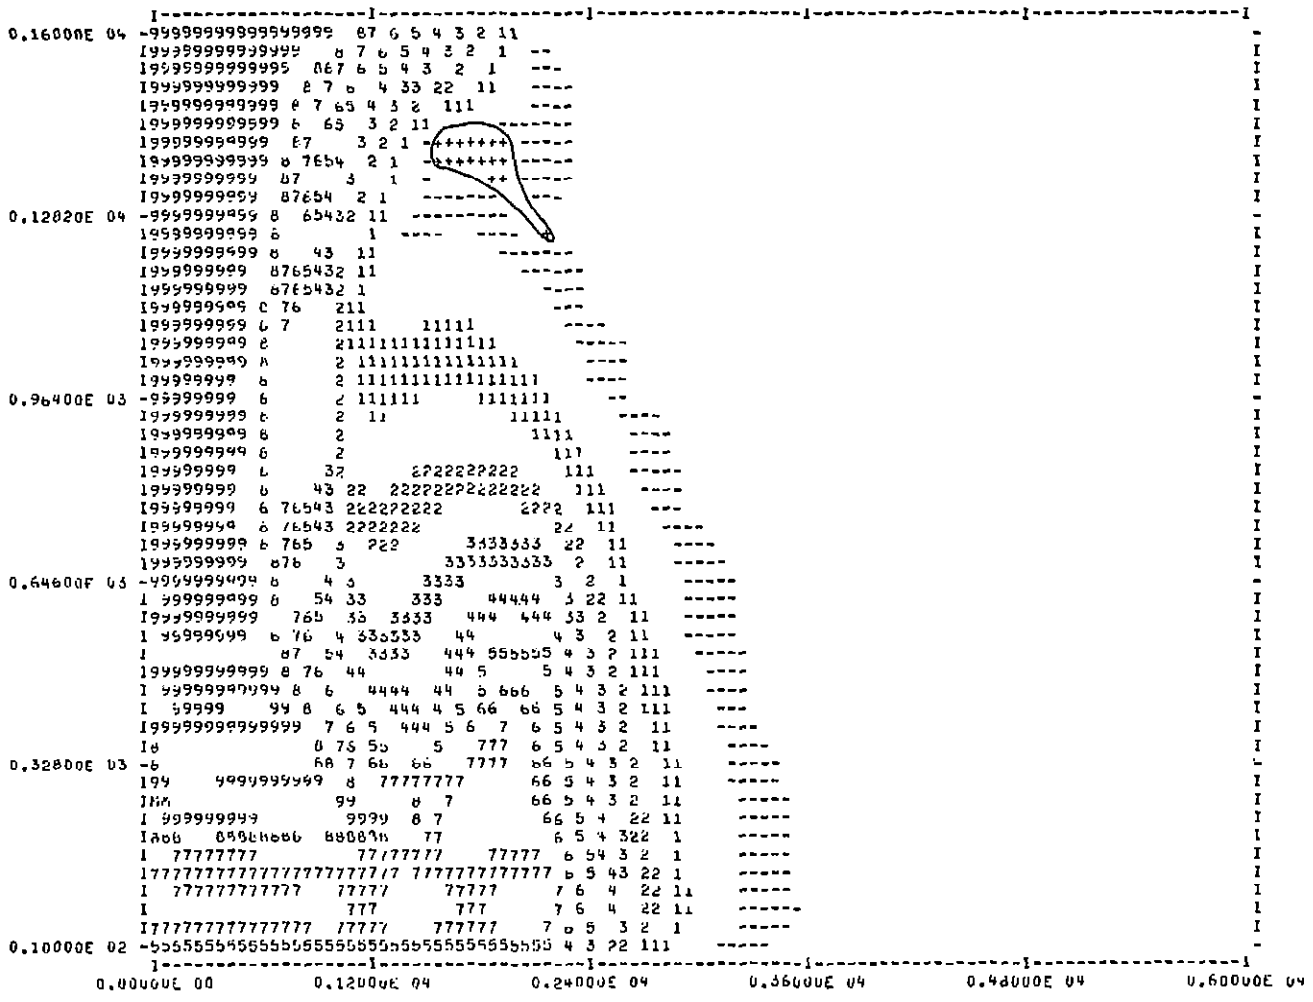
PRINTER PLOT FOR T                    ABS MAX VALUE = 0.11441E 02                    X = 0.26600E 03                    DATE=02/11/77                    FILE=6UST5  
 PERCENT MAX    1/-1                    5/10                    15/20                    25/50                    35/40                    45/50                    55/60                    65/70                    75/80                    85/90                    95/100  
 NOTATION       +-                    1                    2                    3                    4                    5                    6                    7                    8                    9                    PM

Figure 2.3.2. Normalized temperature contours as a function of z and R for an axisymmetric gust front with a 2000 m radius downdraft at t = 200 sec. [The numbers represent the percentage of the maximum value indicated across the top. The same number may represent either a + value. The P represents a positive maximum and M as minimum. The zero contour is outlined.]

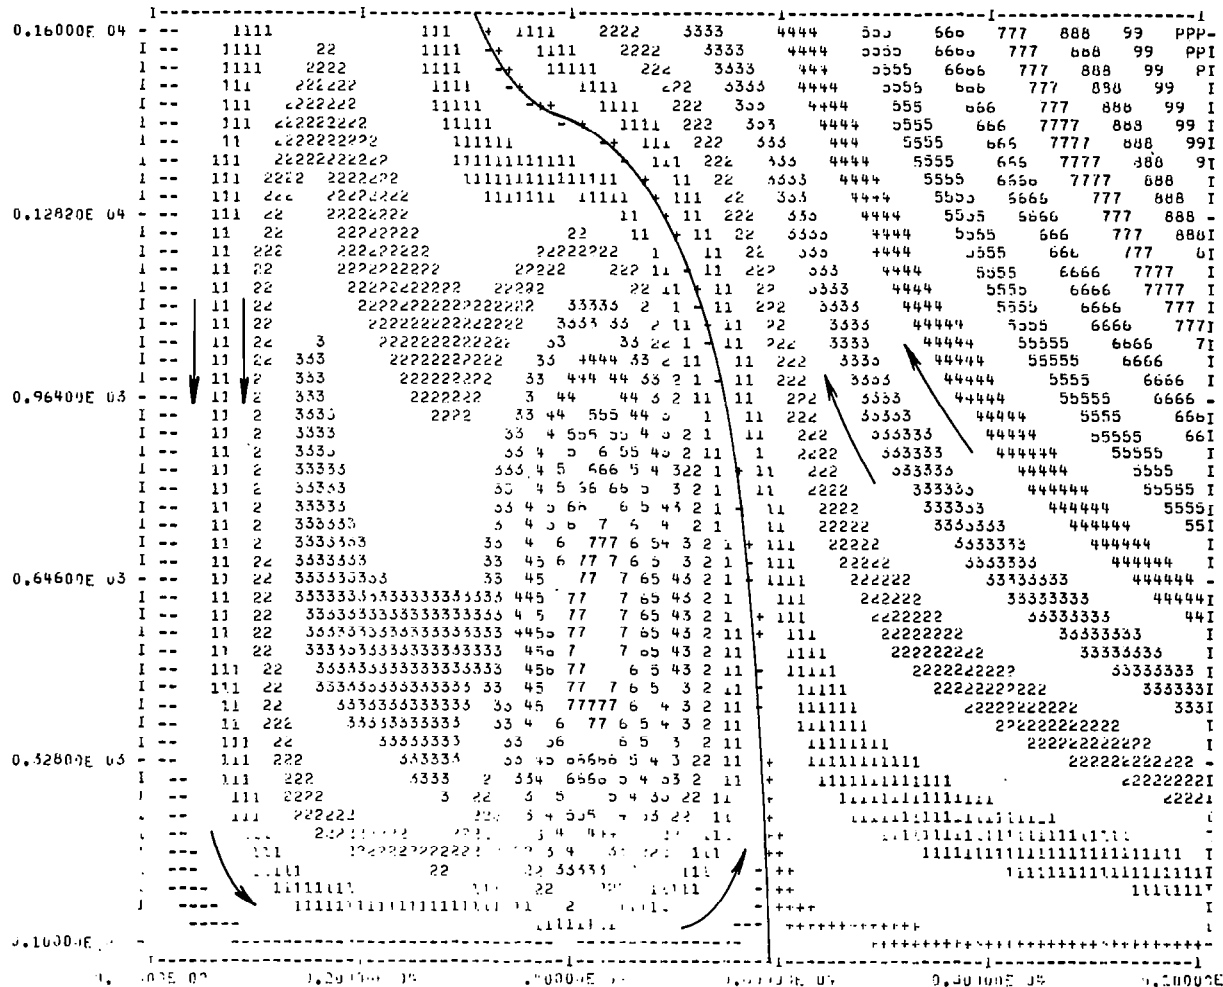
Figure 2.3.6. As above but t = 500 sec. [See figure 2.3.2 for explanation of notation.]

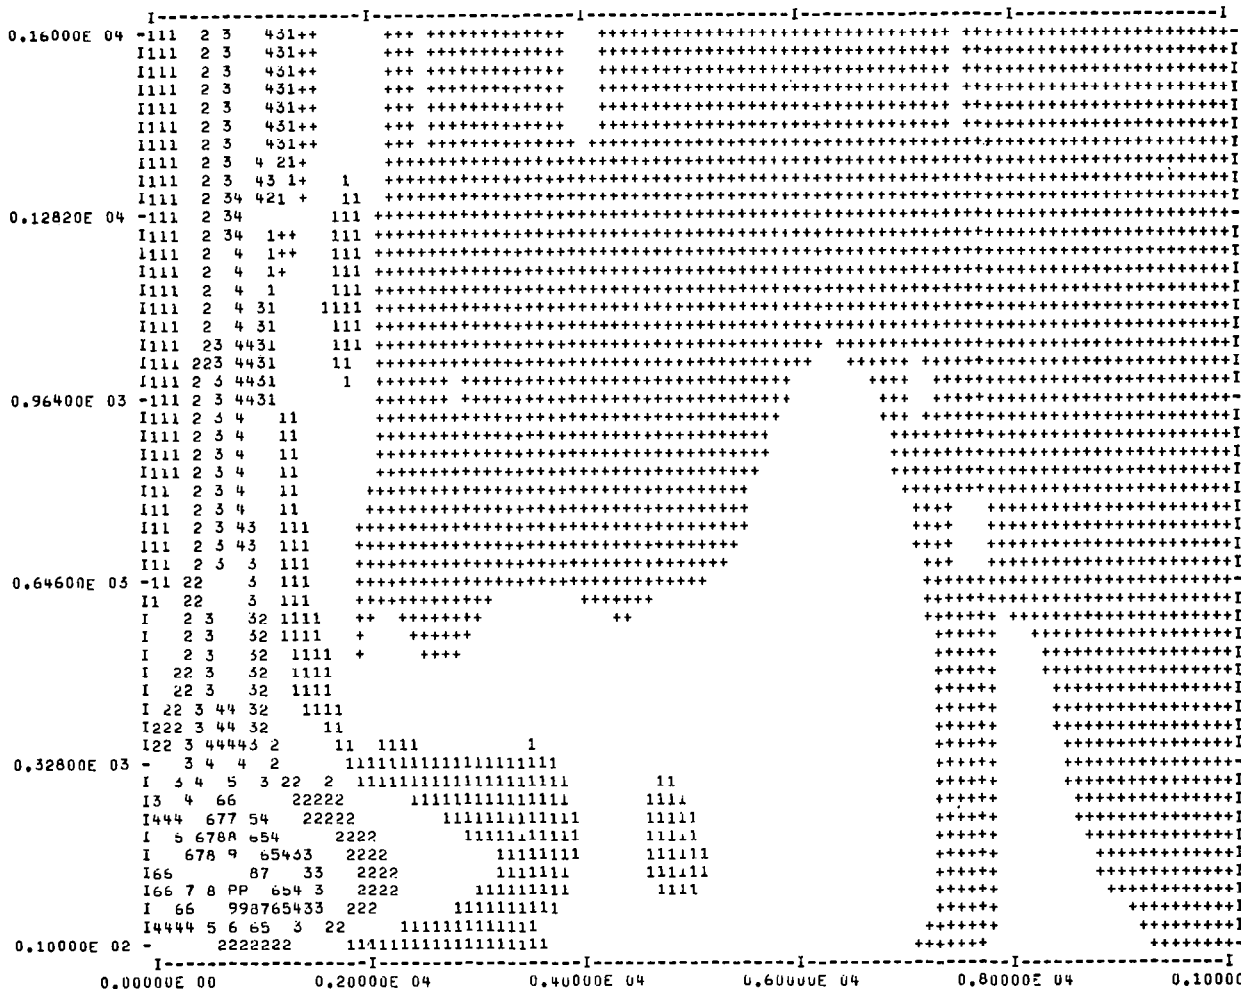
Figure 2.3.16. As above but t = 1000 sec. [See figure 2.3.2 for explanation of notation.]

We show the vertical energy component  $w'w'$  in figures 2.3.14 - 2.3.16. At  $t = 200$  sec the largest values occur in the region of greatest production - near the centerline at the surface. Subsequent profiles at 500 and 1000 sec show the development near the axis, and the decay of generated turbulence in the gust front region.

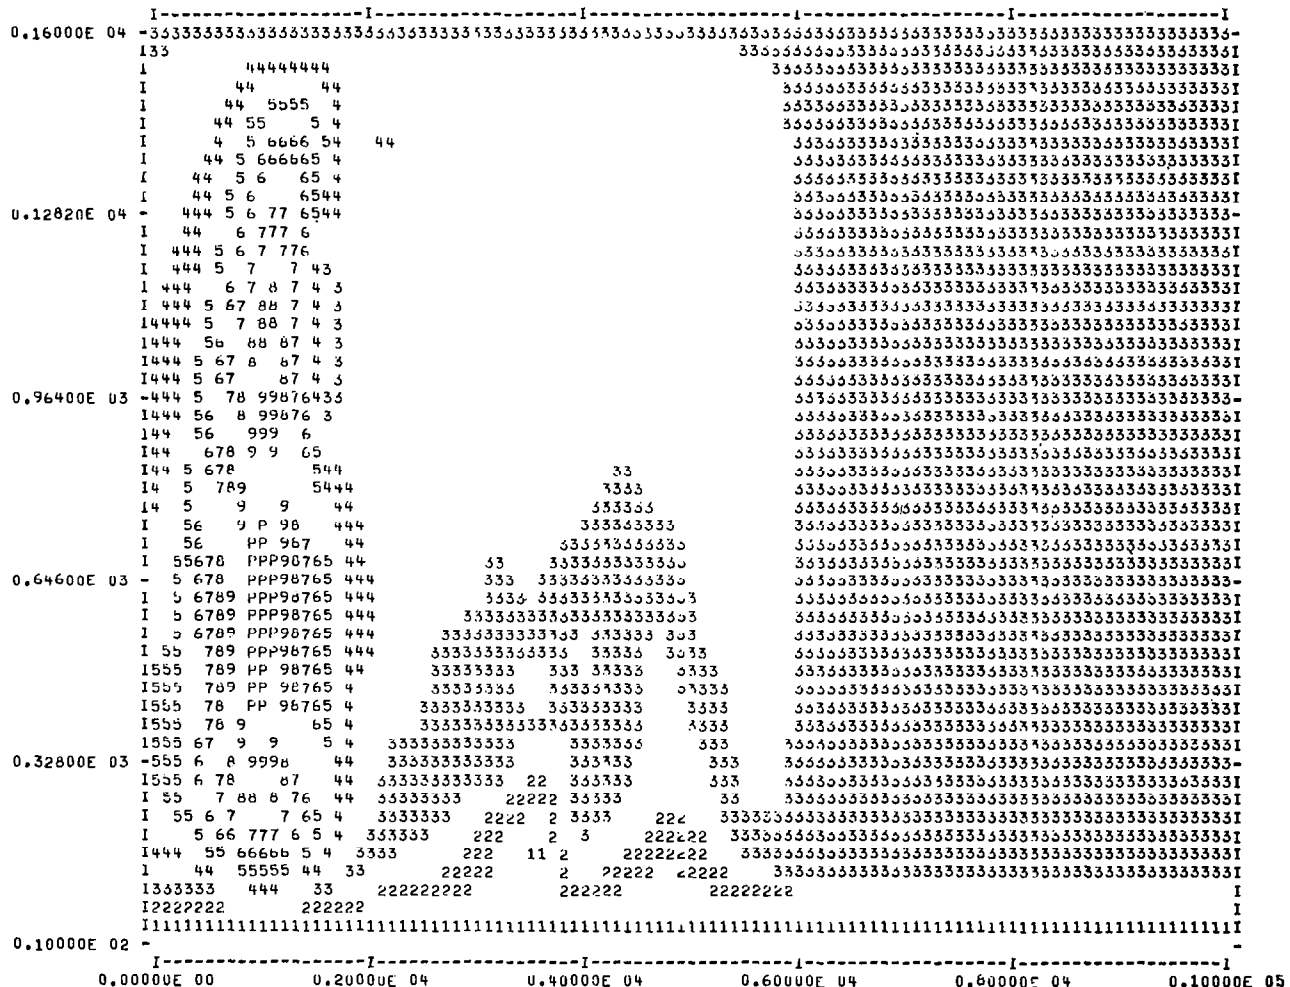
Figure 2.3.18. As above but t = 500 sec. [See figure 2.3.2 for explanation of notation.]

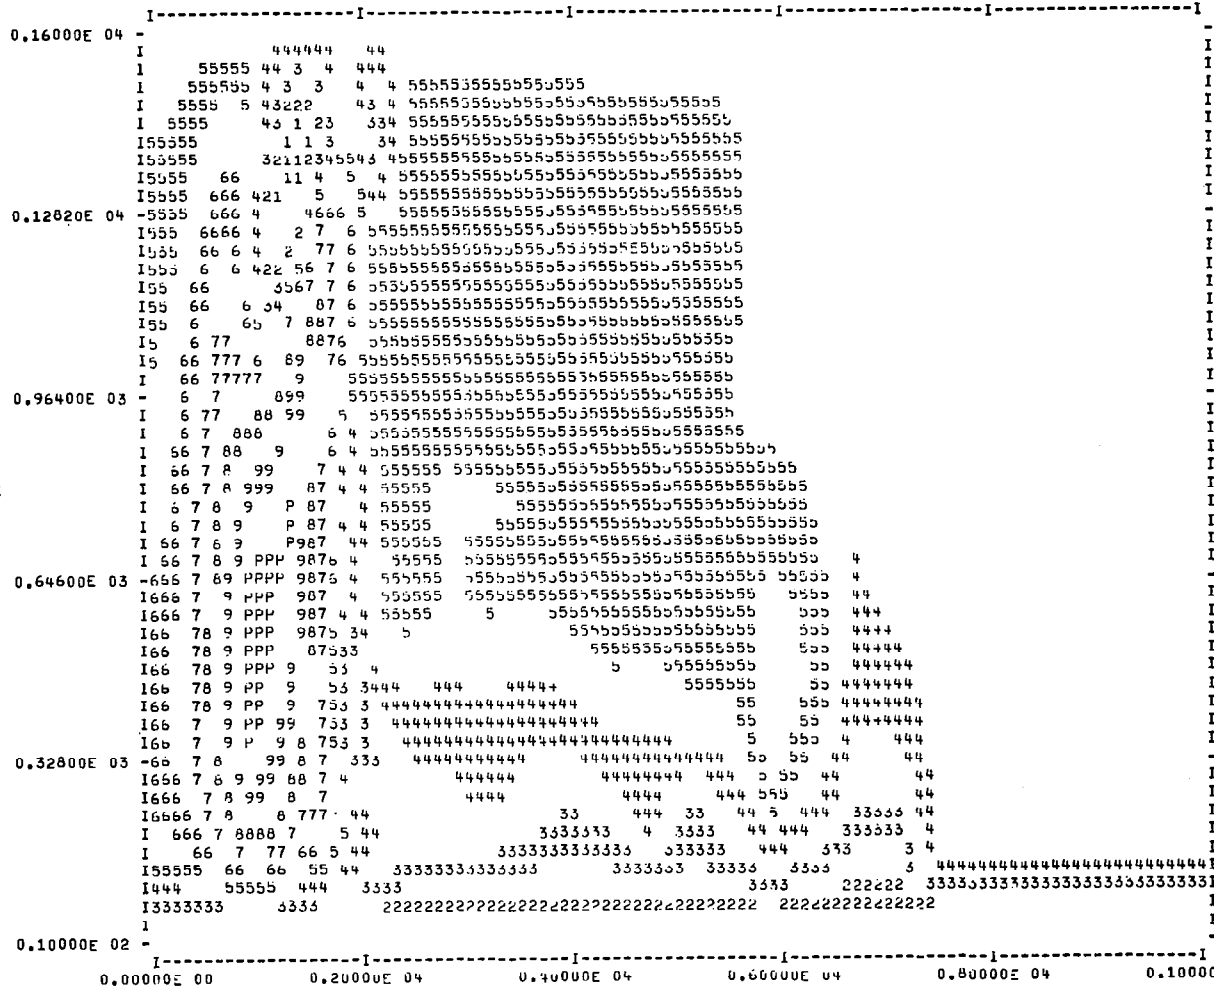
Figure 2.3.19. As above but t = 1000 sec. [See figure 2.3.2 for explanation of notation.]

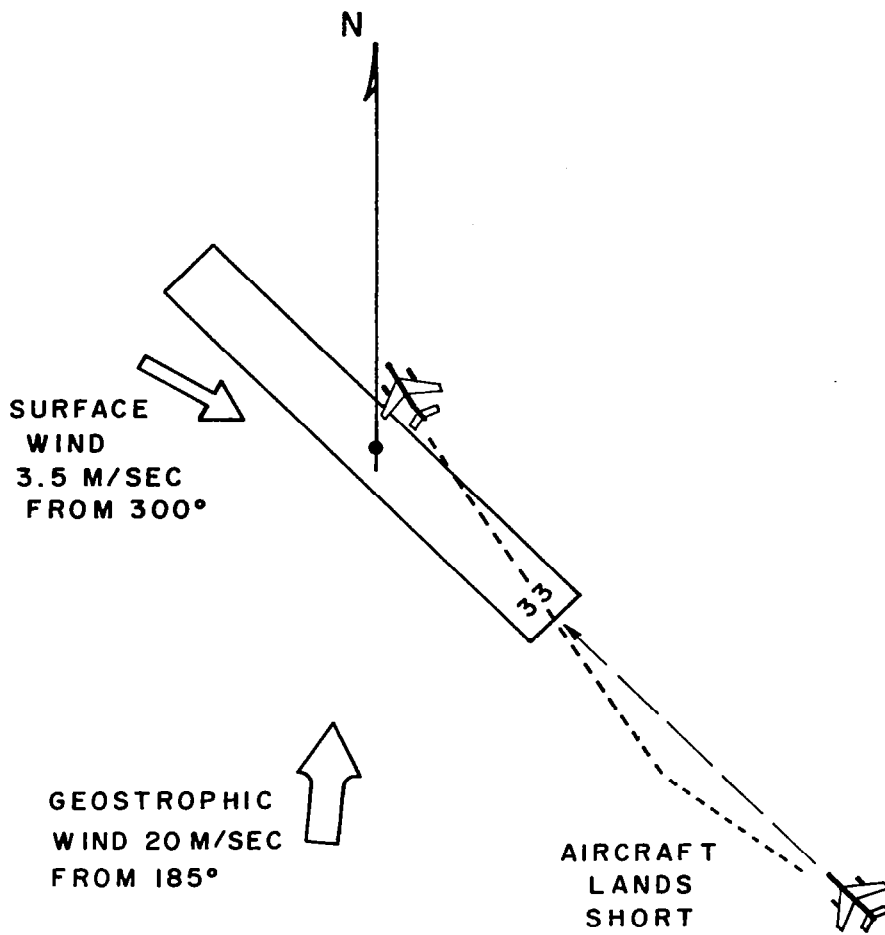
Figure 3.2.1. Aircraft-runway-winds orientation diagram for Boston, December 17, 1973 accident.

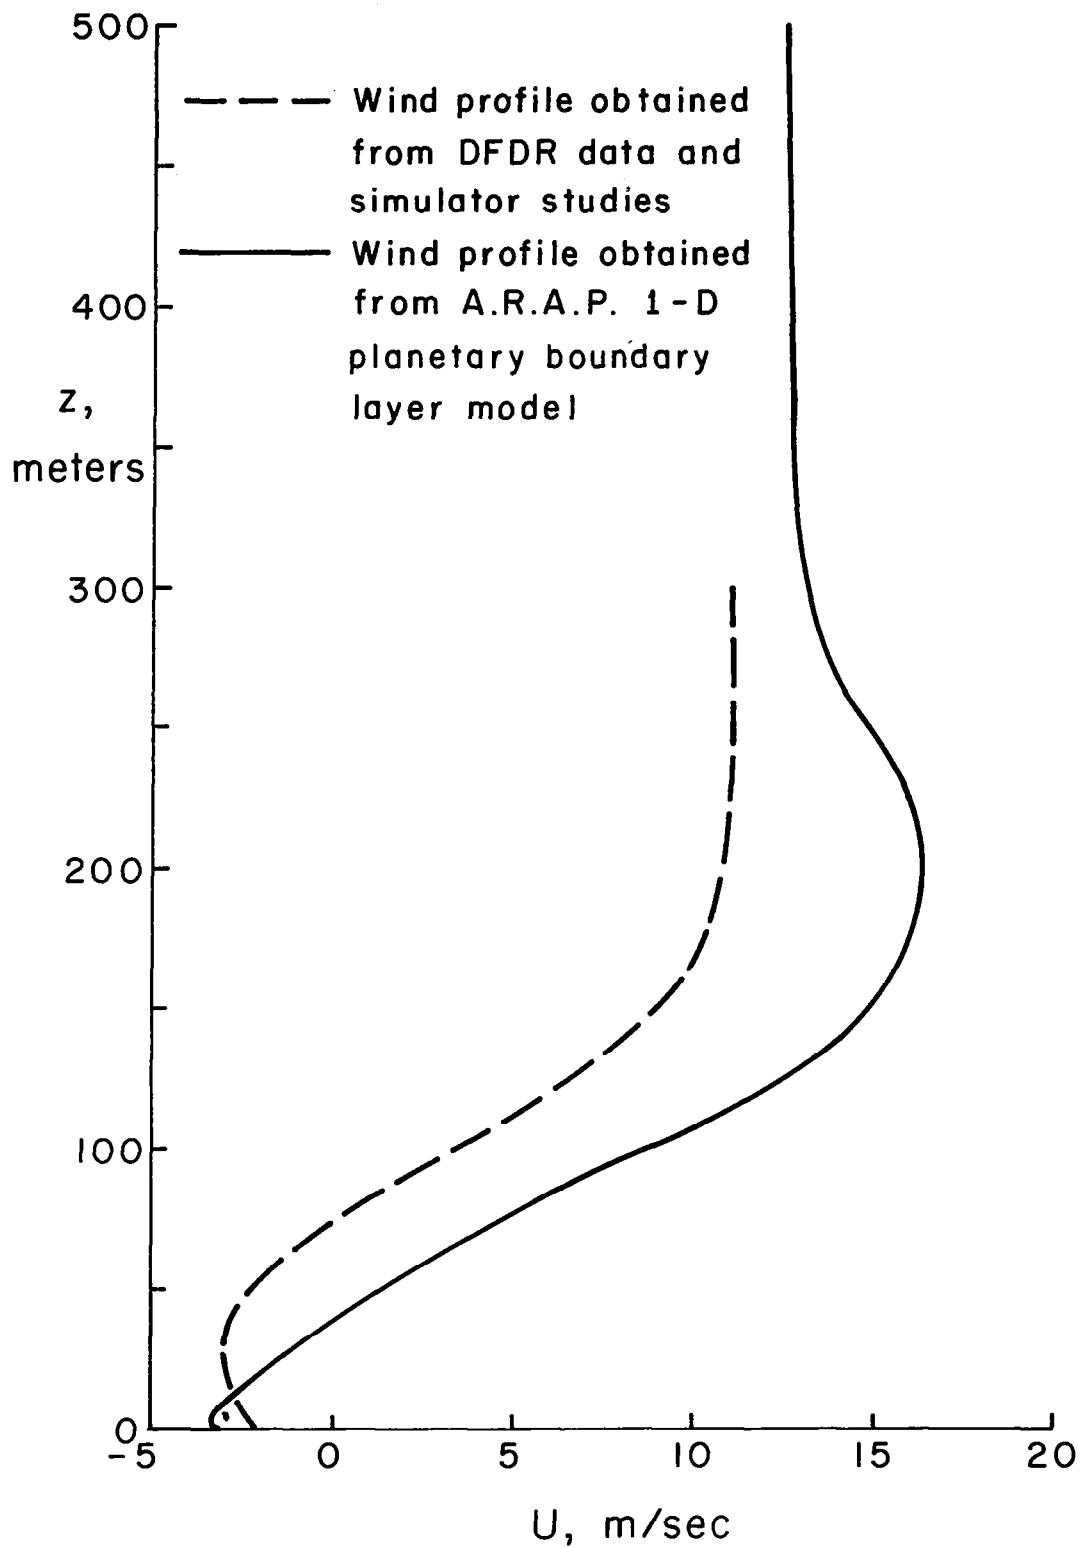
Figure 3.2.8. Altitude profile of mean wind velocity component parallel to runway (+ U, tailwind) for Boston, December 17, 1973 accident.

The significant meteorological conditions in this case were rain and fog at the airport. A precipitation area 400 km in diameter encompassing the airport was observed on the Chatham weather radar. Only weak precipitation echoes showed over the accident site (figure 3.2.2). Surface weather charts showed a front in the general vicinity of the accident (figures 3.2.3-3.2.6). In addition, there existed a temperature differential between the land and the ocean. Either or both of these phenomena may have contributed to the geostrophic velocity differences existing between the surface and 850 mb altitude at 1300 l.s.t. and at 1600 l.s.t. The time variation of the geostrophic velocity distribution used was a linear interpolation between the profiles shown in figure 3.2.7 down to 200 m. Below this altitude the geostrophic velocity profile was altered to account for a horizontal temperature gradient assumed to start one hour before the accident (1443 l.s.t.) and remain until 1900 l.s.t. The magnitude and shape of the change in geostrophic velocity assumed is seen in the profile for  $U_g$  at 1900 l.s.t. The resulting velocity profiles at the time of the accident along with estimates obtained from flight recorder data and simulation studies are shown in figures 3.2.8 and 3.2.9.

The agreement in wind shear ( $.13 \text{ sec}^{-1}$ ) and surface velocity is good. However, the results obtained from the A.R.A.P. weather model extend the shear over a larger altitude interval, thus resulting in a 5 m/sec greater change in forward velocity. Agreement could be further improved by increasing the surface roughness

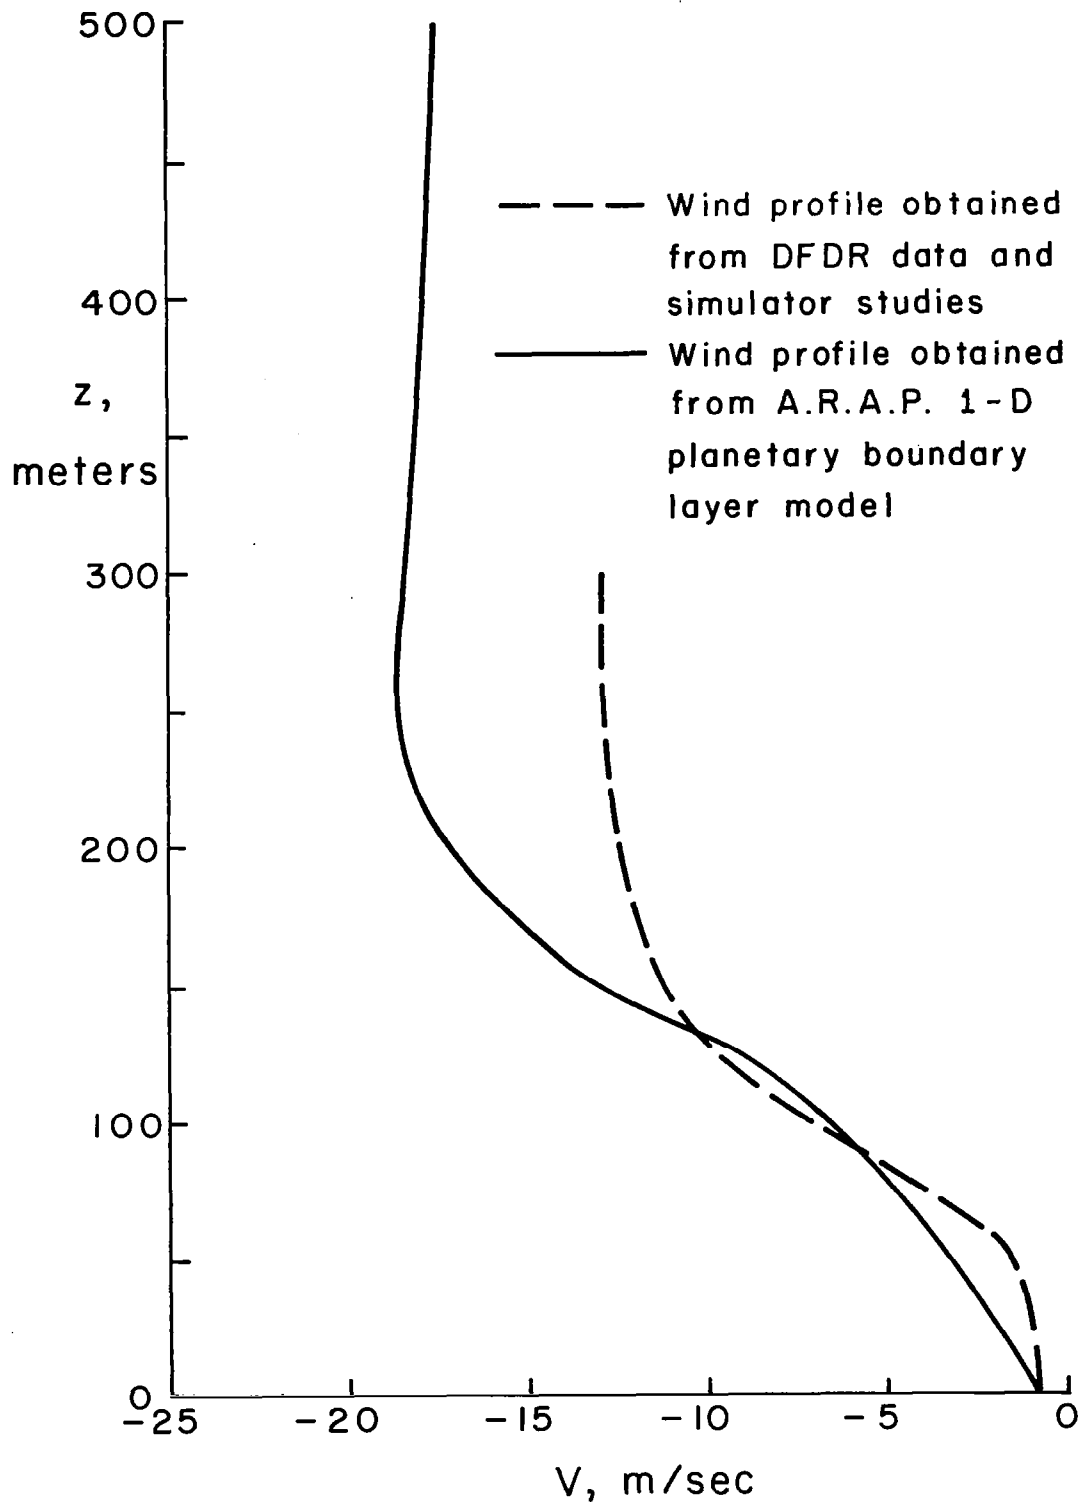
Figure 3.2.9. Altitude profile of mean wind velocity component perpendicular to runway (+ V, crosswind from right) for Boston, December 17, 1973 accident.

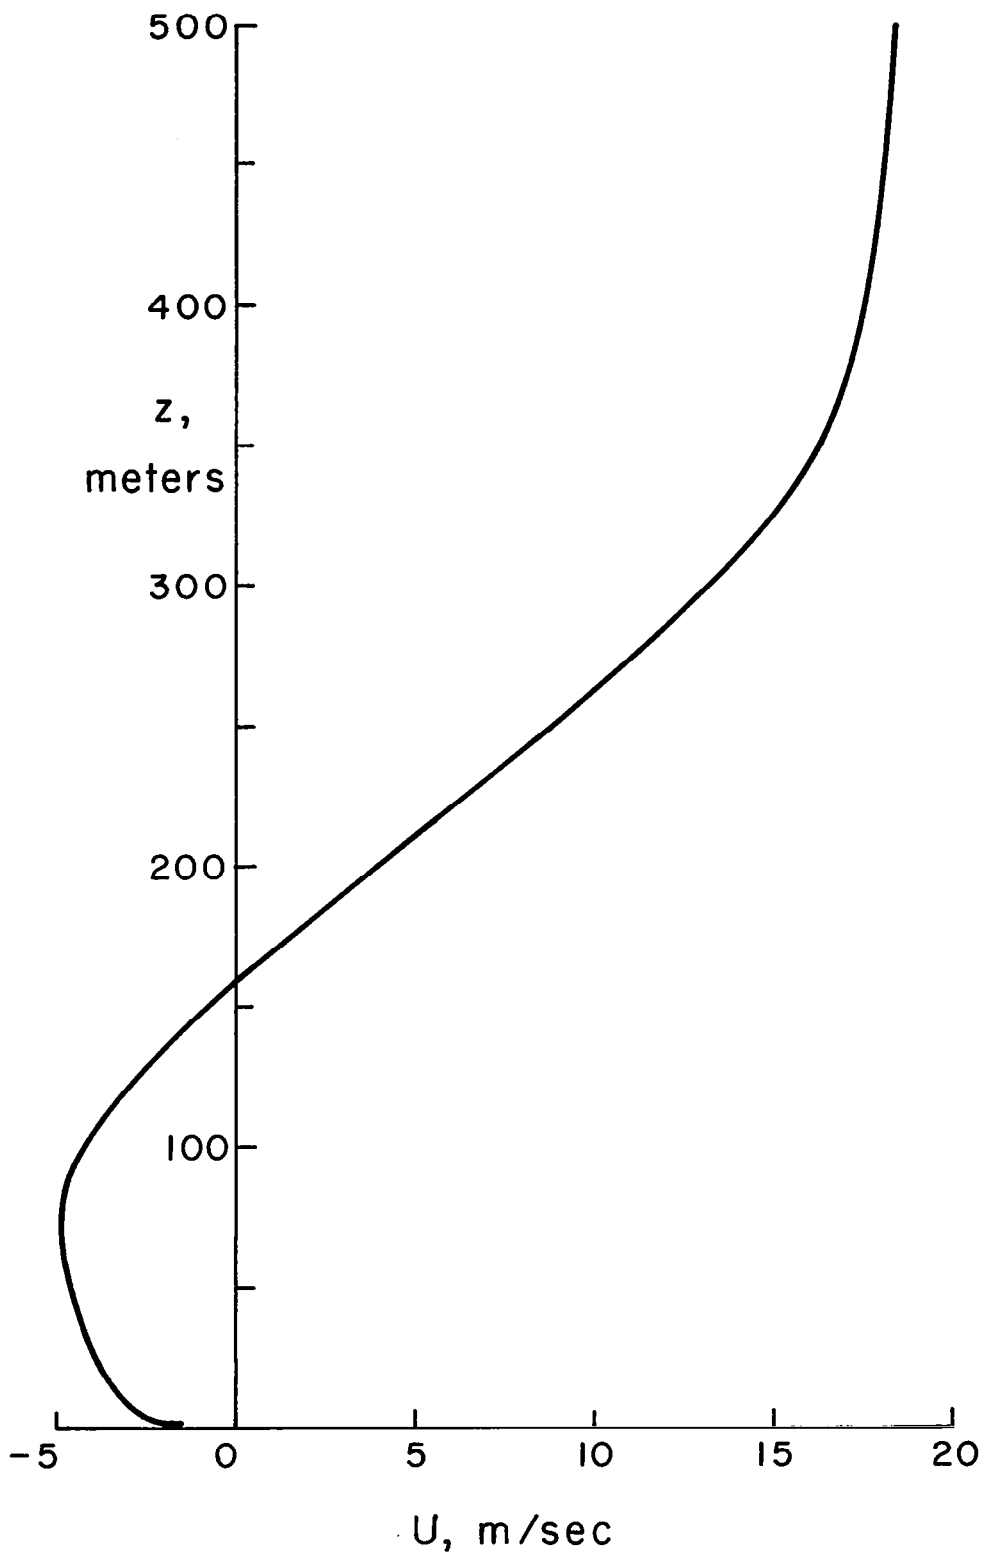
Figure 3.3.7. Altitude profile of mean wind velocity component parallel to runway for the La Guardia Airport, January 4, 1971 accident (+ U, tailwind).

As shown in figure 3.3.7 a 22 m/sec decrease in tailwind occurred between 350 m and 100 m. This is not only a large decrease in velocity but a reasonably large wind shear ( $.09 \text{ sec}^{-1}$ ). If power is not added during the descent phase the aircraft will drop below the glideslope and land short of the runway. This is particularly true if the visual cuing is degraded by rain, fog and darkness. The crosswind shear, in this case, is a factor of 3 lower (figure 3.3.8) and the maximum velocity variance is only 1.4 m/sec. The observed surface wind was 6 m/sec from 60° and that computed from our model at an altitude of 10 m, is 3.6 m/sec from 74°.

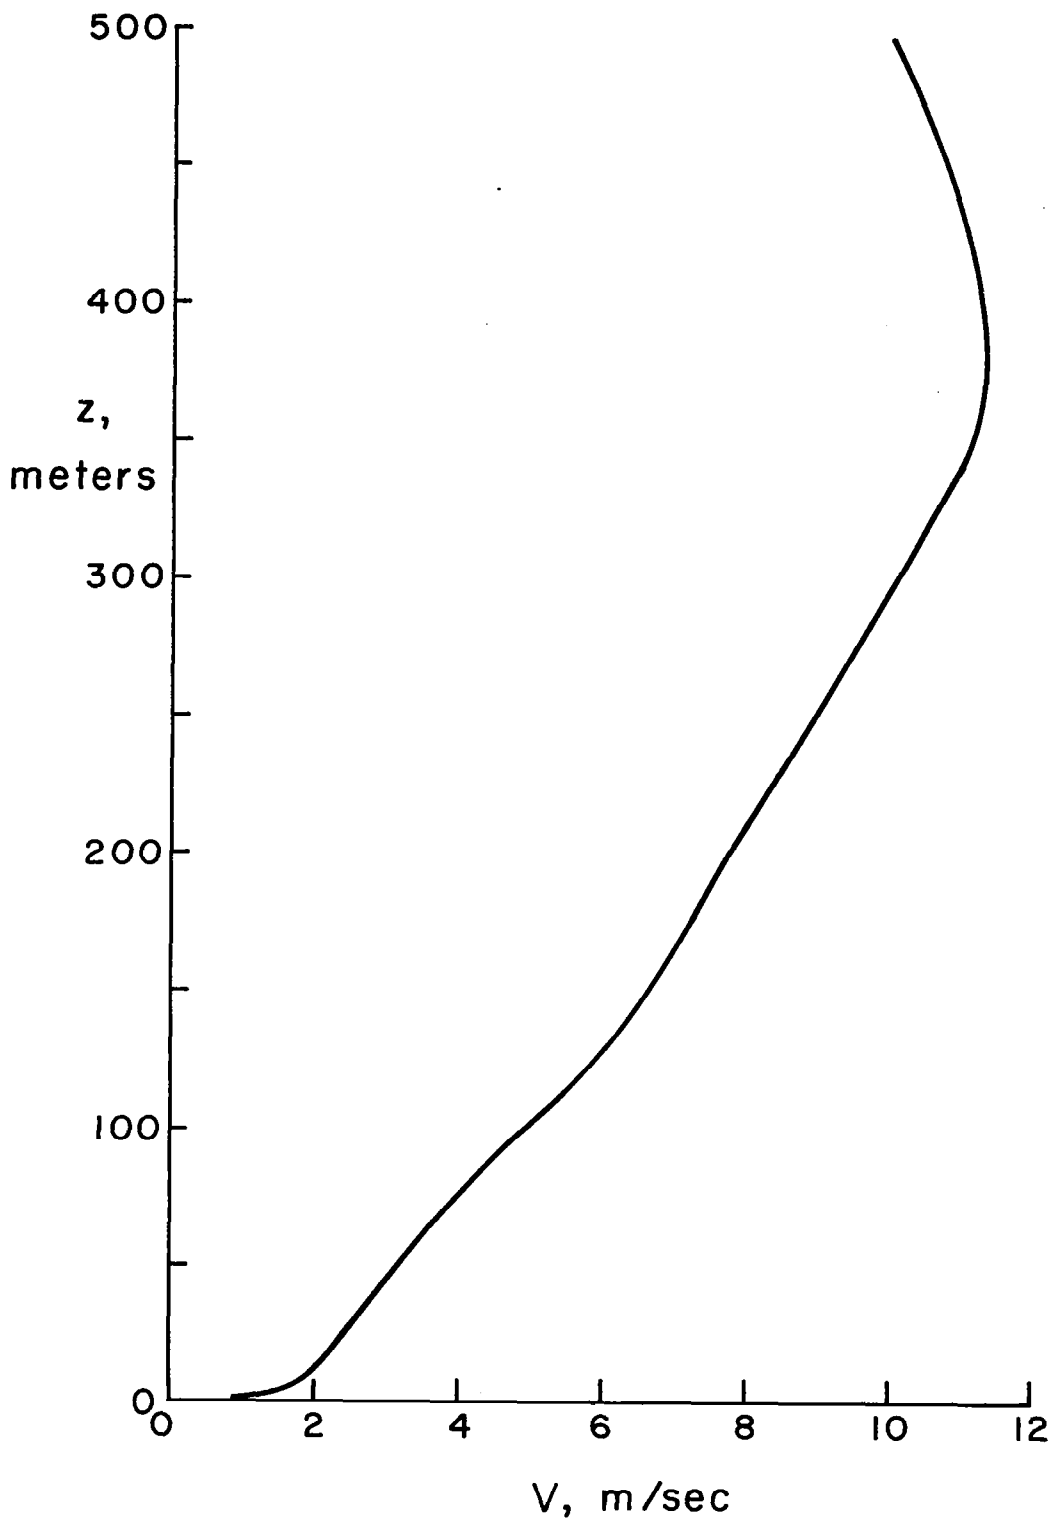
Figure 3.3.8. Altitude profile of mean wind velocity component perpendicular to runway for the La Guardia Airport, January 4, 1971 accident.

Using these inputs and boundary conditions plus a roughness scale of 0.1 m the model yields the profiles for mean velocity, velocity variance and turbulence scale profiles given in figures 3.3.7-3.3.13.

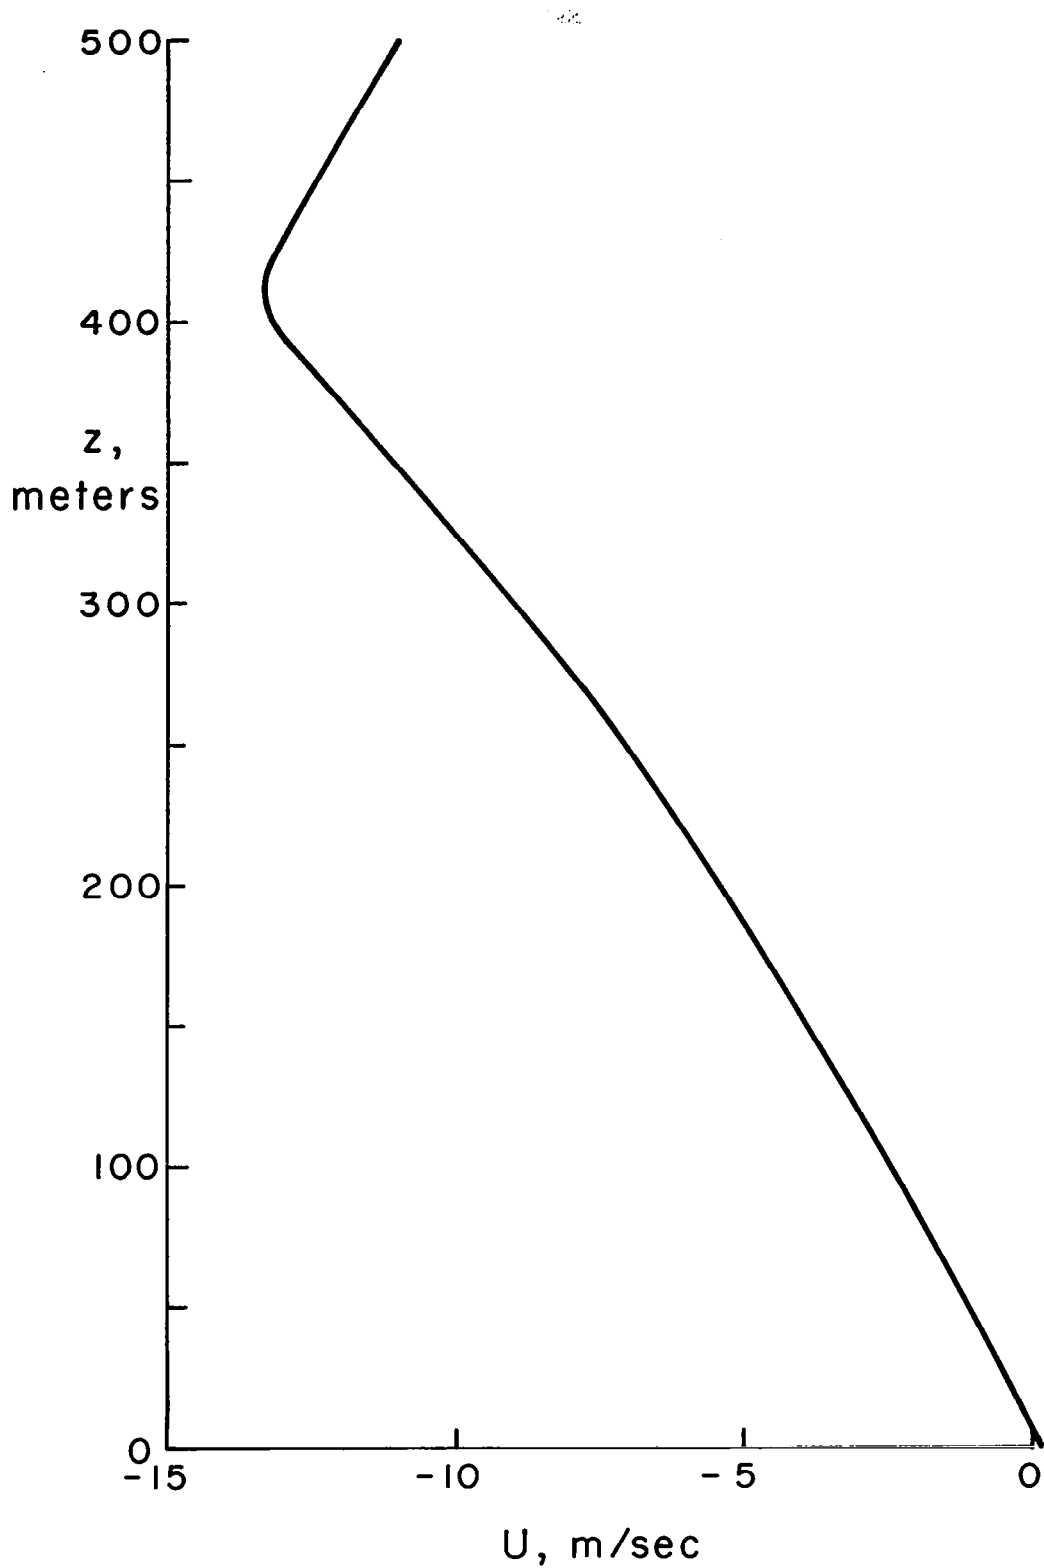
Figure 3.4.7. Altitude profile of mean wind velocity component parallel to runway for the Wichita, Kansas, March 3, 1973 accident.

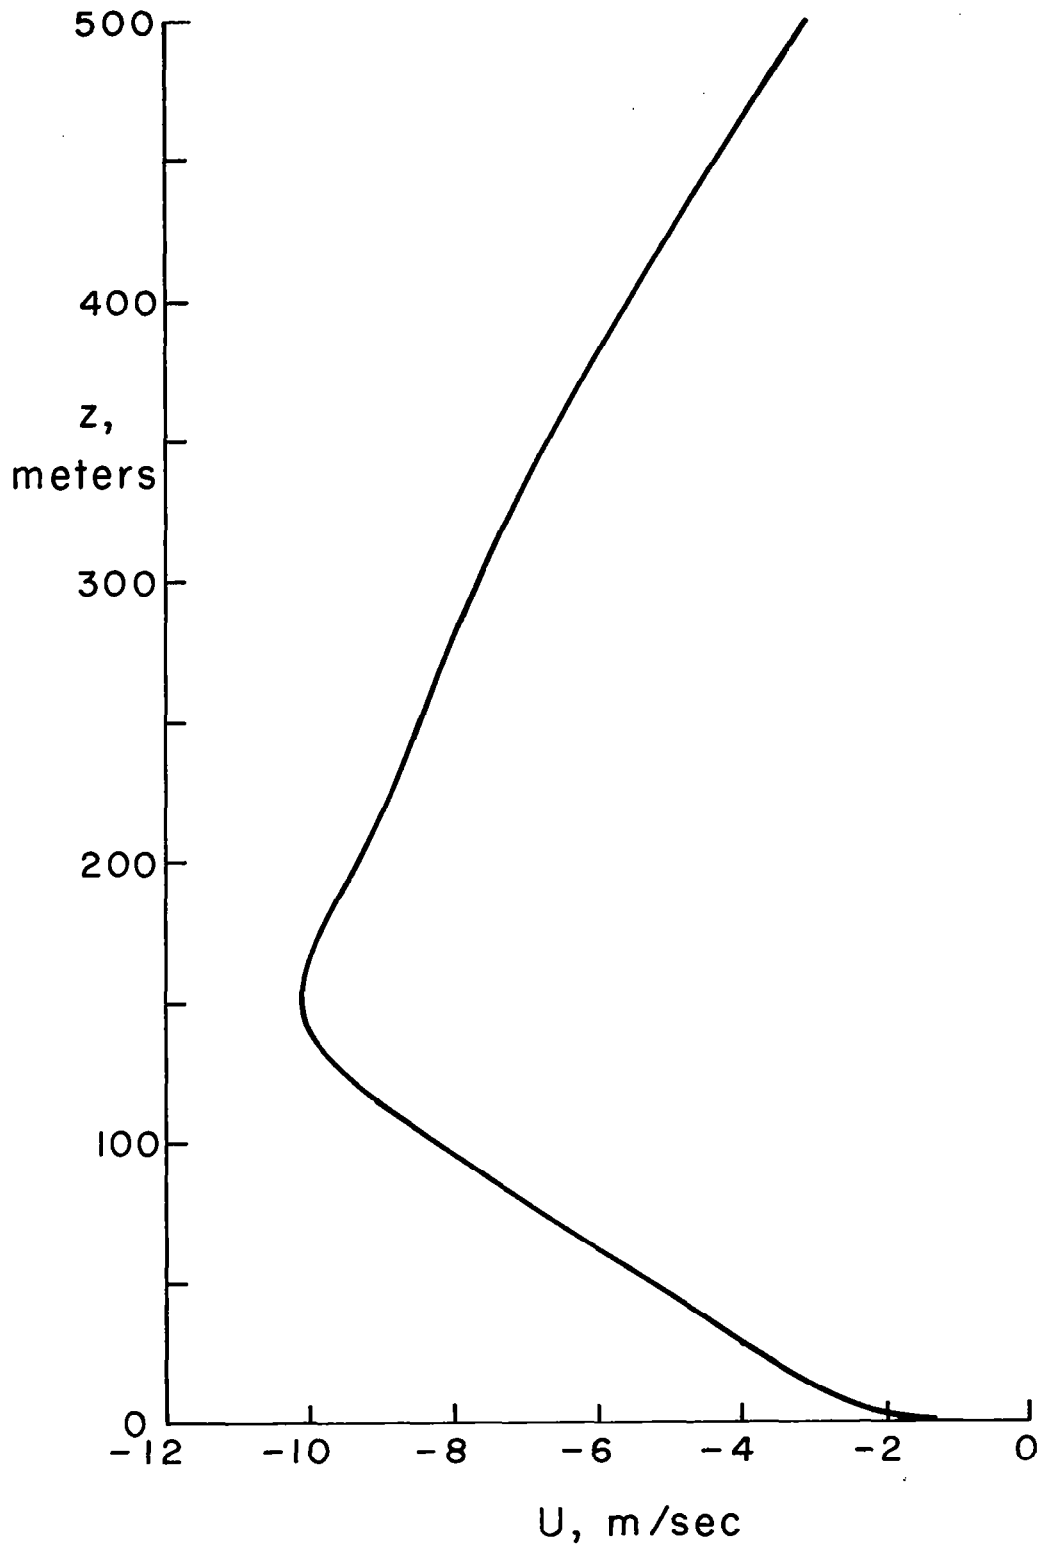
Figure 3.5.7. Altitude profile of mean velocity component parallel to runway (+  $U$ , tailwind) for the JFK Airport, December 12, 1972 accident.

The flight data was recorded normally but was not used to estimate wind profiles. The resulting velocity profile (figure 3.5.7) indicates that the strong tailwind aloft increases to a 10 m/sec headwind down at 140 m. From here on down the headwind drops off to 2 m/sec at ground level which could present problems if timely corrections were not applied. The wind estimate at the 10 m altitude is 2.7 m/sec from 40° as compared with an observed value of 2 m/sec from 40°. The estimated crosswind and turbulence distributions are not large enough to be hazardous for flight operation (figures 3.5.8 - 3.5.13).

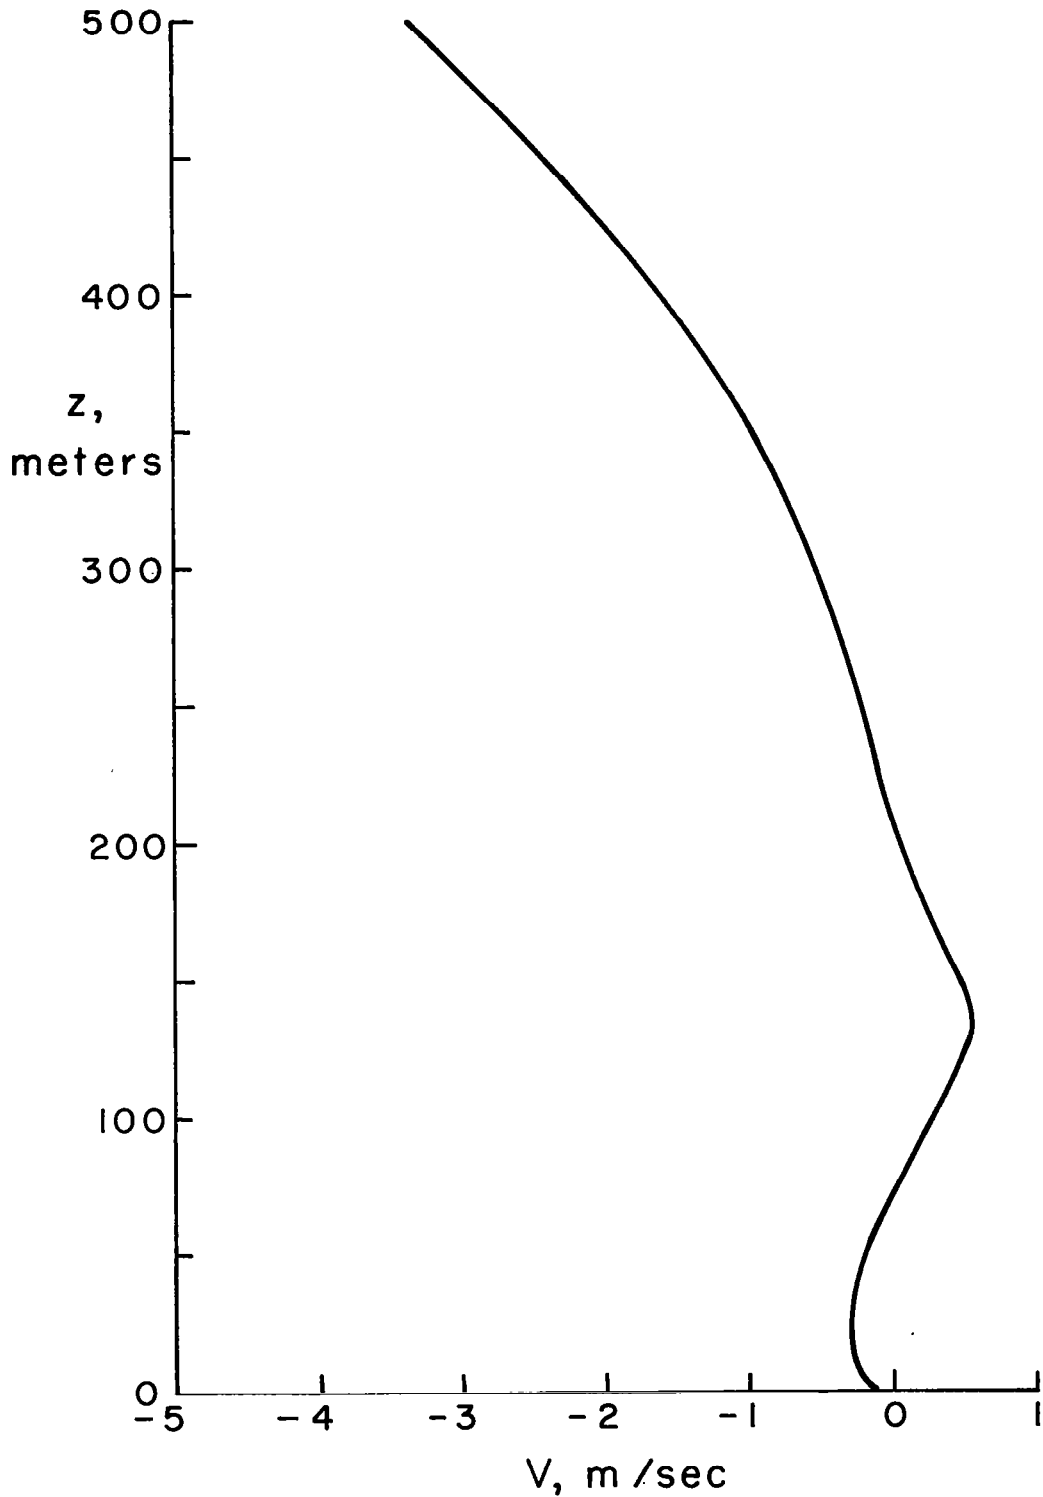
Figure 3.5.8. Altitude profile of mean wind velocity component perpendicular to runway (+ V, crosswind from right) for the JFK airport, December 12, 1972 accident.
