**MODEL PREDICTIONS OF WIND  
AND TURBULENCE PROFILES  
ASSOCIATED WITH AN ENSEMBLE  
OF AIRCRAFT ACCIDENTS**

*G. G. Williamson, W. S. Lewellen,  
and M. E. Teske*

AERONAUTICAL RESEARCH ASSOCIATES OF PRINCETON, INC.

NATIONAL AERONAUTICS AND SPACE ADMINISTRATION • WASHINGTON D. C. • JULY 1977

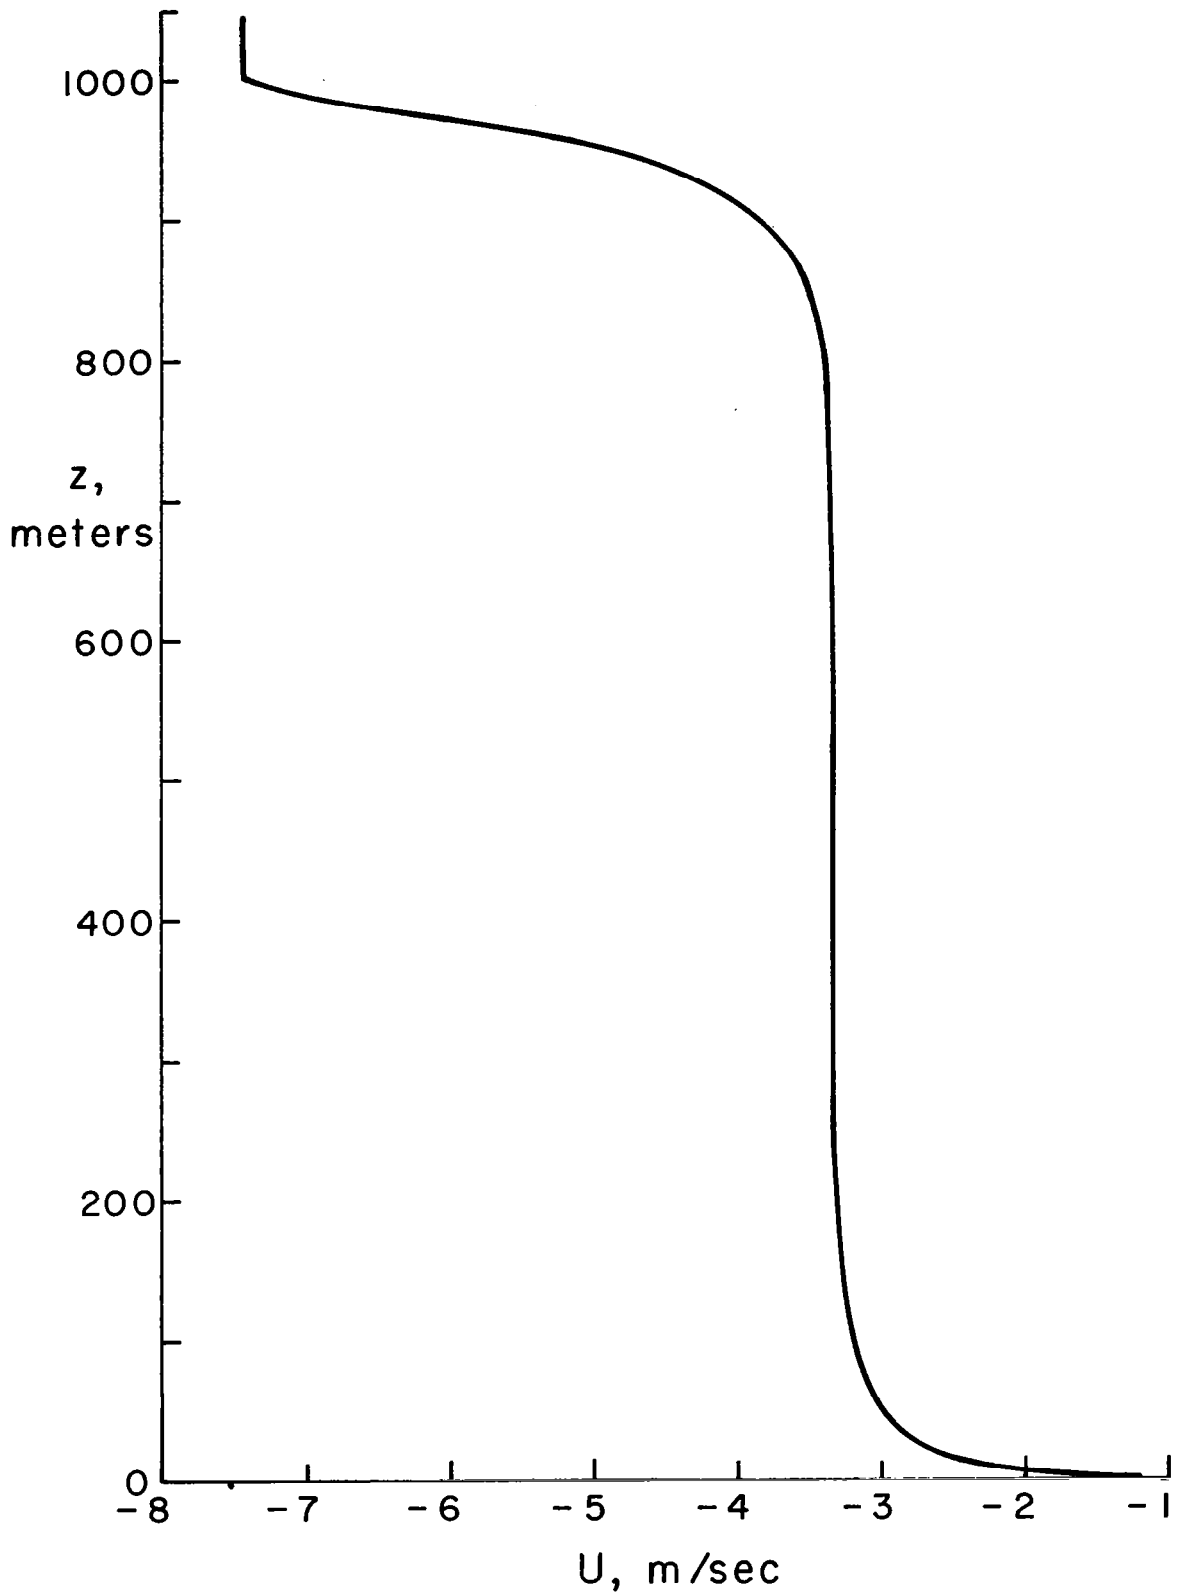
Figure 3.6.7. Altitude profile of mean wind velocity component parallel to runway (+ U, tailwind) for the Johnstown, Pa., January 6, 1974 accident.

NWS radar at Pittsburg indicated no precipitation echoes in the Johnstown area at the time of the accident. At this time, the geostrophic wind velocity at the 850 mb altitude was 14 m/sec from 270° and the surface wind was 6 m/sec from 280° (figures 3.6.2 - 3.6.5). Radiosonde data indicated conditionally unstable air below 1300 mean sea level (m.s.l.) (figure 3.6.6). The above conditions would not be expected to produce hazardous wind shear. However, the case was further investigated and profiles characteristic of this weather situation were generated. As expected, the unstable air does not support significant wind shear so the major velocity changes occur above this layer and at ground level (figures 3.6.7 and 3.6.8).

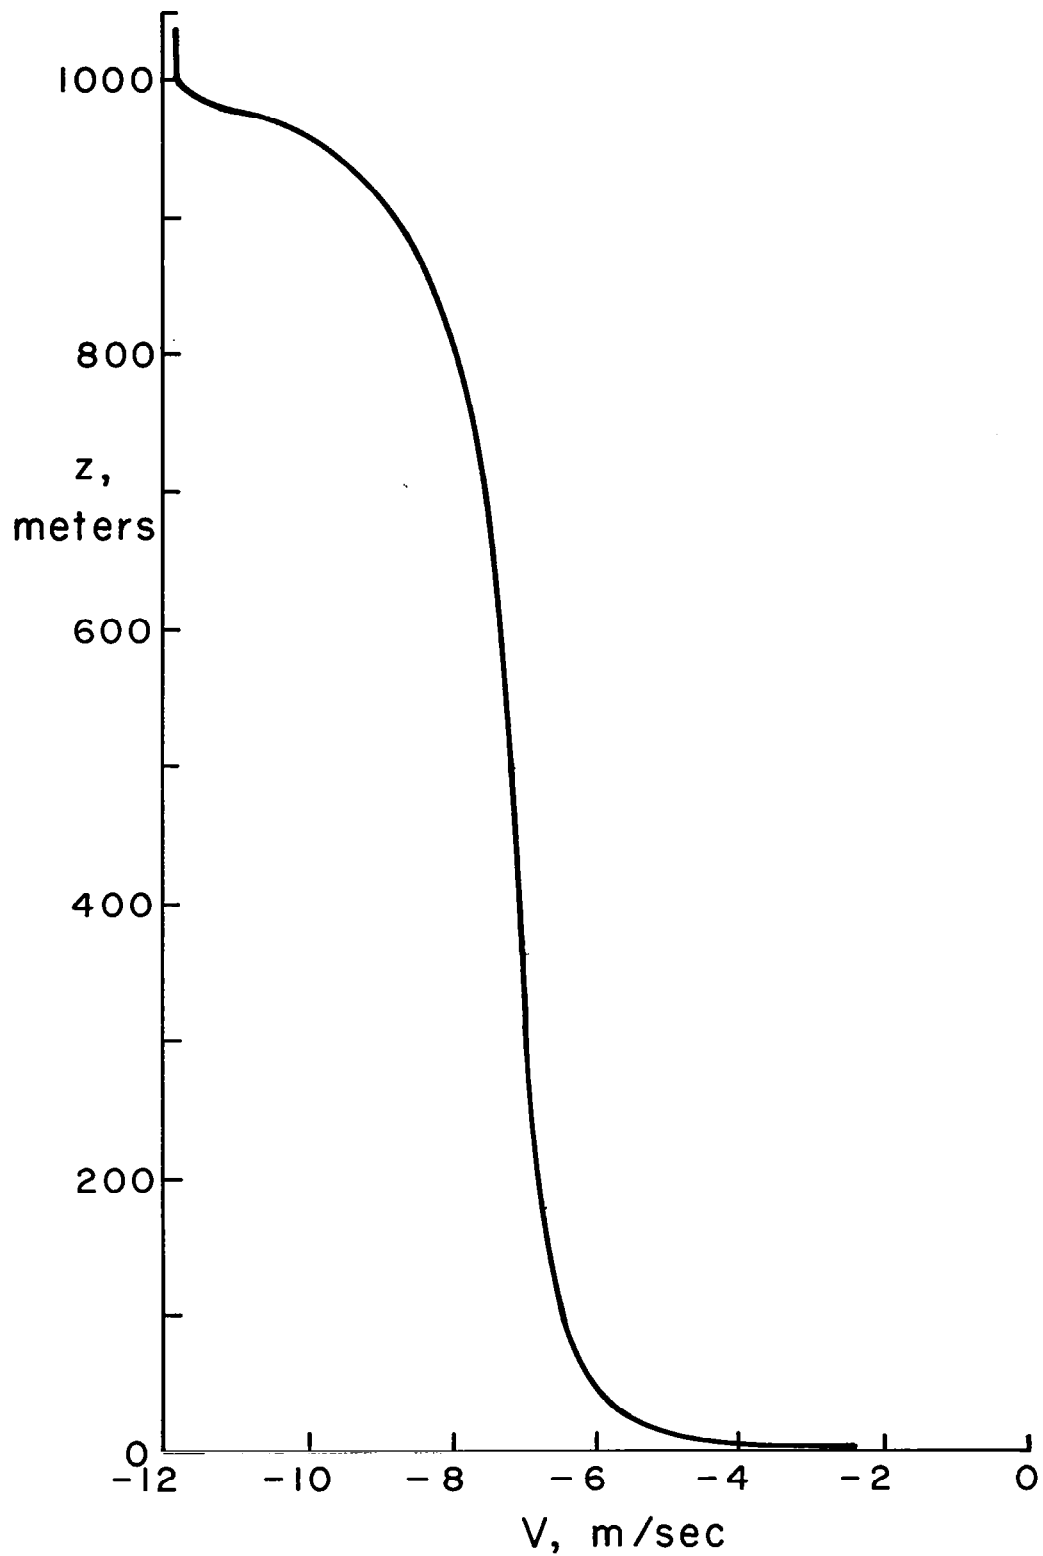
Figure 3.6.8. Altitude profile of mean wind velocity component perpendicular to runway (+ V, crosswind from right) for the Johnstown, Pa., January 6, 1974 accident.

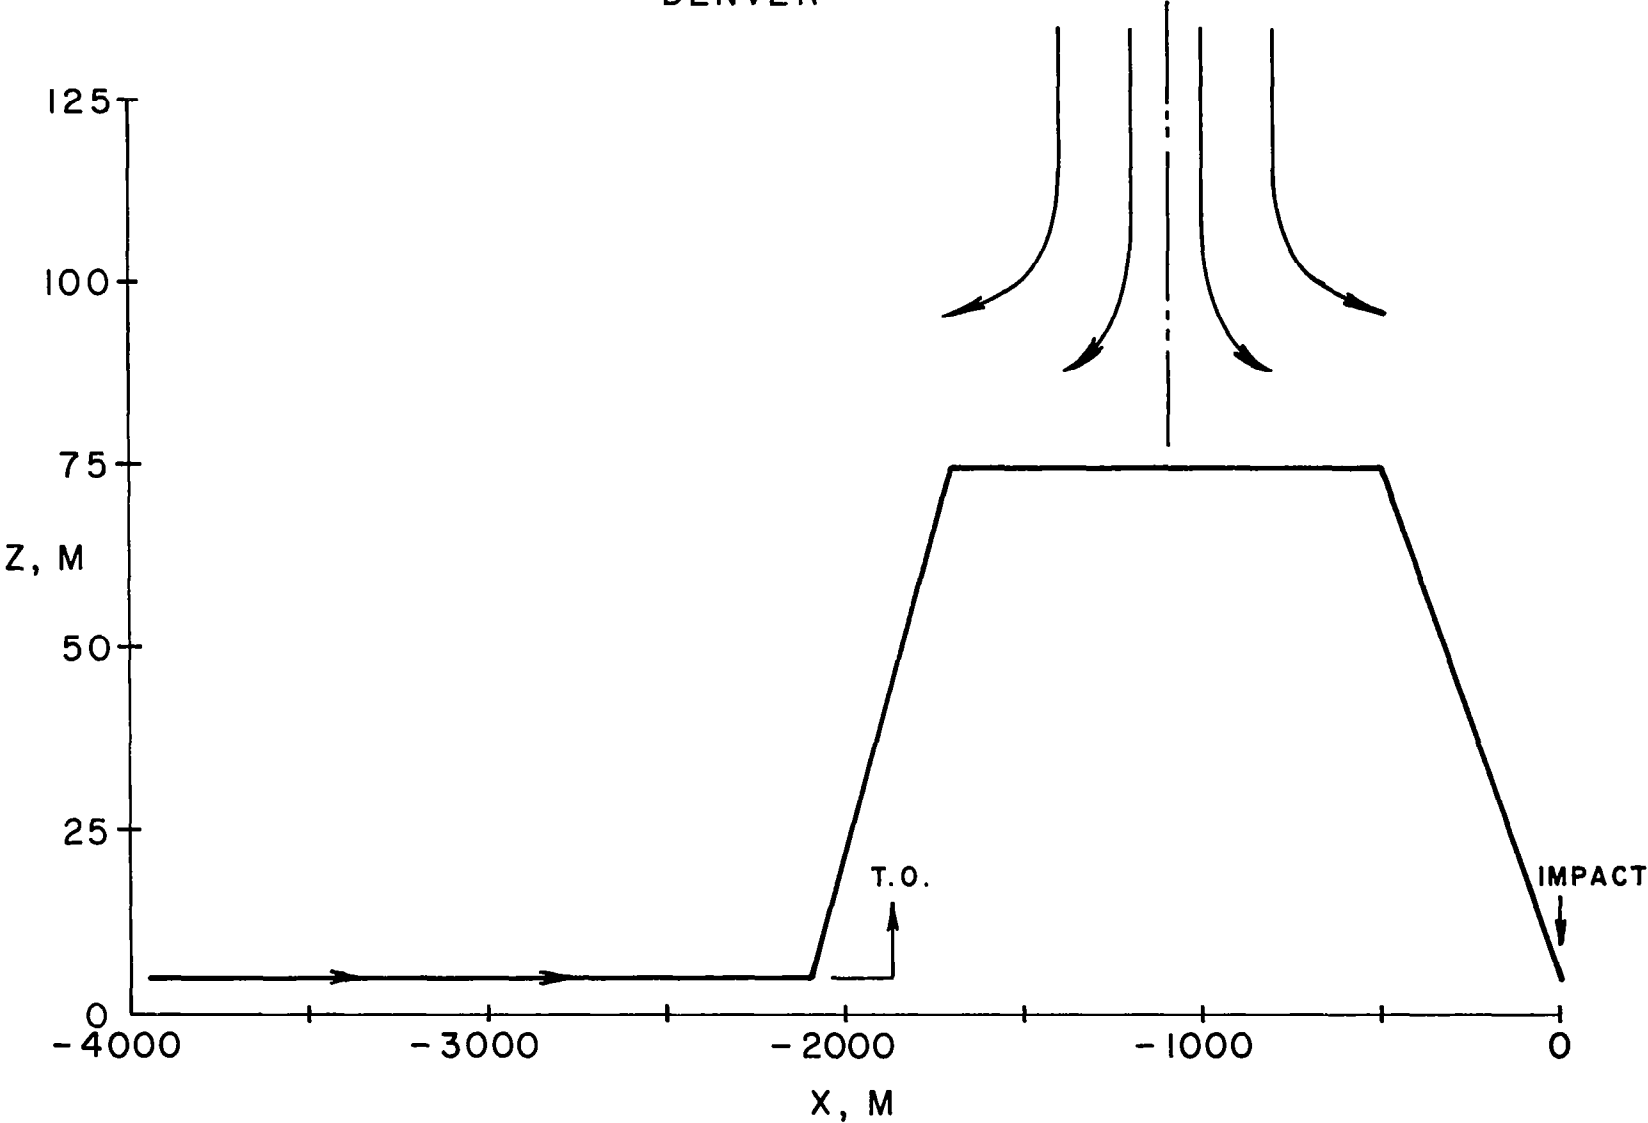
Figure 4.2.8. Approximate aircraft trajectory relative to storm cell and initial point of impact for Denver, Colorado, August 7, 1975 accident.

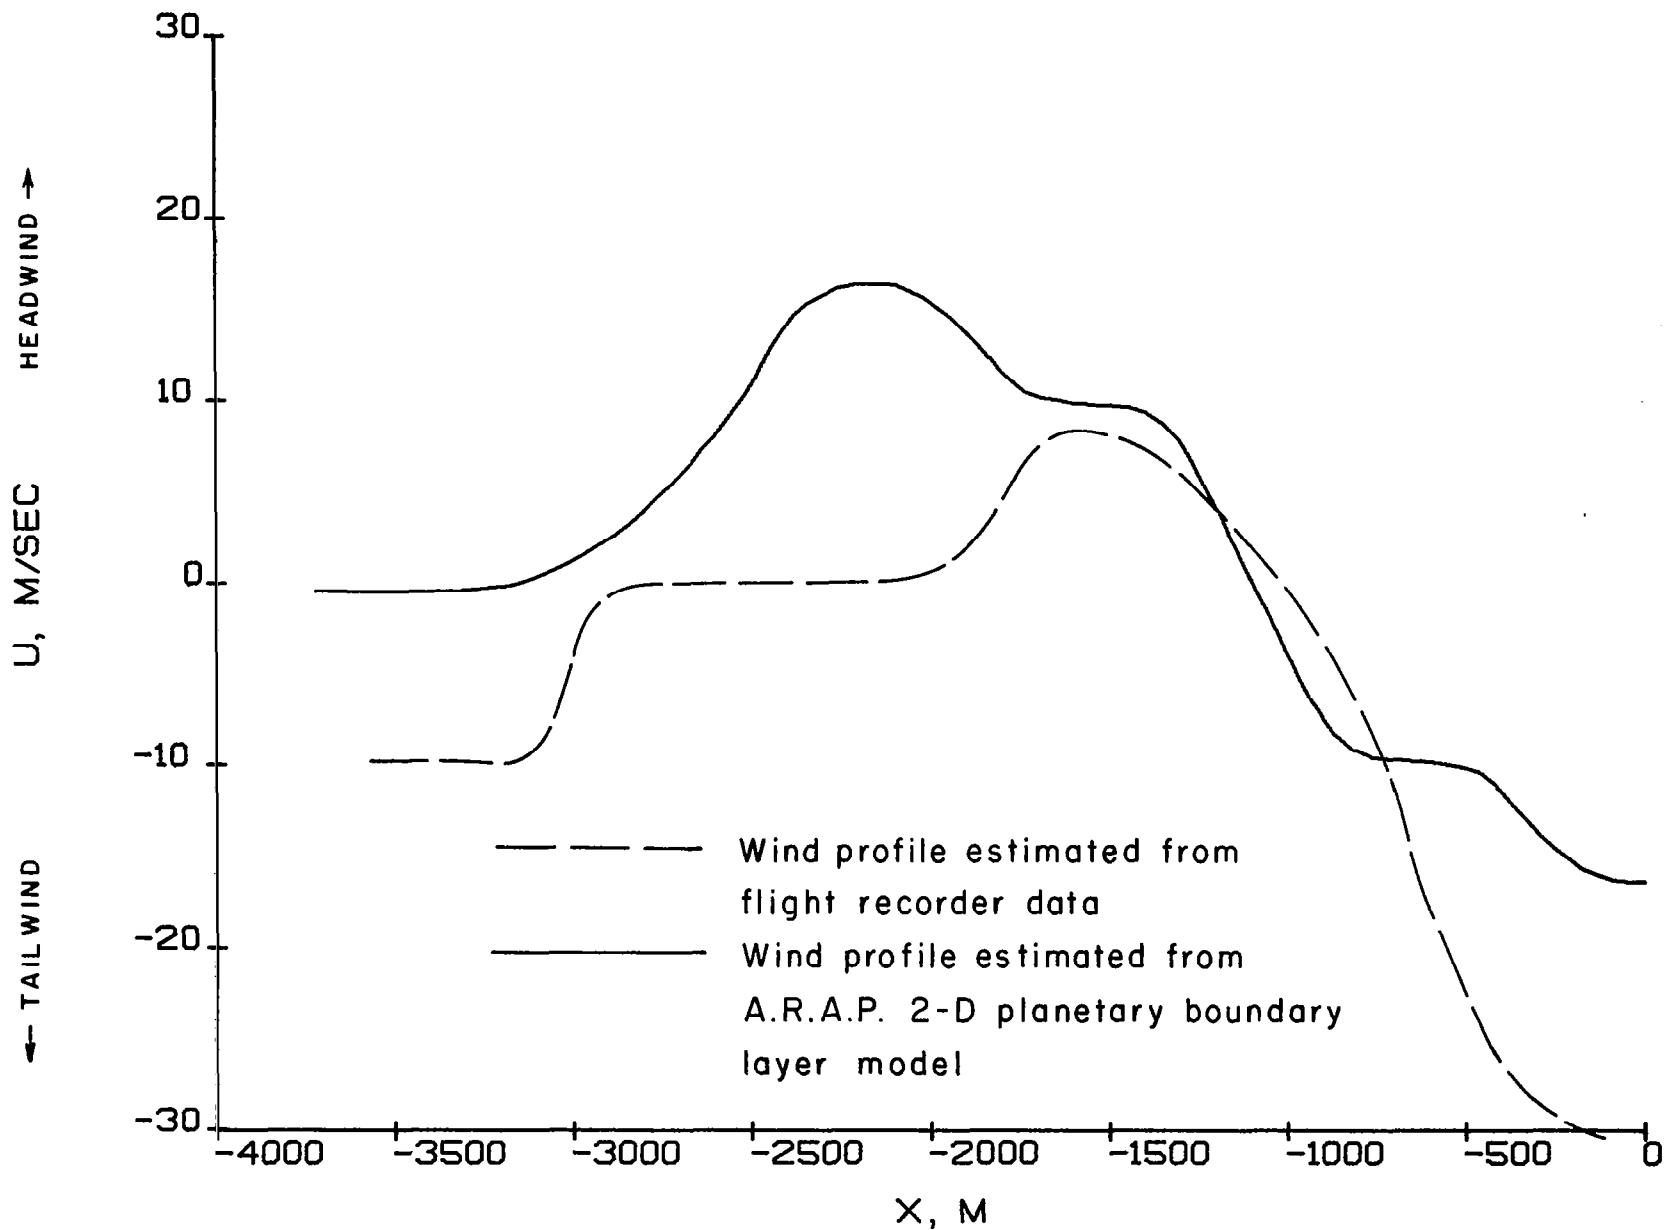
Figure 4.2.9. Velocity component of mean wind parallel to runway as a function of horizontal distance from the initial impact point (+ U, tailwind) for the Denver, Colorado, August 7, 1975 accident.

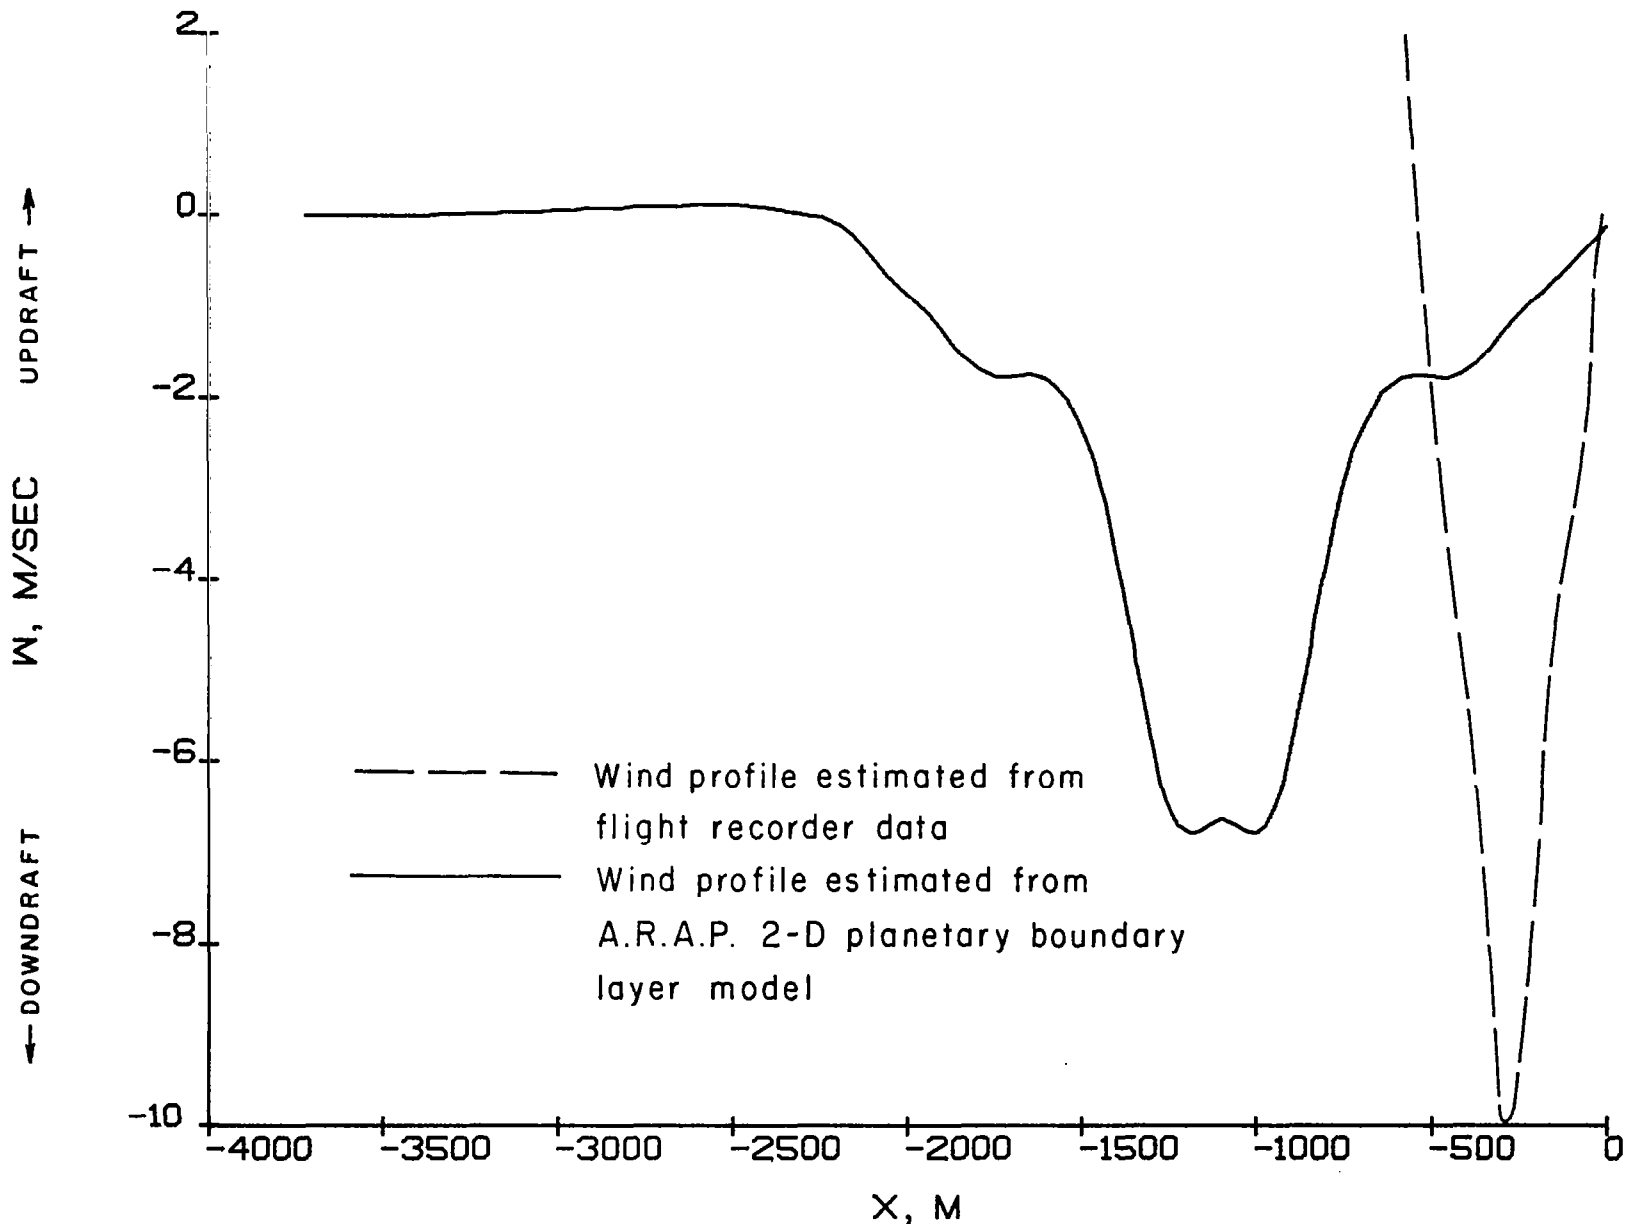
Figure 4.2.10. Vertical velocity component of mean wind as function of horizontal distance from the initial impact point (+ W, up) for the Denver, Colorado, August 7, 1975 accident.

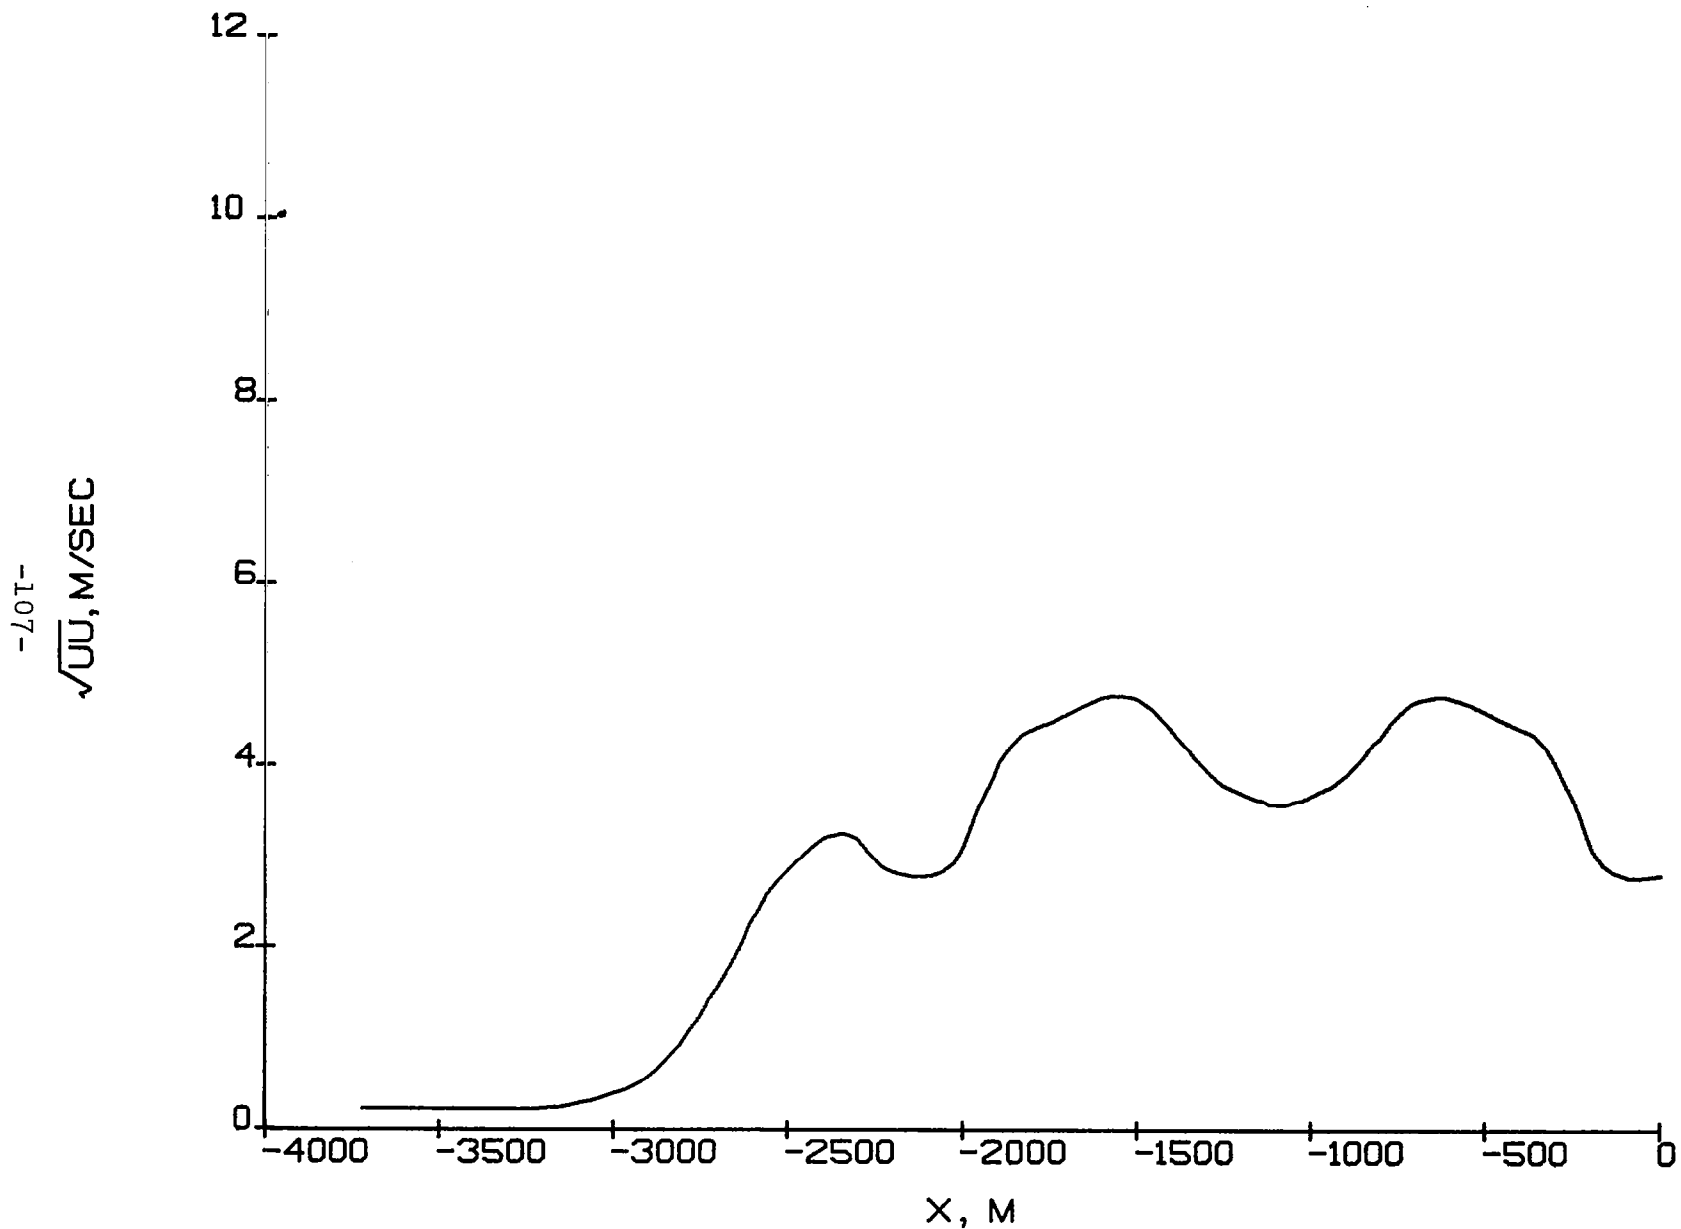
Figure 4.2.12. Variance of the wind parallel to runway as a function of horizontal distance from the initial impact point for the Denver, Colorado, August 7, 1975 accident.

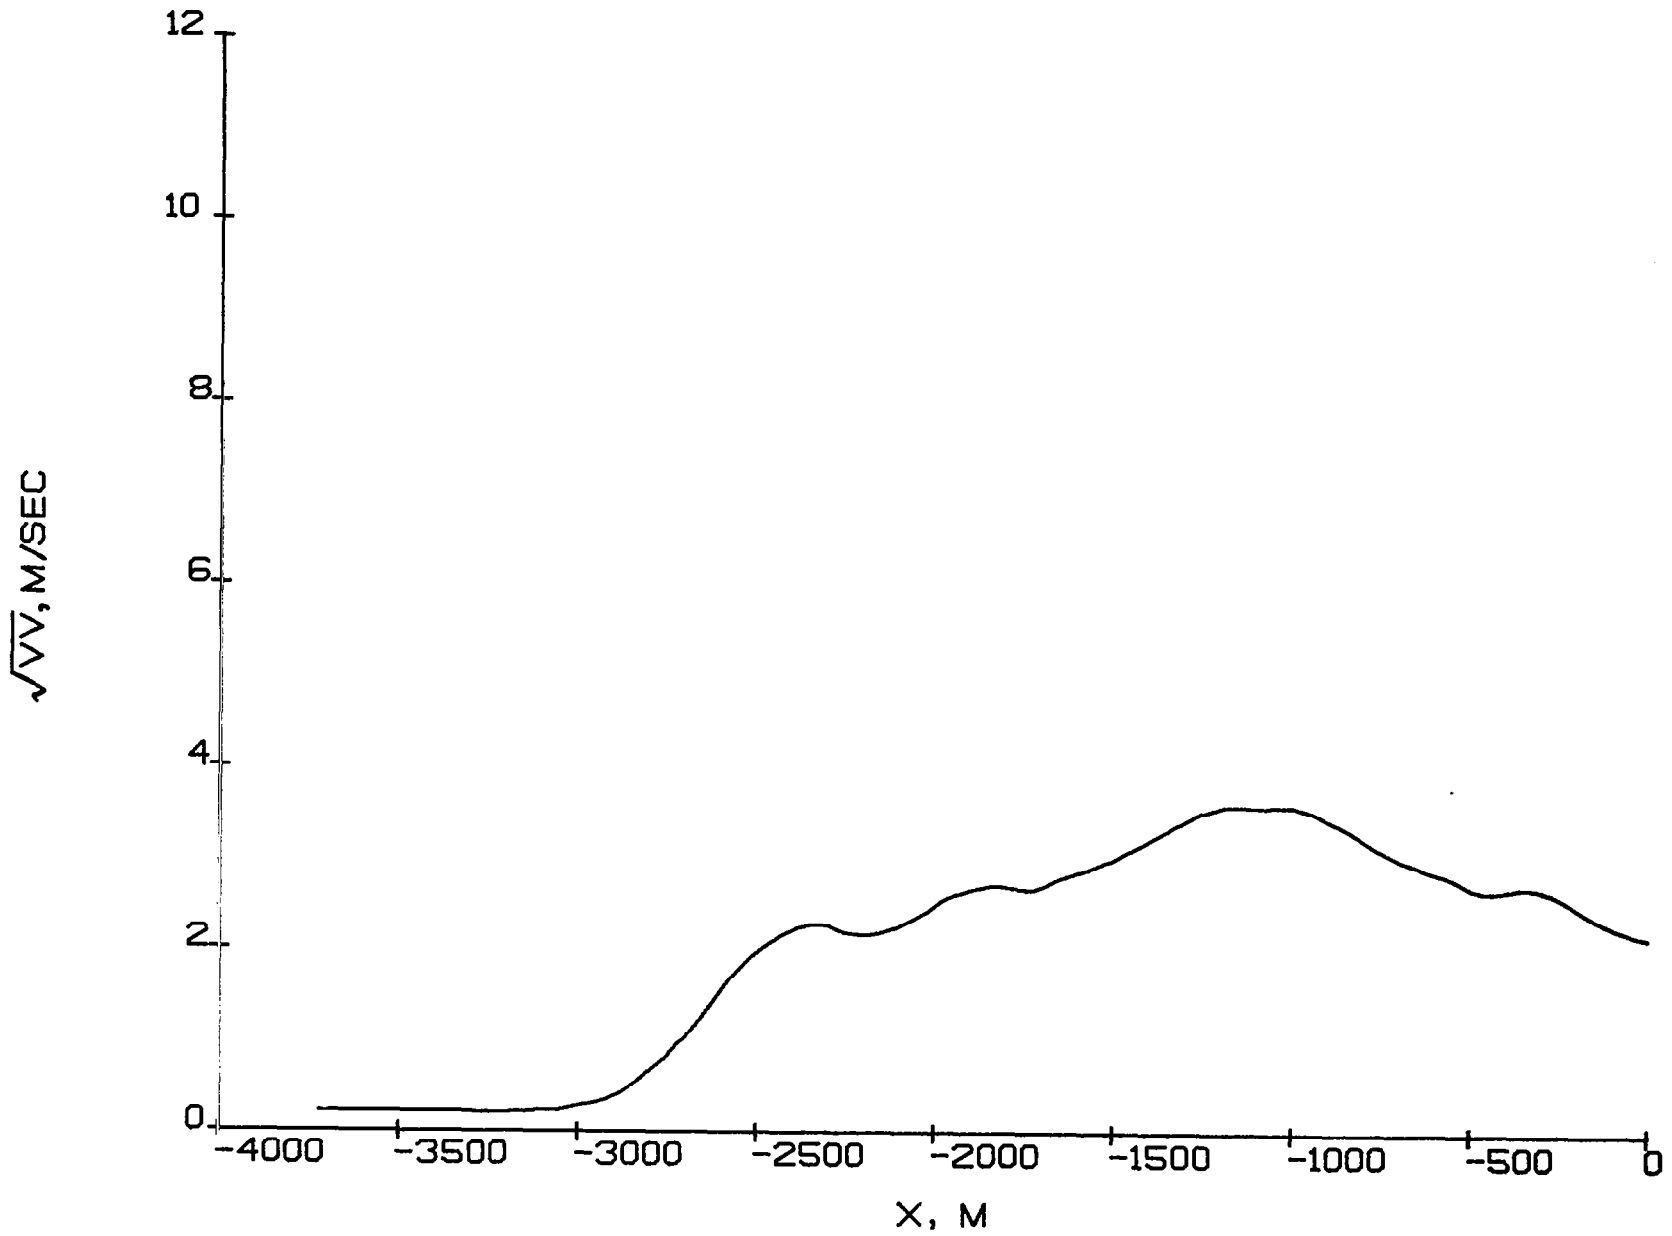
Figure 4.2.13. Variance of the wind perpendicular to runway as a function of horizontal distance from the initial impact point for Denver, Colorado, August 7, 1975 accident.

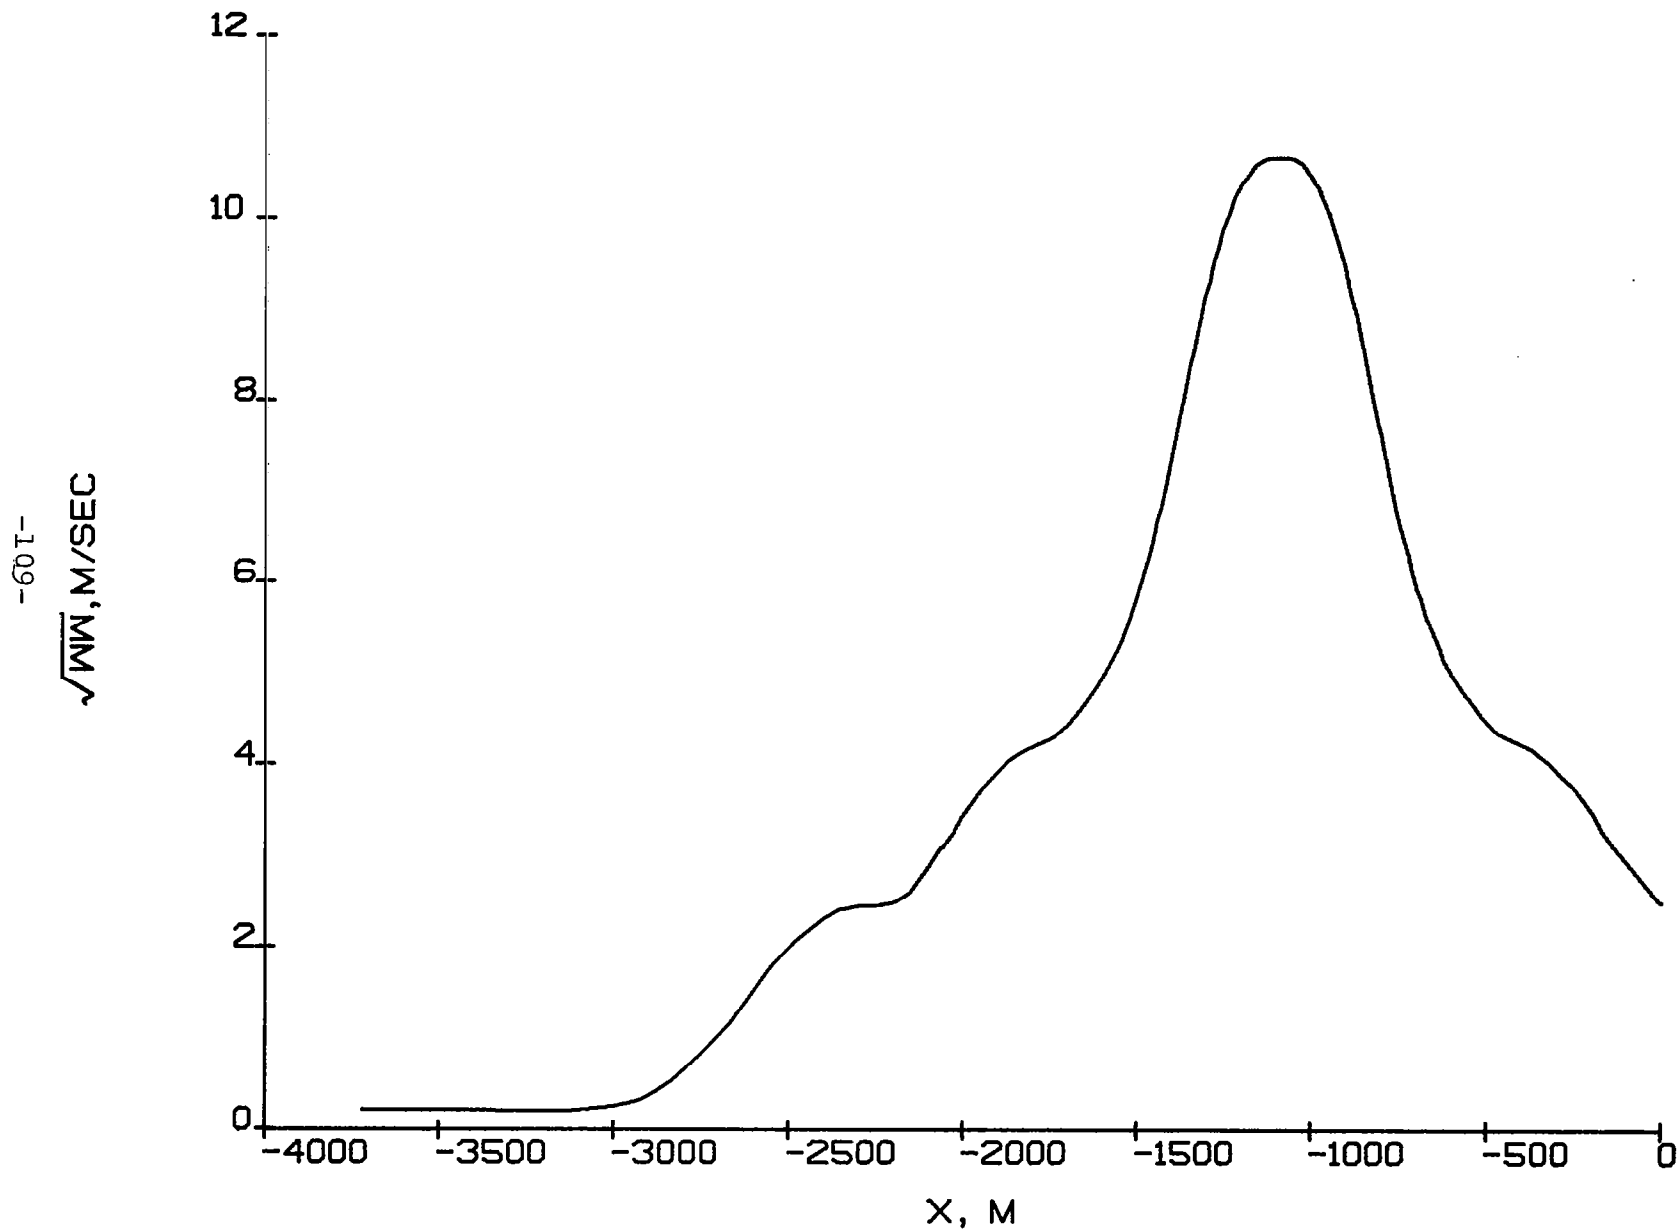
Figure 4.2.14. Variance of the vertical wind as a function of horizontal distance from the initial impact point for Denver, Colorado, August 7, 1975 accident.

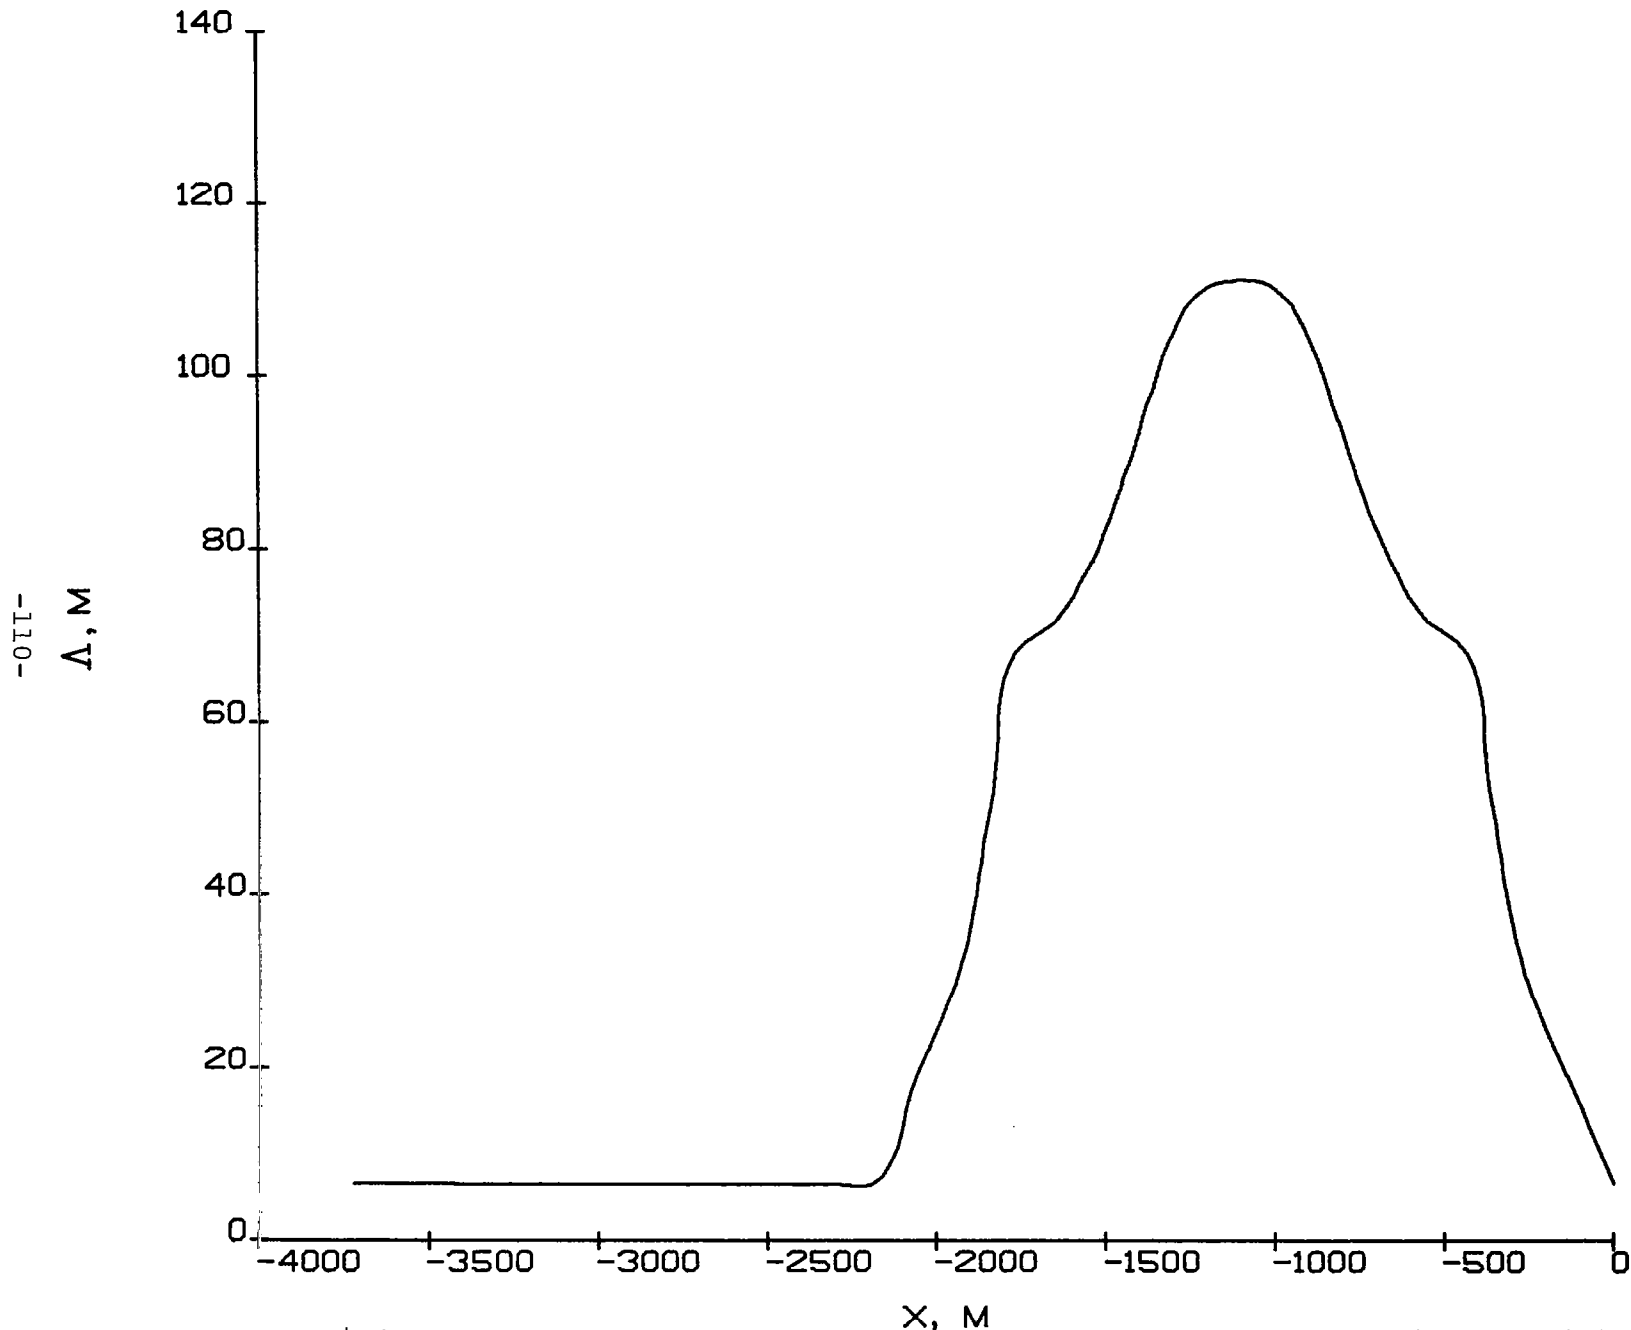
Figure 4.2.15. Turbulence scale as a function of horizontal distance from the initial impact point for Denver, Colorado, August 7, 1975 accident.

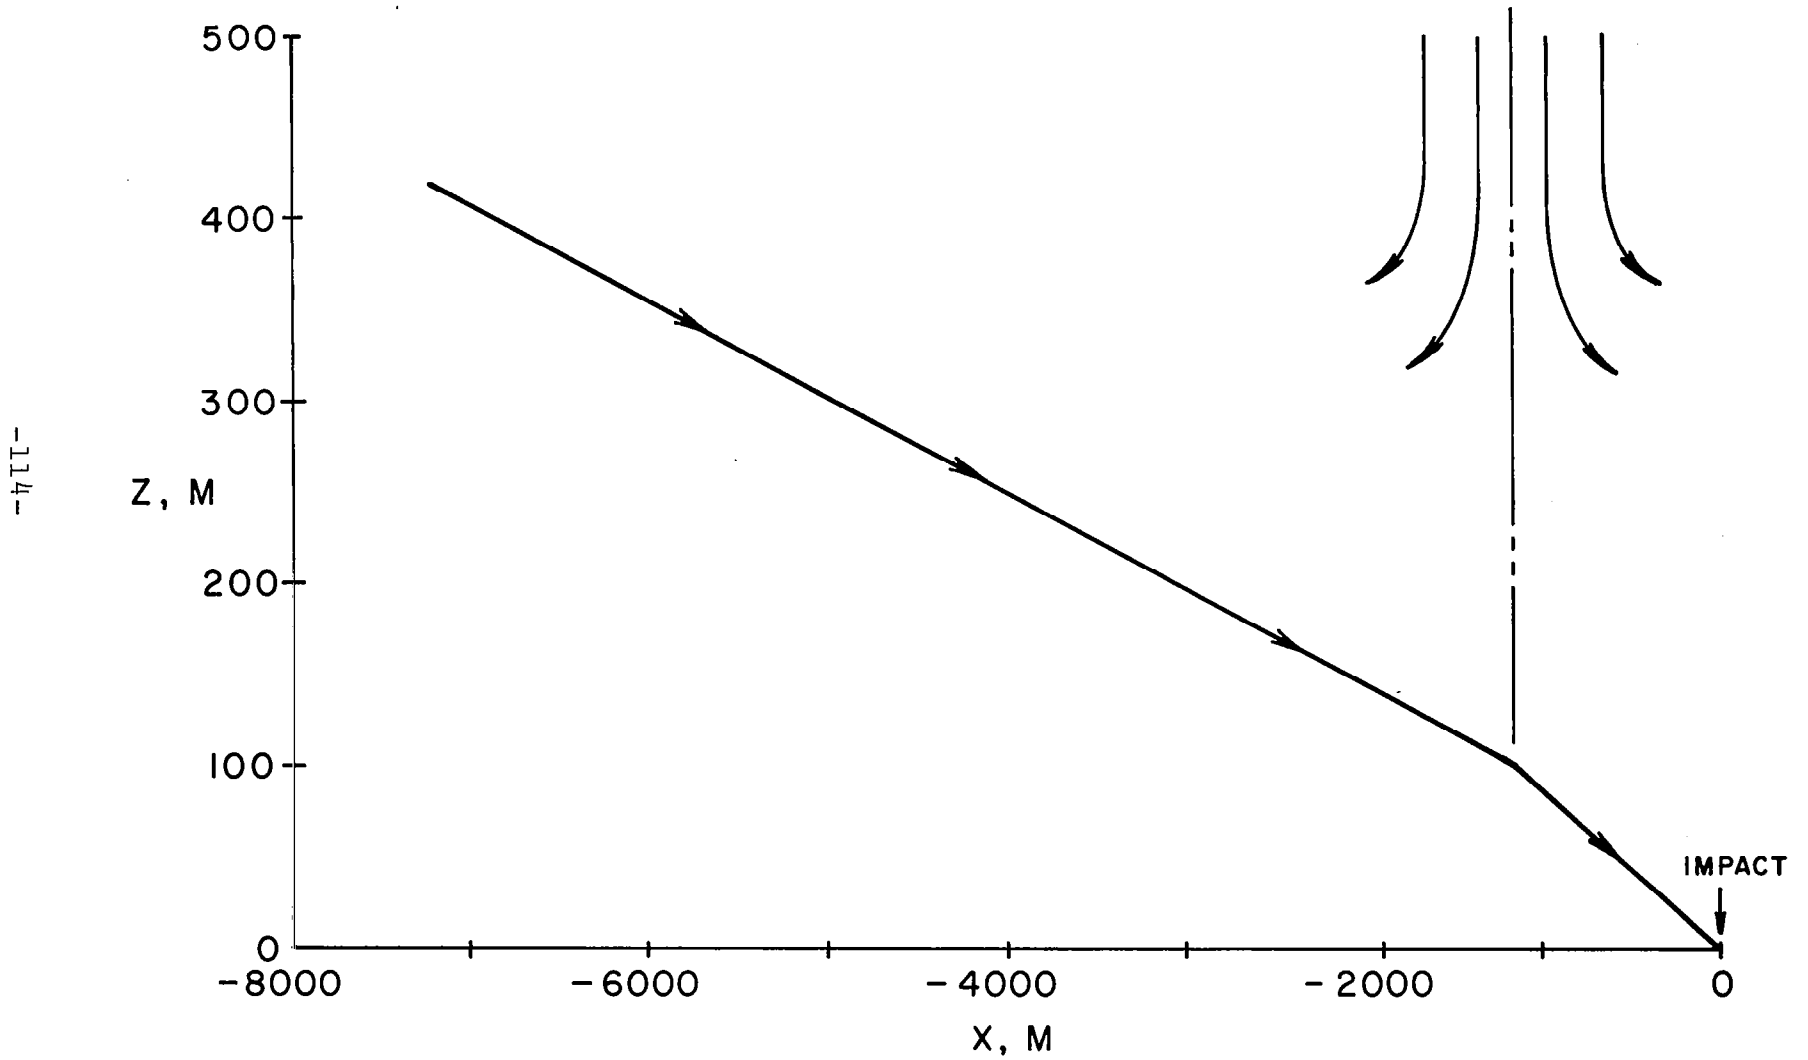
Figure 4.3.2. Approximate aircraft trajectory relative to storm cell and initial point of impact for Chattanooga, Tenn., November 27, 1973 accident.

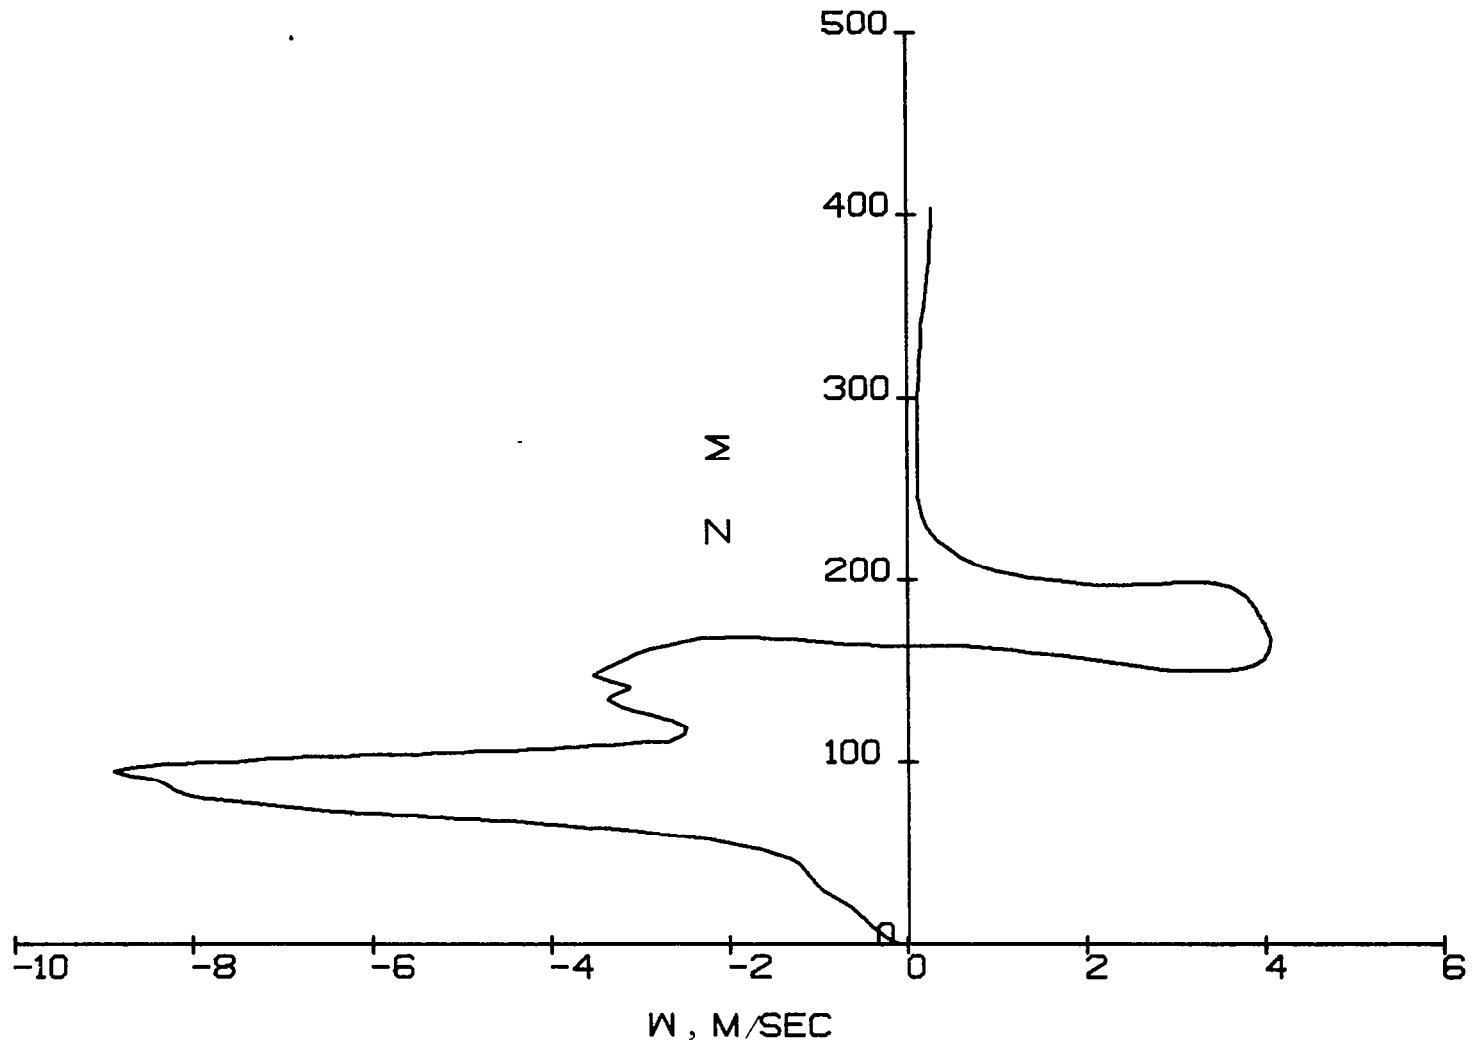
Figure 4.3.4. Altitude profile of mean wind vertical velocity component (+ W, up) for Chattanooga, Tenn., November 27, 1973 accident.
