**MODEL PREDICTIONS OF WIND  
AND TURBULENCE PROFILES  
ASSOCIATED WITH AN ENSEMBLE  
OF AIRCRAFT ACCIDENTS**

*G. G. Williamson, W. S. Lewellen,  
and M. E. Teske*

AERONAUTICAL RESEARCH ASSOCIATES OF PRINCETON, INC.

NATIONAL AERONAUTICS AND SPACE ADMINISTRATION • WASHINGTON D. C. • JULY 1977

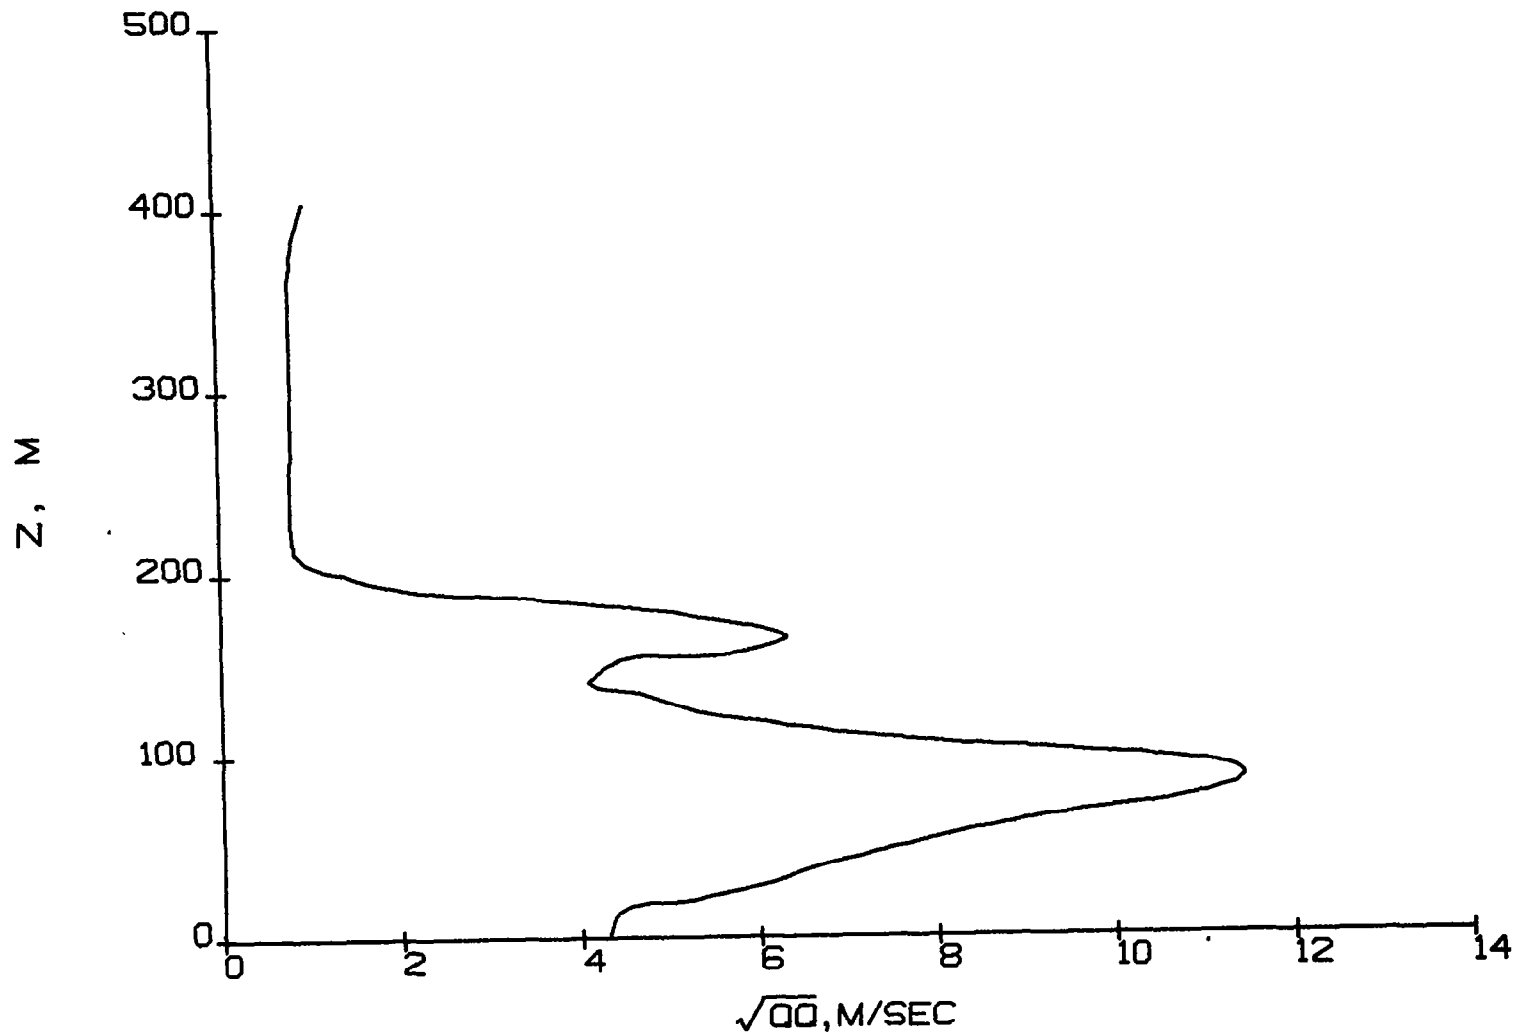
Figure 4.3.5. Altitude profile of variance of the total velocity for the Chattanooga, Tenn., November 27, 1973 accident.

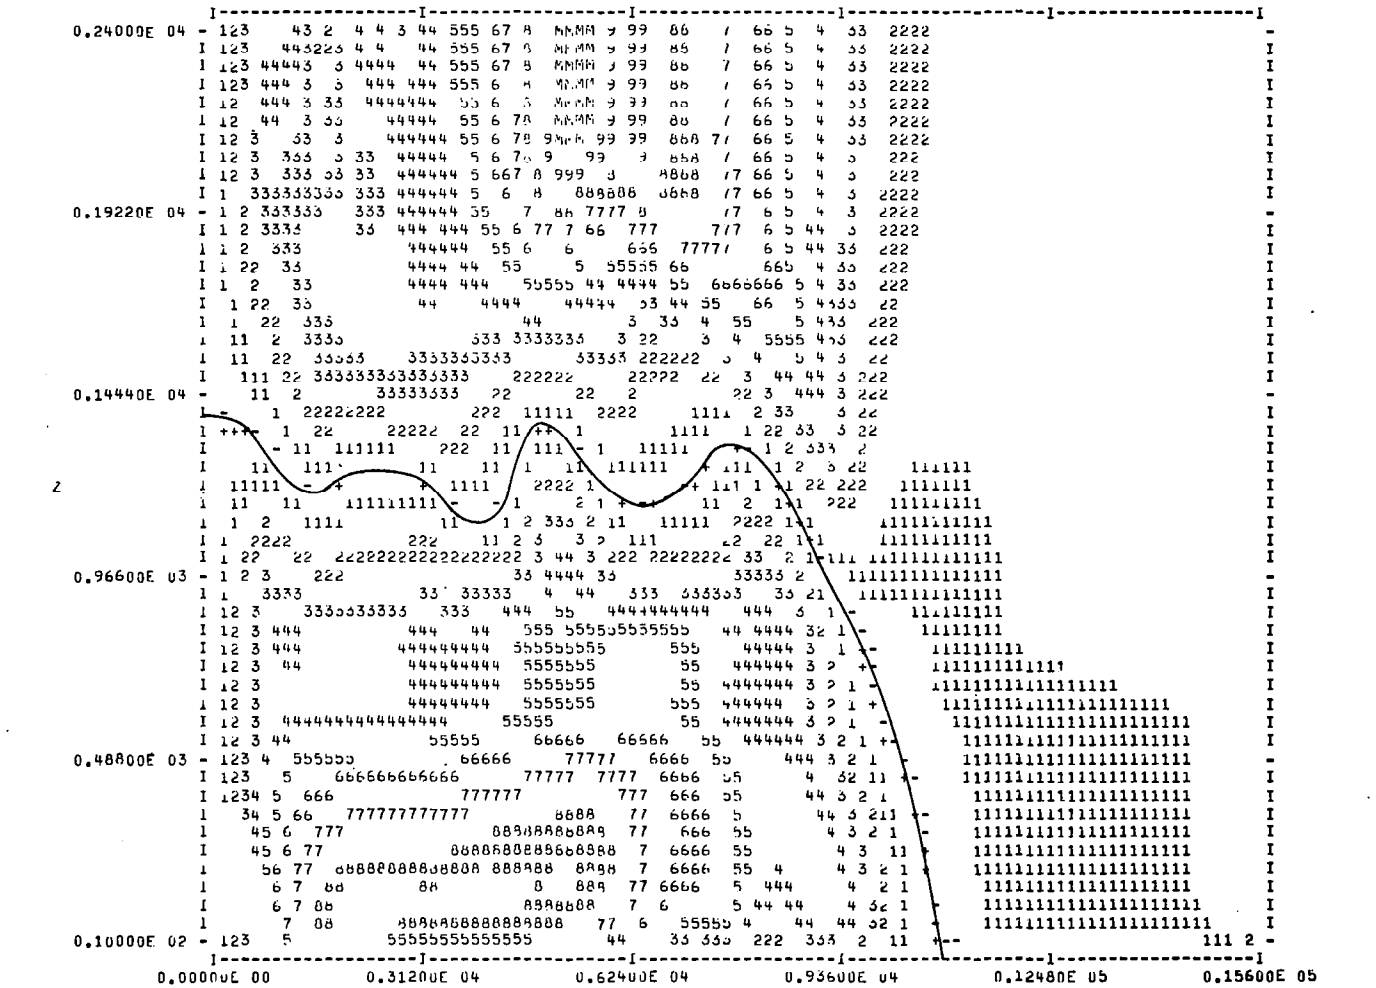
PRINTER PLOT FOR U                      ABS MAX VALUE = 0.29059E 02                      X = 0.10000E 04                      DATE=02/11/77                      FILE=GUST4  
 PERCENT MAX    1/-1                      5/10                      15/20                      25/30                      35/40                      45/50                      55/60                      65/70                      75/80                      85/90                      95/100  
 NOTATION                      +-                      1                      2                      3                      4                      5                      6                      7                      8                      9                      PM

Figure 4.4.4. Normalized mean radial velocity contours as a function of z and y for a two-dimensional gust front with a 2000 m radius downdraft at t = 1000 sec. [See figure 2.3.2 for explanation of notation.]

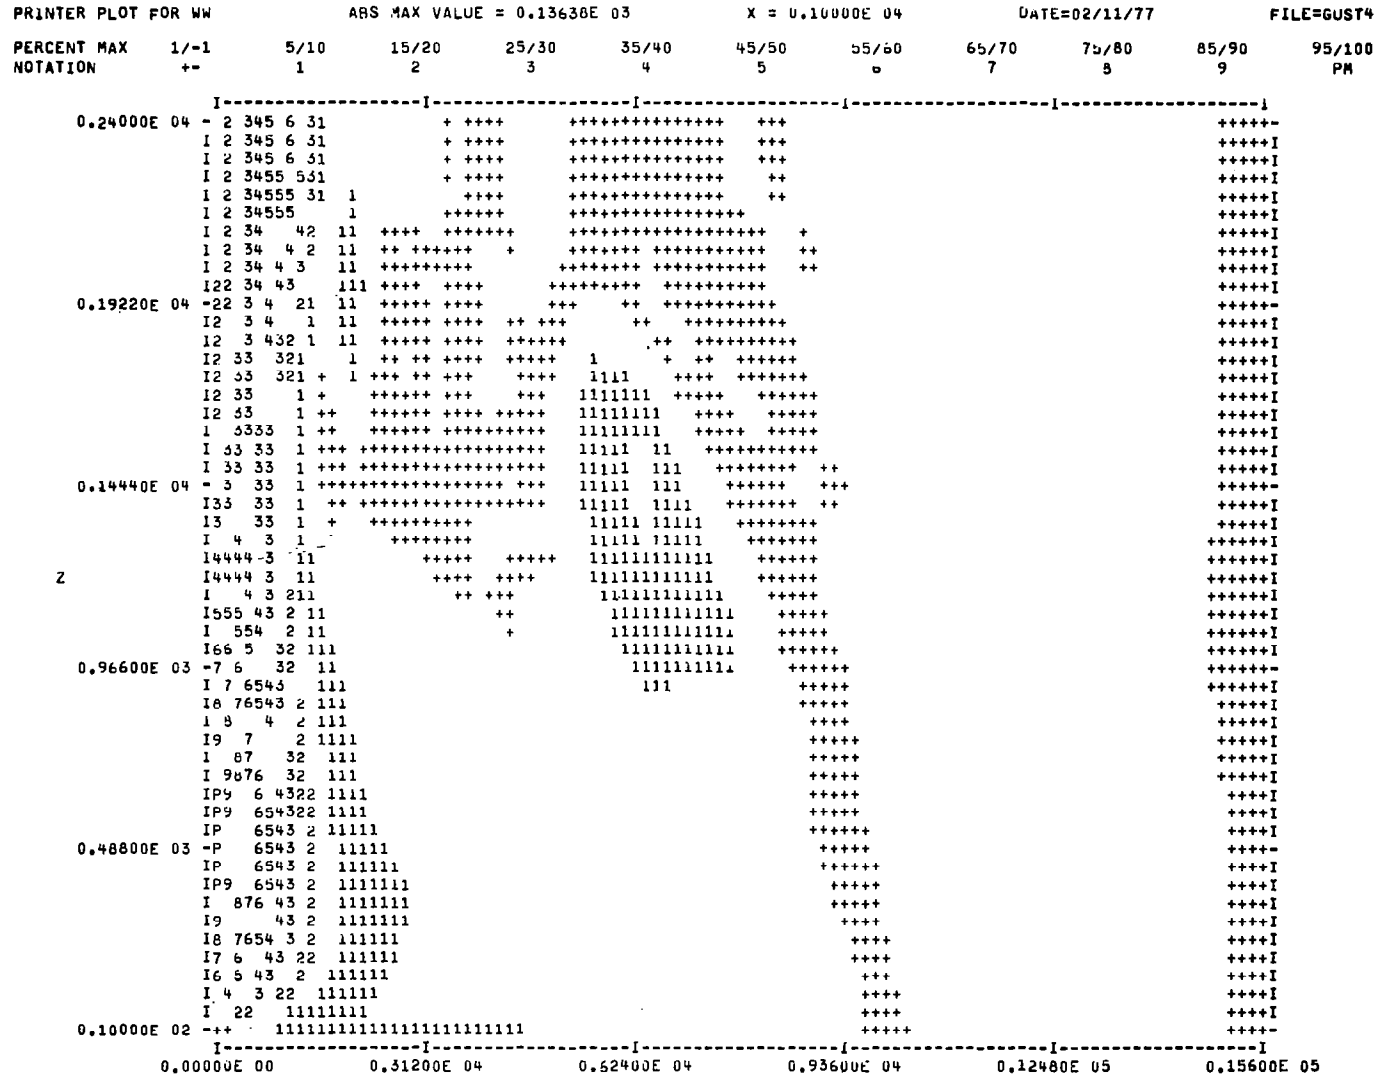
Figure 4.4.6. Normalized variance of vertical velocity contours as a function of z and y for a two-dimensional gust front with a 2000 m radius downdraft at t = 1000 sec. [See figure 2.3.2 for explanation of notation.]

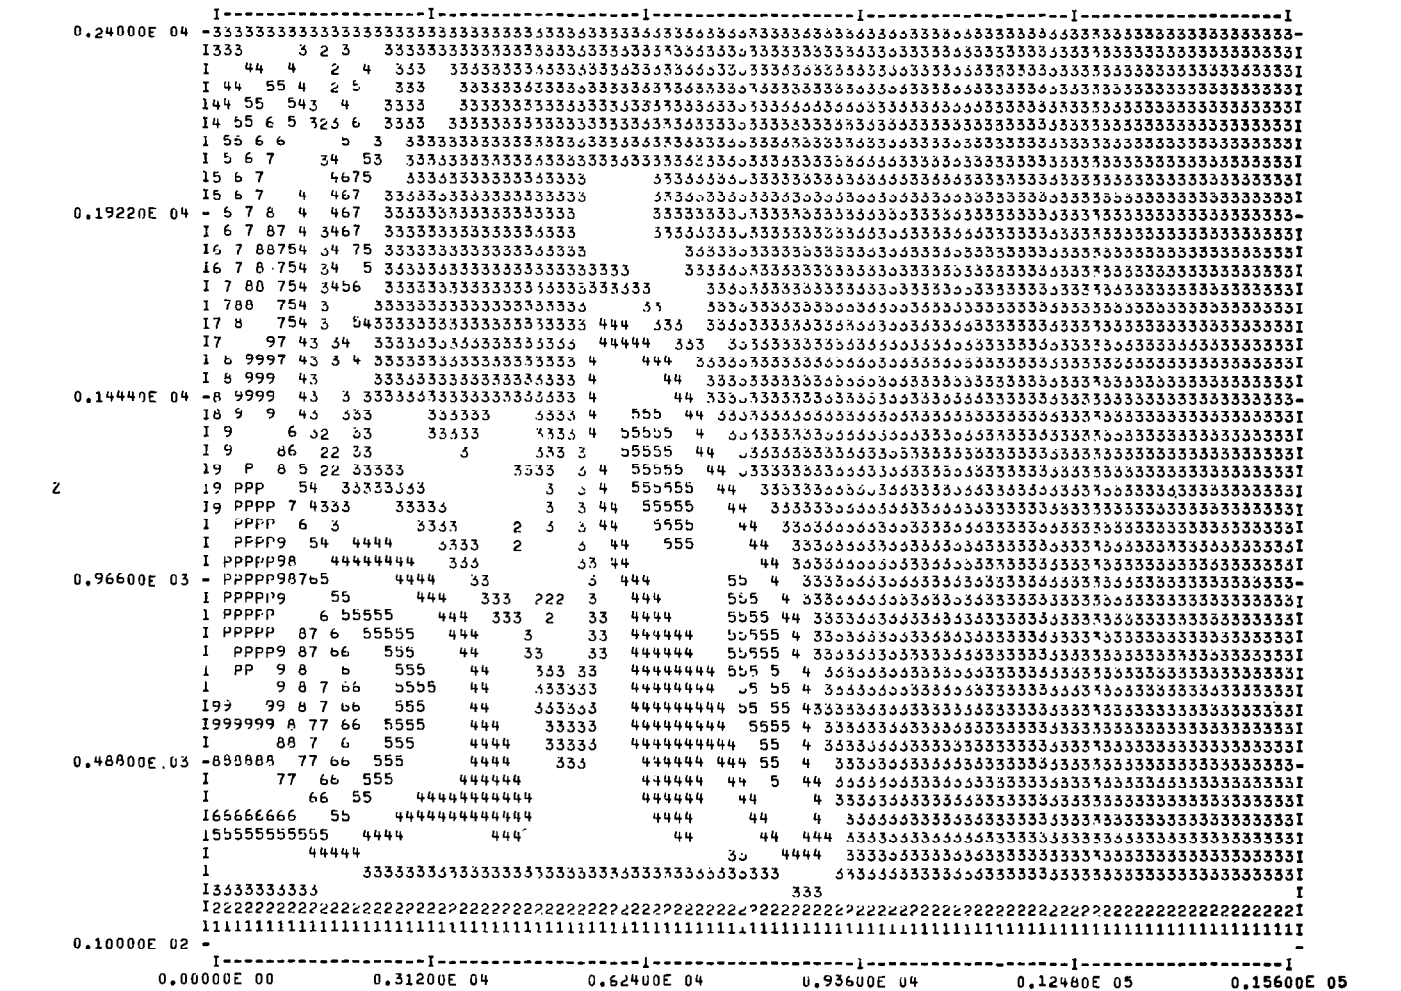
Figure 4.4.7. Normalized scale of turbulence contours as a function of z and y for a two-dimensional gust front with a 2000 m radius downdraft at t = 1000 sec. [See figure 2.3.2 for explanation of notation.]

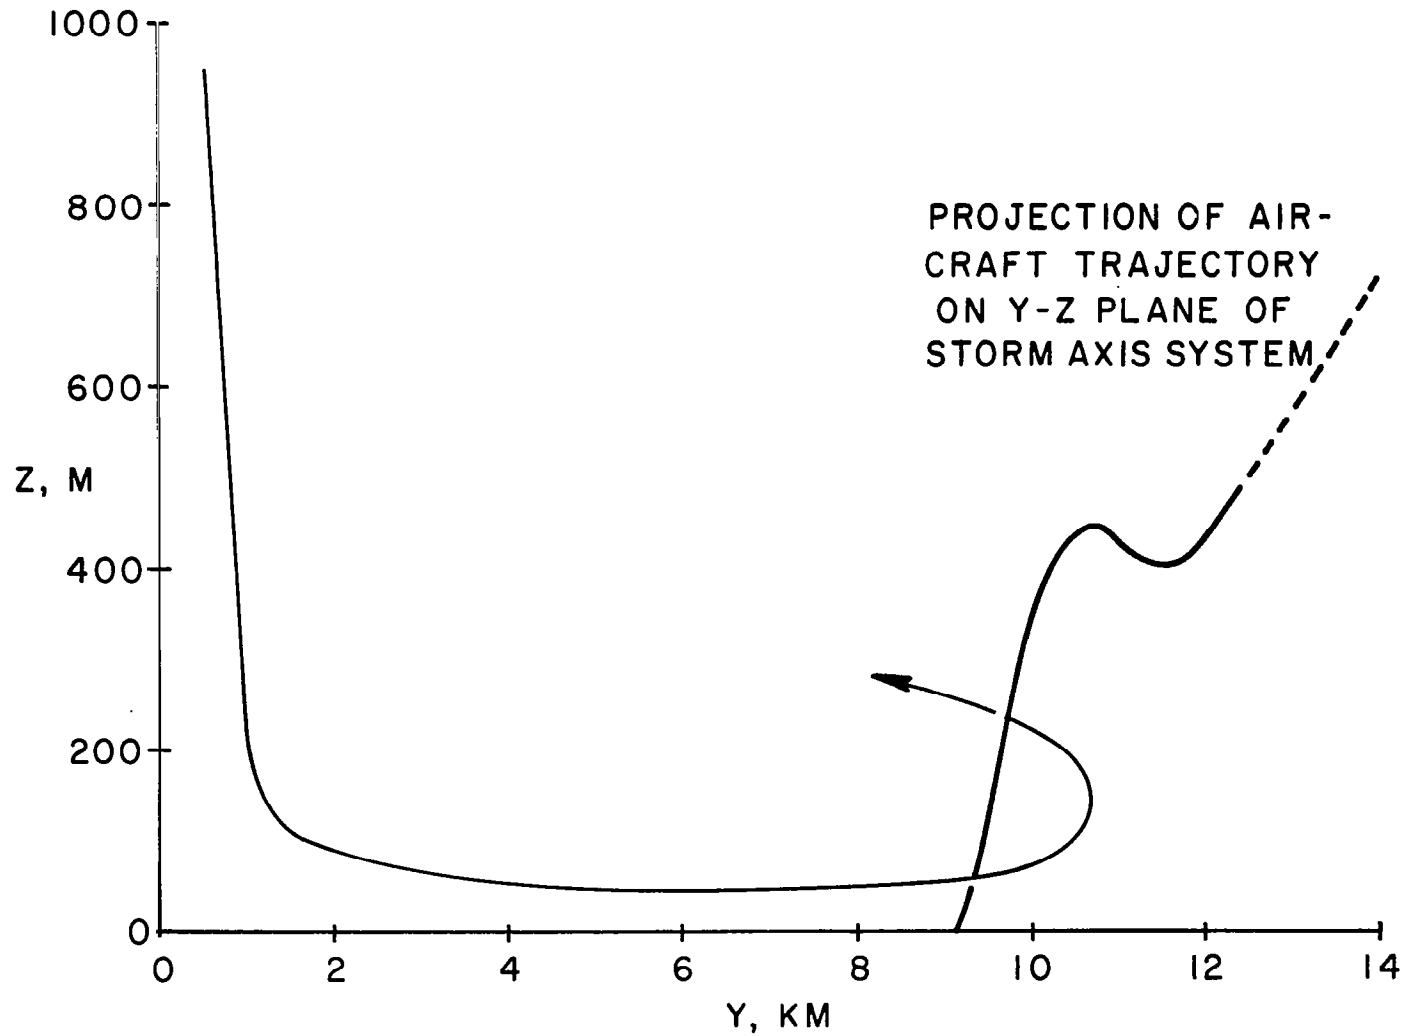
Figure 4.4.9. Projection of aircraft trajectory on the plane of the gust front for the St. Louis, Mo., July 23, 1973 accident.

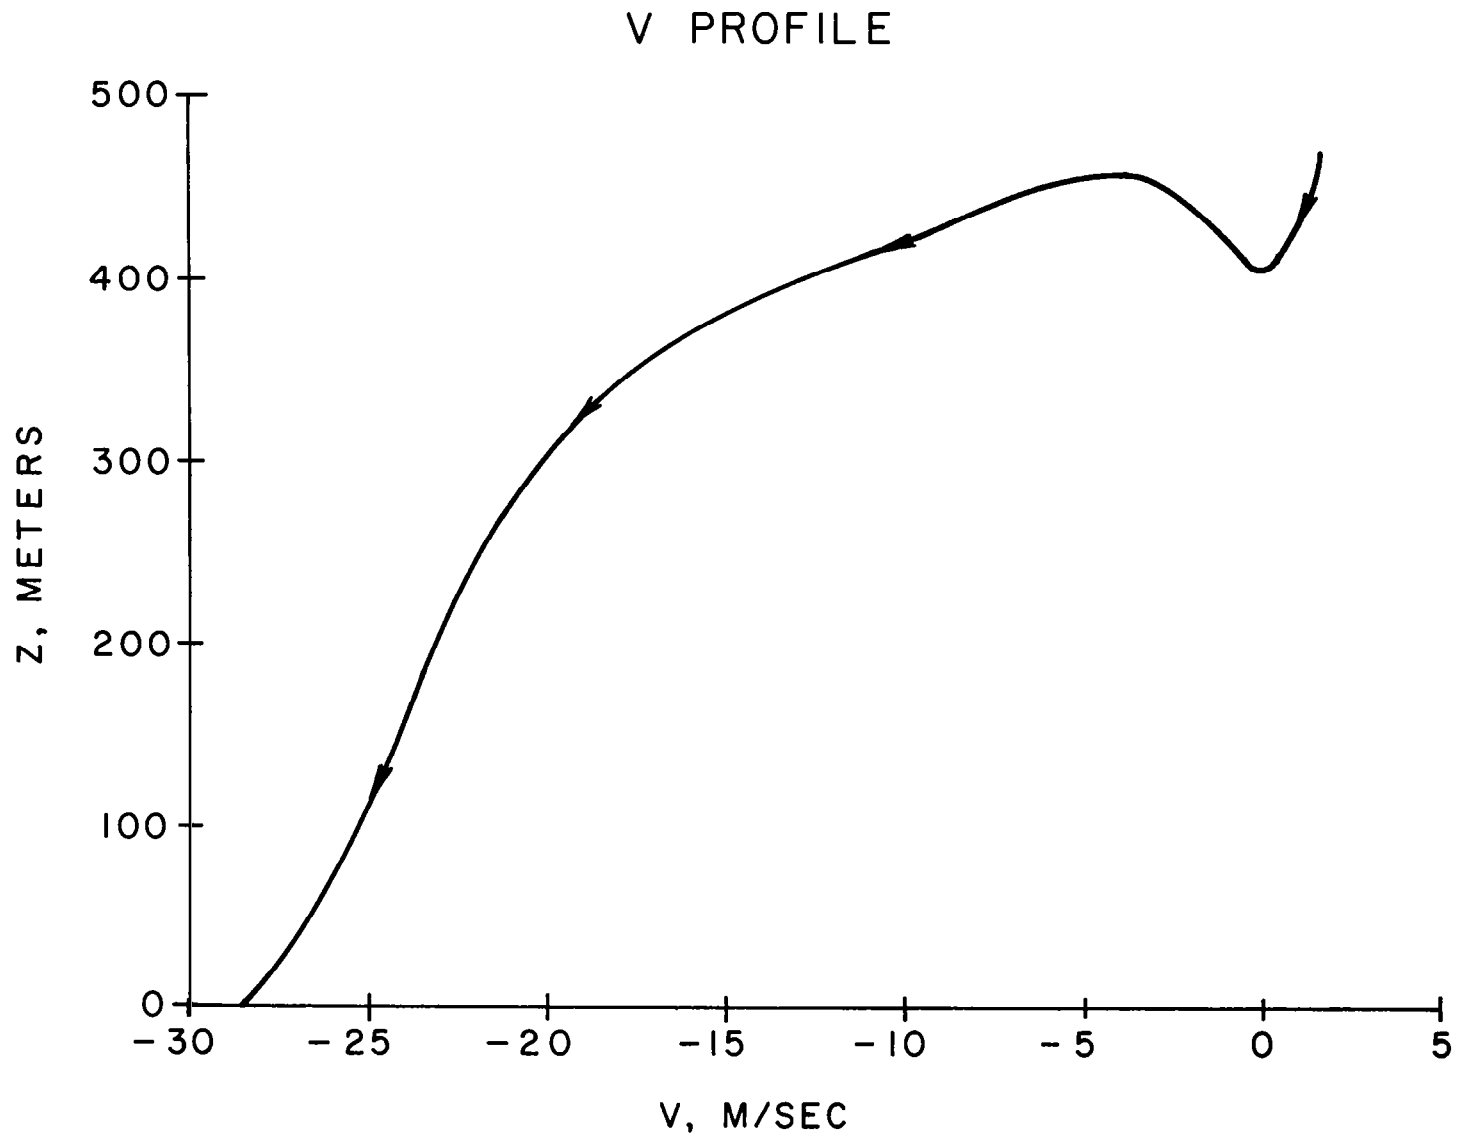
Figure 4.4.10. Altitude profile of horizontal mean wind velocity component along aircraft trajectory for the St. Louis, Mo., July 23, 1973 accident (+ V, crosswind from right).

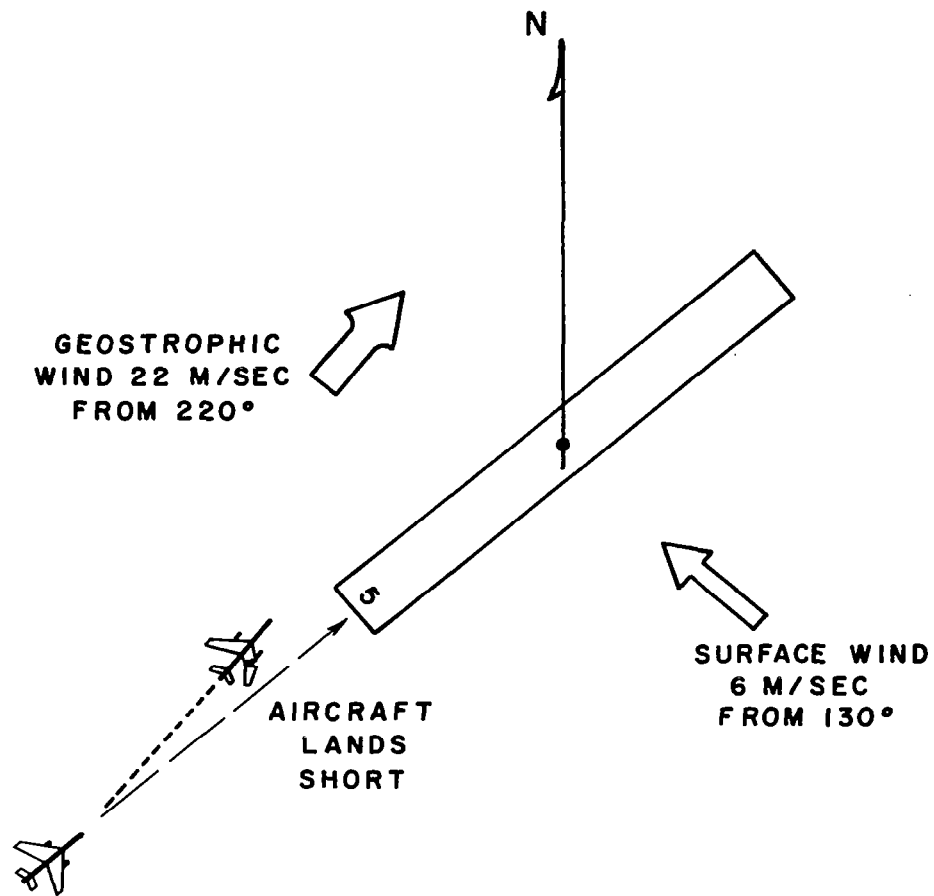
Figure 5.1.1. Aircraft-runway-winds orientation diagram for Raleigh-Durham, N.C., April 2, 1970 accident.

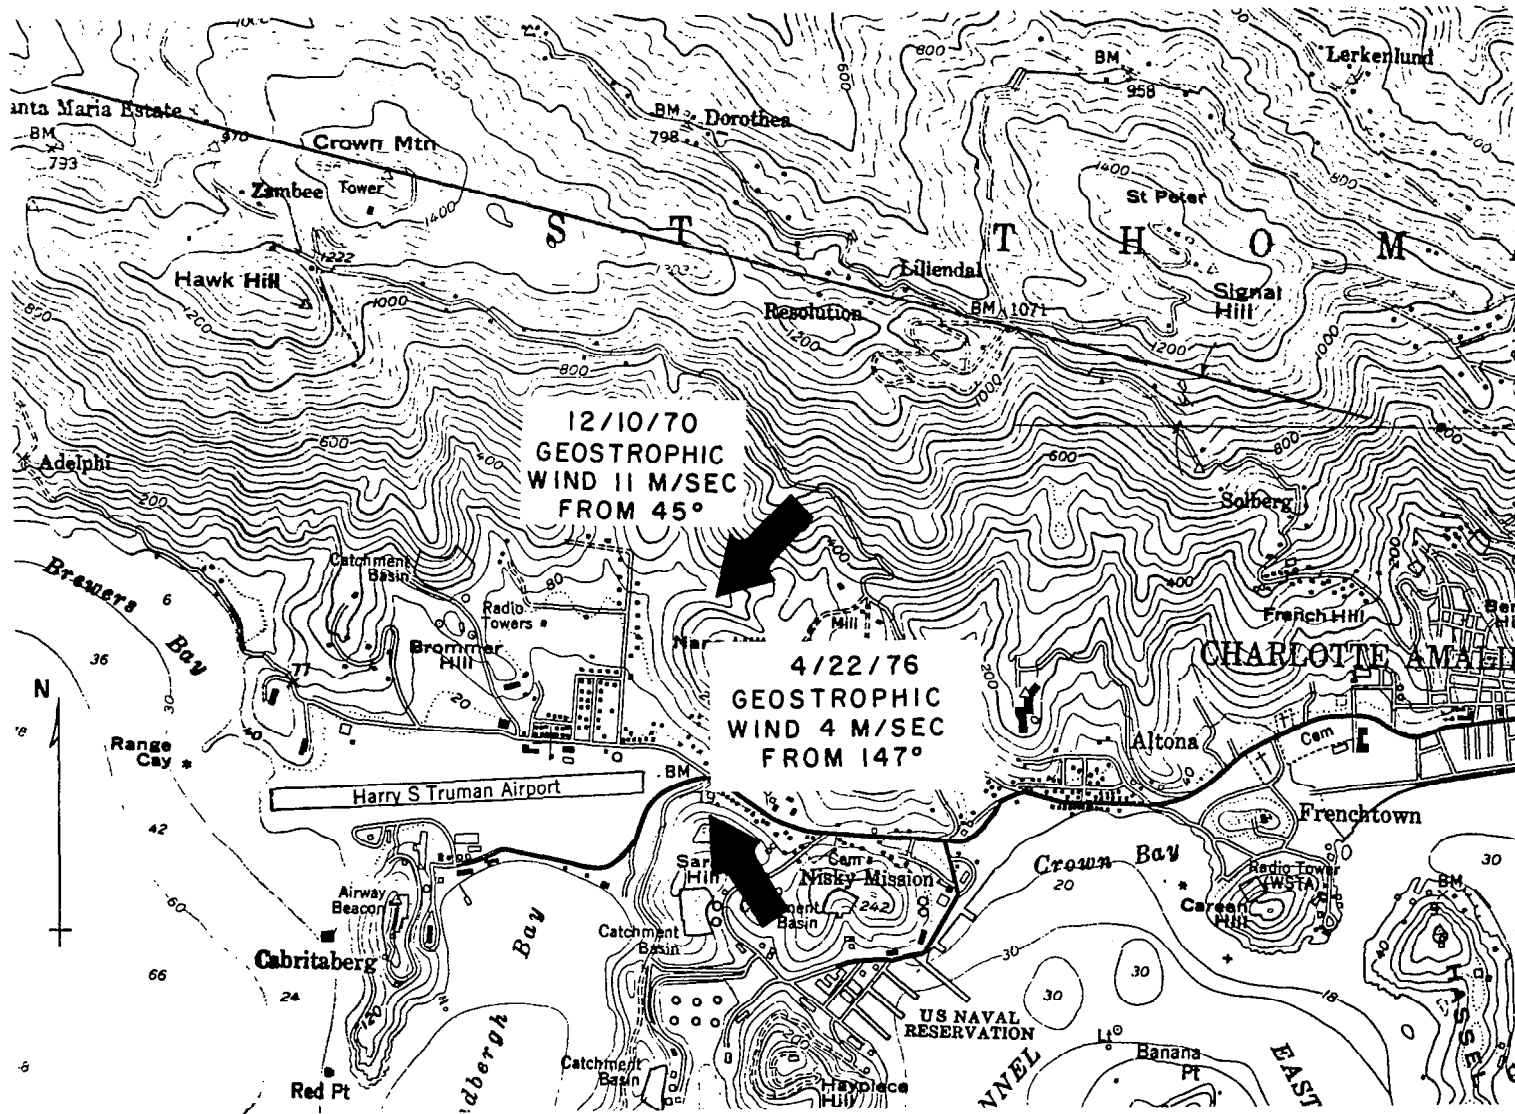
Figure 5.2.1. Airport-topography-wind orientation drawing for the two St. Thomas, V.I. accidents.
