TECHNICAL REPORT HL-89-27

NAVIGATION CONDITIONS AT OLIVER LOCK AND DAM BLACK WARRIOR RIVER PROJECT

Hydraulic Model Investigation

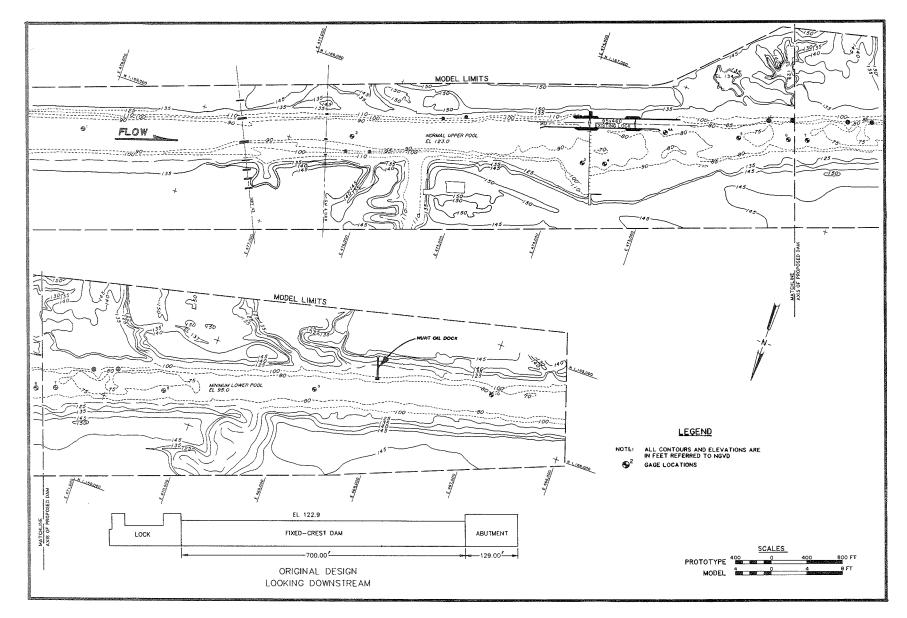
Figure 2. Existing conditions

18. Base tests were conducted with the model reproducing existing conditions as shown in Figure 2. The purposes of the tests were to verify that the model was reproducing known prototype conditions and to provide information and data that could be used to evaluate the effect of the proposed modifications on water-surface elevations, current direction and velocities, and navigation conditions. The principal features reproduced or simulated in the model, shown in Figures 2 and 3, included:

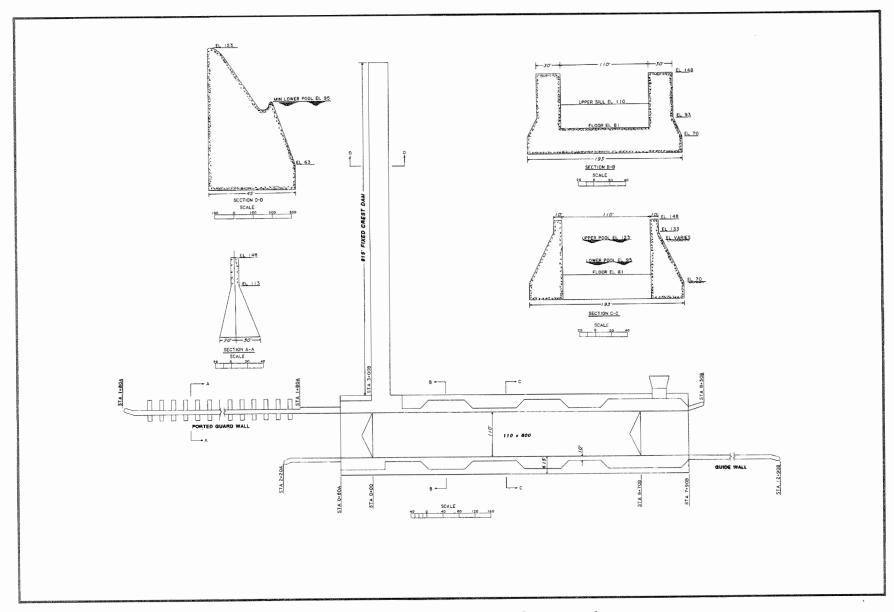
Figure 5. General plan and section of proposed structure

22. Plan A involved removing a major portion of the existing fixedcrest dam and placing a 110- by 600-ft lock and an 815-ft fixed-crest dam about 2,300 ft downstream of the existing dam (Figures 4 and 5). The axis of the dam was located at river mile 337.6, and the intersection of the center line of the lock and the pintle of the upper lock gate was located at coordinates N 1,167,585, E 471,511. Features of this plan concerning the elevation and amount of existing dam to be removed and the limits of the left bank excavation in the vicinity of the new dam were developed during preliminary tests and construction sequence tests. The principal features of Plan A were as follows (Figures 4 and 5):

> a. The existing fixed-crest dam and right bank abutment were removed to el 95.0 except for the 250 ft of dam adjacent to the existing lock, which was removed to el 111.0 (12 ft below minimum pool).

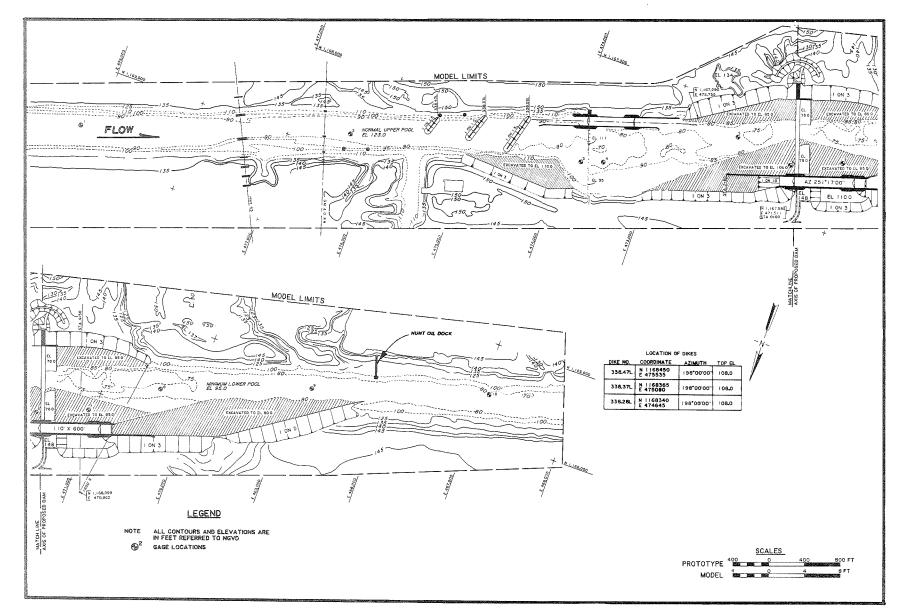
Figure 6. Plan A-Modified

29. Plan A-Modified was the same as Plan A except three submerged dikes of various lengths with top el 108.0 were added in the main river channel at river miles 338.47, 338.37, and 338.28 (Figure 6). The dikes were connected to the left bank, spaced about 500 ft apart, and angled upstream to provide the most efficient training of the currents into the right bank excavation. The submerged dikes were developed to increase the flow into the excavation along the right bank upstream of the existing structure in an attempt to improve navigation conditions for tows turning from the main river channel into the right bank excavation. The gates in the existing lock were closed to aid in moving the currents toward the right bank.

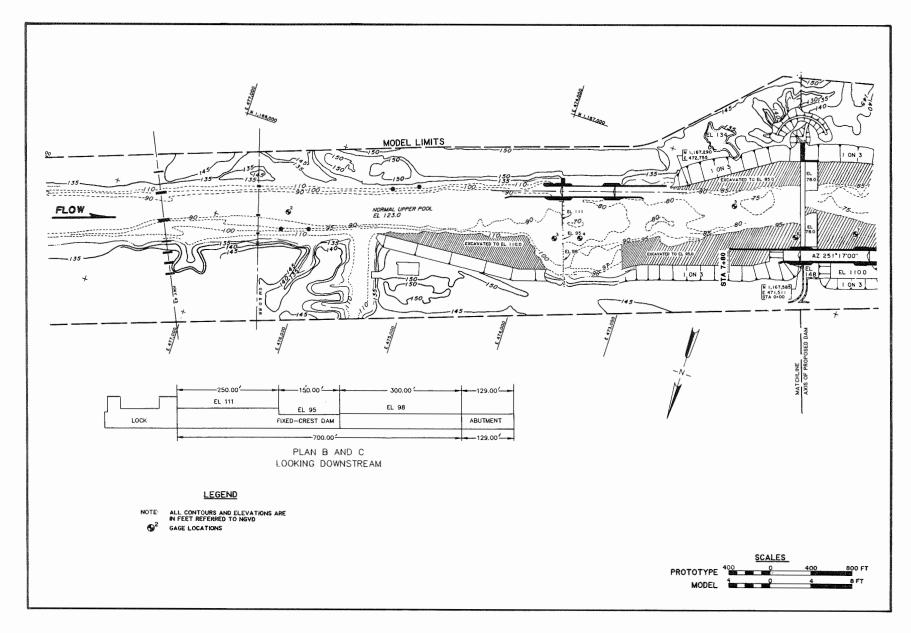
- 33. Plan B (Figure 7) was the same as Plan A except for the following:
  - a. The right bank upstream of the existing dam was excavated landward to el 110.0 extending from the dam upstream to the creek (this excavation encroached on the existing access road).

- b. The 250 ft of existing dam adjacent to the existing lock was removed to el 111.0, the center portion of the dam was removed to el 95.0, and 300 ft of existing dam adjacent to the right bank and the abutment were removed to el 98.0.
- c. The right bank and channel bottom upstream of the new lock and the right end of the dam were excavated to el 95.0.

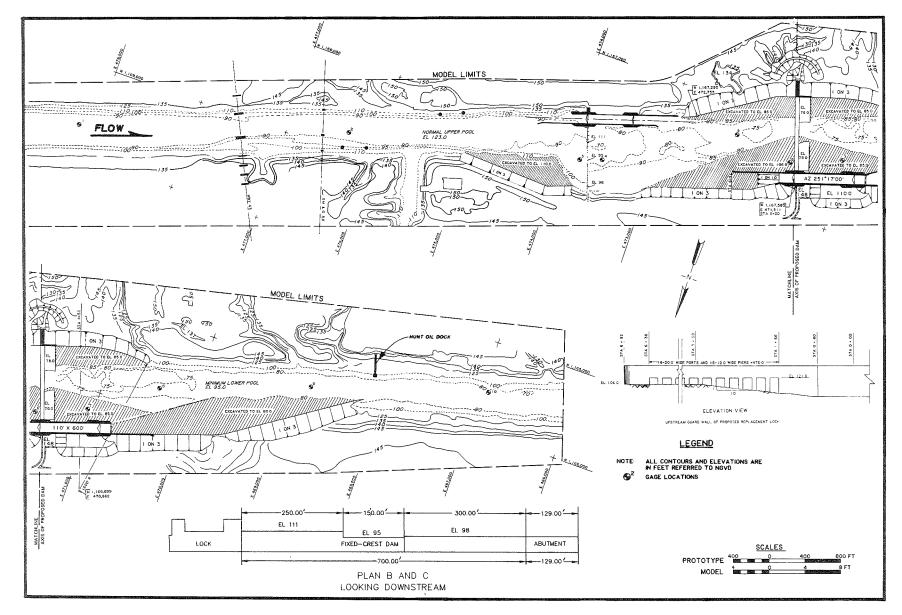
- 37. Plan C (Figure 8) was the same as Plan A except for the following:
  - <u>a</u>. The upper guard wall was shortened 88 ft from sta 7+80 to sta 6+92 due to design considerations, providing a 526-ft ported wall with sixteen 20-ft-wide ports and fifteen 10-ftwide piers with the top of the ports at el 121.0.
  - b. The 250 ft of existing dam adjacent to the existing lock was removed to el 111.0, the center portion of the dam was removed to el 95.0, and 300 ft of existing dam adjacent to the right bank and the abutment was removed to el 98.0.

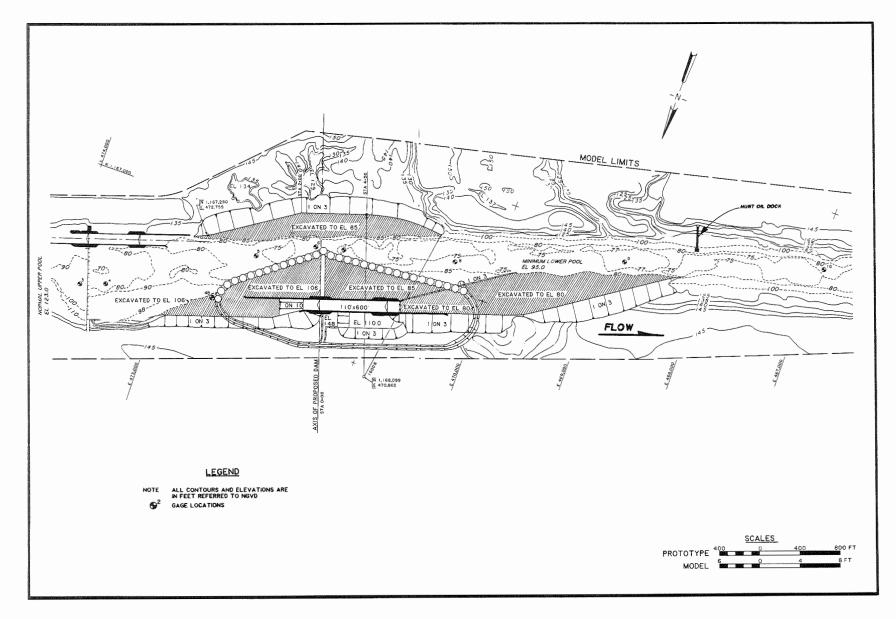
51. The principal features of the first-stage cofferdam (Figure 10 and Photo 18) were the same as existing conditions except for the following:

- a. A cofferdam with top el 150.0 was placed along the right bank about 2,600 ft downstream of the existing dam for construction of the replacement lock and 350 ft of the replacement dam.
- b. The left bank and channel bottom were excavated to el 85.0 beginning near the downstream end of the existing guide wall and extending downstream about 2,400 ft to provide a navigation channel with a 400-ft minimum width past the cofferdam. Additional excavation indicated by preliminary tests was incorporated into the model.
- c. The mooring cells along the left bank downstream of the existing lock were removed.

d. The right bank upstream and downstream of the cofferdam was excavated to el 106.0 and 80.0, respectively, to provide navigation channels to the new lock.

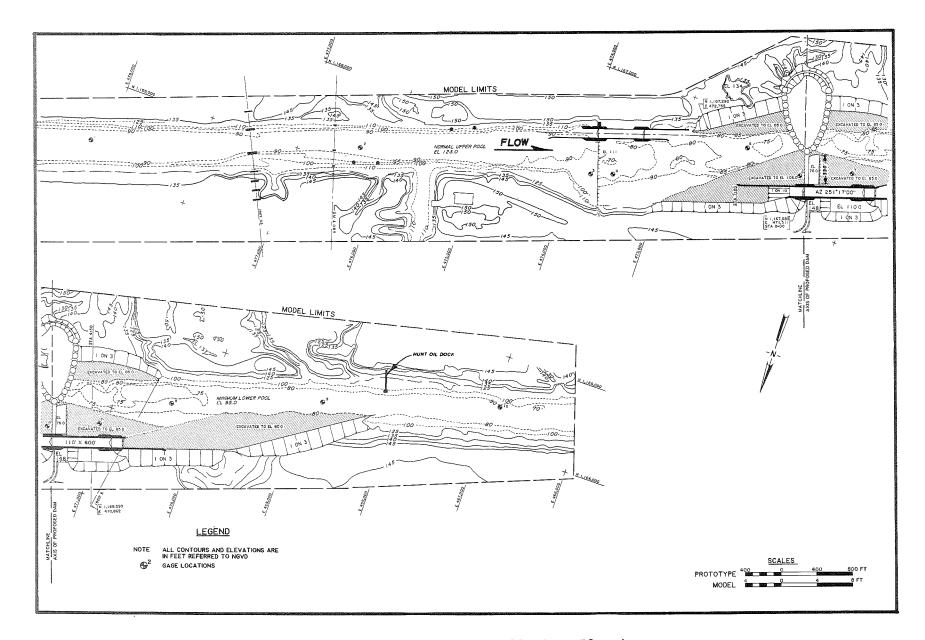
Figure 11. Second-stage cofferdam, Plan A

55. The principal features of the second-stage cofferdam, Plan A (Figure 11), were as follows:

a. The 110- by 600-ft replacement lock with its upper guard wall

- b. The right bank upstream and downstream of the replacement lock was excavated to el 106.0 and 80.0, respectively, to provide navigation channels to the new lock.
- c. The left bank and channel bottom were excavated to el 85.0 beginning near the downstream end of the existing guide wall and extending downstream about 2,400 ft.
- d. The 350-ft section of the new dam adjacent to the replacement lock was in place.
- e. The second-stage cofferdam with top el 155.0 was in place adjacent to the left bank and extended from the left bank and incorporated the left end of the partially completed dam. This configuration provided 330 ft of the new dam for passing flow.
- f. The existing dam from the existing lock to the right bank abutment was removed to el 111.0.

57. Current directions and velocities. Data shown in Plates 34-36 indicate the currents were generally parallel to the bank lines from upstream of the bridges to about 3,600 ft upstream of the axis of the replacement dam, then moved toward the right bank and into the approach of the replacement

lock. The currents approaching the replacement lock turned toward the dam about 1,000 ft upstream of the guard wall and moved across the lock approach. The maximum velocity in the navigation channel upstream of the replacement lock varied from about 2.3 to 4.6 fps through the bridges, 2.1 to 5.3 fps about 3,600 ft upstream of the replacement lock, and 1.5 to 3.9 fps about 1,000 ft upstream of the guard wall with the 30,000- and 100,000-cfs riverflows, respectively. With riverflows of 60,000 cfs and below, the flow was concentrated over the 330-ft useable portion of the dam adjacent to the replacement lock, creating high-velocity currents along the riverside lock wall that turned toward the left bank near the downstream end of the lock wall. A large counterclockwise eddy formed downstream of the cofferdam with a maximum upstream current velocity of 3.6 fps occurring with the 60,000-cfs riverflow. A large clockwise eddy formed in the lower approach to the replacement lock with the maximum upstream current velocity of 5.6 fps occurring with the 60,000-cfs riverflow. As the riverflow increased to 100,000 cfs, the eddy downstream of the cofferdam increased in size and intensity and high-velocity currents moved across the lower lock approach.

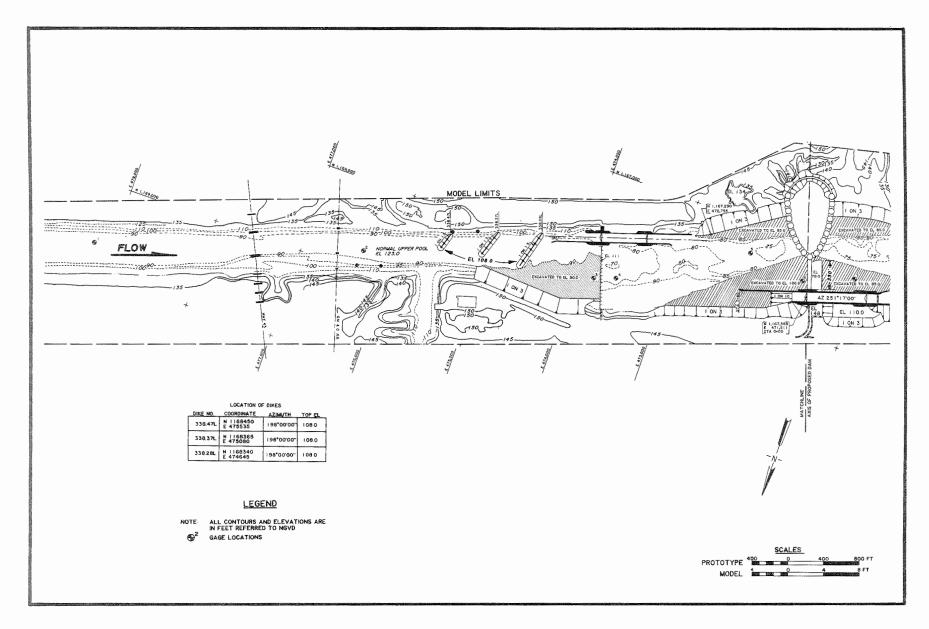
Figure 12. Second-stage cofferdam, Plan B

60. Plan B (Figure 12) was developed to improve navigation conditions for downbound tows approaching the new lock and was the same as second-stage cofferdam Plan A except for the following:

62. <u>Current directions and velocities.</u> Data shown in Plates 37 and 38 indicate the submerged dikes and right bank excavation increased the flow along the right bank from upstream of the existing dam to the lock forebay with the 30,000- and 60,000-cfs riverflows compared with Plan A. There was also a corresponding increase in the velocity of the currents along the right bank and in the upper lock approach with a maximum velocity of 4.2 fps occurring with the 60,000-cfs riverflow in the vicinity of the submerged dikes.

63. <u>Navigation conditions.</u> Conditions were satisfactory for tows entering and leaving the upper lock approach with riverflows through 60,000 cfs. A downbound tow navigating through the center of the navigation spans of the bridges could turn from the main river channel into the excavation along the right bank, align with the guard wall approximately two tow lengths upstream of the guard wall, and enter the lock forebay at a slow speed.

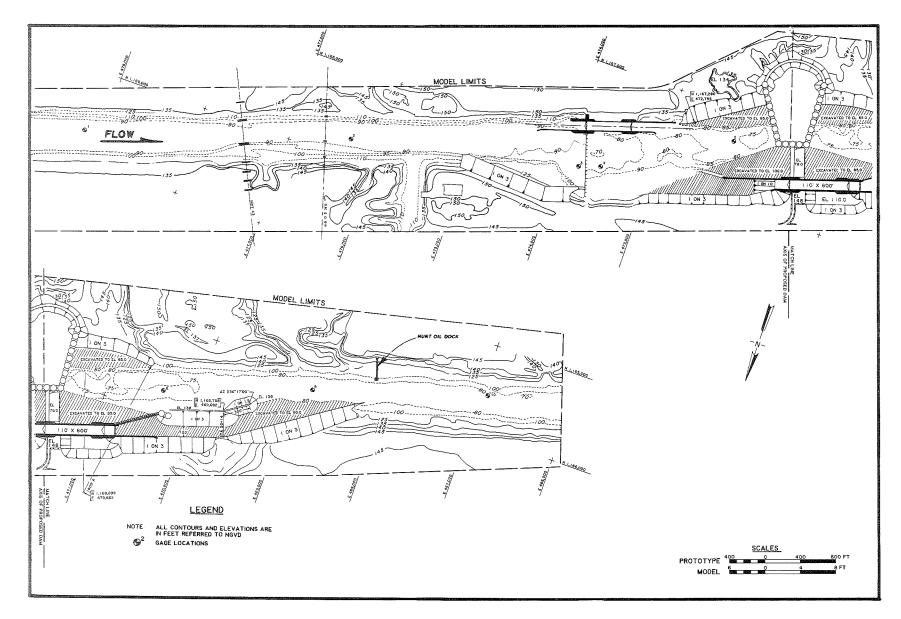
Figure 14. Second-stage cofferdam, Plan D

68. Plan D was the same as Plan C except the second-stage cofferdam was changed to a rectangular configuration with a straight riverward face that was parallel to the lock. The first-stage cofferdam cells forming the upstream end of the training structure in the vicinity of the lower lock approach were replaced with a row of cells extending from the riverward lock wall to the existing embankment (Figure 14 and Photo 33). The fixed-crest dam available to pass flow remained the same as with Plan C (330 ft). Results

69. <u>Water-surface elevations</u>. Elevations shown in Table 9 indicate an increase of 0.3 to 0.4 ft upstream of the cofferdam with riverflows of 30,000 and 60,000 cfs compared with second-stage cofferdam Plan C. As the riverflow

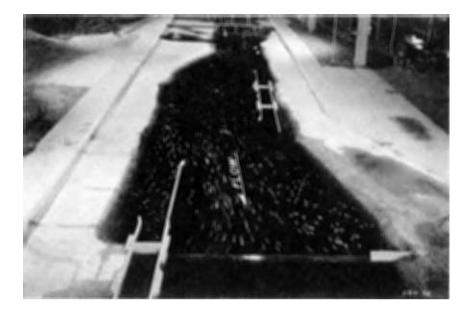
Photo 1. Plan A, looking upstream, discharge 30,000 cfs. Confetti showing current patterns approaching replacement lock and dam

the existing lock closed (Plates 6-10 and Photos 1 and 2) indicate the currents upstream of the lock were generally parallel to the bank lines from upstream of the bridges to the upstream end of the right bank excavation (about 3.600 ft upstream of the new dam axis), then moved toward the right bank and into the approach to the new lock. The currents approaching the replacement lock moved into the right bank excavation about 2,500 ft upstream of the guard wall and then turned toward the dam about 1,000 ft upstream of the guard wall. The currents near the downstream end of the lock moved toward the right bank and across the lower lock approach and then at about 2,500 ft downstream of the dam became generally aligned with the right bank (Photos 3 and 4). The maximum velocity in the navigation channel upstream of the lock varied from about 2.4 to 7.3 fps through the bridges, 2.5 to 7.7 fps near the upstream end of the right bank excavation, and 2.3 to 6.7 fps about 1,000 ft upstream of the guard wall with the 30,000- and 160,000-cfs riverflows, respectively. The maximum velocity in the lower lock approach near the downstream end of the guide wall varied from 1.9 to 4.7 fps with the 30,000- and 100,000-cfs riverflows, respectively, and the maximum velocity near the downstream end of the right bank excavation varied from about 2.8 to 6.3 fps with the 30,000- and 160,000-cfs riverflows, respectively.

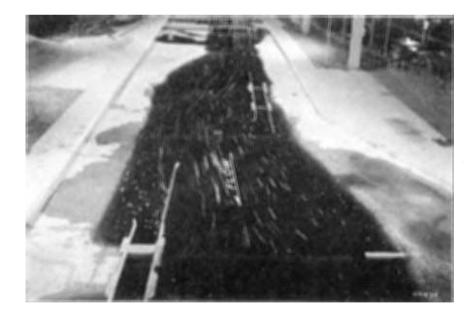
Photo 2. Plan A, looking upstream, discharge 100,000 cfs. Confetti showing current patterns approaching replacement lock and dam.

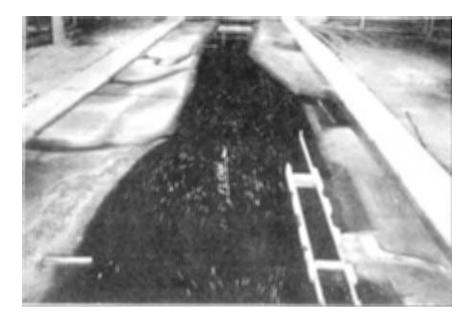
Photo 3. Plan A, looking downstream, discharge 30,000 cfs. Confetti showing current patterns approaching replacement lock and dam

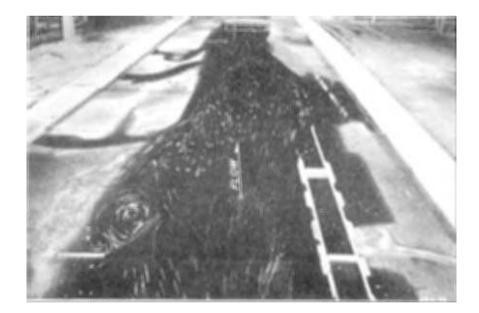
Photo 4. Plan A, looking downstream, discharge 100,000 cfs. Confetti showing current patterns approaching replacement lock and dam

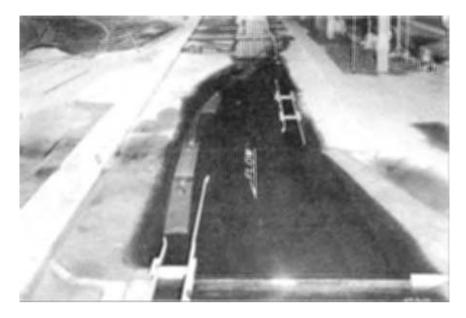
Photo 5. Plan A, looking upstream, discharge 30,000 cfs. Path of downbound tow approaching replacement lock

27. <u>Navigation conditions.</u> Locating the replacement lock immediately downstream of the existing structures and along the right bank will require downbound tows to move through the navigation spans of the highway and railroad bridges adjacent to the left bank, turn toward the right bank as quickly as possible, enter the right bank excavation, and turn toward the left to align with the replacement lock, all in a very limited distance. As the velocity of the currents increases, this maneuver becomes more difficult. With riverflows through 60,000 cfs, downbound tows could navigate through the center of the bridges, make the turn into the right bank excavation, align with the lock one to two tow lengths upstream of the guard wall, and reduce speed to approach the guard wall (Photos 5 and 6). As the riverflow increased

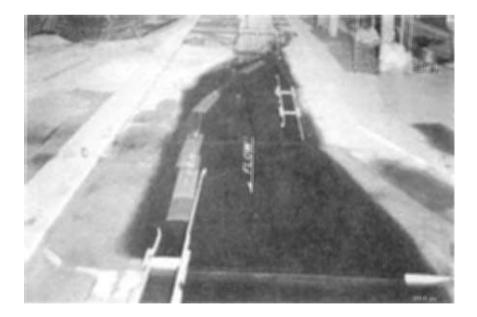
Photo 6. Plan A, looking upstream, discharge 60,000 cfs. Path of downbound tow approaching replacement lock

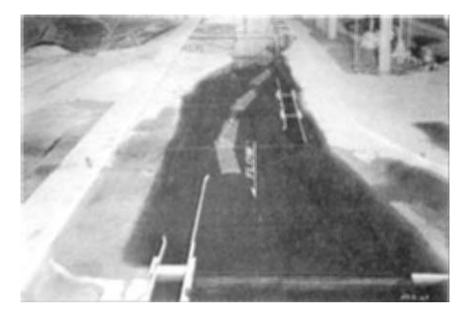
Photo 7. Plan A, looking upstream, discharge 100,000 cfs. Path of downbound tow approaching replacement lock. Note tendency for tow to be moved riverward of guard wall

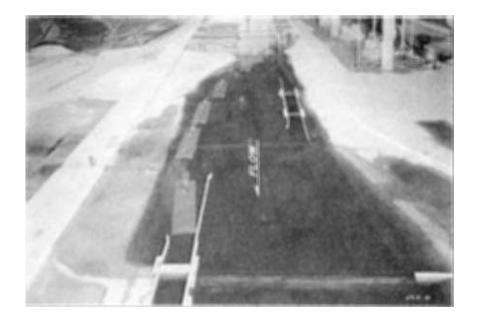
Photo 8. Plan A, looking upstream, discharge 100,000 cfs. Path of downbound tow flanking to approach replacement lock

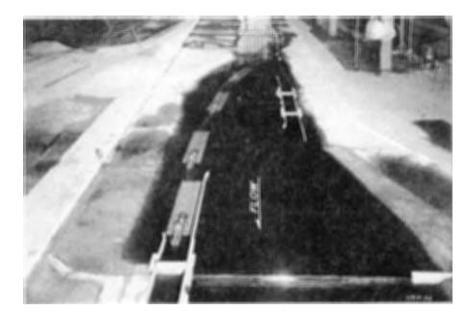
Photo 9. Plan A, looking upstream, discharge 30,000 cfs. Path of upbound tow leaving replacement lock

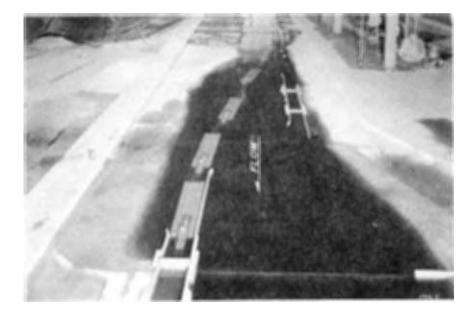
Photo 10. Plan A, looking upstream, discharge 60,000 cfs. Path of upbound tow leaving replacement lock

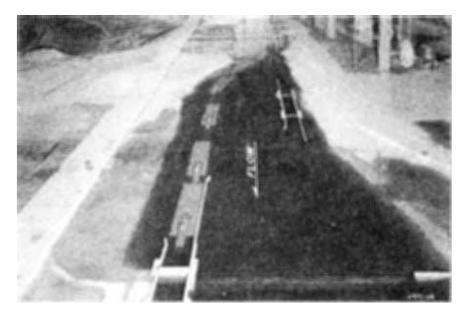
Photo 11. Plan A, looking upstream, discharge 100,000 cfs. Path of upbound tow leaving replacement lock

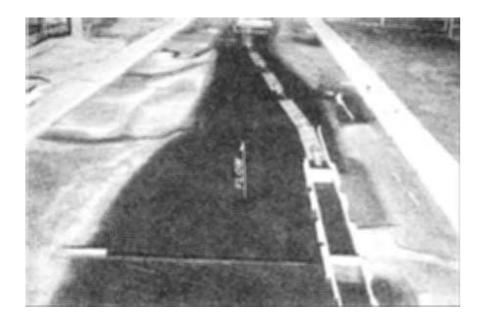
Photo 12. Plan A, looking downstream, discharge 30,000 cfs. Path of downbound tow leaving replacement lock

28. Opening the gates of the existing lock to pass flow did not significantly change navigation conditions for tows entering or leaving the upper lock approach. Tows could also enter and leave the lower lock approach without any major difficulties. However, the Hunt Oil Dock located along the left bank near the downstream end of the lower approach to the lock did restrict the channel width in an area that a tow would be maneuvering to enter or leave the approach and could create some difficulties (Photos 12-17).

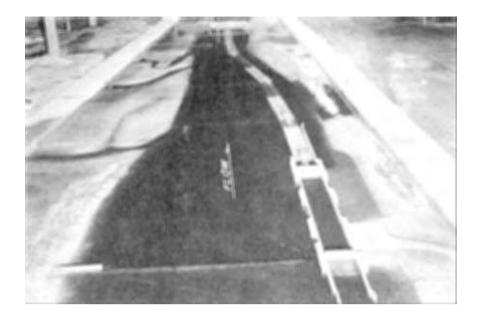
Photo 13. Plan A, looking downstream, discharge 60,000 cfs. Path of downbound tow leaving replacement lock

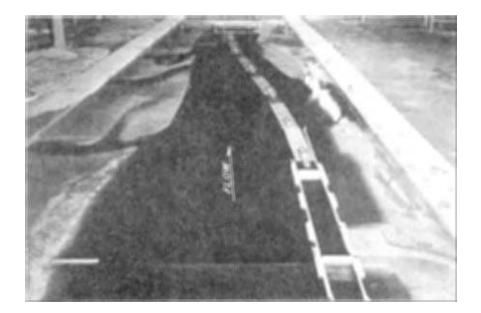
Photo 14. Plan A, looking downstream, discharge 100,000 cfs. Path of downbound tow leaving replacement lock

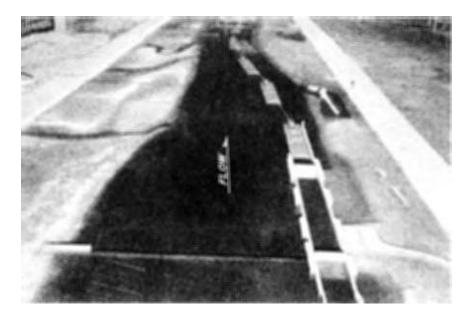
Photo 15. Plan A, looking downstream, discharge 30,000 cfs. Path of upbound tow entering replacement lock

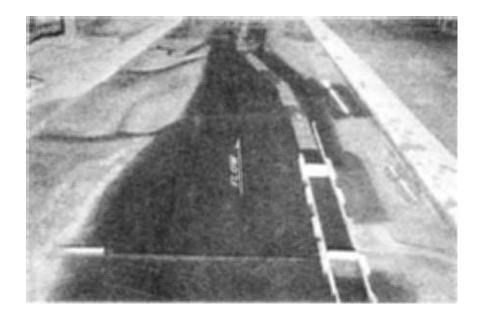
Photo 16. Plan A, looking downstream, discharge 60,000 cfs. Path of upbound tow entering replacement lock

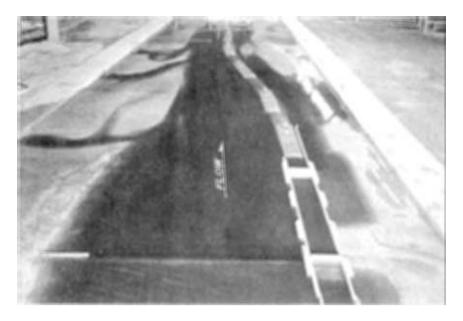
Photo 17. Plan A, looking downstream, discharge 100,000 cfs. Path of upbound tow entering replacement lock

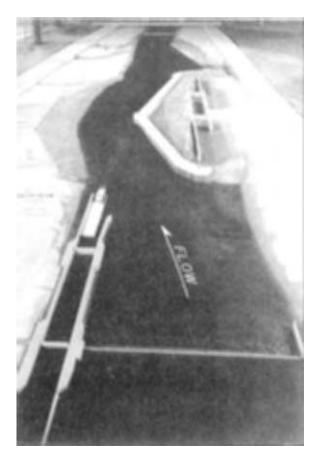
Photo 18. First-stage cofferdam, looking downstream

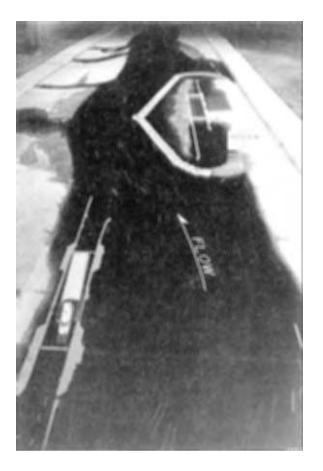
Photo 21. First-stage cofferdam, looking downstream, discharge 100,000 cfs. Confetti showing surface current patterns approaching the cofferdam

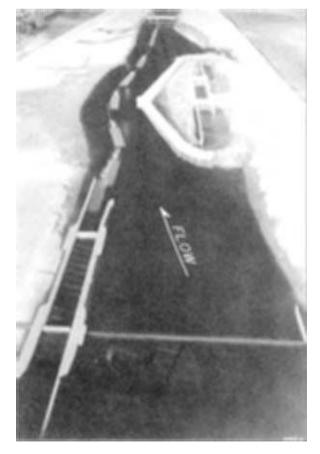
Photo 22. First-stage cofferdam, looking downstream, discharge 30,000 cfs. Path of upbound tow navigating the reach

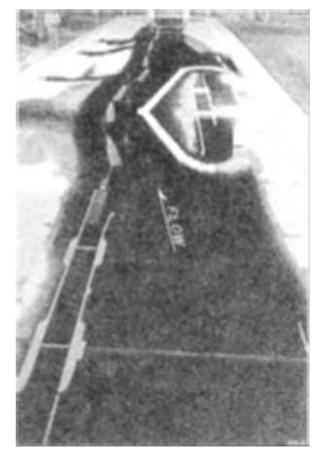
Photo 23. First-stage cofferdam, looking downstream, discharge 60,000 cfs. Path of upbound tow navigating the reach

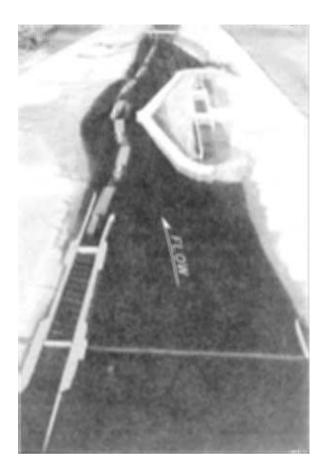
Photo 24. First-stage cofferdam, looking downstream, discharge 100,000 cfs. Path of upbound tow navigating the reach

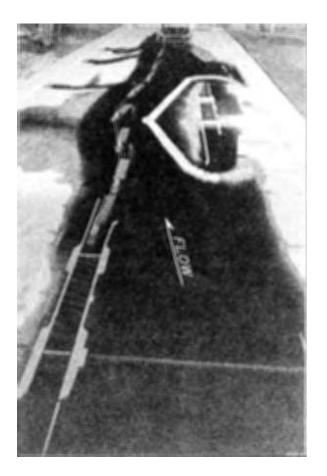
Photo 27. First-stage cofferdam, looking downstream, discharge 100,000 cfs. Path of downbound tow navigating the reach

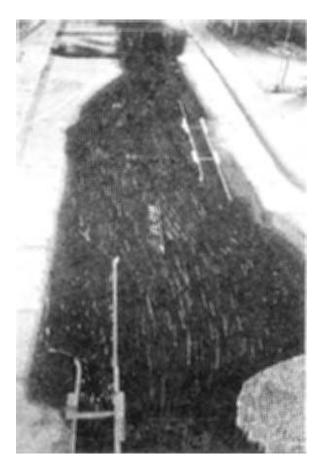
Photo 28. Second-stage cofferdam, Plan C, looking upstream, discharge 60,000 cfs. Confetti showing surface current patterns approaching the lock and cofferdam

66. <u>Current directions and velocities.</u> Data shown in Plates 39-41 and surface current patterns shown in Photo 28 indicate the alignment of the currents upstream of the dam was generally the same as with Plan A of the completed project test series, except in the immediate vicinity of the dam, where the flow was concentrated over the completed portion of the dam adjacent to the lock. The velocity of the currents was generally less than with Plan A due to the increase in water-surface elevations, which can be attributed to the second-stage cofferdam. The maximum velocity in the navigation channel upstream of the lock varied from about 2.4 to 5.0 fps through the bridges, 2.5 to 5.1 fps near the upstream end of the right bank excavation, and 2.0 to 4.1 fps about 1,000 ft upstream of the guard wall with the 30,000- and 100,000-cfs riverflows, respectively. Downstream of the dam the currents were moved toward the left bank by the training structure, and the currents remained generally parallel to the left bank through the model reach (Photo 29). A clockwise eddy formed in the lower lock approach downstream of the training

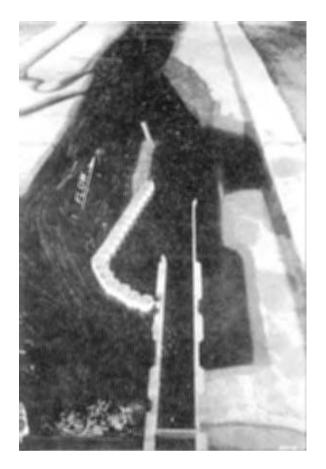
Photo 29. Second-stage cofferdam, Plan C, looking downstream, discharge 60,000 cfs. Confetti showing surface current patterns downstream of cofferdam

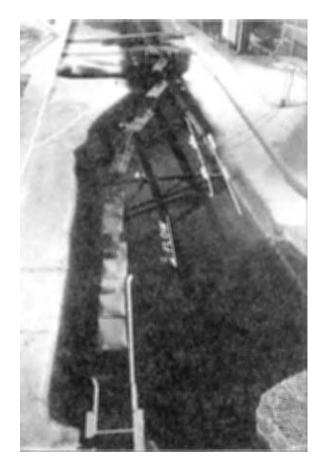
Photo 30. Second-stage cofferdam, Plan C, looking upstream, discharge 60,000 cfs. Path of downbound tow approaching replacement lock

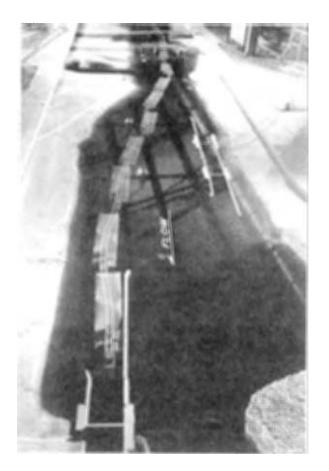
Photo 31. Second-stage cofferdam, Plan C, looking upstream, discharge 60,000 cfs. Path of upbound tow leaving replacement lock

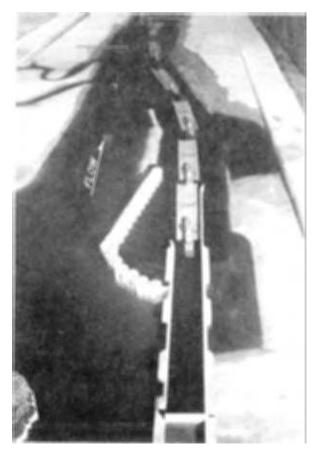
Photo 32. Second-stage cofferdam, Plan C, looking downstream, discharge 60,000 cfs. Path of downbound tow leaving replacement lock

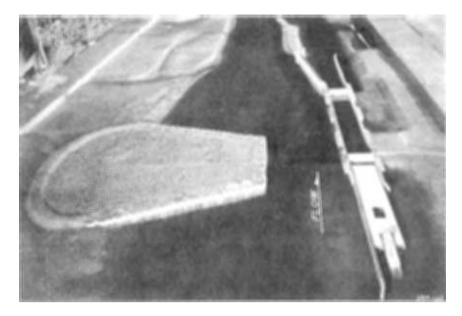
Photo 33. Second-stage cofferdam, Plan D, looking downstream

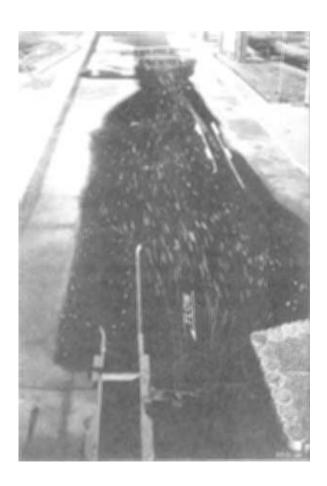
Photo 34. Second-stage cofferdam, Plan D, looking upstream, discharge 60,000 cfs. Confetti showing surface current patterns approaching the lock and cofferdam

70. <u>Current directions and velocities.</u> Data shown in Plates 42-44 and Photos 34 and 35 indicate the alignment and velocity of the currents were generally the same as with second-stage cofferdam Plan C except in the immediate vicinity of the cofferdam. The straight riverward face of the cofferdam and the straight closure between the lock and the canal embankment provided more uniform flow through the reach compared to Plan C. The maximum velocity of the currents near the downstream end of the right bank excavation varied from about 3.3 to 4.8 fps with the 30,000- and 100,000-cfs riverflows.

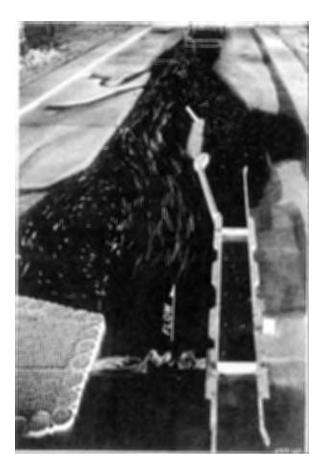
Photo 35. Second-stage cofferdam, Plan D, looking downstream, discharge 60,000 cfs. Confetti showing surface current patterns downstream of cofferdam

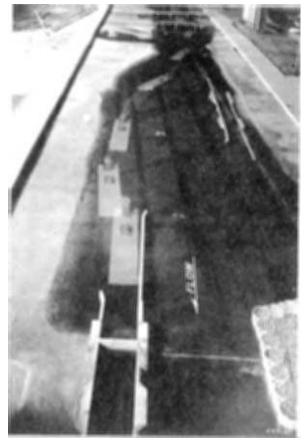
Photo 36. Second-stage cofferdam, Plan D, looking upstream, discharge 60,000 cfs. Path of downbound tow approaching replacement lock

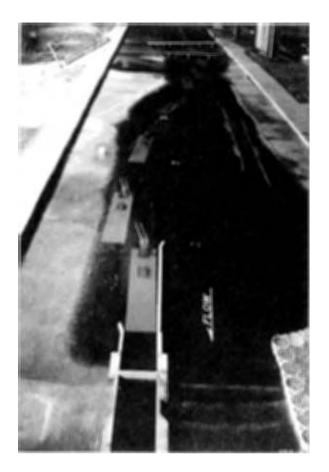
Photo 37. Second-stage cofferdam, Plan D, looking upstream, discharge 100,000 cfs. Path of downbound tow flanking to approach replacement lock

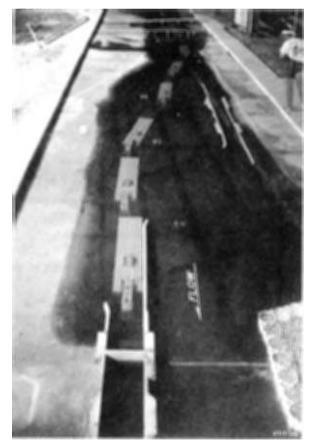
Photo 38. Second-stage cofferdam, Plan D, looking upstream, discharge 60,000 cfs. Path of upbound tow leaving replacement lock

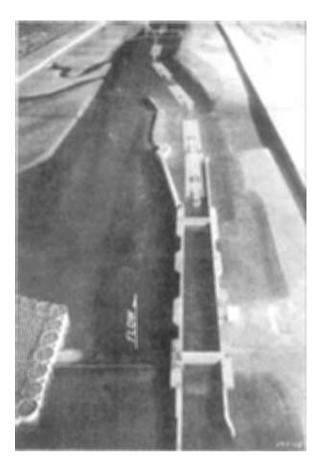
Photo 39. Second-stage cofferdam, Plan D, looking downstream, discharge 60,000 cfs. Path of downbound tow leaving replacement lock

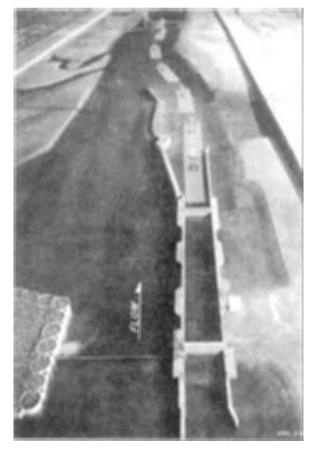
Photo 40. Second-stage cofferdam, Plan D, looking downstream, discharge 60,000 cfs. Path of upbound tow approaching replacement lock
