# Non-destructive Damage Detection in Fibre Metal Laminates

## Abstract

The work explores the possibilities of application of ultrasonic testing in the assessment of fibre metal laminates. Basic problems concerning the use of ultrasonic methods in the research of laminates are explained, and methods for solving these problems are suggested. Tests were conducted using two phased array methods: ultrasonic pulse-echo and through transmission. The efficiency of both selected ultrasonic methods are compared with respect to detecting and dimensioning defects in laminate structures. Based on the analyses and proposed solutions, it has been proven that the developed through transmission phased array (TTPA) method ensures a much more effective, in terms of quality and quantity, assessment of the condition of hybrid laminates than conventional ultrasonic methods, irrespective of the degree of surface deformation and the type of laminate structure.

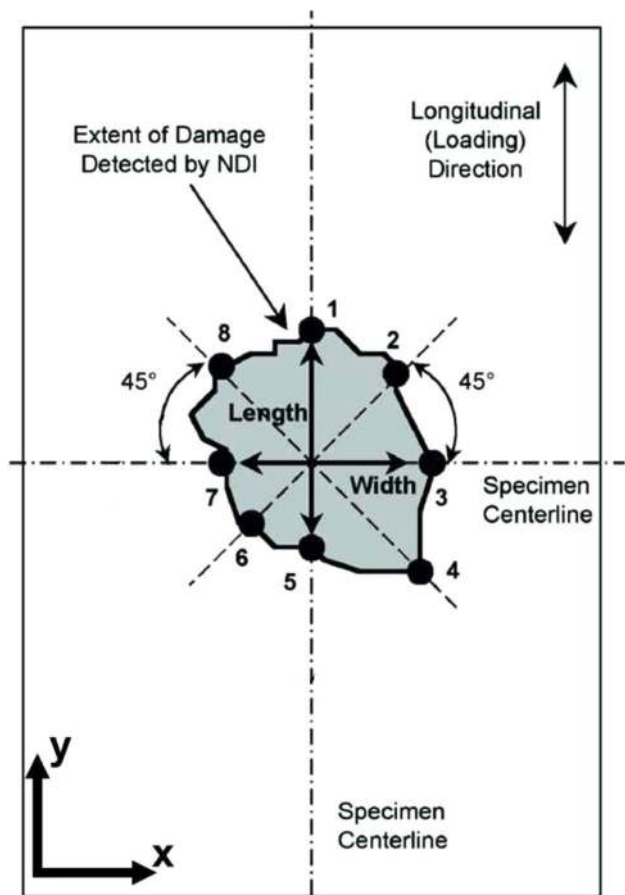
Fig. 1 Measurement of extent of damage according to ASTM 7136 standard

The AGL after low speed impact (impact tower, Instron 9340) within the energy range of 2.5–20 J was subjected to full surface scanning by identifying eight points in the area of potential structure defects (Fig. 1). The ASTM D7136 standard guide of damage evaluation after impact is presented in Fig. 1.

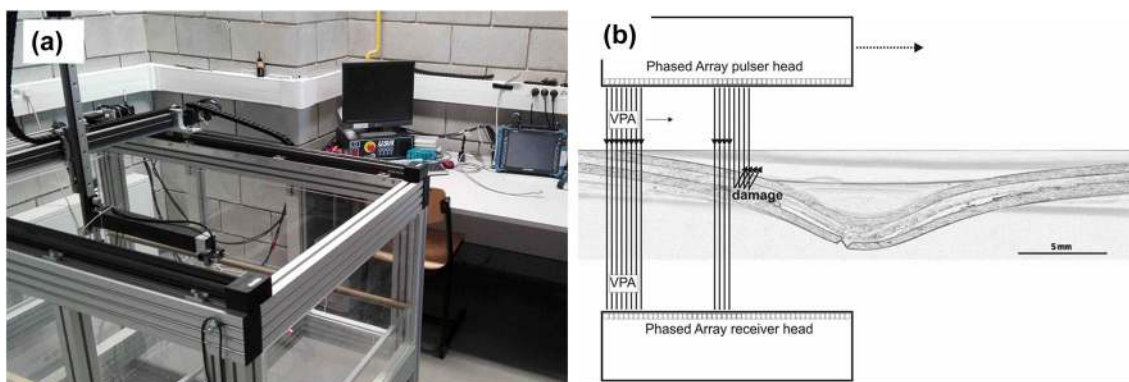
Fig. 2 TTPA test stand (a) and schematic design (b) of FLM damage assessment

The other method required the use of a custom-designed stand for through transmission phased array (TTPA) scanning. Figure 2 presents the test stand and a schematic drawing of defects in the FML structure.

The TTPA analyses made use of the OmniScan MXII ultrasonic defectoscope (Olympus, Japan) and TomoView Inspection software for results analysis (Olympus, Japan). The TTPA tests also utilised the Olympus 5L64-I1 ultrasonic transducer (64 piezoelements, frequency 5 MHz, elevation 10.0 mm, active aperture 38.4 mm, pitch 0.6 mm), virtual aperture VPA (8 piezoelements, wave angle: 0 $^\circ$ ), and Olympus 5L64-I1 receiver transducer (64 piezoelements, frequency 5 MHz, elevation 10.0 mm, active aperture 38.4 mm, pitch 0.6 mm), virtual aperture VPA (8 piezoelements, wave angle: 0 $^\circ$ ). The kinetic system of the head was developed based on a 3-axis movement controller of transducers, USN 3D6A (Poland), Mach3 software. The tests were conducted in a 10–18 dB amplification range.

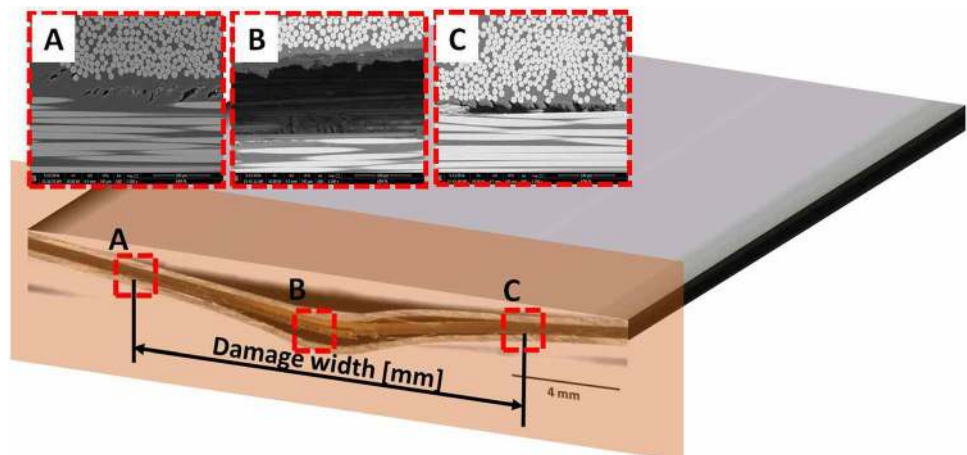
**Fig. 3** Delamination width measurement using scanning electron microscope for laminate subjected to dynamic load with energy of 15 J

Results of the non-destructive tests, i.e. laminate internal structure analysis, were verified with the use of a scanning electron microscope (NovaNano SEM 450, FEI, Japan). After the ultrasonic tests, dynamically loaded samples were coated with polymer resin, precisely cut, ground and buffed to achieve the central point of impactor influence (cross-section). The total length of individual delamination was determined based on a SEM image of damaged laminate structure. Figure 3 shows an example of the cross-section of AGL subjected to dynamic loads and SEM images of the microstructure at the ends and in the central part of delamination between composite layers with the reinforcing fibre orientation (0/90).

Microscopic observations of AGL laminates subjected to impact with the energy ranging from 2.5 to 20 J showed the presence of delamination at the metal-composite phase boundary and between the composite layers (0/90). At the same time, it was observed that the most extensive delamination propagation in composite layers was caused by a much lower energy of the composite layer (0/90) interface cracking than in the case of the metal/composite interface [20]. Measured damage widths in AGL laminates along the x-axis are listed in Table 5.

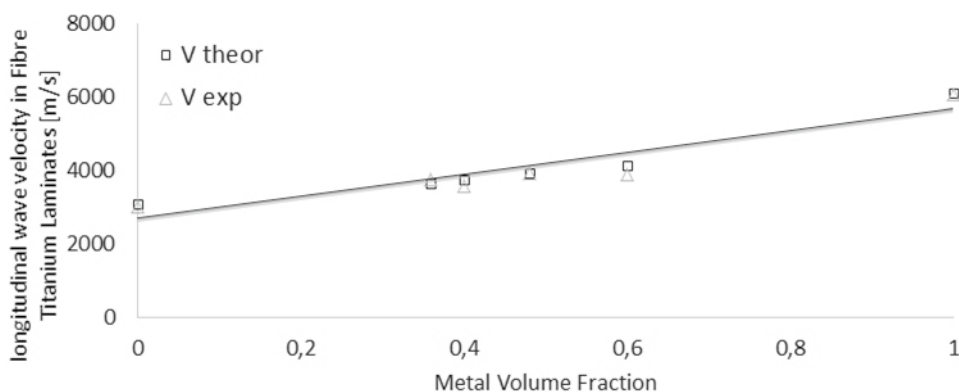
**Fig. 4** Longitudinal ultrasonic wave propagation speed in titanium carbon fibre laminates depending on metal volume fraction

speeds in FMLs could be forecast by a linear dependence, without any calculations, with an accuracy of approx.  $\pm 10\%$ , based on a nearly linear dependence of wave propagation speed to MVF (Fig. 4).

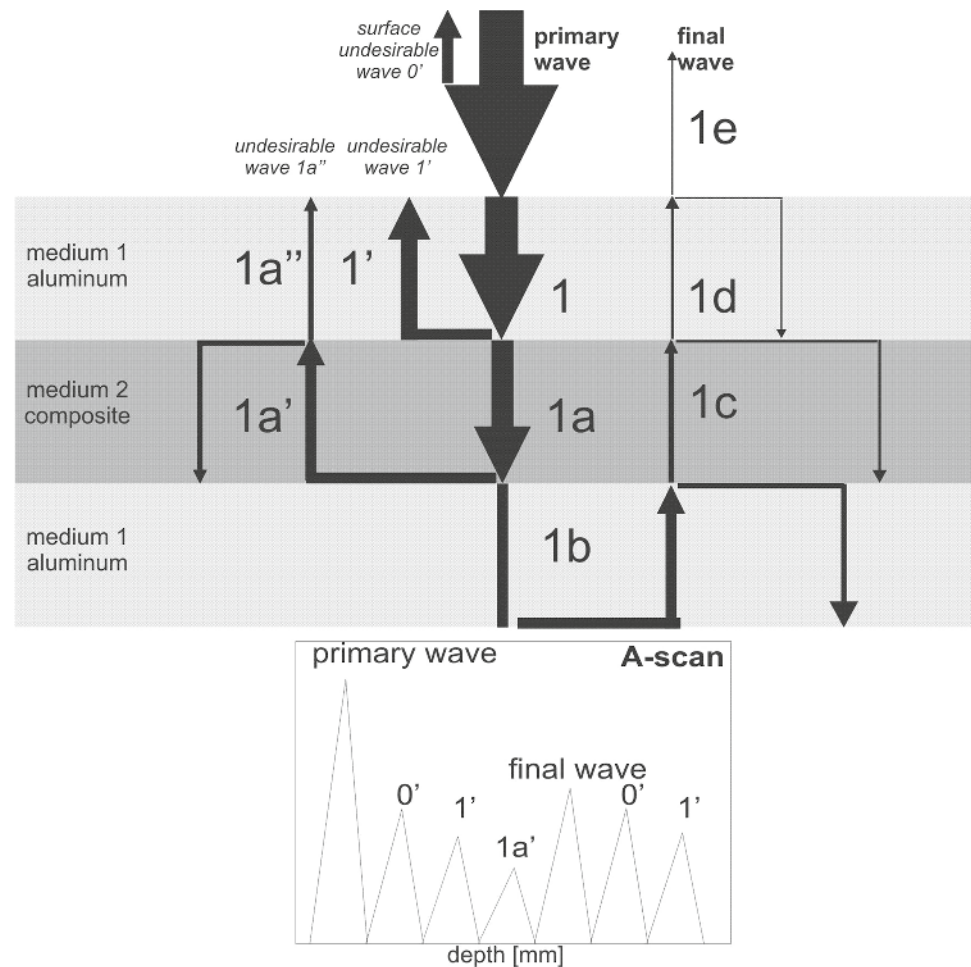
**Fig. 5** Simplified model of ultrasonic wave penetration and reflection in AGL laminate

For complex (multilayered) materials such as fibre metal laminates, where the number of metal layers is one more than the number of composite layers and the composite layers are within the laminate, it is possible to theoretically estimate the penetration coefficient for the entire laminate  $q_{FML}$  according to Eq. 6.

Despite the applied simplifications (exclusion of the actual contact surface, damping and wave phenomena) in the theoretical analysis, one should note that in the case of non-destructive tests of 2/1 FMLs by the pulse-echo method, A-scan signals constitute at least several signals of reflections from individual layers. Due to the multilayered nature of FMLs, the signal which reaches the opposite external surface has a greatly reduced amplitude (Fig. 5, point 1b), which results in it being indistinguishable from the signals reflected from other interlayers (Fig. 5, point 1e). In the case of more complex laminates, e.g. 3/2, 4/3, the number of reflected signals increases proportionately, as the signal reflected from the bottom decreases. The actual A-scan images of 2/1 FML can contain much more noise than shown by the theoretical analysis of the present surfaces of interface with different acoustic impedance. One should note that this is a result, among others, of:

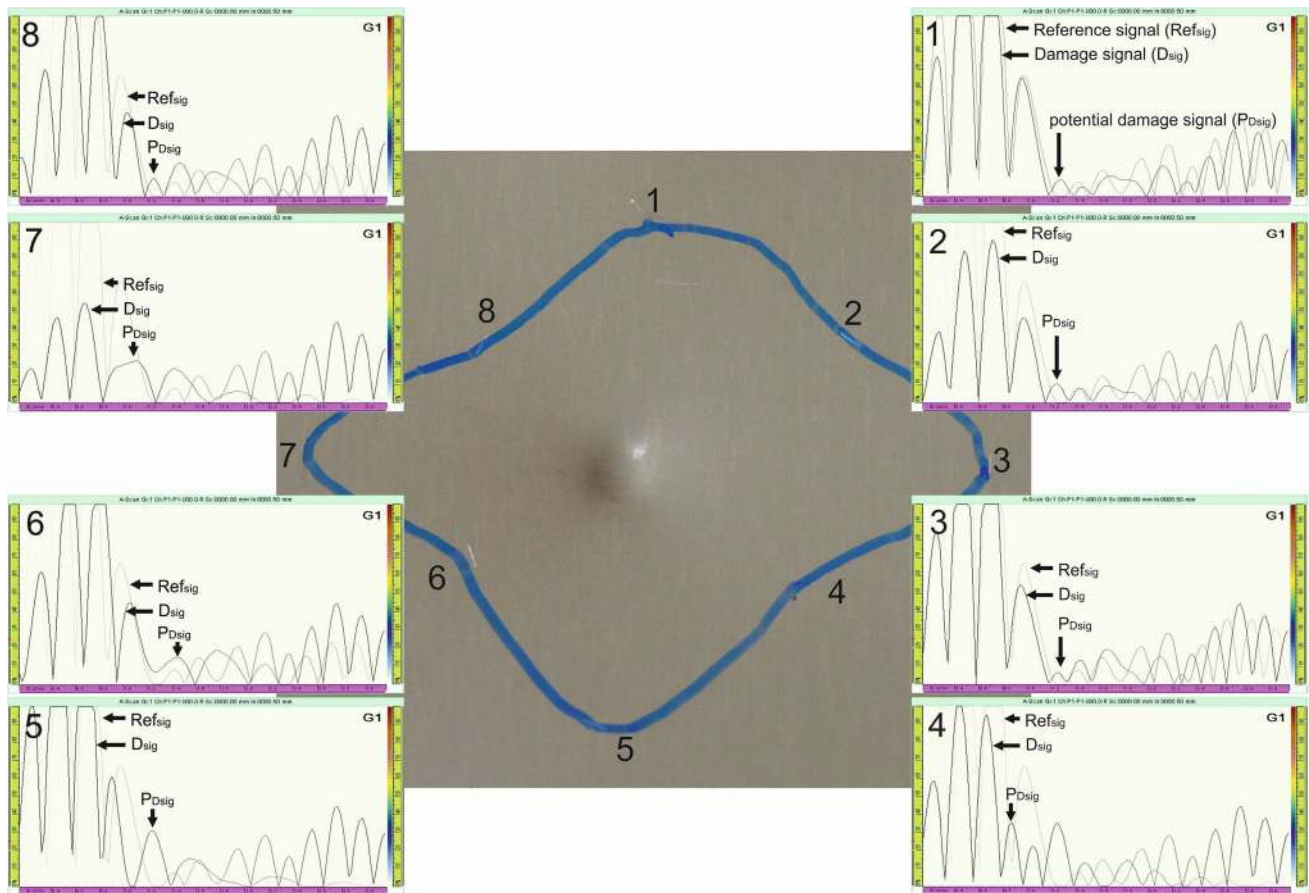
Fig. 6 Example of ultrasonic testing results of AGL after 20 J impact

area, and then compared the reference image with A-scans of remaining areas (Fig. 6).

Eight points were specified within the area of the changed waveform. In points 1, 2, 3, 6, 8 (Fig. 6) an additional signal was revealed as well as decreased amplitudes of subsequent secondary signals. In points 4, 5, 7, it was possible to observe signal displacement in the path axis and a significant decrease in the amplitude of following signals. Each of the observed signal disruptions was classified as a point indicating a structural defect. On the basis of the above, an outline of the defect was created (Fig. 6). The location of a potential defect in the impact zone (highest deformation) and its shape indicate that the structural defects were detected correctly. The delamination of polymer composite materials under impact propagates in line with the direction of fibres in individual layers, forming the cross section of the defect outline [18, 19]. This has not yet been confirmed in fibre-metal laminates.

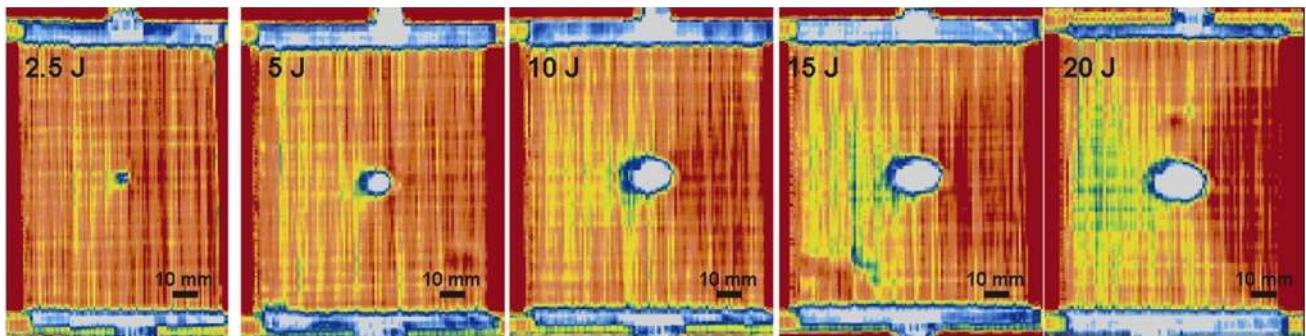
**Fig. 7** Damage of ALG after impact identified by TTPA method

methods, through transmission methods are not sensitive to the shape and multilayered structure of laminates [12]. They require, however, two-sided access to the tested element. Figure 7 shows examples of the results of tests of AGLs subjected to impacts with an energy of 2.5–15 J, in accordance with the TTPA method.

In the TTPA method, a colour scale illustrates damage easily distinguishable by clear contrast. The clear separation between the areas with different damping properties of the wave passing through the material eliminates the risk of incorrect identification of the damaged and undamaged zones. Results of geometric measurements of AGL laminate damage, as revealed by TTPA testing, are given in Table 4.

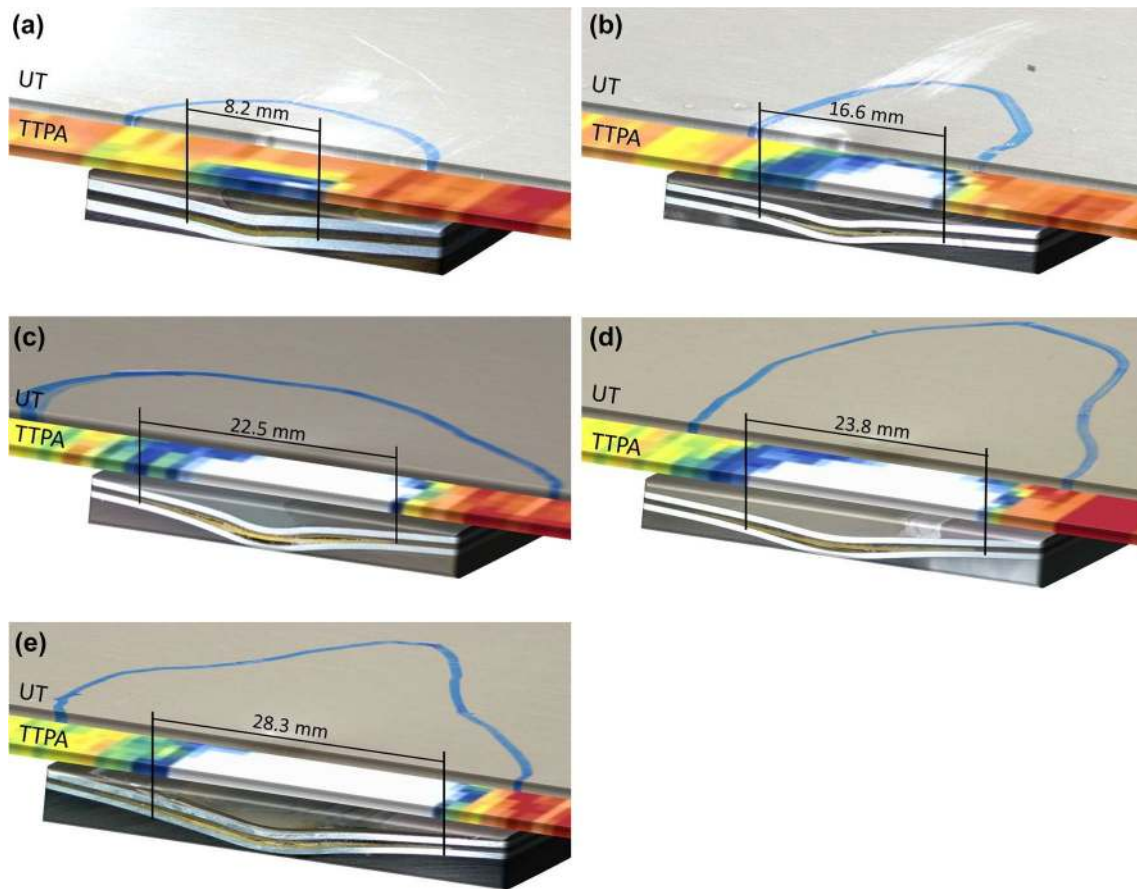
Fig. 8 Comparison of damage width detected in AGL after 2.5 J (a), 5 J (b), 10 J (c), 15 J (d) and 20 J (e)

Based on total delamination width measurements on the cross section of samples by UT, TTPA and SEM methods, individual methods were compared (Figs. 8, 9).

The distance between the beginning of outmost delamination of FMLs after impact determined with the destructive microscopic method served as a reference for comparison

with the results of ultrasonic non-destructive tests (Fig. 8). The discrepancy between the results obtained with the destructive SEM method and the non-destructive TTPA method is not > 10%, whereas with respect to the UT pulse-echo method, the discrepancy ranges 16.9–220% (Fig. 9). These significant differences between the results obtained by the classical ultrasonic testing methods for fibre metal laminates result from the impossibility of separating signals which originate from defects from those reflected from individual laminate layers with various acoustic impedance. The TTPA method is sensitive to secondary reflections, hence the results obtained with this method reflect real condition of the internal structure of laminates, irrespective of design and curvature. Summing up, it has been found that the devised method of scanning in through-transmission mode with the application of phased array is an accurate procedure for quantitative assessment of fibre metal laminate damage, irrespective of the tested object condition (contactless method).

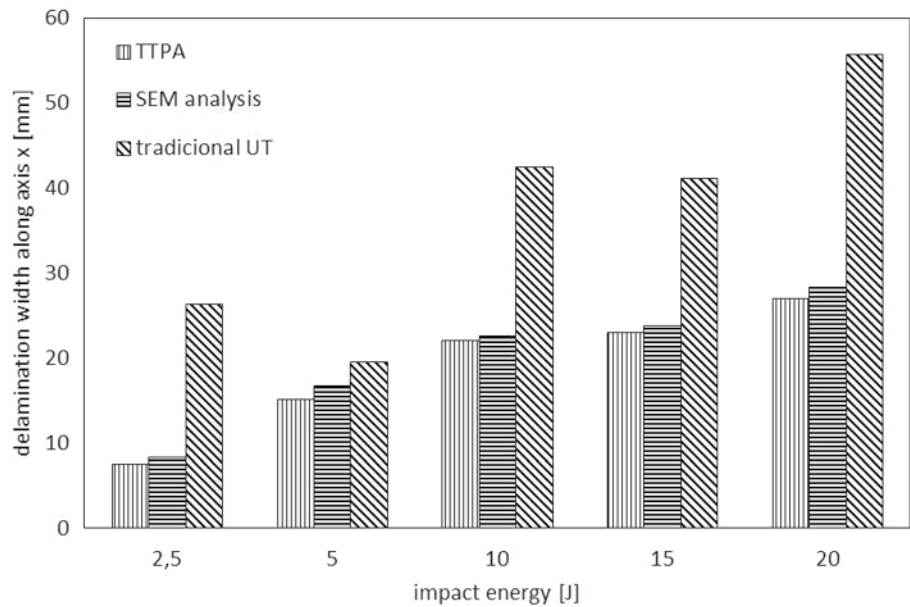
Fig. 9 Comparison of damage width in AGL detected by three methods
