OPERATIONAL MODAL ANALYSIS AND WAVELET TRANSFORMATION FOR DAMAGE IDENTIFICATION IN WIND TURBINE BLADES

Martin D. Ulriksen¹, Dmitri Tcherniak², Poul H. Kirkegaard¹, Lars Damkilde¹

The presented study demonstrates an application of a previously proposed modal and wavelet analysis-based damage identification method to a wind turbine blade. A trailing edge debonding was introduced to a SSP 34 m blade mounted on a test rig. Operational modal analysis (OMA) was conducted to obtain mode shapes for undamaged and damaged states of the blade. Subsequently, the mode shapes were analyzed with one-dimensional continuous wavelet transformations (CWTs) for damage identification. The basic idea of the method is that structural damage will introduce local mode shape irregularities which are captured in the CWT by significantly magnified transform coefficients, thus providing combined damage detection, localization, and size assessment. It was found that due to the nature of the proposed method, the value of the identification results highly depends on the number of employed measurement points. Since only a limited number of measurement points were utilized in the experiments, valid damage identif

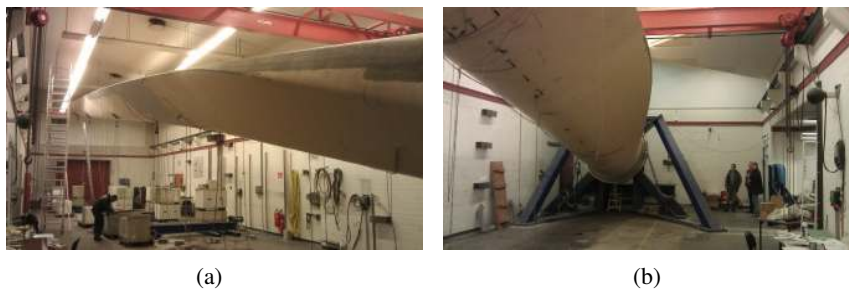
Figure 1 : SSP 34 m blade mounted on the test rig. (a) Root-to-tip view. (b) Tip-to-root view.

A 34 m long wind turbine blade, designed and manufactured by SSP, was mounted on an indoor test rig as shown in Figure 1. The SSP 34 m blade is made from epoxy fiberglass and has a mass of 4,600 kg [10].

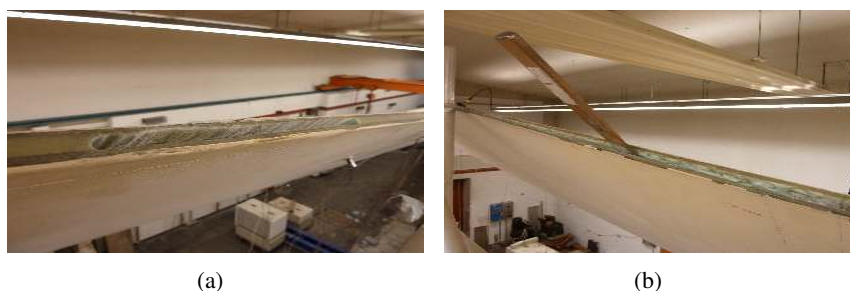
Figure 3 : Debonding introduced in the trailing edge of an SSP 34 m blade. (a) Original drilled debonding. (b) Extended debonding.

In [2], 15 blades of 300 kW wind turbines and 81 blades of 100 kW wind turbines, all with a lifetime range of between 16 and 19 years, were inspected. As a result of these inspections, several different damage types were found and subsequently categorized into the three overall groups; cracks, edge damages, and debondings. Of these damage types, the most frequently occurring and severe were debondings plus longitudinal and transverse cracks near and at the blade edges. These all required structural repairs for the blades to operate properly, c.f. [2]. Consequently, in the present study we decided to treat one of these specific damage types, namely a trailing edge debonding, see Figure 3.

The debonding was first introduced by drilling a series of holes perpendicular to the trailing edge, such that the glue connecting the shells was removed to yield the damage depicted in Figure 3(a). Subsequently, the debonding was gradually extended using a hammer and a chisel, resulting in the 1,200 mm long debonding shown in Figure 3(b). The extended debonding was located between 18,800 mm and 20,000 mm from the blade root.
