RESEARCH ARTICLE

Optimal seismic retrofitting techniques for URM school buildings located in the southwestern Iberian peninsula

Department of Building Structures and Geotechnical Engineering, University of Seville, Seville, Spain

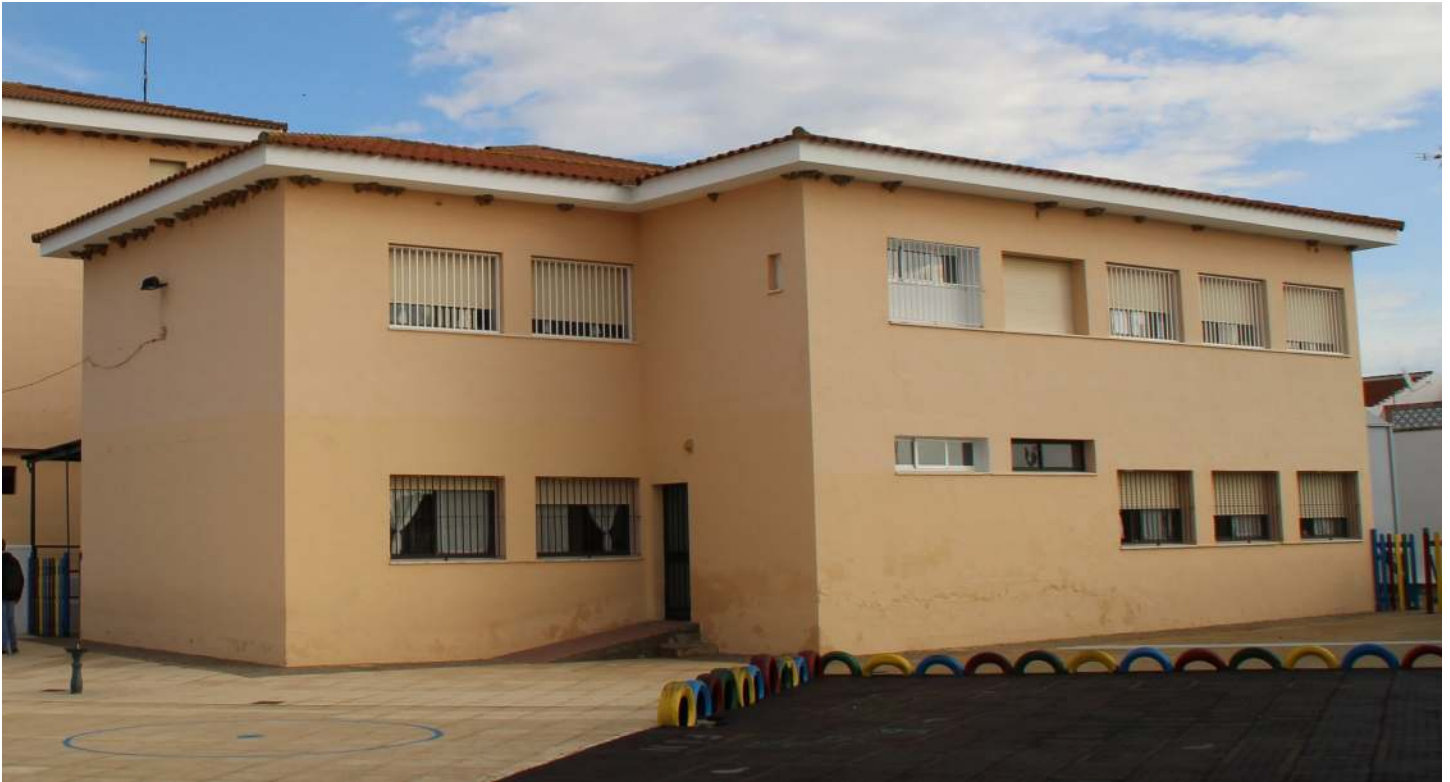
Fig 1. Façade of the building selected as case study (Authors' ownership).

The school was constructed in 1986 and is used by pre-school children. This is a two-storey building characterized by a regular and compact geometry generated by the intersection of two volumes (Fig 1).

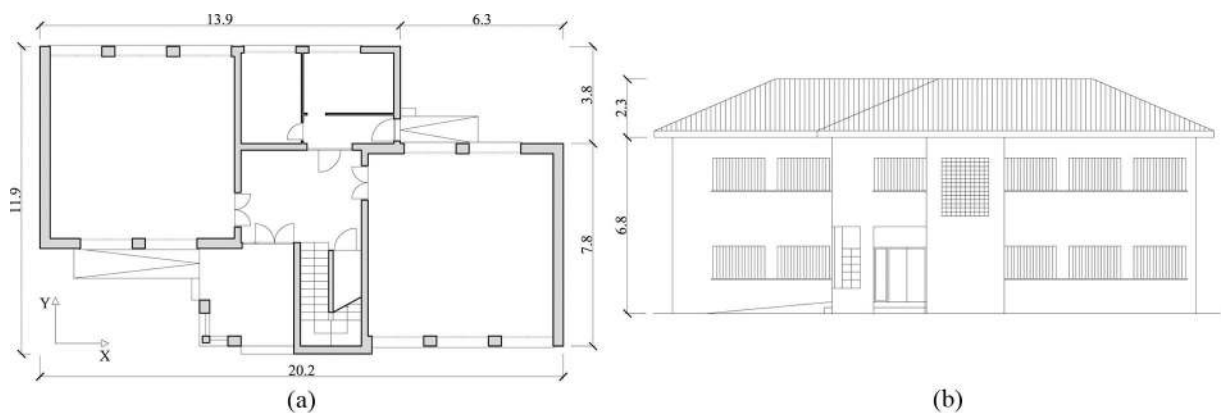
Fig 2. Distribution of the ground floor (a) and main façade (b) of the case study school.

The building was constructed with URM walls homogeneously distributed in each orthogonal direction (Fig 2A). The total wall length in the X and Y direction is similar. The walls are 25 cm thick and are composed of clay brick and cement mortar, with 25x35 reinforced concrete ring beams placed on the top to reinforce the walls together. The foundation is a concrete beam on band footings. The building has a sloping roof with tiles. The most important seismic weakness of the building is the heterogeneous distribution of the openings. The opening ratio is much higher in the X direction (Fig 2B), reaching up to 25%, while, the walls in the Y direction are blind walls.

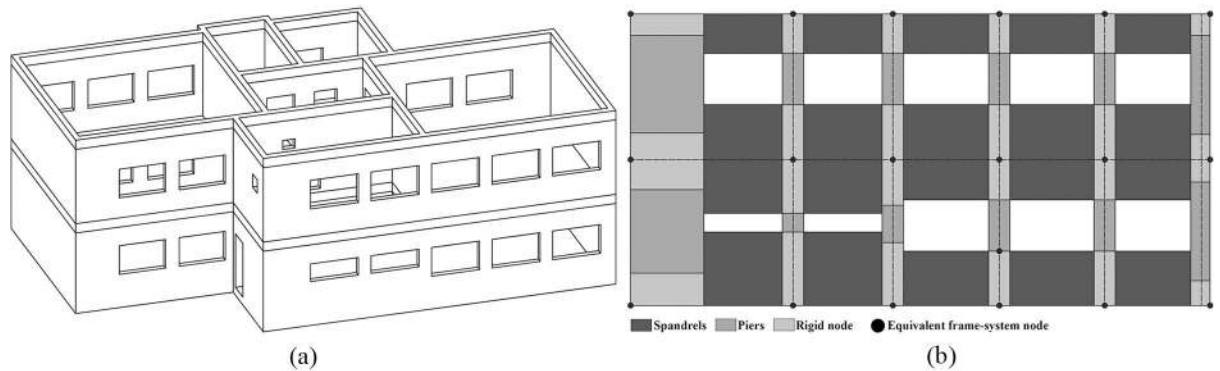
Fig 3. Modelling of the 3D building (a) and macroelements of the south wall (b) (Authors' ownership).

The EFM approach in pushover analyses has been widely applied to assess the efficiency of different seismic retrofitting techniques such as in [14][15]. The model of the school is shown in Fig 3A. In Fig 3B, the macroelements of the south wall are depicted as well as the distribution of the EFM system.

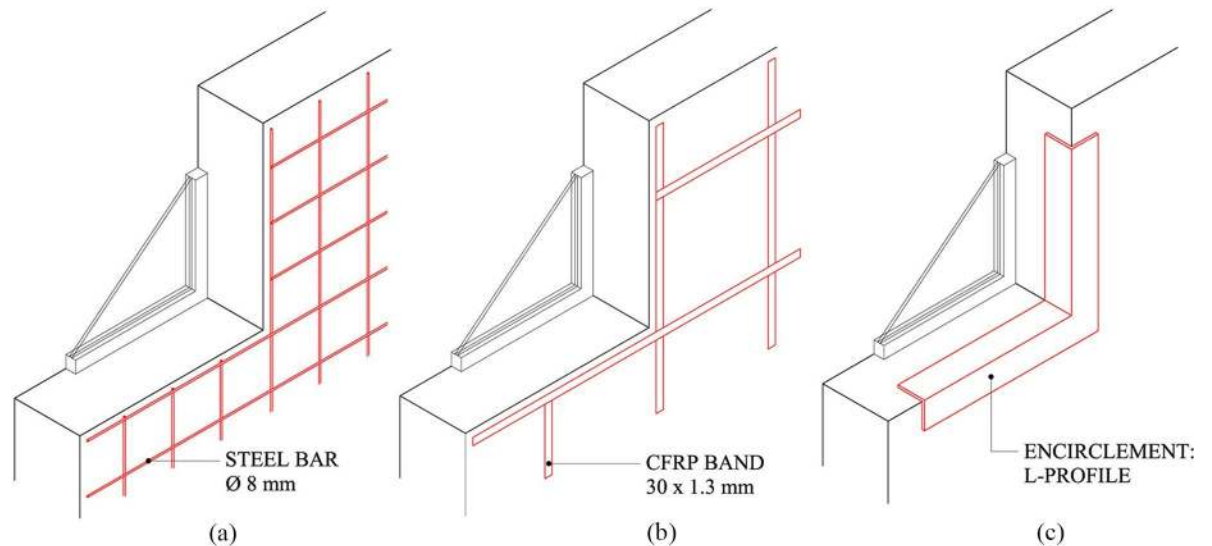
Fig 4. Retrofitting techniques: steel grid (a), CFRP grid (b) and encirclements (c).

The first technique is based on the addition of steel grids in the exterior faces of the walls as shown in [Fig 4A](#). The material used has been steel B500S. The diameter of the rebars has been 8 mm and the bar spacing has varied from 20, 40, 60 to 80 cm. Previously to the addition of the grids, the paint must be removed. Then, an acrylic resin bonding layer must be applied between the existent and the new mortar renders. Next, the grids are mechanically anchored to the walls. Finally, a cement render and painting layer must be applied. The four cases studied have been named as S.G. Ø8-20, S.G. Ø8-40, S.G. Ø8-60 and S.G. Ø8-80, respectively.

The second technique analysed has been the addition of CFRP grids in the walls as shown in [Fig 4B](#). In this case, bands of 30 mm width and 1.3 mm thick have been

The third technique is the encirclement of the openings, carried out by adding L-shaped steel profiles. They have been mechanically anchored in the outer edge of the window frame, as shown in Fig 4C. Despite the fact that the L-profile is visible from the outside, the architectural impact is low. Moreover, this technique can be easily implemented. During the construction process, the windowsills are first removed and then placed back again. The four cases studied have been named as E. L50.5, E. L80.10, E. L100.10 y E. L120.12, each implementing a different L-shaped profile: L50.5, L80.10, L100.10 and L120.12, respectively.

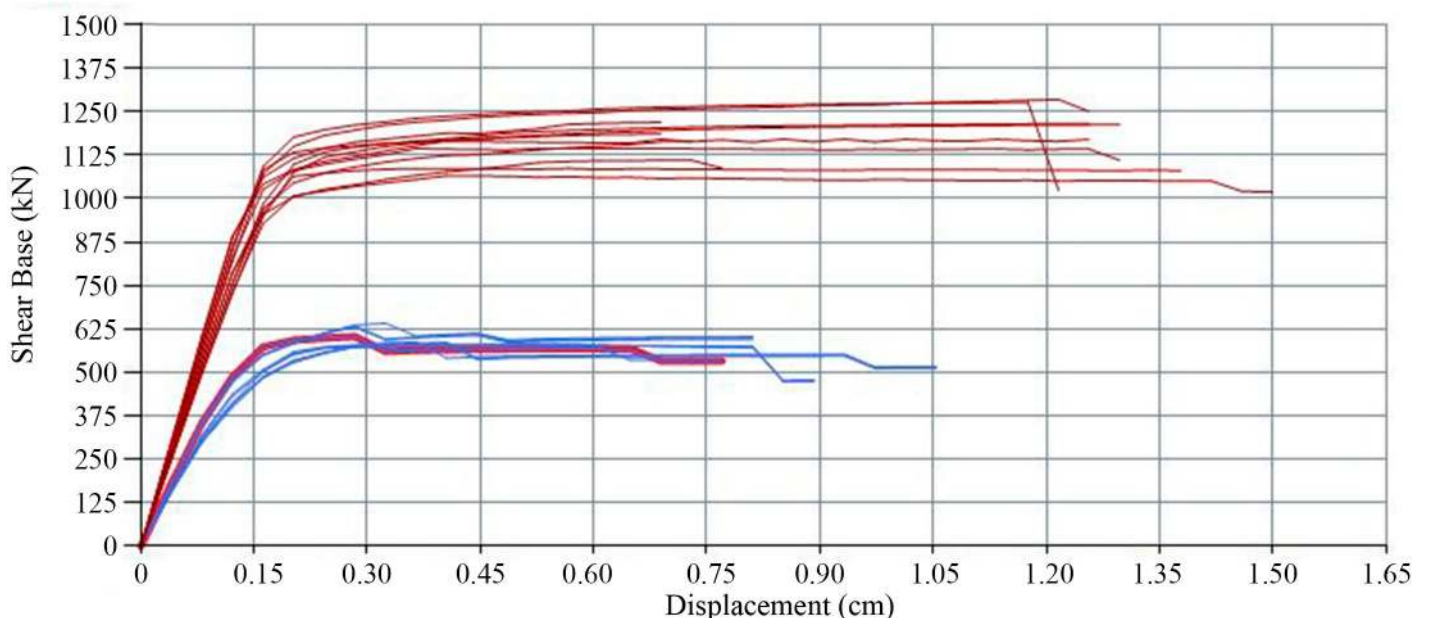
Fig 5. Reference building capacity curves for the $\pm X$ and $\pm Y$ direction considering two load patterns and positive, negative or null eccentricity.

Fig 5 shows the results of the pushover analysis of the original building. A total of 24 capacity curves for the +X, -X, +Y and -Y directions of the building have been obtained, corresponding to the different hypotheses considered (see section 3.3). Then, the performance points have been determined by means of the N2 method. In the X direction, the displacement of the most unfavourable hypothesis has been 0.77 cm and the basal shear force 581 kN. In the Y direction, the displacement has been 0.11 cm and the basal shear force 829 kN.

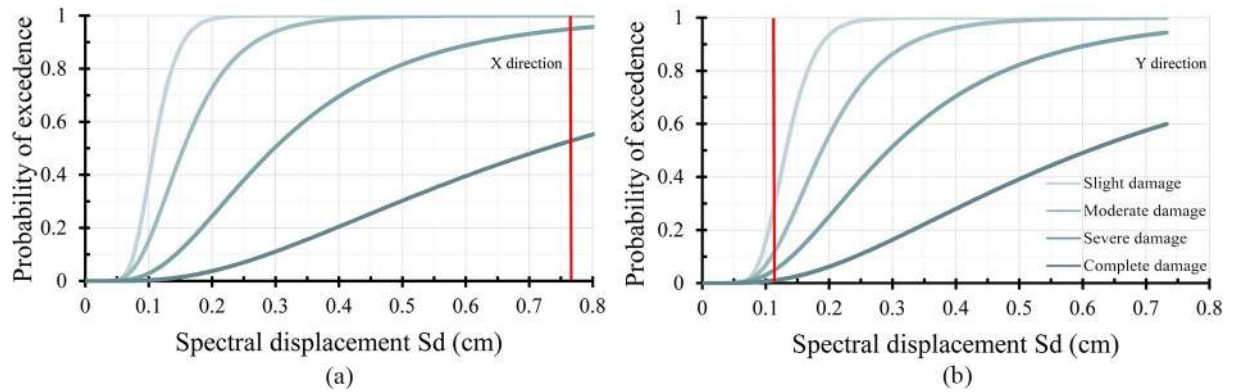
Fig 6. Reference building fragility curves in the X (a) and Y (b) direction, highlighting in red the PP displacement.

Once the capacity curves have been determined, the fragility curves have been obtained. Fig 6 shows the fragility curves corresponding to the reference building and the PP displacement in the X and Y direction.

The results show considerable differences regarding the building strength capacity in the X and Y direction. In X, the capacity is only half as much as strength in Y direction. Regarding the PP, the difference is more considerable: the displacement in X is 7 times greater than in Y. Consequently, the probability of damage is much greater in the X direction. In particular, higher percentages of severe and complete damage have been obtained in the X direction. Contrariwise, in the Y direction the probable damage level is minimum. These different results were expected owing to the higher ratio of openings in the X direction. Therefore, the analysis of the improvement provided by the different retrofitting schemes will be focused in the X direction, which is the one presenting a higher vulnerability.

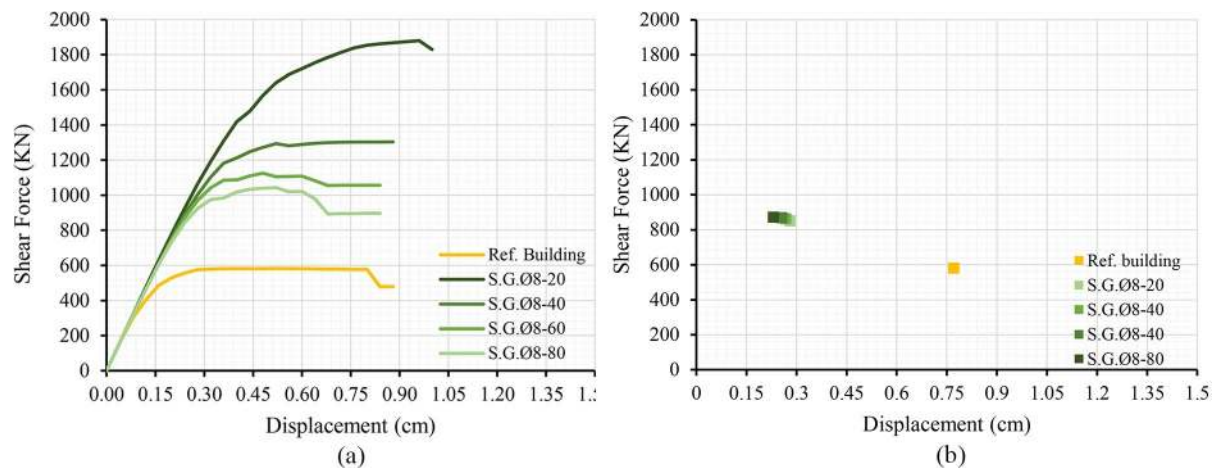
Fig 7. Capacity curves (a) and performance points (b) of the models adding steel grids varying the bar spacing.

The results of the addition of the retrofitting techniques are shown below; in terms of capacity curves and performance point (Figs 7, 8 and 9). The most unfavourable curve has been selected in each case, considering two load patterns and a 5% eccentricity. The curve of the reference building has been included in order to compare it with the curves obtained.

Adding a steel grid spaced 20 cm (S.G. Ø8-20) has produced a maximum peak strength three times higher than the original capacity. Grids with higher rebar spacings (40, 60 and 80 cm) have increased the original capacity by 200% approximately. As for the PP displacement, values ranging from 0.2 to 0.3 cm have been obtained, which constitutes a significant reduction from the original PP displacement value (0.77 cm). On the other hand, varying the rebar spacing has resulted in no significant change in the values of the PP displacement. This is due to the fact that all capacity curves are similar for small displacements. The maximum capacity increase has been obtained for higher displacements ranging from 0.5 to 1 cm.

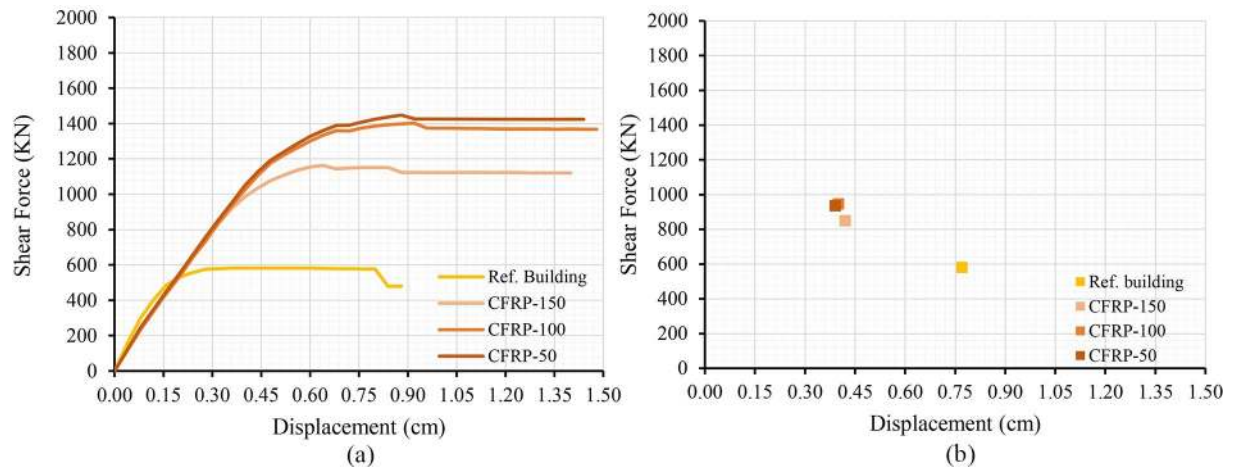
Fig 8. Capacity curves (a) and performance points (b) of the models adding CFRP bands varying the band spacing.

Concerning the CFRP bands, the resistant capacity of the building has increased from 100% to 160%, in the case of the CFRP-100 and CFRP-150, respectively. However, the improvement has not been noticeable when decreasing the band spacing from 100 to 50 cm (CFRP-100 and CFRP-50). A similar analysis was reported in [27], where the authors tested different walls retrofitted with different types of CFRP and concluded that adding fibres of better quality did not produced better results. Moreover, they concluded that the optimal retrofitting solution should determine a critical resistant value of the fibre according to the mechanical properties of

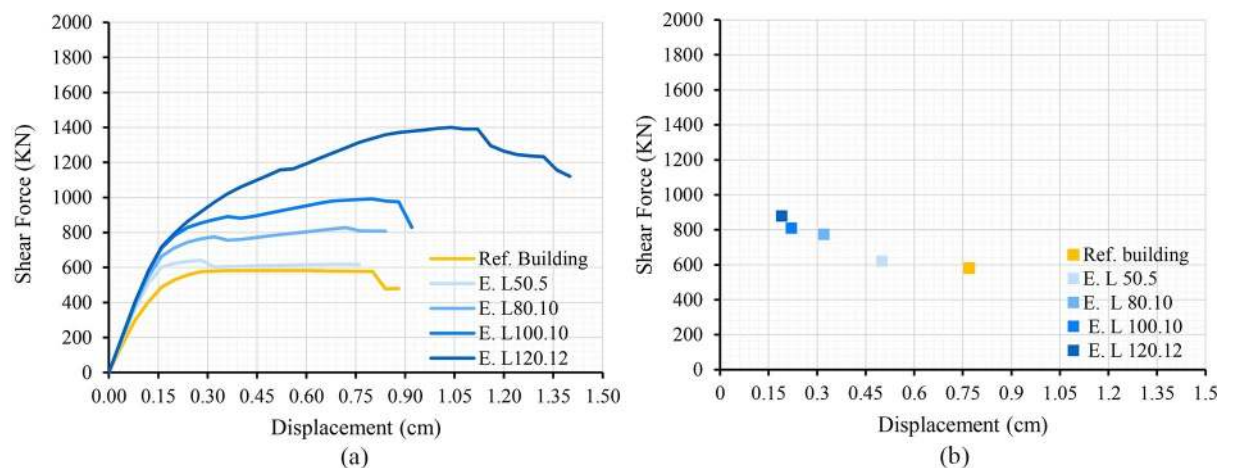
Fig 9. Capacity curves (a) and performance points (b) of the models adding steel profiles in the openings varying the profile size.

The addition of encirclements has produced a different tendency. In this case, clear differences can be observed in the resistance increase generated by the four solutions. The solution with a L50.5 profile has not produced a significant enhancement. The L80.10, L100.10 and L120.12 profiles have produced an enhancement of the capacity in a 30%, 70% and 160%, respectively. These differences between profiles have been noticeable since the initial phases of the calculations. Consequently, the values obtained for the PP have differed considerably. In fact, this variation has ranged between the 30% for the L50.5 profile and the 75% in the case of the L120.12 profile. Regarding the structural behaviour, in Fig 9A it can be observed that a stiffness increase in the initial deformation has been produced. This is due to the fact that openings can maintain the shape owing to the profiles addition. Therefore, the deformation is then initiated when higher loads are applied.

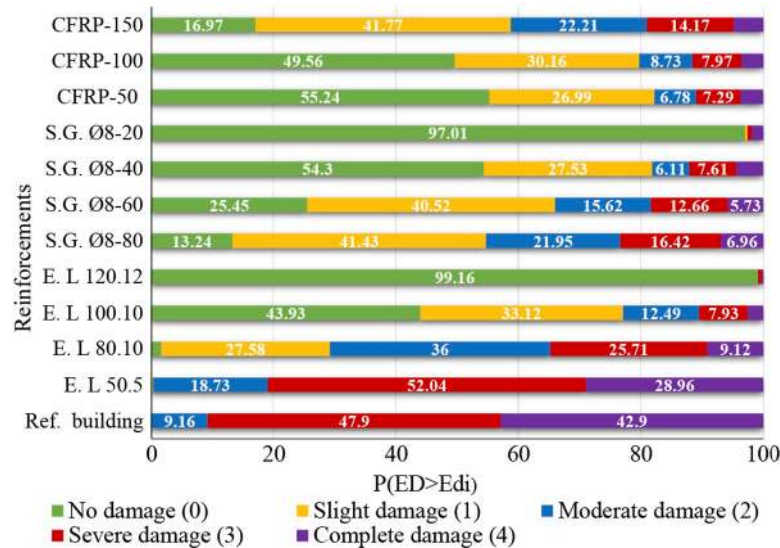
Fig 10. Damage states probabilities.

To assess the damage level for each retrofitting solution, the damage states probabilities have been obtained from the fragility curves and the PP's displacements (Fig 10). In Fig 11A, the DI obtained for each retrofitting solution is shown. Finally, in Fig 11B, the results of the cost-benefit analysis have been plotted for each retrofitting solution.

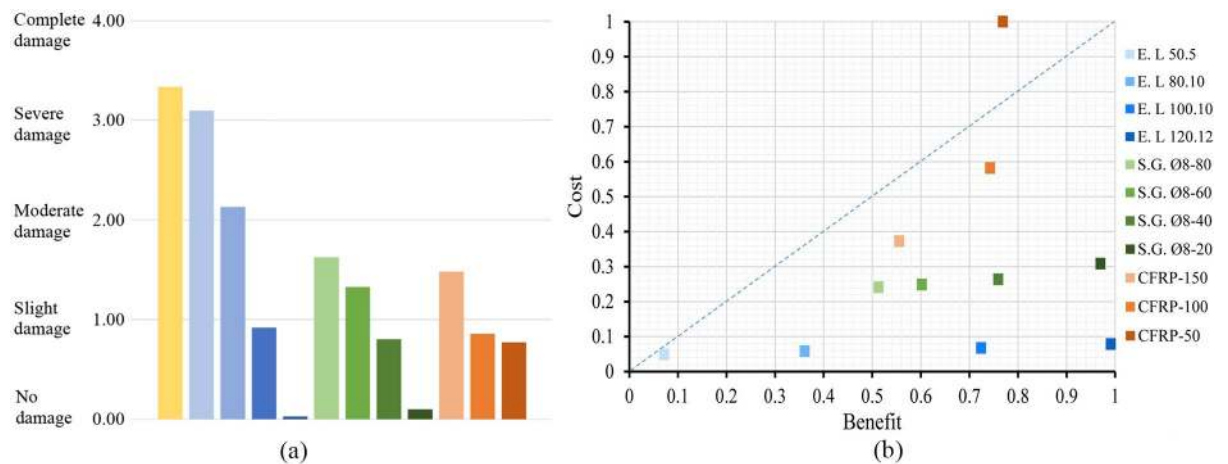
Fig 11. DI for each retrofitting solution (a) and cost-benefit index (b).

The cost analysis (Fig 11B) has revealed considerable differences in each construction costs' solution. The addition of CFRP bands has resulted the most expensive technique. However, the encirclements have been the least expensive solution for all profile options considered. In the case of the steel grids and the encirclements, varying the amount of material does not impact significantly in the construction cost. This is due to the fact that the costs are mainly based on the workmanships costs, and not in the material quantity. Contrariwise, in the case of CFRP, the cost is much more dependent on the quantity of material added. The most expensive solution has not reached the maximum effectiveness, being only the 30% of the most effective solution. Overall, the addition of L120.12 encirclements has been proved to have the most optimal cost-benefit ratio.
