NASA CR-179,487

OXIDIZER HEAT EXCHANGER COMPONENT TESTING

FINAL REPORT

Prepared by
United Technologies Corporation
Pratt & Whitney
Government Products Division

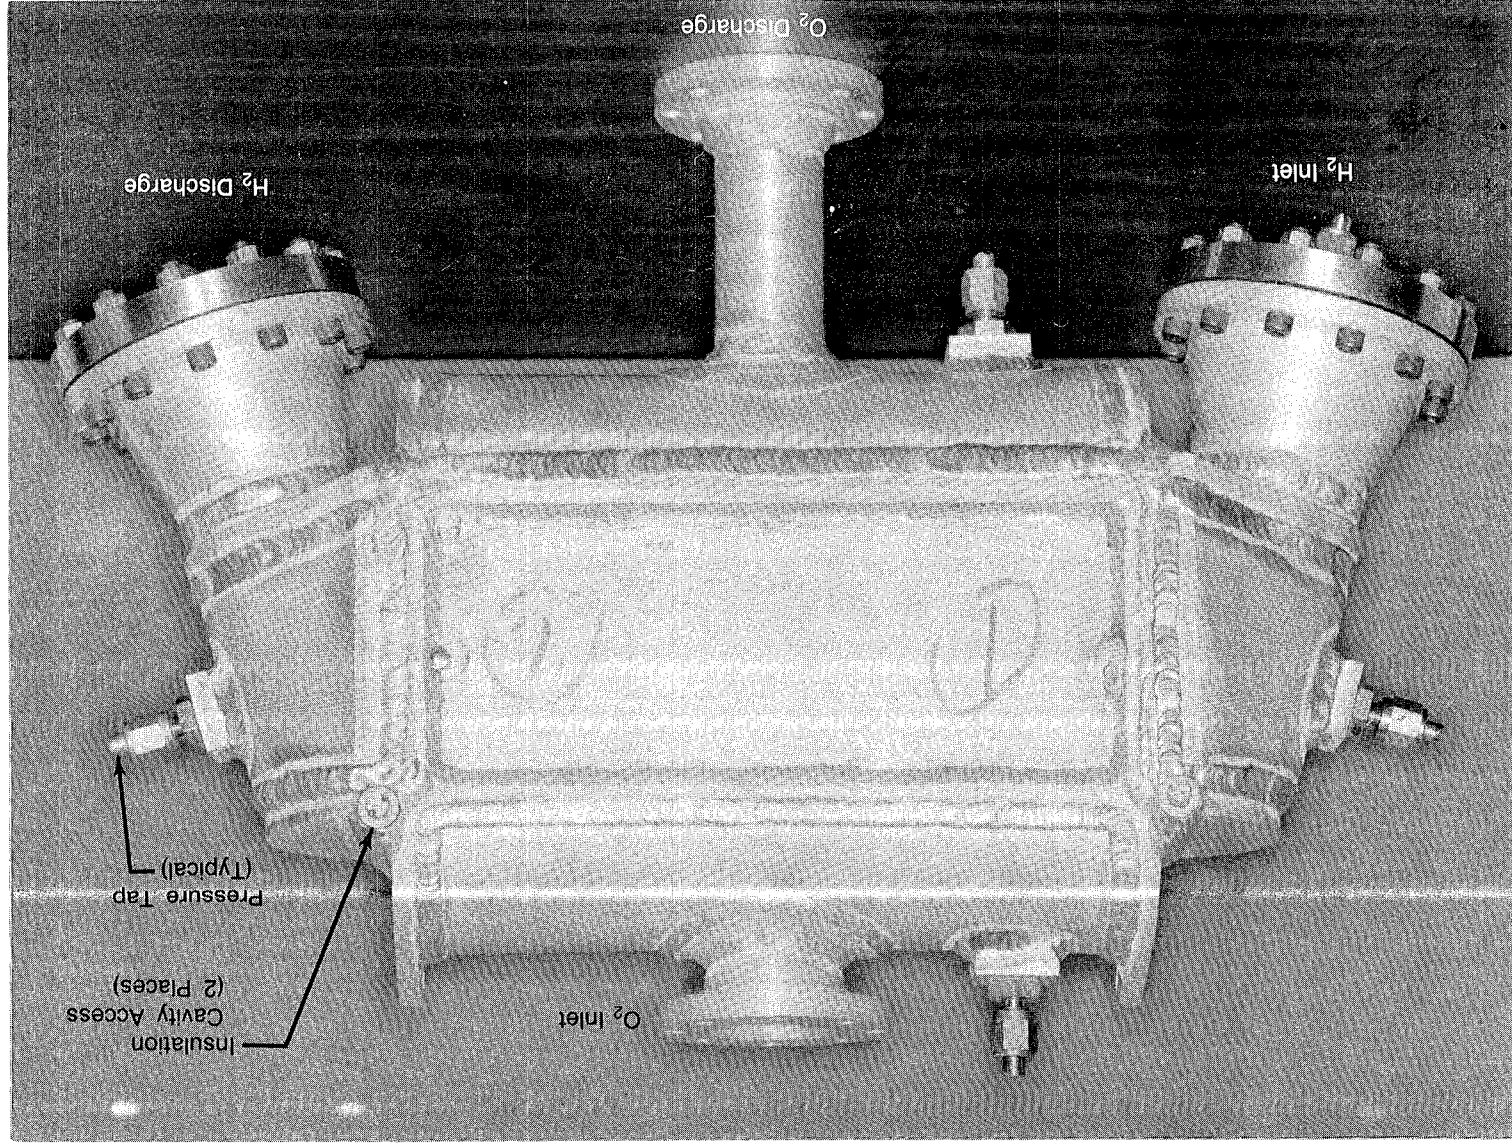
Figure 1. Oxidizer Heat Exchanger Stage 1 (Side View)

While the stage 1 core was exposed, the H₂ and O₂ flow passage cross section dimensions were measured to determine if any deviations from the original drawing specifications occurred during fabrication. Slight reductions in flow areas were found. Manifolds were salvaged from the stage 1-and-2 assembly, and modified to fit the stage 1 core to allow its individual flow. The remanifolded stage 1 heat exchanger is shown in Figures 1 and 2.

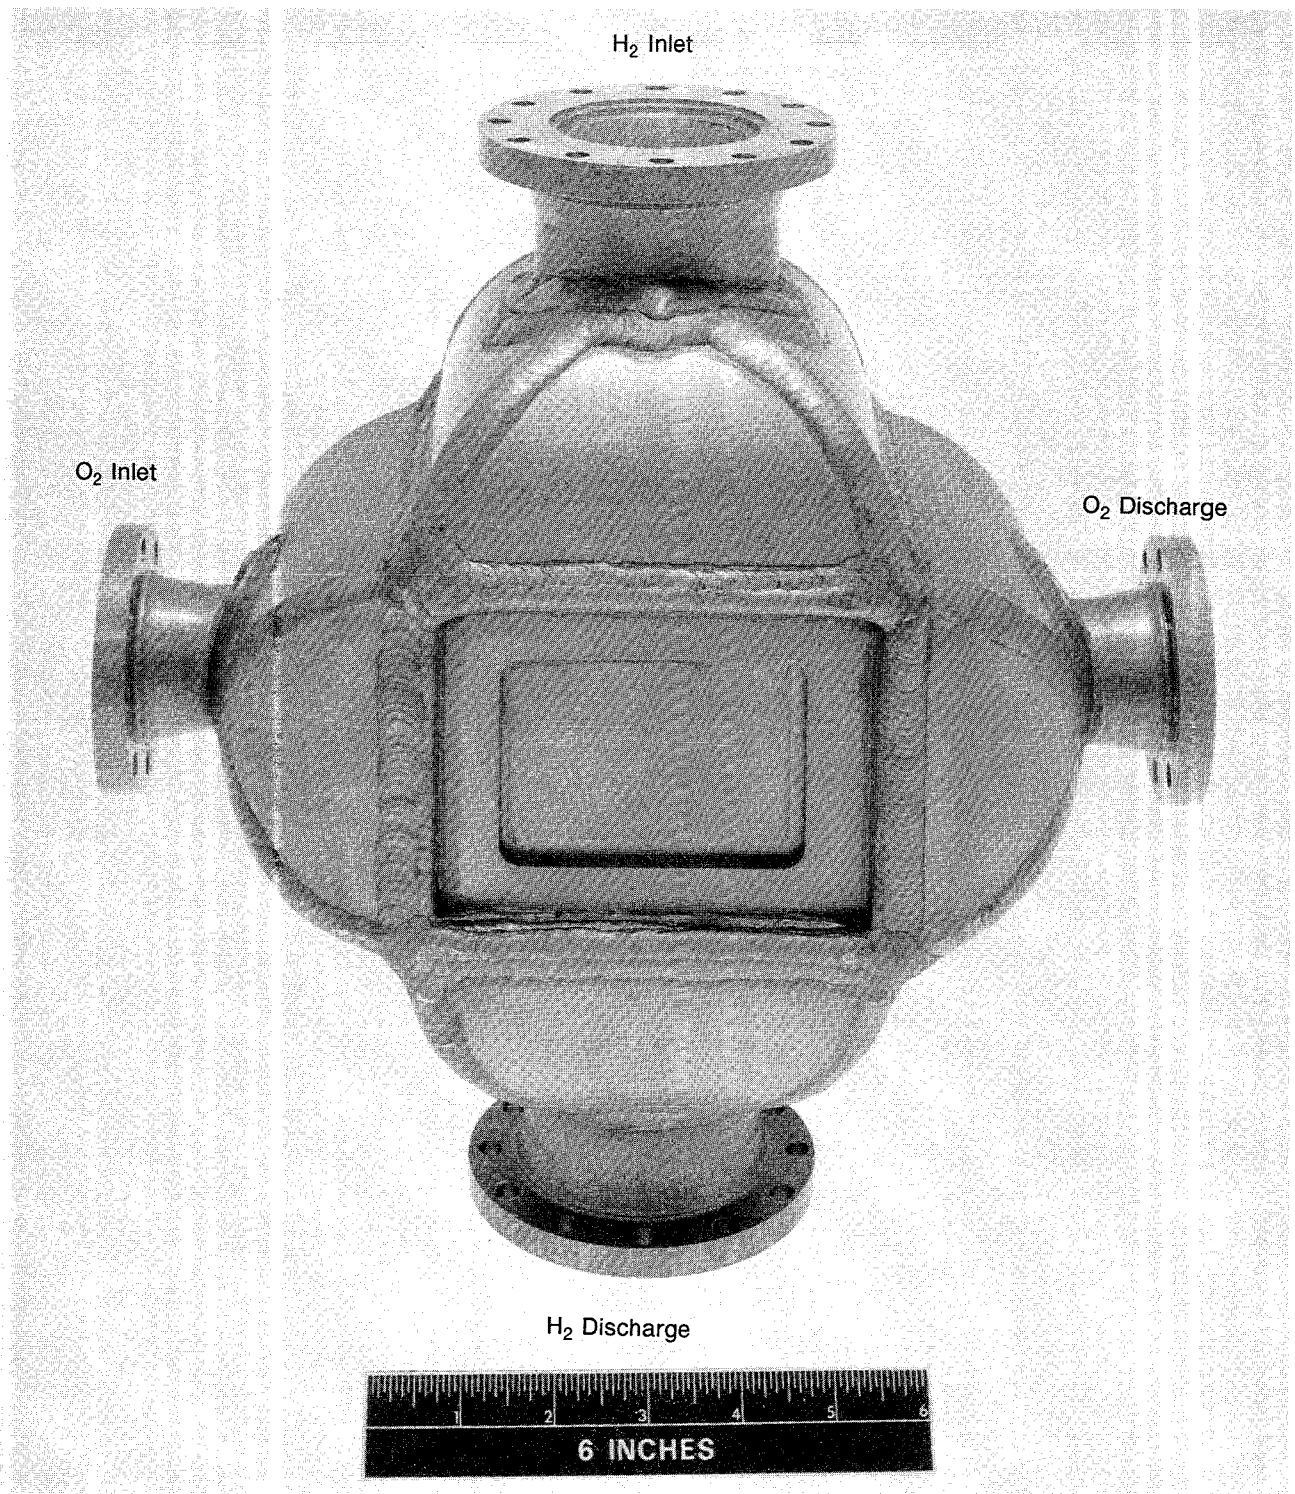
Figure 3. Oxidizer Heat Exchanger Stage 3 (Side View)

Pressure taps were installed on each inlet and discharge manifold, after which the heat exchanger was proof tested to a pressure of 200 psig. Flow passage cross sectional dimensions and surface roughness of this unit were also determined. As with stage 1, area reductions were found. These data are presented in Appendix B. The stage 3 OHE is shown prior to installation of the pressure taps in Figures 3 and 4.

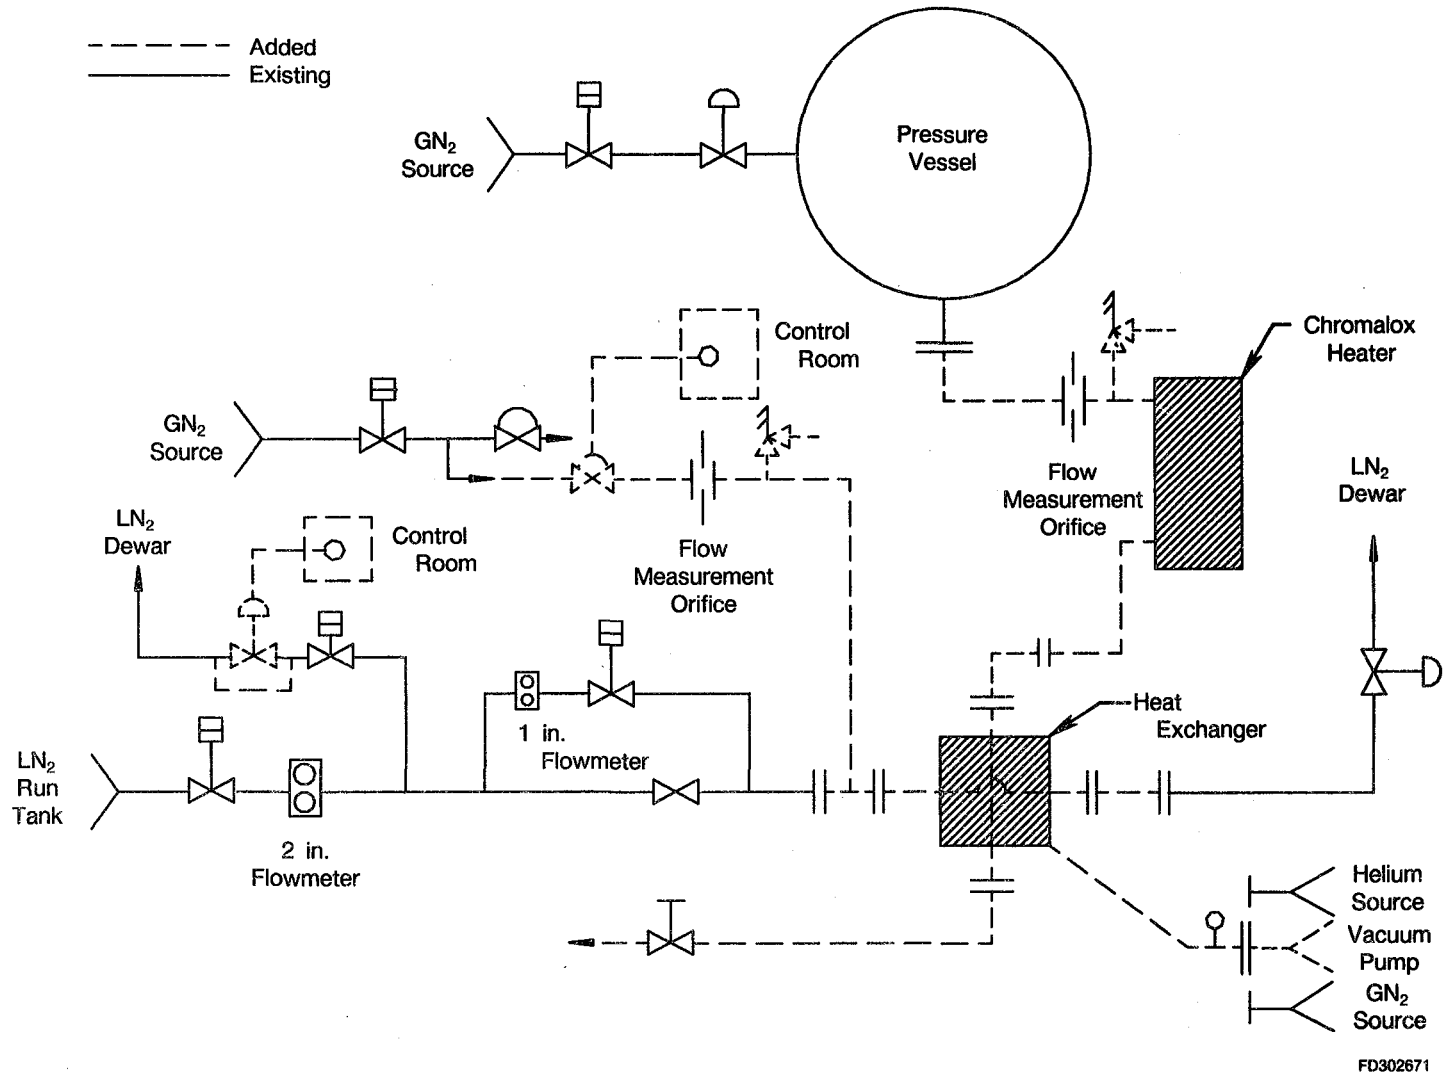
Figure 5. Oxidizer Heat Exchanger Flowbench Configuration

The tests were conducted on the G-1 flowbench, which is a liquid nitrogen flowbench used to test rocket engine components. The configuration was modified to provide the following:

- Gaseous, in addition to liquid, nitrogen flow through the OHE O₂ circuit
- Heated gaseous nitrogen flow through the OHE hydrogen circuit
- Insulated plumbing to achieve and maintain liquid flow
- Capability to provide gaseous helium, vacuum, or gaseous nitrogen in the stage 1 insulation cavity.

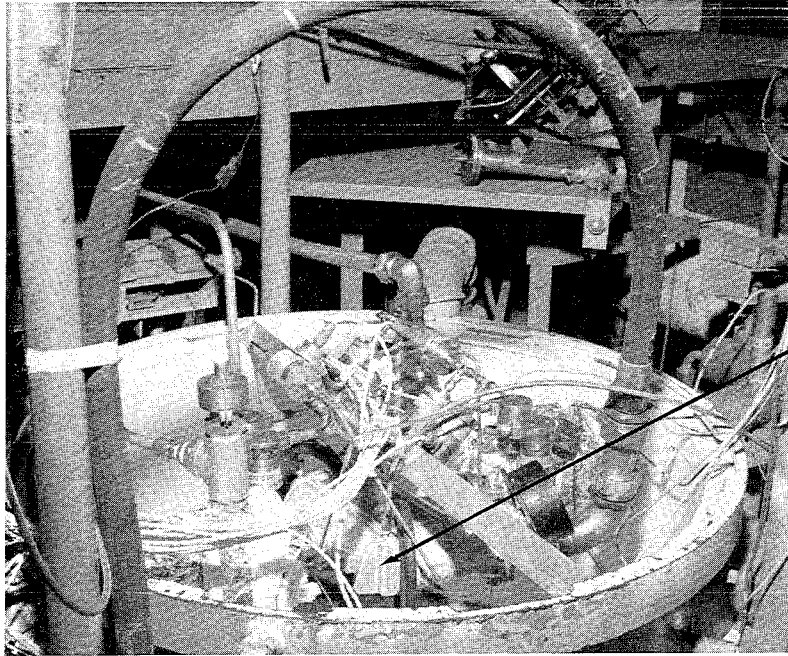
Figure 6. Oxidizer Heat Exchanger Rig Test Flowbench — Stage 1 Mounted

Stage 1 is shown mounted in the stand in Figures 6 and 7, and stage 3 is shown in Figure 8. These photos were taken prior to insulation installation.

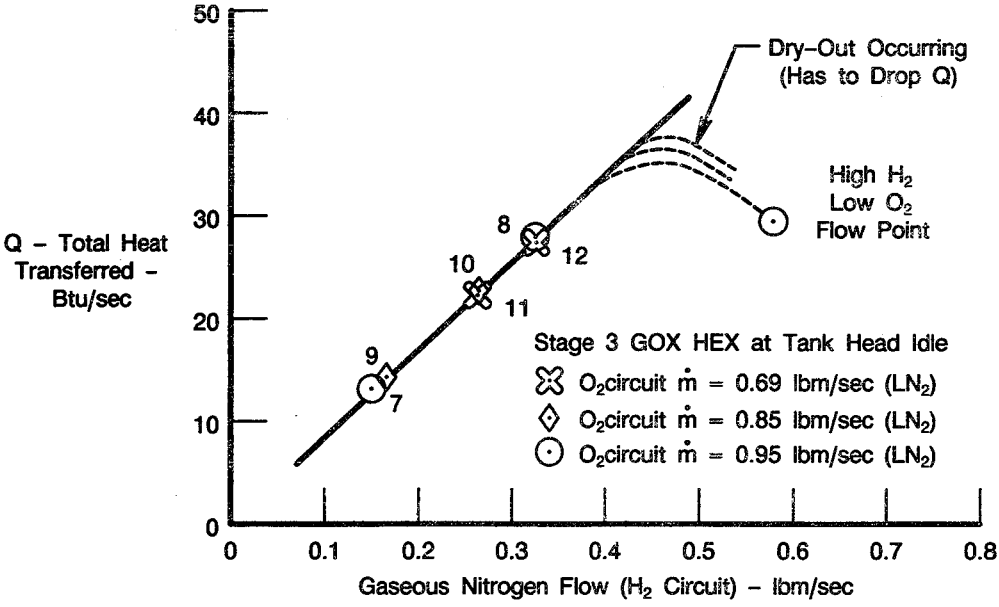
Figure 9. Stage 3 Heat Exchanger Performance — Tank Head Idle

- It appears that oxygen circuit dryout of the LN₂ occurred during the high H₂ low O₂ flow point, as overall heat transfer went down despite the high GN₂ flowrate in the H₂ circuit, as shown in Figure 9. The dryout phenomenon, which occurs when a gas film forms on the passage walls due to a high temperature differential between the liquid and the hot wall, is discussed in Appendix E.
- The maximum LN₂ exit quality calculated during the tank head idle points was 0.47.
- The maximum attainable GN₂ flowrate of 0.7 lbm/sec was not high enough to initiate dryout at simulated pumped idle, as shown in Figure 10. The total heat transferred is limited by the specific heat of GN₂ which is much lower than that of the GH₂ in the engine testing.
- No flow instabilities were observed during testing.

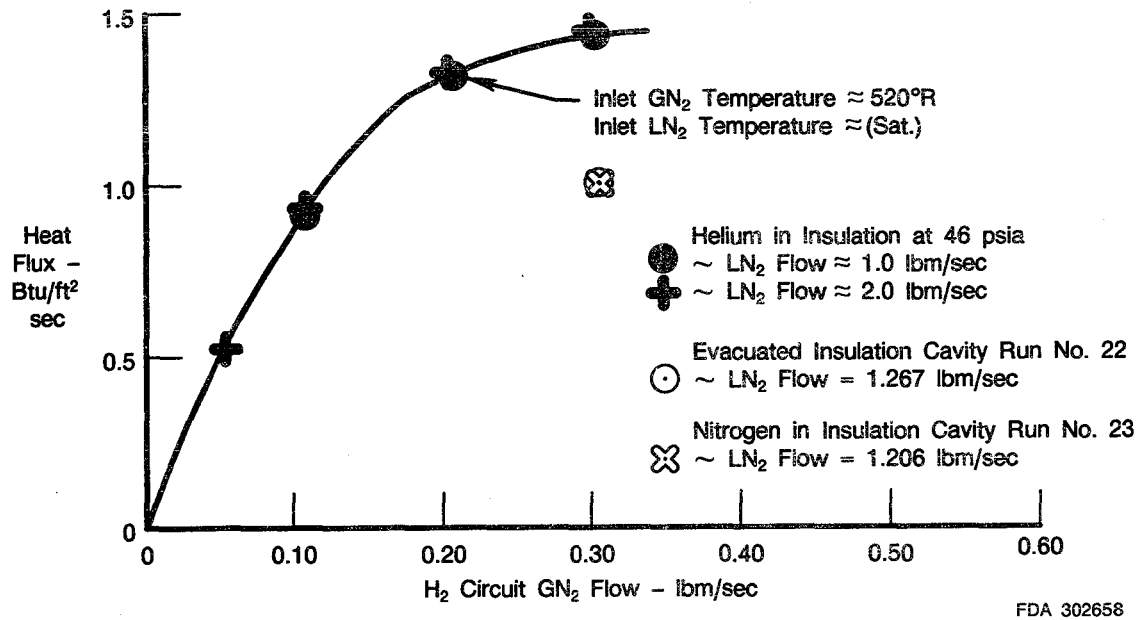
Figure 11. Stage 1 Heat Exchanger Performance

- As expected, helium in the insulation cavity provided greater heat transfer than nitrogen or vacuum, as shown in Figure 11. The difference in heat fluxes between nitrogen and vacuum atmospheres was not noticeable. This may have been due to a fluid leakage into the insulation cavity, as discussed in Appendix A.
- The maximum LN₂ exit quality calculated at the O₂ discharge was 0.022.

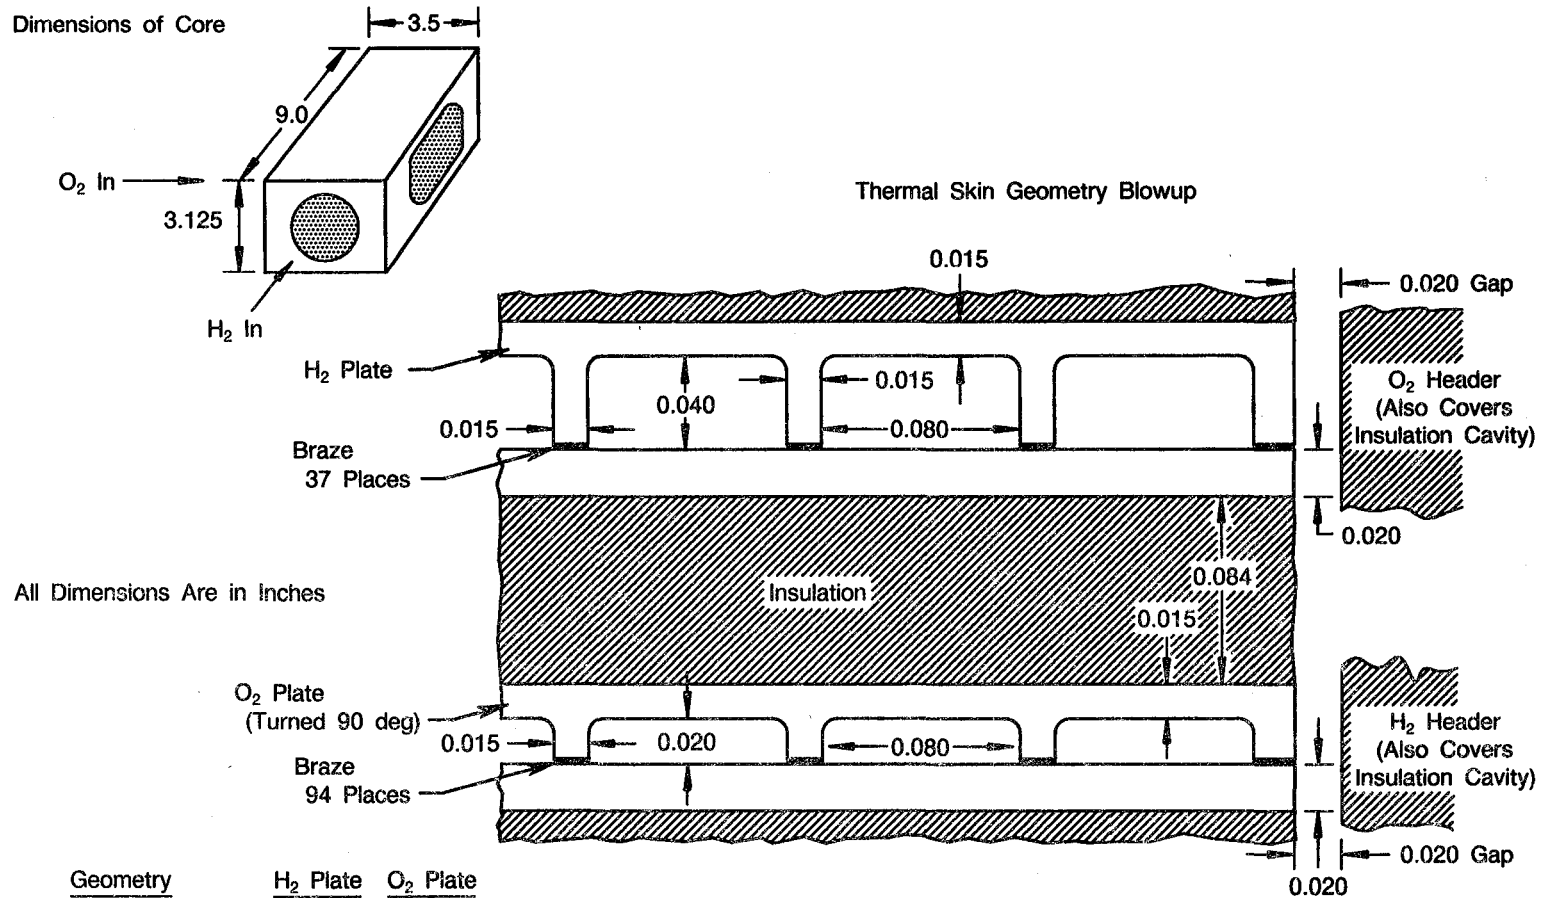
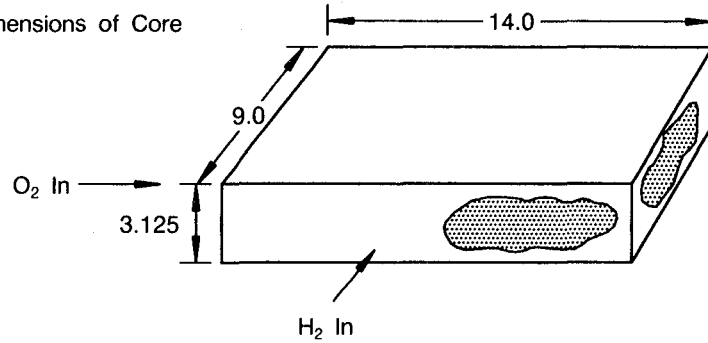
Figure A-1. Oxidizer Heat Exchanger Stage 1 Configuration

Each unit consisted of a set of thermal skin flow panels arranged in a crossflow configuration and separated by layers of insulation designed to limit heat transfer between the two working fluids. Since the insulation was low density felt, the design allowed for changes in the insulation cavity atmosphere to provide variations in the rate of heat transfer. A diagram detailing the core configuration for each stage is shown in Figures A-1 and A-2.

Geometry	H ₂ Plate	O ₂ Plate
No. Plates	12.0	11.0
Passage Diameter, in.	0.0513	0.0336
Flow Area, in. ²	1.213	1.602
Heat Transfer Area, ft ²	5.2	
Core Weight, lb	7.5	
Insulation Type	2% Dense Metal Felt (0.150 in. compressed to 0.084 in.)	
Insulation Material	300 Series Stainless Steel

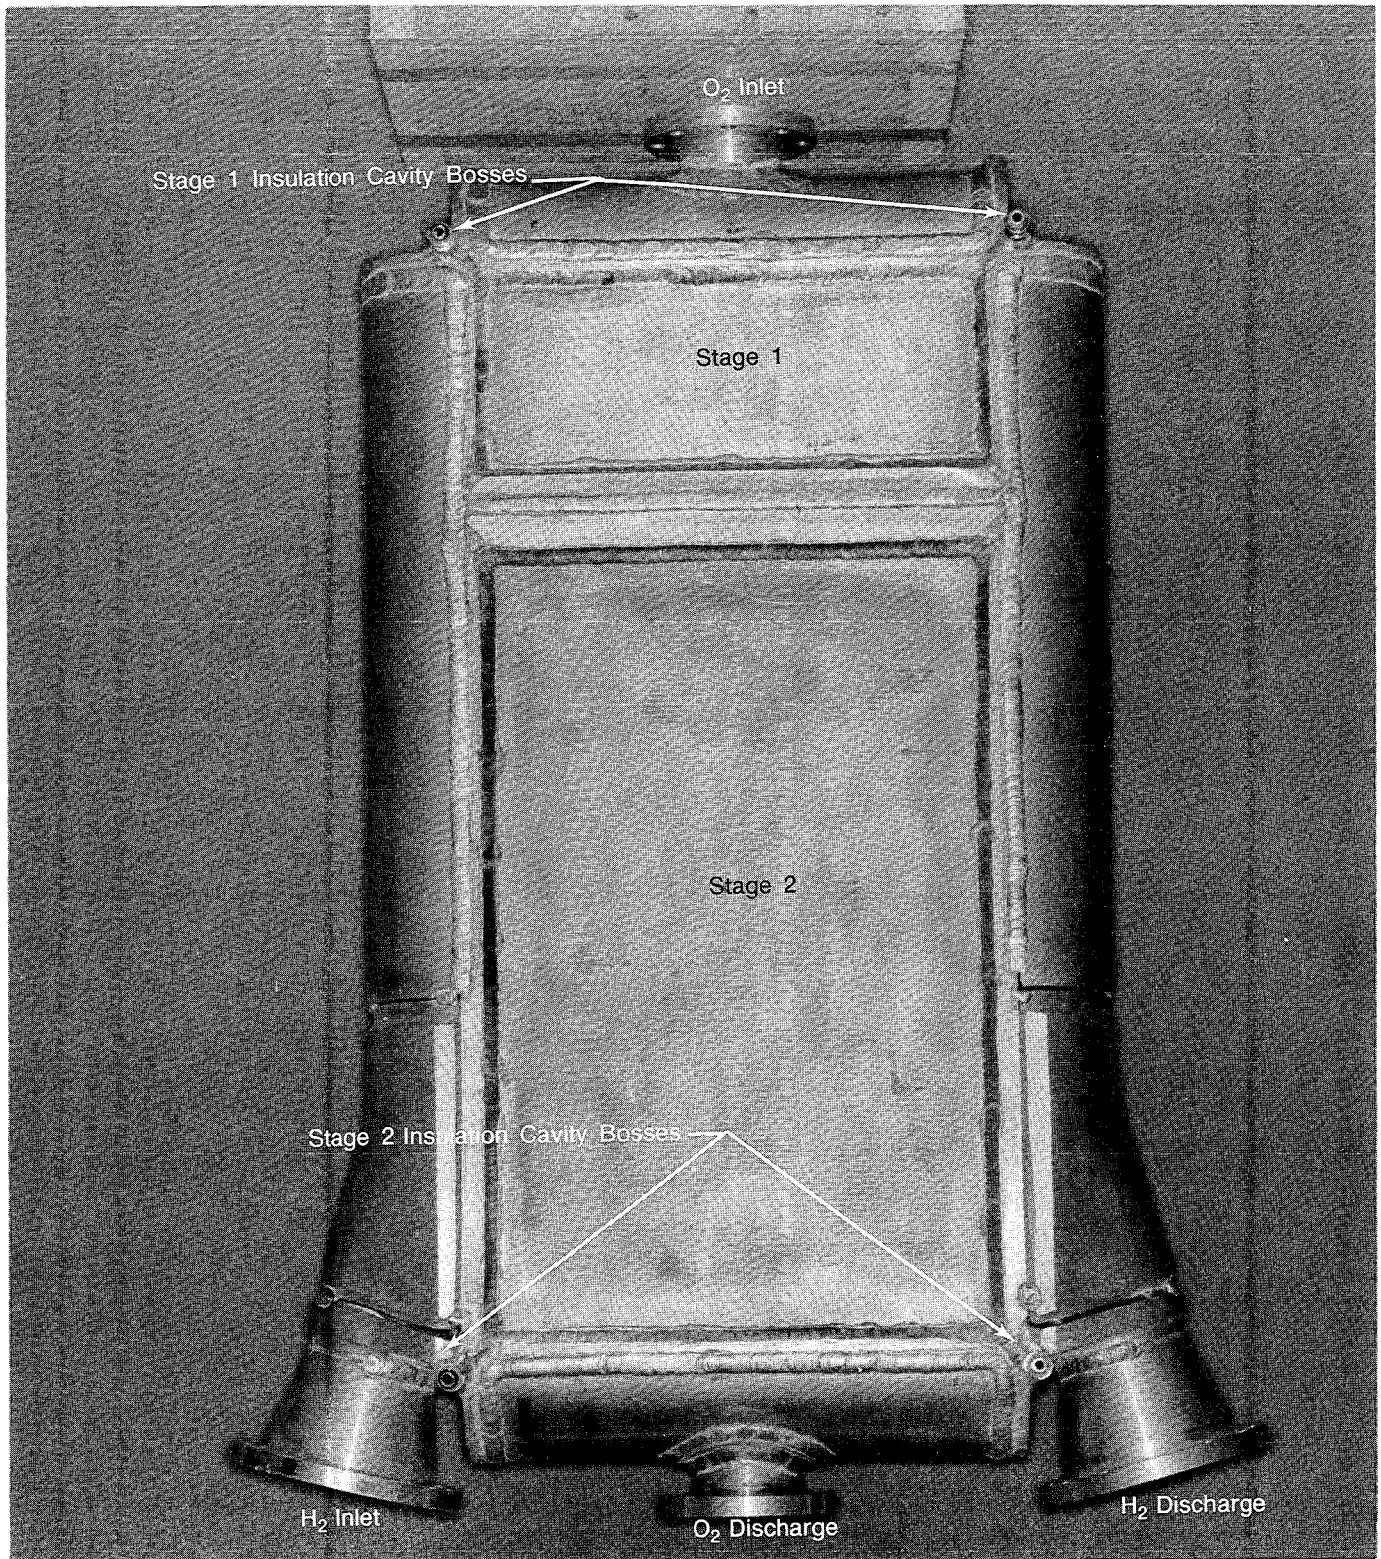
Figure A-8. Oxidizer Heat Exchanger Stage 1-and-2 Assembly As Received

Considerable difficulty was encountered during the assembly and brazing of the stage 1-and-2 units due to the large number of detail parts and difficulty in maintaining braze clearances and preventing wicking of the braze into the insulation. Figures A-3 and A-4 show that the stage 1 core was successfully assembled and brazed. However, the stage 2 unit displayed incomplete braze joints and crushed panels after the initial braze attempt, as shown in Figures A-5 and A-6. After an attempt to rebraze the stage 2 core proved unsuccessful, the vendor pursued a salvaging process consisting of TIG welding all flow panel-header joints as illustrated in Figure A-7. The stages were then joined. Subsequent pressurization of the stage 2 insulation cavity revealed extensive leakage to the oxidizer and fuel manifolds. At this point, it was felt that all reasonable avenues of success had been exhausted, and a decision was made not to attempt any further repair. The stage 1-and-2 assembly is shown as received partially assembled in Figure A-8.

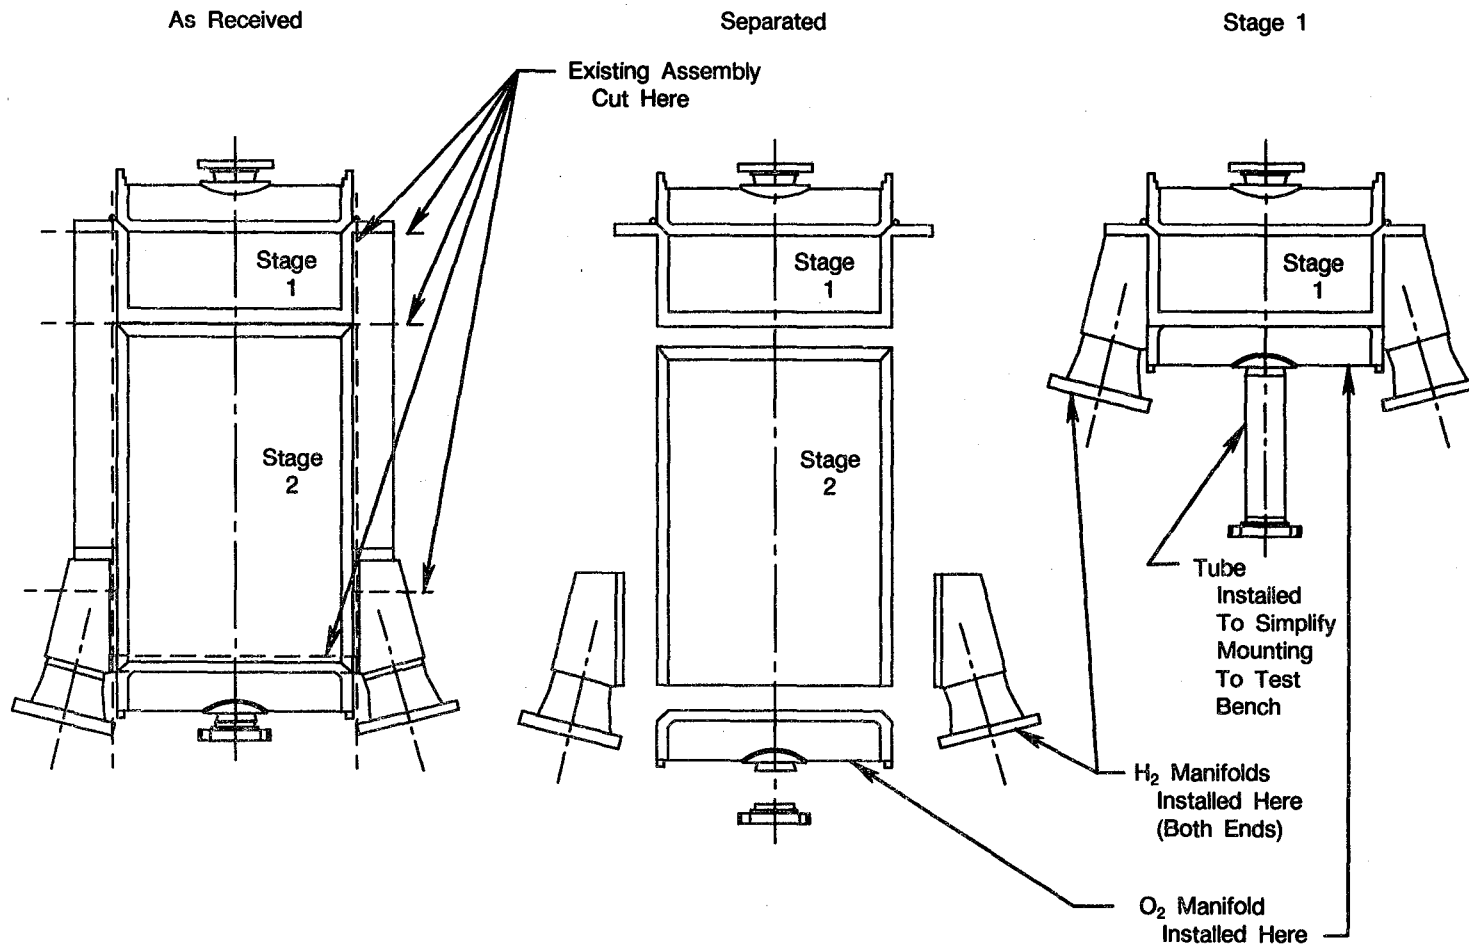
Figure A-9. Oxidizer Heat Exchanger Stage 1 Rework

In order to test the stage 1 unit individually, it had to be removed from the stage 2 core and remanifolded. This was accomplished by salvaging manifolds from stage 2, modifying them, and welding them in place as shown in Figure A-9. Also, a section of tubing was added to one of the O₂ flanges to make the flange separation the same as stage 3 to simplify test bench mounting. Pressure taps were drilled and bosses welded in place on each manifold. The unit was proof tested to 50 psig in both the O₂ and H₂ circuits and the insulation cavity revealed no leaks at 4 psig internal pressure, which is the maximum pressure that could be applied to the cavity without deforming the outer O₂ panels.

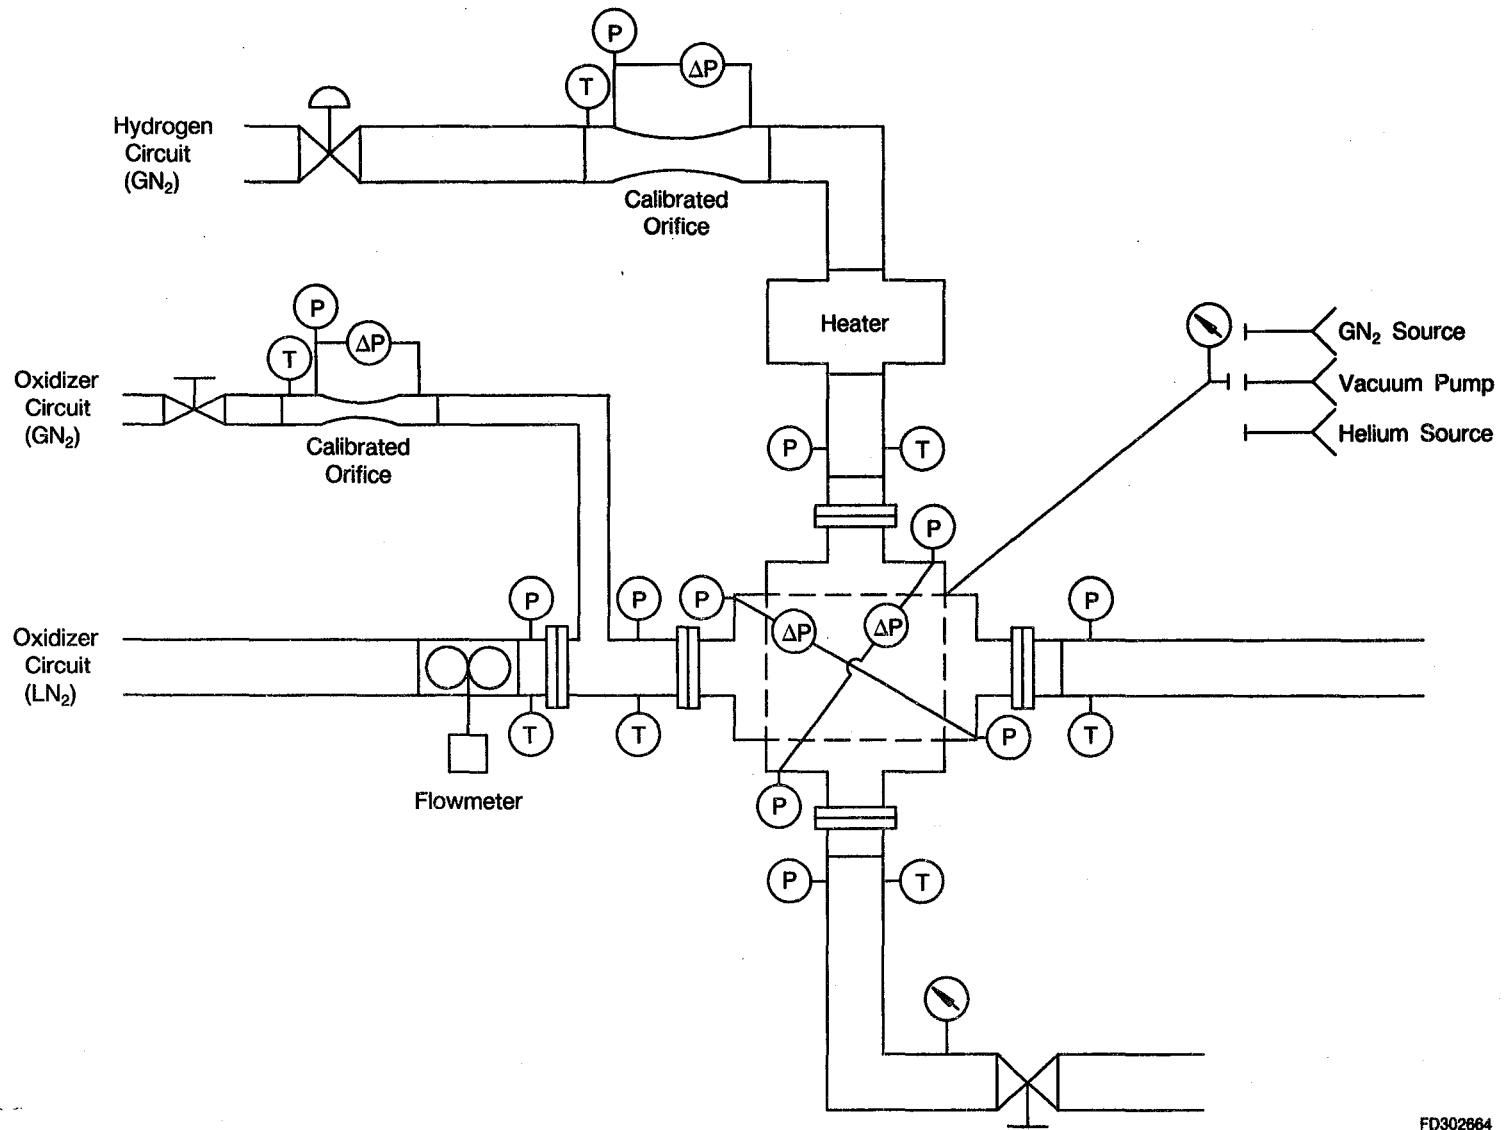
Figure C-1. Oxidizer Heat Exchanger Rig Test Instrumentation Locations

Instrumentation was installed on the rig to provide sufficient accurate data for performance analysis. Instrumentation locations on the test rig are depicted in Figure C-1. An Accurex Model 800 Datalogger was used to calculate GN_2 orifice flows and to record and display data. Rosemount temperature probes were used where possible. Chromel alumel thermocouples were used elsewhere, although several were replaced with copper-constantan thermocouples when some temperature data appeared questionable after the first run. Flowrates were such that sufficient accuracy could be provided by existing stand liquid flowmeters and added gas measurement orifices. O-graph recordings of oxidizer circuit inlet and discharge pressures and flow were taken only during gas-liquid test points to check for possible oscillations due to unstable boiling.

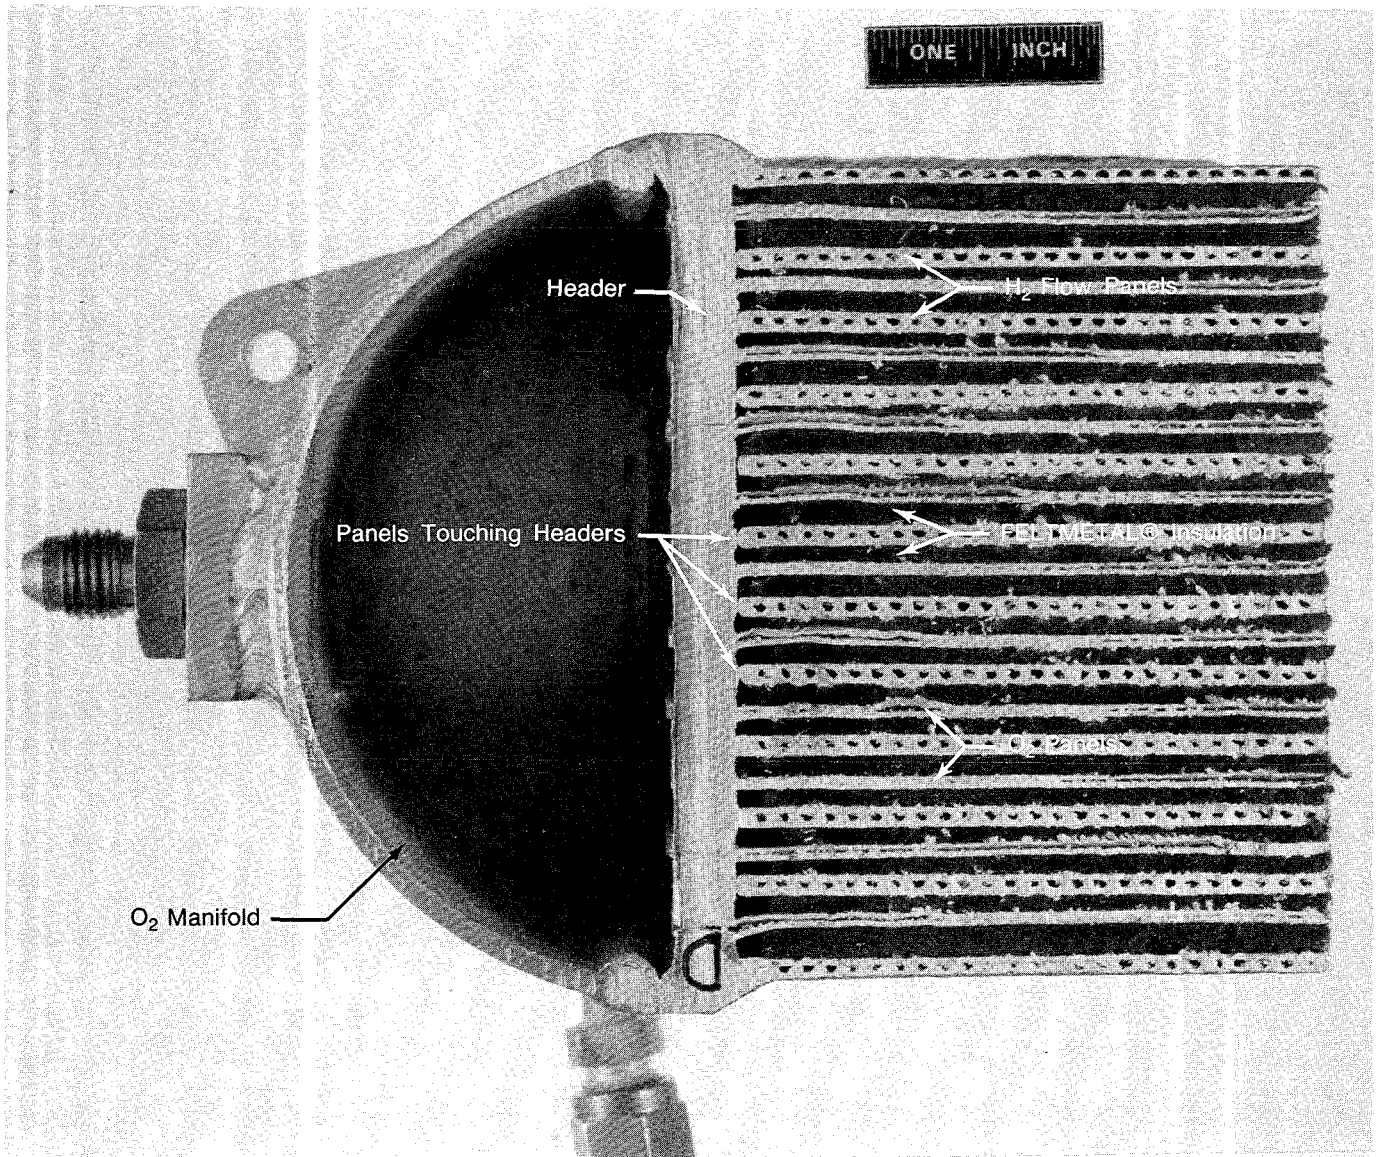
Figure E-1. Stage 1 Heat Exchanger Section — H₂ Flow Section

Due to discrepancies between the predicted and measured heat transfer rates for stage 1, short-circuiting past the insulation was suspected. After testing, the stage 1 was sectioned to examine the insulation cavity and the position of the flow panels. Figures E-1 and E-2 show views of the two circuits. Although there was no apparent wicking of the braze filler into the insulation, many flow panels were touching the header of the other fluid, creating a short circuit around the insulation. This may be partially responsible for the discrepancies.

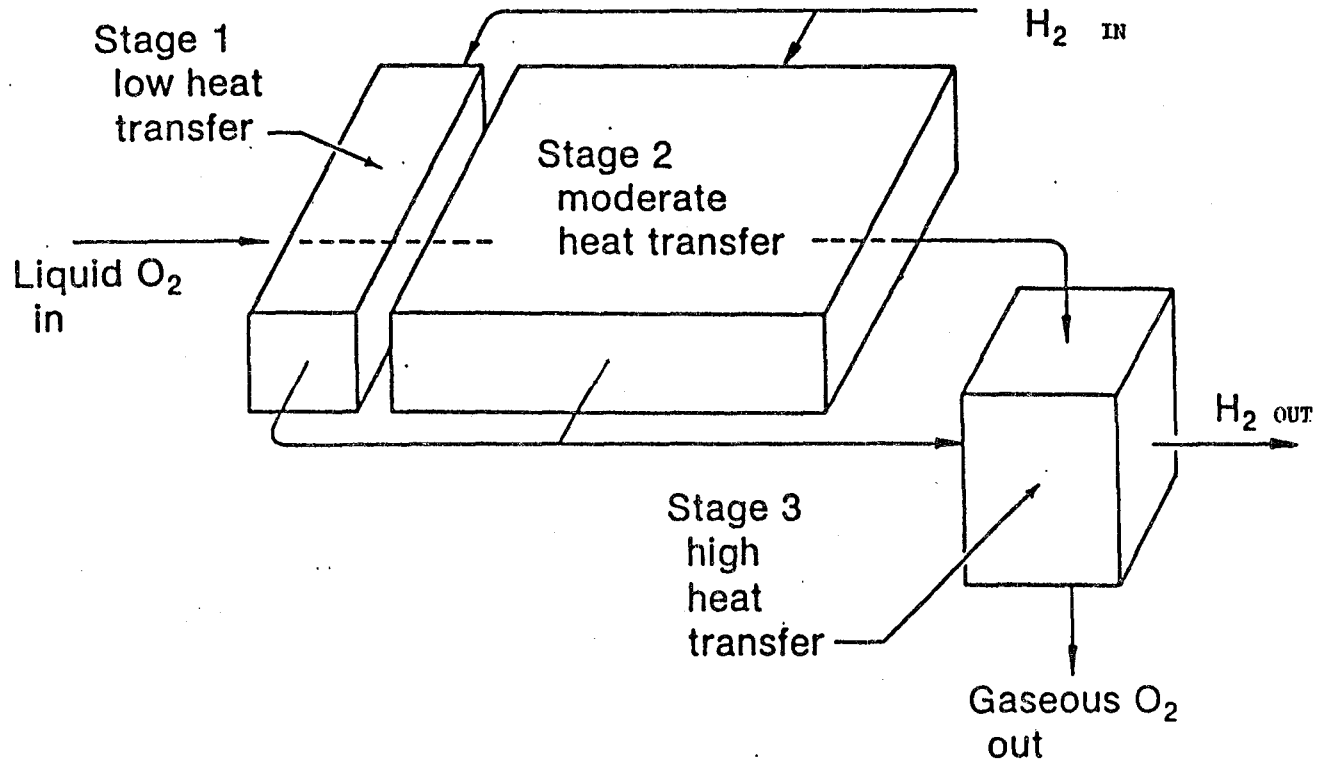
GOX HEAT EXCHANGER SCHEMATIC

The RL10-IIB GOX heat exchanger, as defined by Reference 2, consists of three modular stages, each optimized for one mode of operation. The oxygen flows through all three stages in series while the hydrogen flows through Stages 1 and 2 in parallel and then through Stage 3. This arrangement is shown schematically in Fig. 1. In order to control flow stability during tank head idle and pumped idle conditions, insulation has been added between adjacent heat exchanger plates in Stages 1 and 2 to limit the maximum heat flux. This configuration is illustrated in Fig. 2.

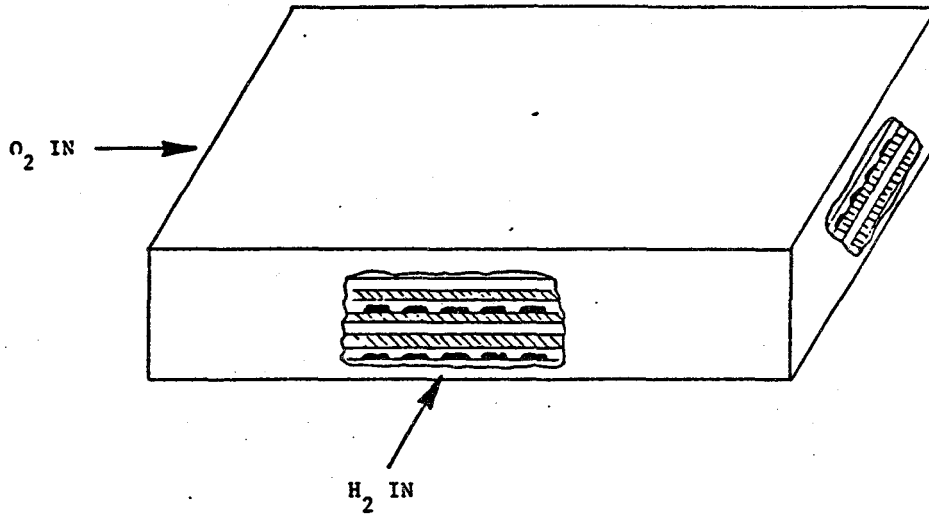
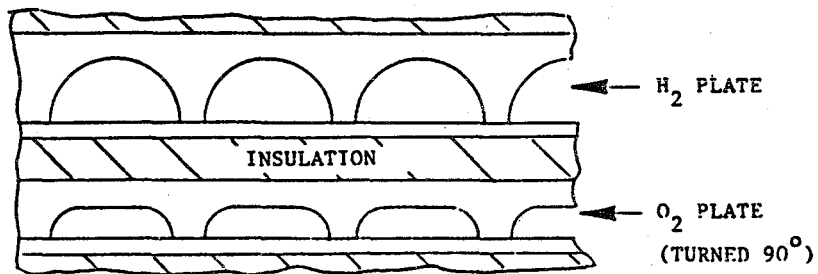
RL10 IIB GASEOUS OXYGEN
HEAT EXCHANGER - TYPICAL STAGE

THERMAL SKIN GEOMETRY BLOW-UP
