Final Report FDOT Project BD521-02

# Performance Assessment of Portland Cement Pervious Pavement

## Report 2 of 4: Construction and Maintenance Assessment of Pervious Concrete Pavements

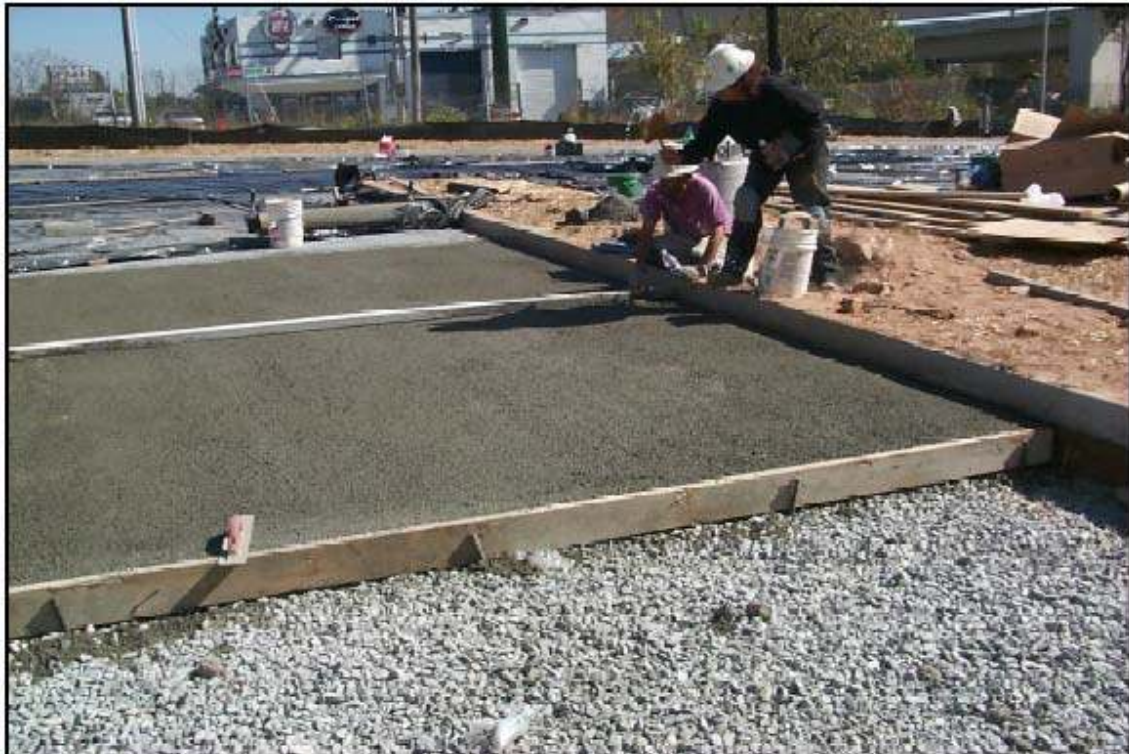
Figure 2: Typical Porous Concrete Installation

Porous concrete systems are typically used in low-traffic areas, such as, parking pads in parking lots, residential street parking lanes, recreational trails, golf cart and pedestrian paths and emergency vehicle and fire access lanes. Heavy vehicle traffic use must be limited to ensure raveling or structural failure does not occur in the porous pavement surface, which may fail under constant exposure to heavy vehicle traffic. The slopes of these installations should be flat or gentle to facilitate infiltration versus runoff and the EPA recommends a four-foot minimum clearance from the bottom of the system to the water table if infiltration is to be relied on to remove the stored water volume (EPA, 1999). Figure 2 shows a typical porous concrete installation.

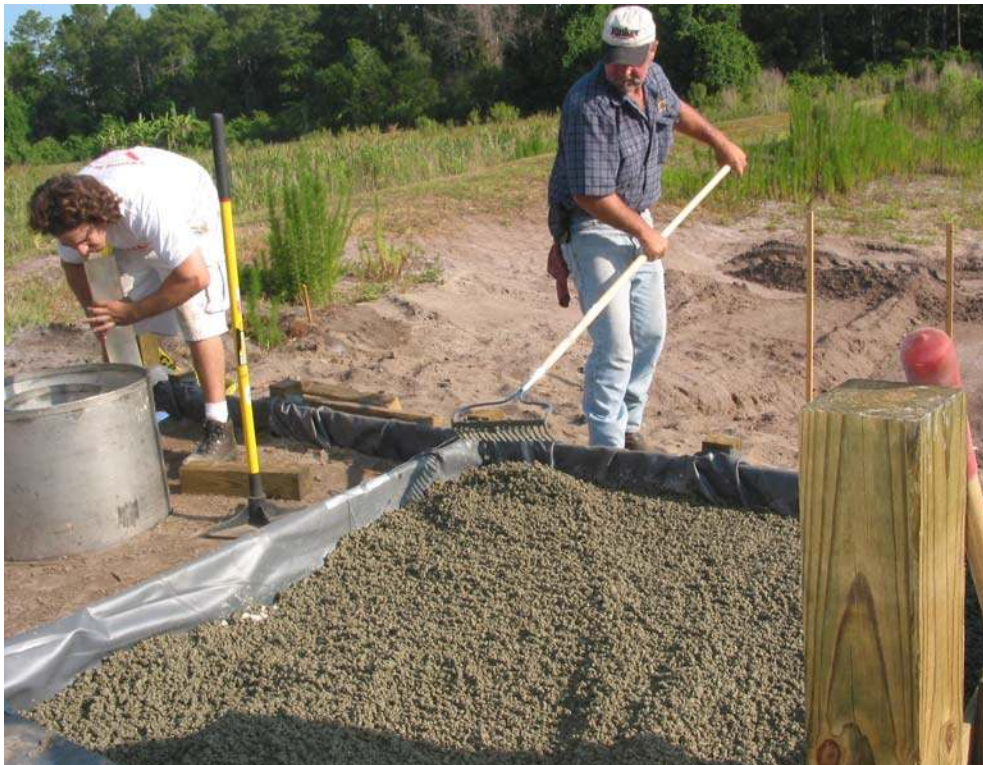
per hour as determined by application of a double-ring infiltrometers test (ASTM D 3385-94). One cell contains a five-inch deep reservoir of  $\frac{3}{8}$  to  $\frac{1}{2}$  inch coarse aggregate, and both cells have a five- inch thick pervious concrete slab. Depicted in Figure 3 is the installation of the pervious concrete in the test cells as well as a double-ring infiltrometer test being performed on the compacted subsoil.

Figure 3: Stormwater Academy Porous Concrete Test Cell Installation

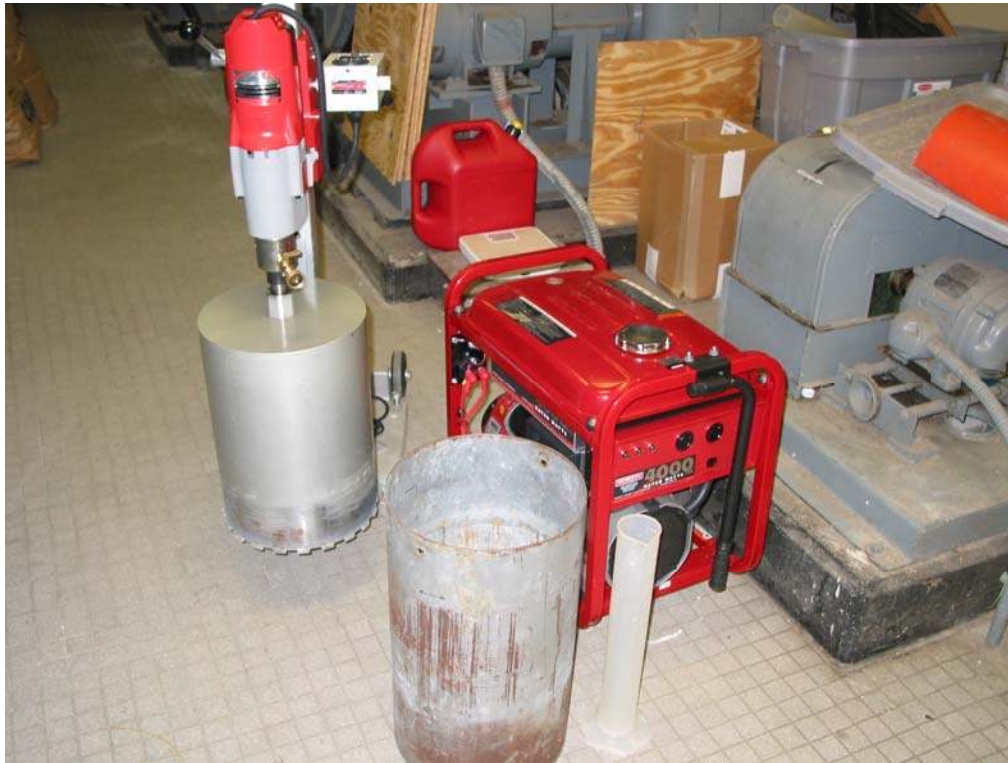
1. The pervious concrete surface is cored in three evenly spaced locations utilizing a 12 inch outside diameter, diamond tipped concrete core bit. The drilling process takes between 10 and 30 minutes per concrete core depending on the type of aggregate used in the concrete mix and depth of the concrete slab. The coring rig and the core bit are shown in Figure 7.

Figure 7: Coring Rig, Core Bit, Single-Ring Infiltrometer, and Generator

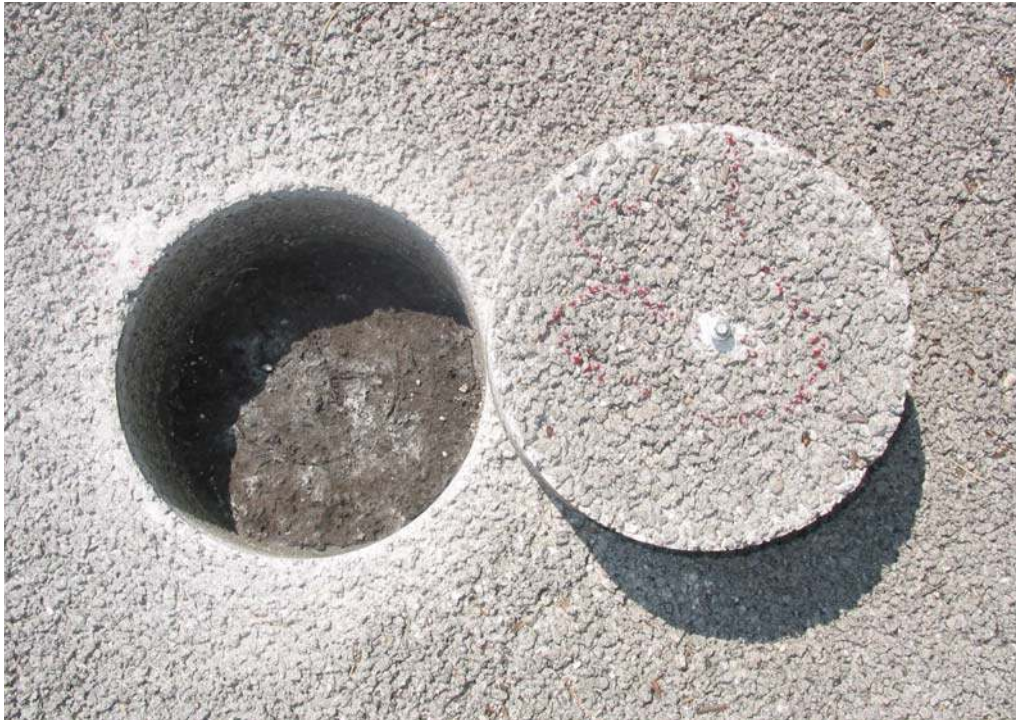
The core samples are left in place after drilling for in-situ infiltration testing. When necessary, the cores were extracted and grinded along the sides to remove irregularities formed during the coring process to allow the single-ring infiltrometer to fit around the core. A four-inch angle grinder with a masonry disk was utilized for this task. Figure 8 shows the 12 inch core placed next to the location it was removed from in the pavement. It is clear that the pavement system at this site does not have a drainage layer of gravel. This configuration is typical for pavements on soils with high permeability values.

Figure 8: Pervious Concrete Pavement Core

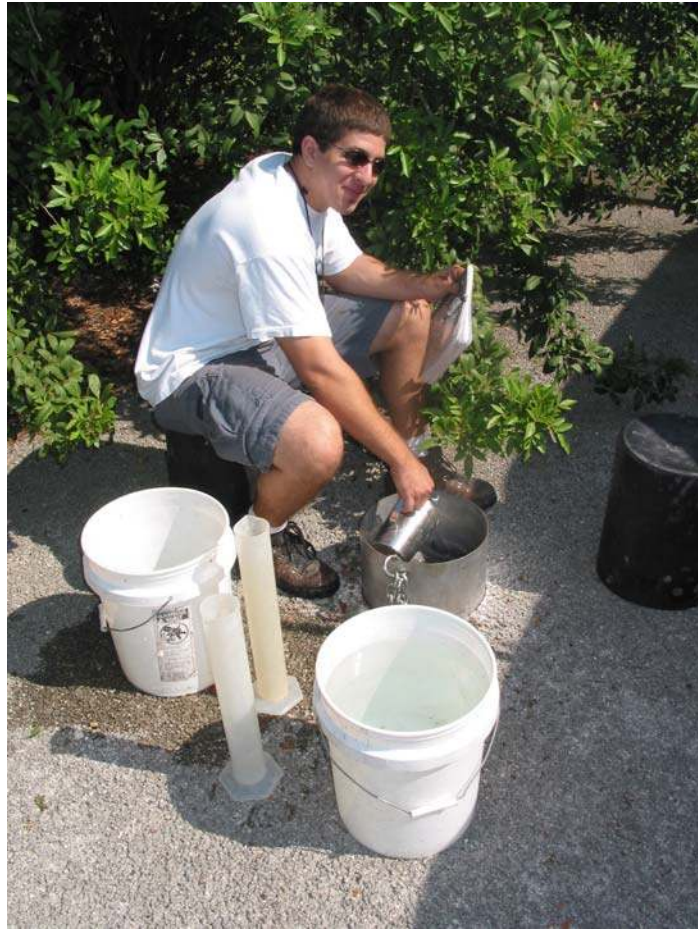
2. Once the single-ring infiltrometer can pass into the cut made by the coring rig, the infiltrometer is embedded into the subsoil by applying a downward force. The infiltrometer is typically installed using a hand-tamper making sure to mark the infiltrometer before embedment to ensure the infiltrometer is installed to the proper depth.
3. After the single-ring infiltrometer is embedded to the proper depth, a bead of plumber's putty is placed around the inside circumference of the infiltrometer to prevent side-wall leakage.
4. Infiltration rates of the three cored locations are measured using the embedded Single-ring Infiltrometer Test as discussed in the previous section. Figure 9 shows a test in progress with the infiltrometer in the embedded state.

Figure 9: Pervious Concrete Pavement Core Test

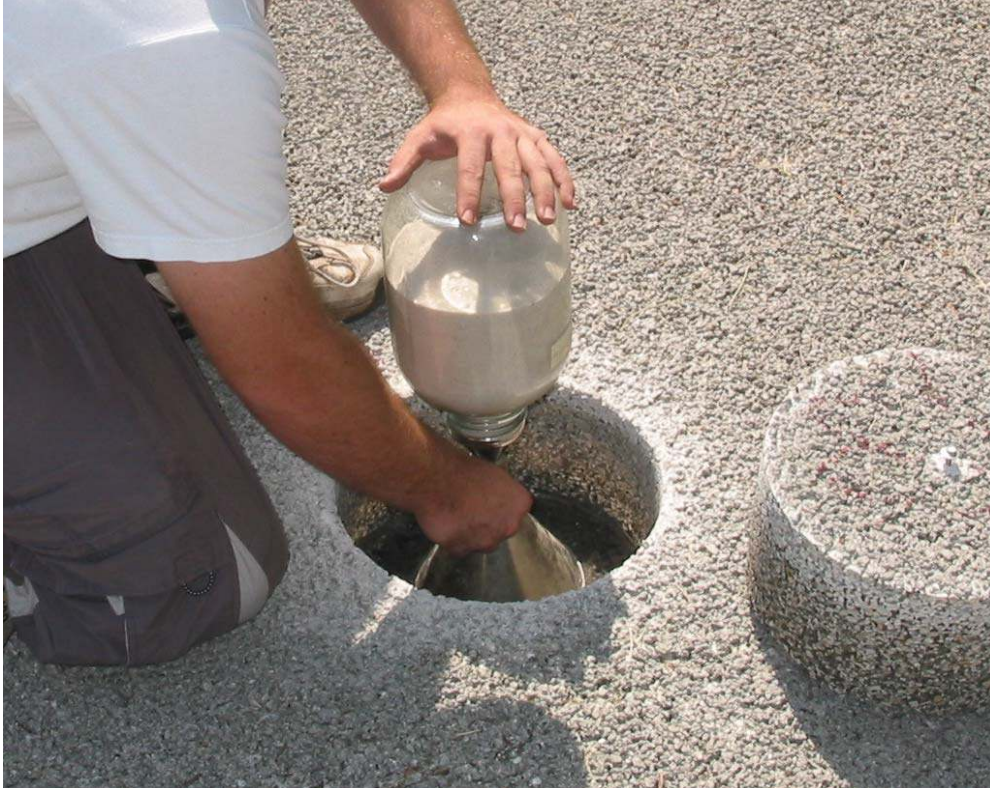
7. The field unit weight of the subsoil is then determined using the Sand Cone Method as outlined in ASTM D 1556 “Standard Test Method for Density and Unit Weight of Soil in Place by the Sand-Cone Method”. Figure 10 shows a sand cone test in progress.

Figure 10: Performing Sand Cone Test

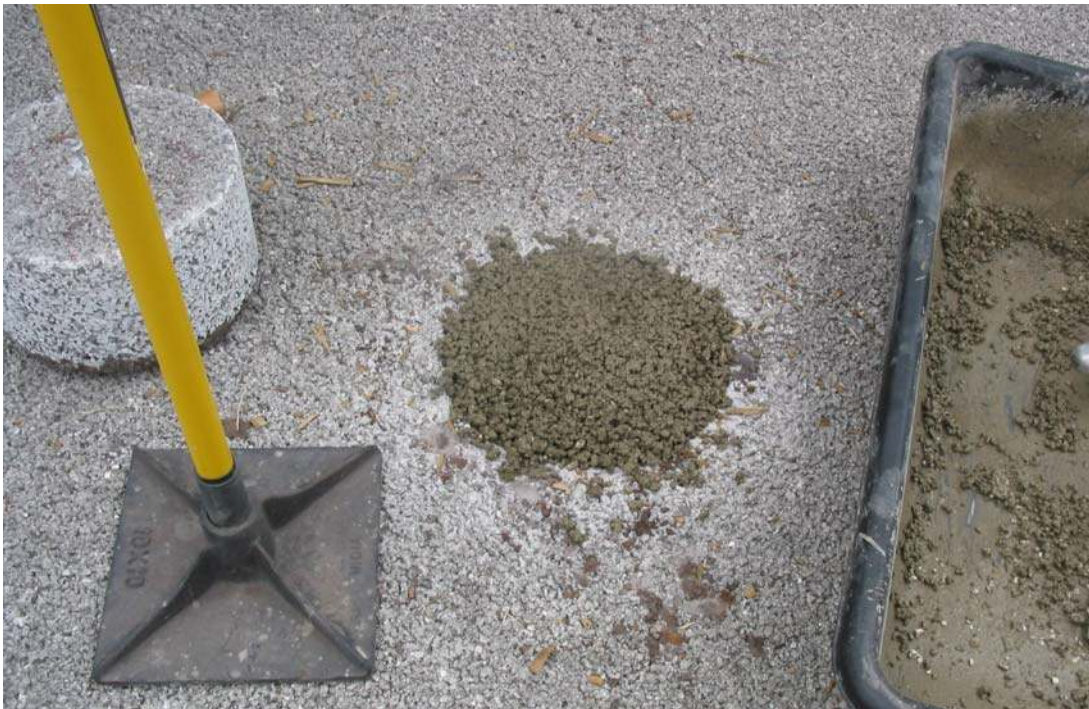
9. Water table depths are recorded for use in modeling studies planned for the pervious concrete system.
10. The subsoil shall be replaced and the pervious concrete is repaired using the original specifications at the locations where it was cored. An example of this patching is depicted in Figure 11.

Figure 11: Repair of Concrete Core Area

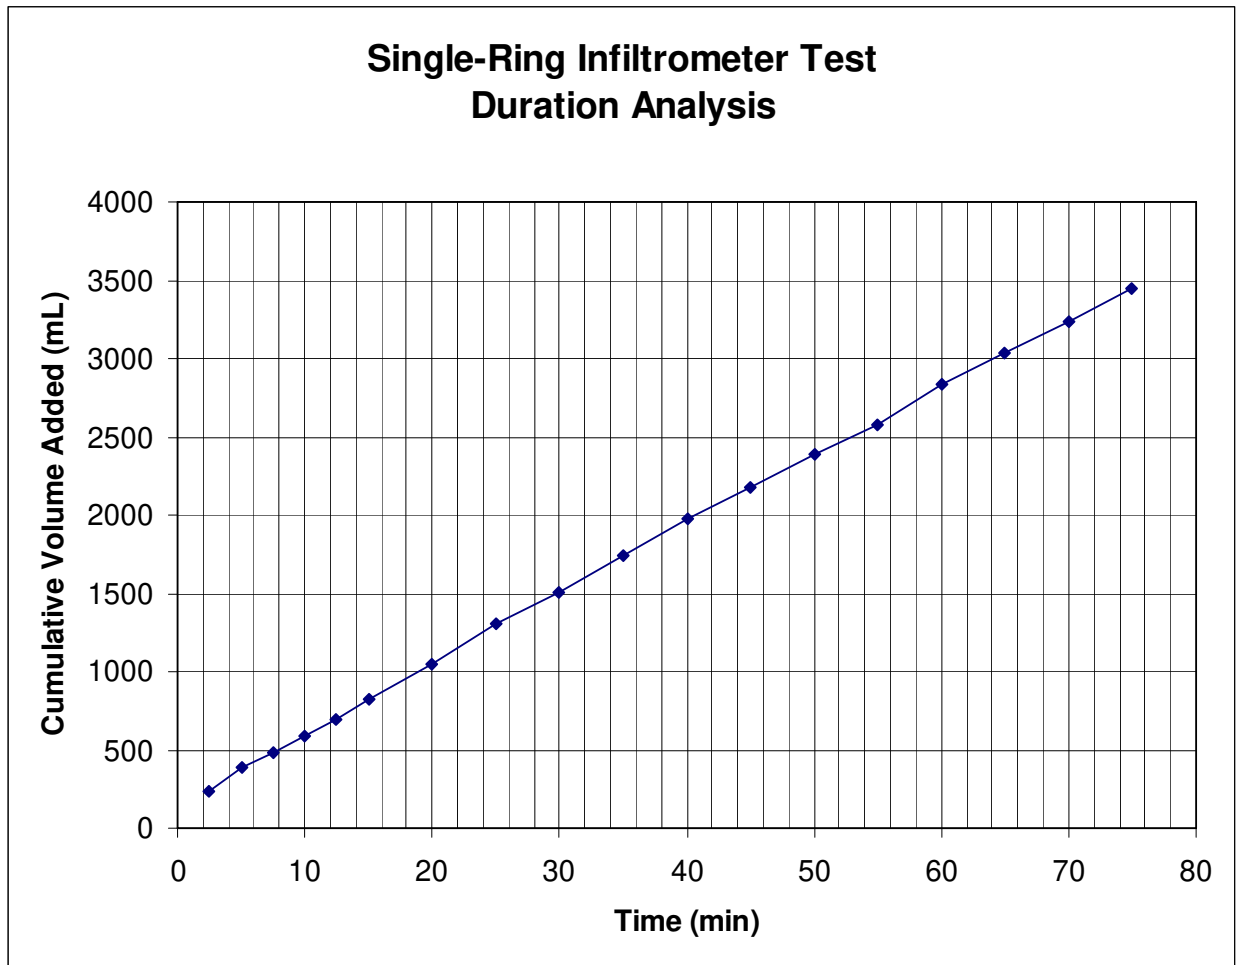
specified to confirm the accuracy of the single-ring infiltrometer results. The hydraulic head applied during the test was determined by performing a single-ring infiltrometer test, allowing the flow rate to reach equilibrium, and then adjusting the hydraulic head in a range of 4 to 8 inches above the pervious concrete surface. A head of 1 inch was also used and the rate decreased by about 50% but there was still no significant differences between the double and single ring infiltration rate measurements. Finally, the test duration was evaluated by allowing a single test to run for an extended duration. A graph of the results of this test is depicted in Figure 13.

Figure 13: Single-Ring Infiltrometer Duration Analysis

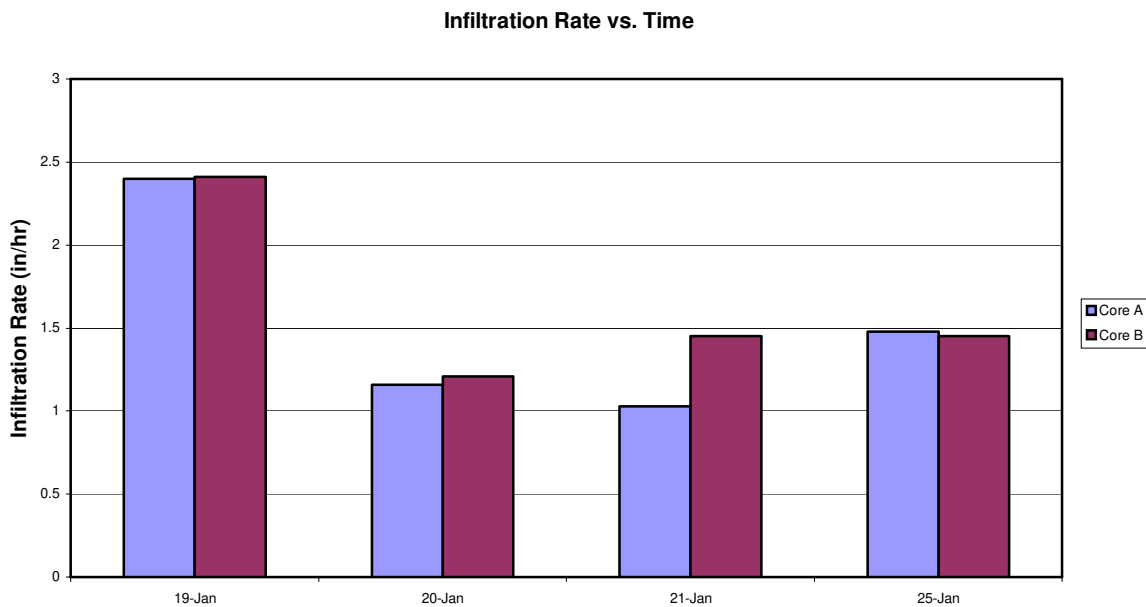
Figure 14: Visual Summary of Pervious Concrete System Infiltration Rates

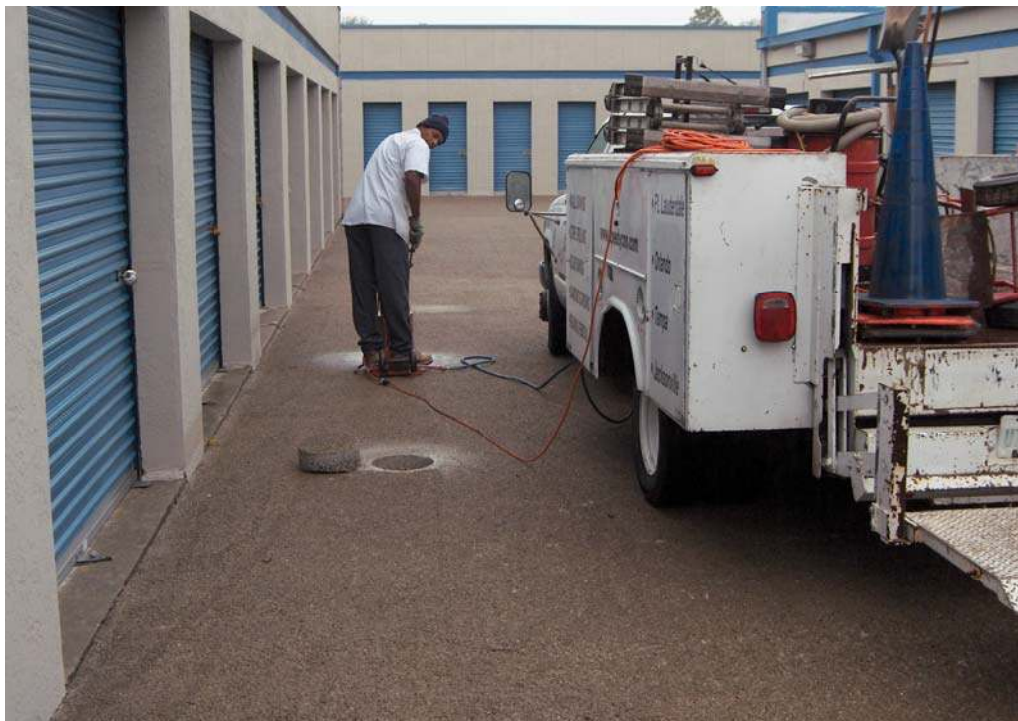
infiltration rates measured in the laboratory that ranged from a high of 627 to a low of 3 in/hr. Instances where the system infiltration rates are higher than the individual core infiltration rates measured in the lab is due to infiltration along the sidewall of the cores that occurred in the field but was restricted in the lab producing false high infiltration rates in the field. The cores performed in the area of cores 1, 2 and 3 exhibited higher infiltration rates than other areas. This result was anticipated as the pervious concrete surface in that area was after visual determination in better condition; this area is shown in Figure 16.

Figure 16: Sun Ray Store-Away Pervious Pavement at Core Locations 1, 2 & 3

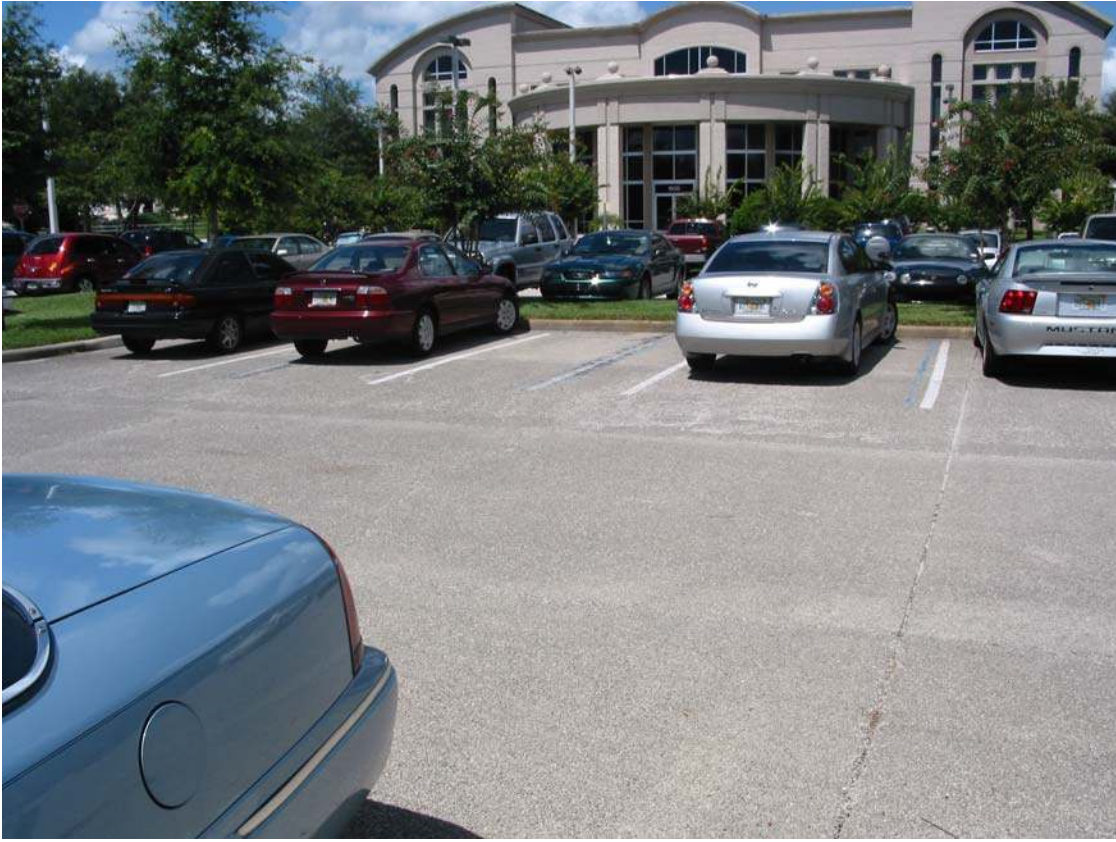
This pervious parking lot exhibited minimal damage to the surface, although, significant raveling has taken place in one location on the site. Raveling is the deterioration of the concrete due to repeated loads over time on an area. The nine spaces located in the northwest area of the pervious concrete are raveling at the entrance to each stall. Also, a small amount of raveling at the entrance to the parking row on the west was also noted. Algae and leaf debris staining are also present over a majority of the pervious concrete parking lot. Figure 17 shows the location of the raveling and algae in this parking area. Depicted in Figure 18 is a picture of this site.

Figure 18: Strang Communication Office Parking Lot

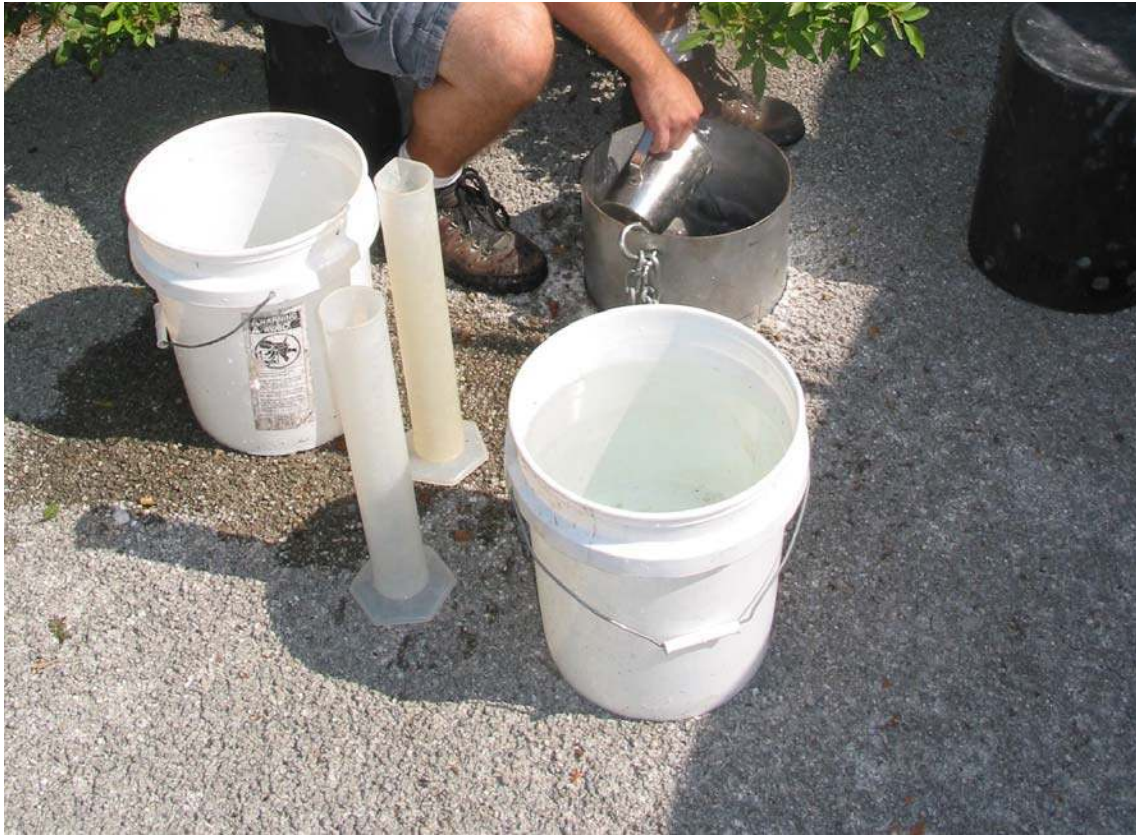
The subsoil characteristic to the pervious concrete parking lot at the Murphy Veterinarian Clinic exhibited infiltration rates typical of type A hydrologic soils. Infiltration rates of the subsoil ranged from 15.78 to 27.21 in/hr. in the field and 3.41 to 7.91 in/hr. in the laboratory permeability tests. The difference in infiltration rate is believed to be due to the higher level of compaction of the laboratory soil samples. Field system infiltration rates were not measured due to the lack of access to a power source at the field site, which limited the ability to grind the sides of the pervious concrete cores to allow the single-ring infiltrometer to fit around the core. Core infiltration rates exhibited infiltration rates measured in the laboratory that ranged from 2.3 to 24 in/hr. This result indicates that the pervious concrete surface is acting as the limiting factor at this pervious concrete installation. Figure 20 depicts a subsoil infiltration test being performed at the field site.

Figure 20: Murphy Veterinarian Clinic Core Test

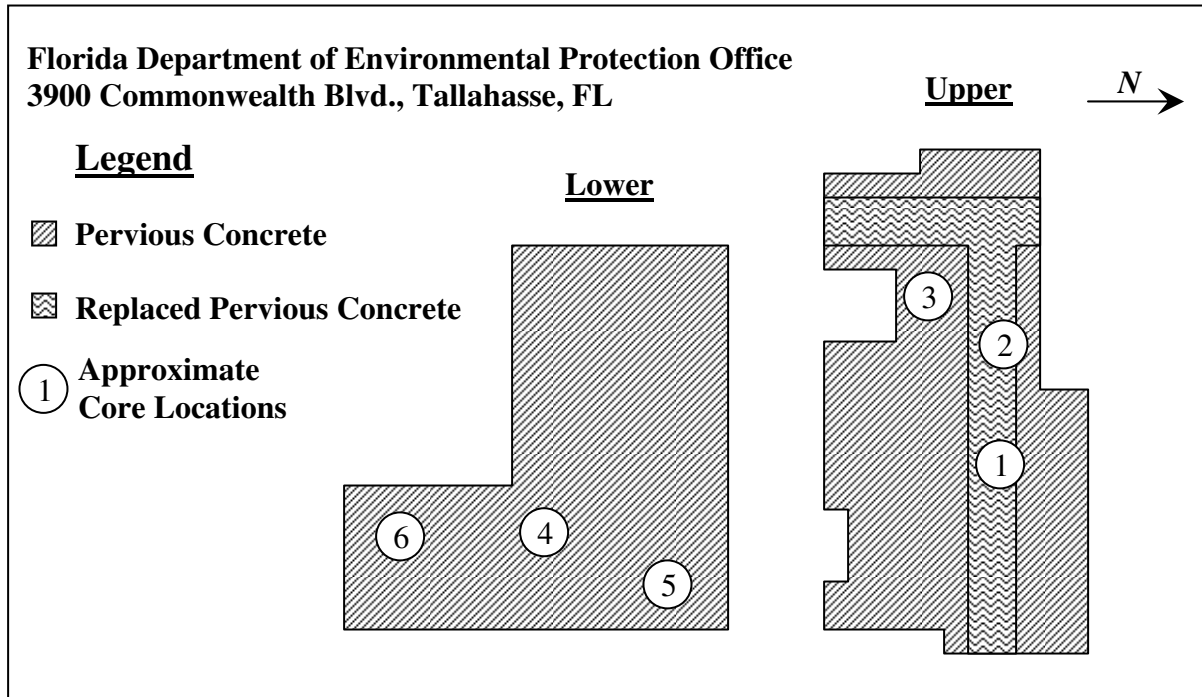
sealed concrete. Site infiltration tests were also done on these suspected concrete areas to further document the impervious nature of the concrete. These areas of concrete have no pores, possibly due to an excess of water used in the initial construction. This sealed state is primarily found in the area of pervious concrete that was replaced.

Figure 21: Florida Department of Environmental Protection Parking Lot Schematic (Not to Scale)

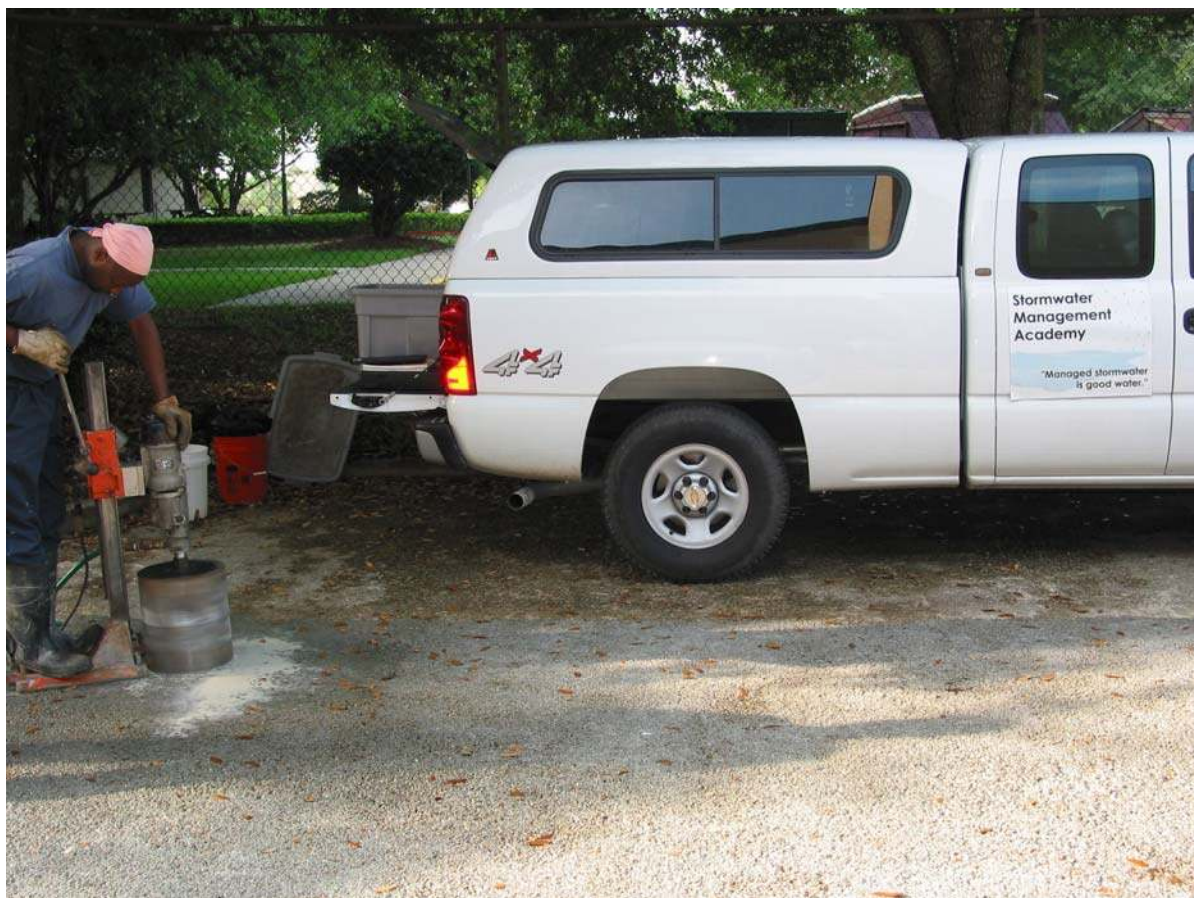
ranged from 0 to 5.2 in/hr. The cores performed in the area of cores 4, 5 and 6 exhibited higher infiltration rates than other areas. This result was anticipated as the condition of the pervious concrete surface in the other areas was compromised due to poor construction practices. Higher than typical unit weights are also indicative of poor construction practices. Low infiltration rates of the subsoil in the areas of Cores 4 through 6 was due to a layer of poorly draining, orange clay encountered directly beneath the pervious concrete. Figure 22 depicts the coring operation performed at this site.

Figure 22: FDEP Parking Lot Core Test

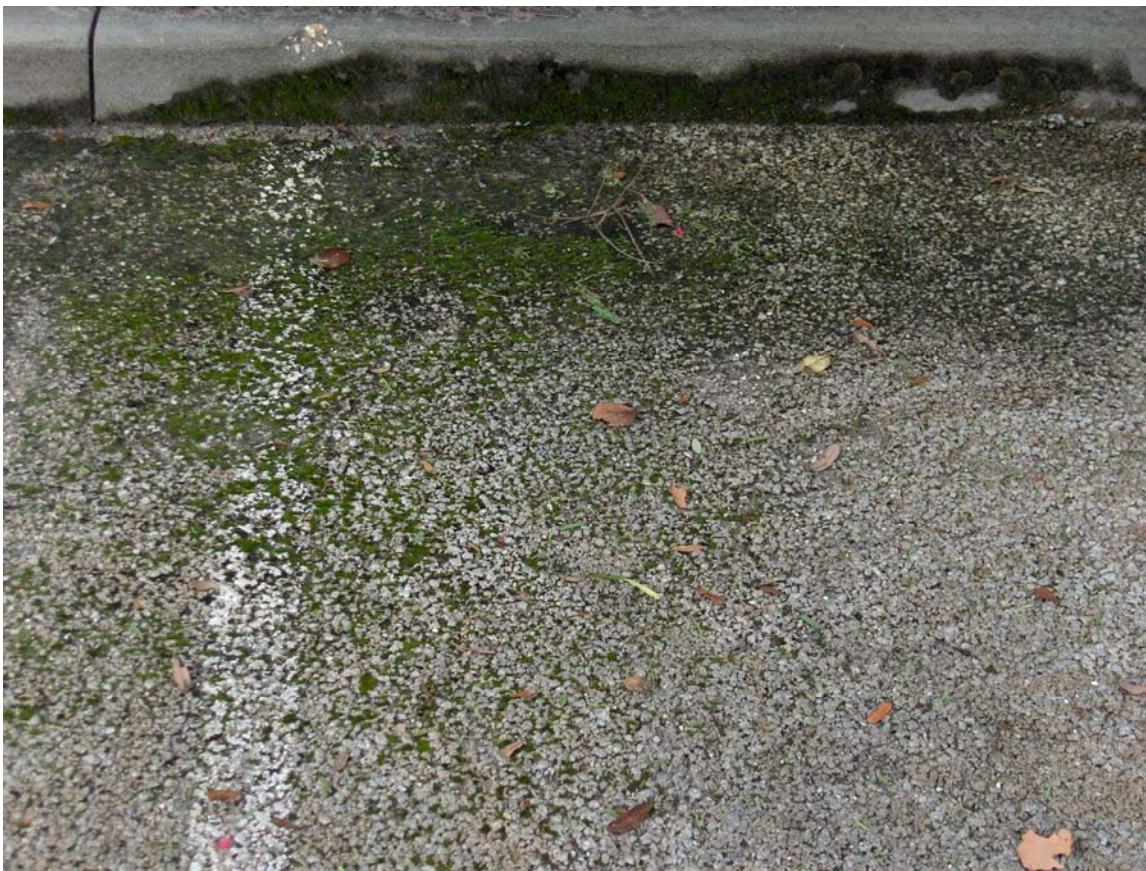
ranged from 8.54 to 9.07 in/hr. in the field and laboratory permeability tests confirmed these rates. Core infiltration rates measured in the laboratory ranged from 1.8 to 5.8 in/hr. Field system infiltration rates were not measured due to the lack of access to a power source on the site, which limited the ability to grind the sides of the pervious concrete cores to allow the single-ring infiltrometer to fit around the core. This result indicates that the pervious concrete surface is acting as the limiting factor at this pervious concrete installation. A photograph depicting the condition of the pervious concrete in this area is shown in Figure 24.

Figure 24: FCP&A Parking Lot

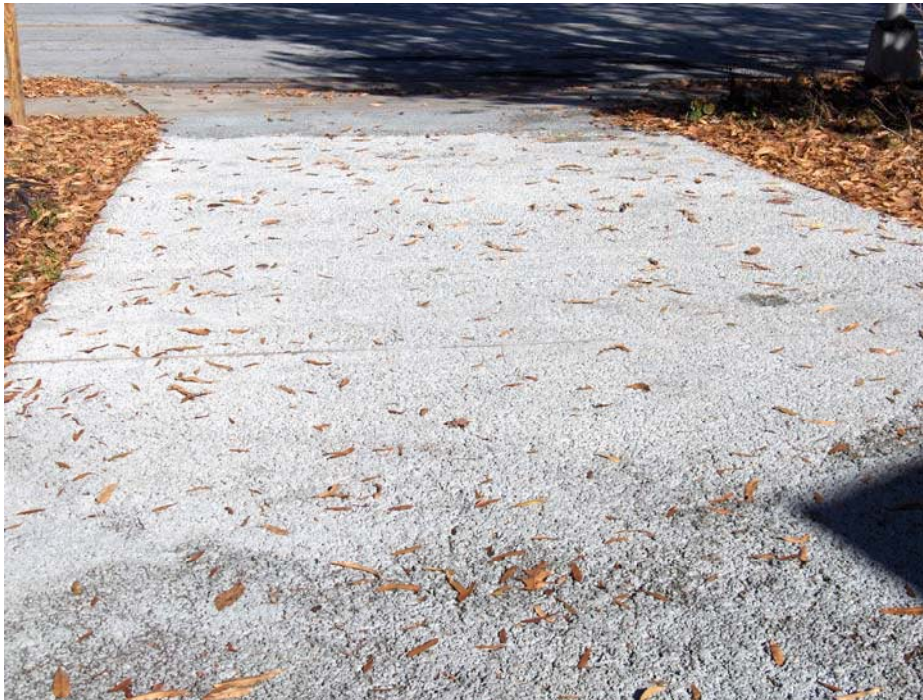
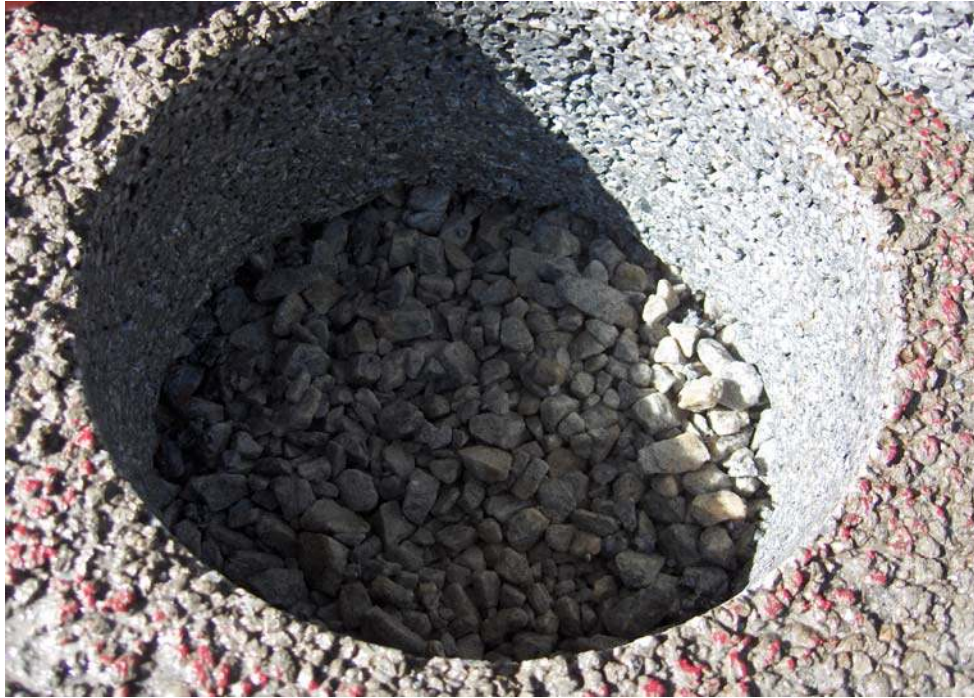
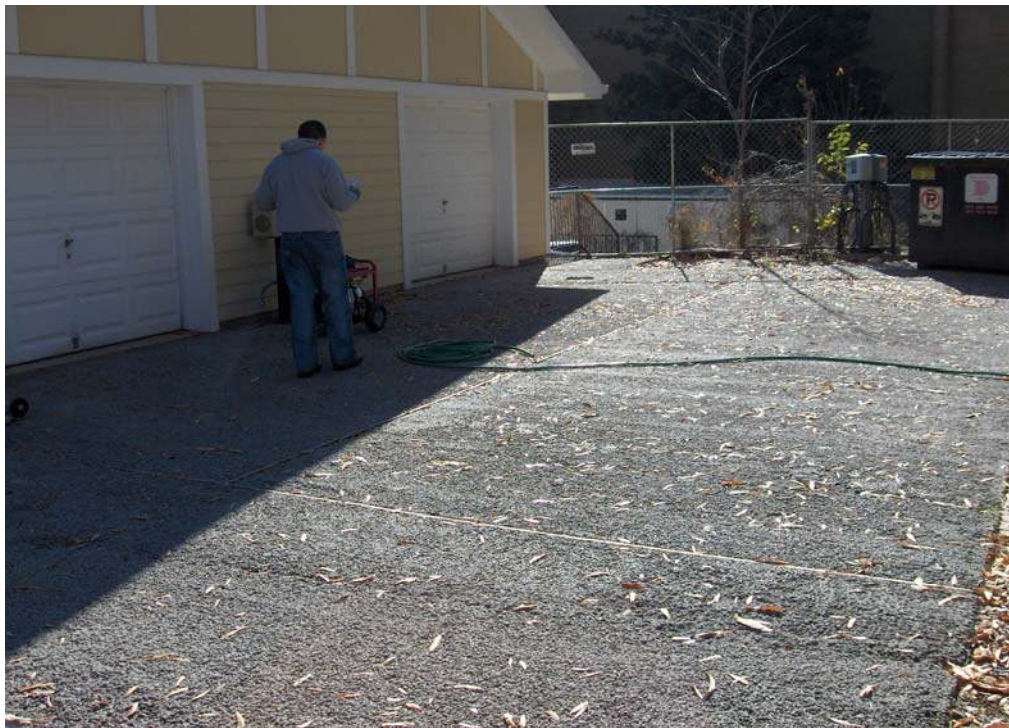
188 in/hr. This wide range of infiltration rates can be contributed to varying surficial pore sizes and unit weights in pervious concrete due to poor construction techniques. Field system infiltration rates were not measured due to the presence of a gravel reservoir, which the single-ring infiltrometer is unable to penetrate. These results indicate that the subsoil is acting as the limiting factor at this pervious concrete installation, however a gravel reservoir has added storage to the site to allow a longer recharge time. Laboratory tests indicate the gravel reservoir has a porosity of approximately 0.32 or a storage capacity of approximately 2 inches of water. Photographs depicting the condition of the pervious concrete in this area are shown in Figures 26, 27 and 28.

Figure 26: Southface Institute Parking Lot

Figure 27: Southface Institute Gravel Subbase

Figure 28: Southface Institute Parking Lot

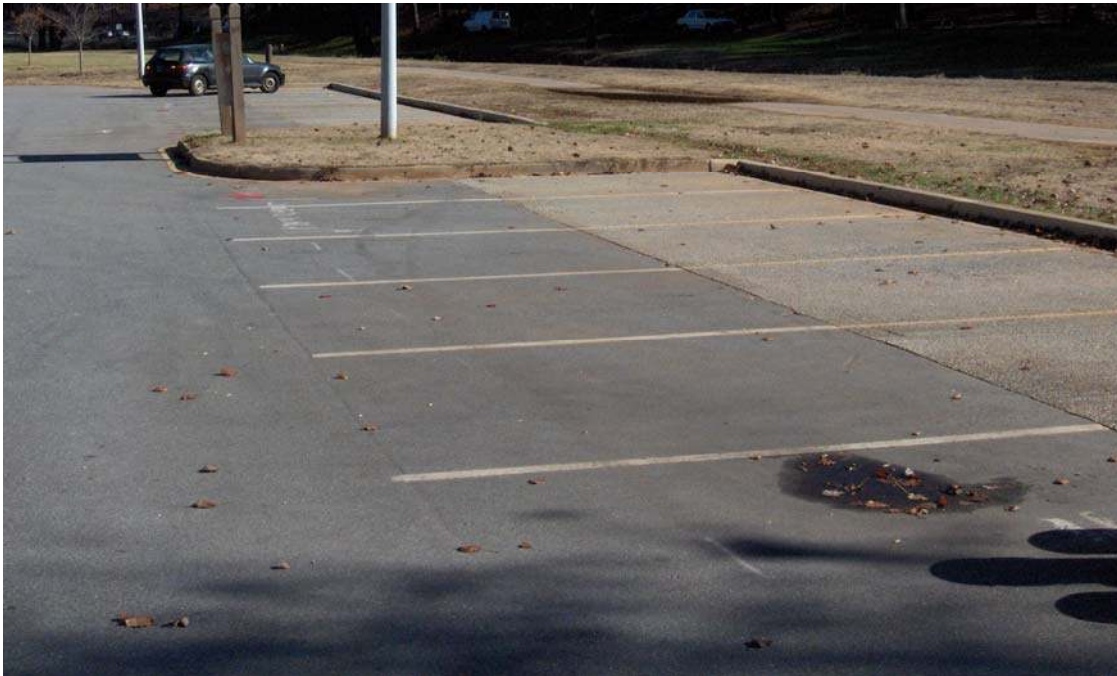
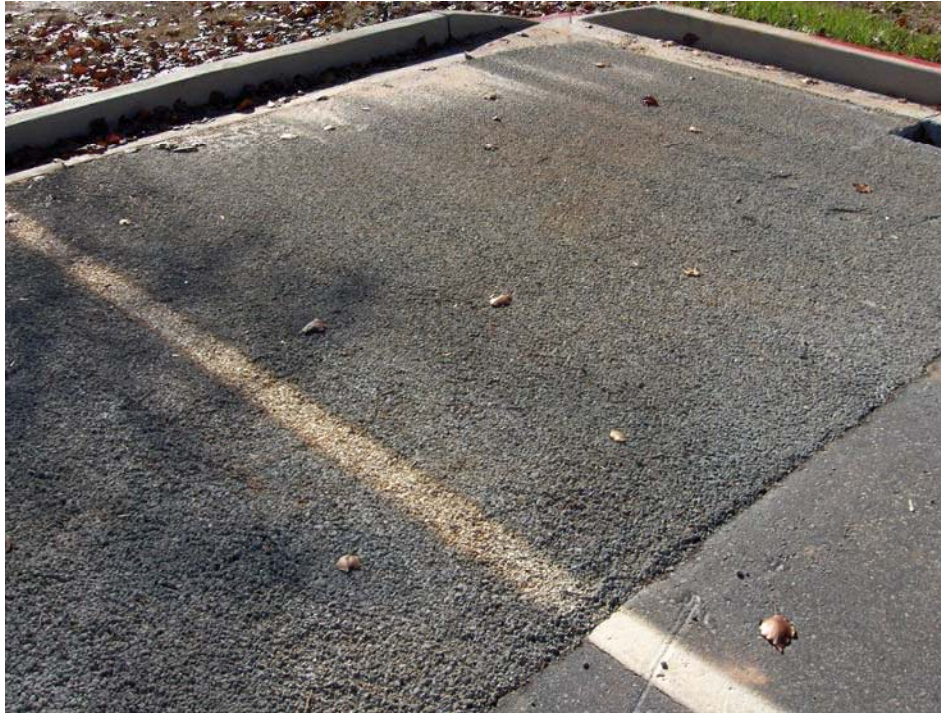
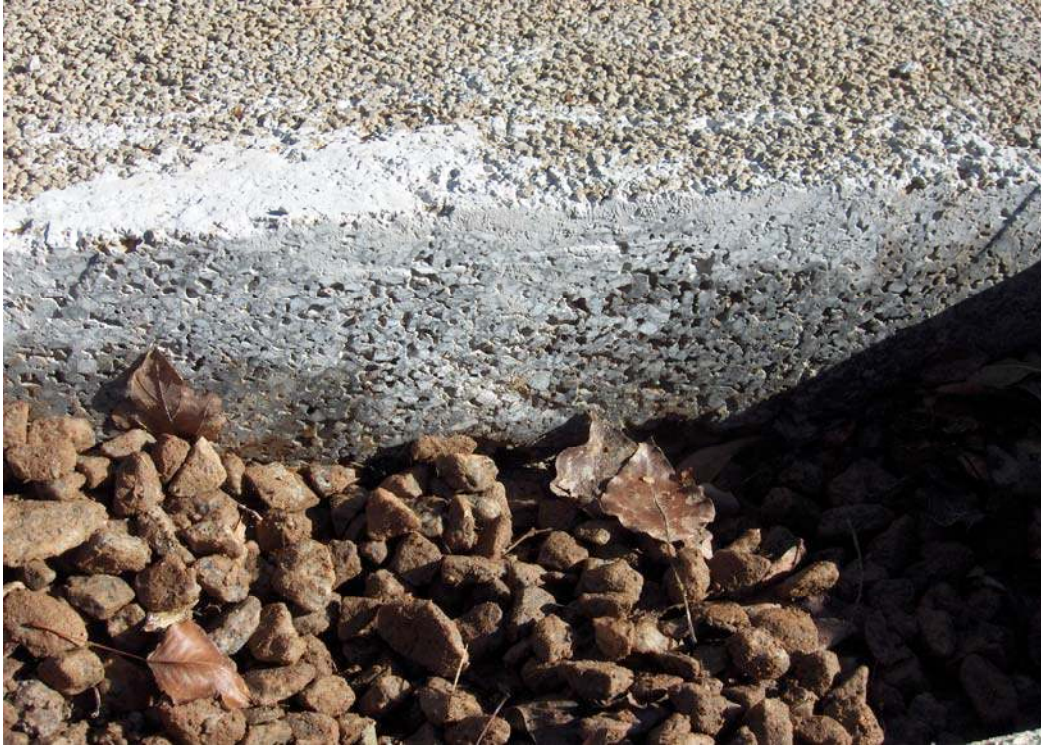
zero that was measured was due to a lack of voids present in the concrete due to poor construction techniques as verified by the comparatively high unit weight of the core. Field system infiltration rates were not measured due to the presence of a gravel reservoir, which the single-ring infiltrometer is unable to penetrate. These results indicate that the subsoil is acting as the limiting factor at this pervious concrete installation, however, a gravel reservoir has added storage to the site to allow a longer recharge time. Laboratory tests indicate the gravel reservoir has a porosity of approximately 0.32 or a storage capacity of approximately 2 inches of water. Photographs depicting the condition of the pervious concrete in this area are shown in Figures 30, 31 and 32.

Figure 30: Cleveland Park Parking Lot

Figure 31: Cleveland Park Parking Lot Pavement

Figure 32: Cleveland Park Parking Lot Reservoir

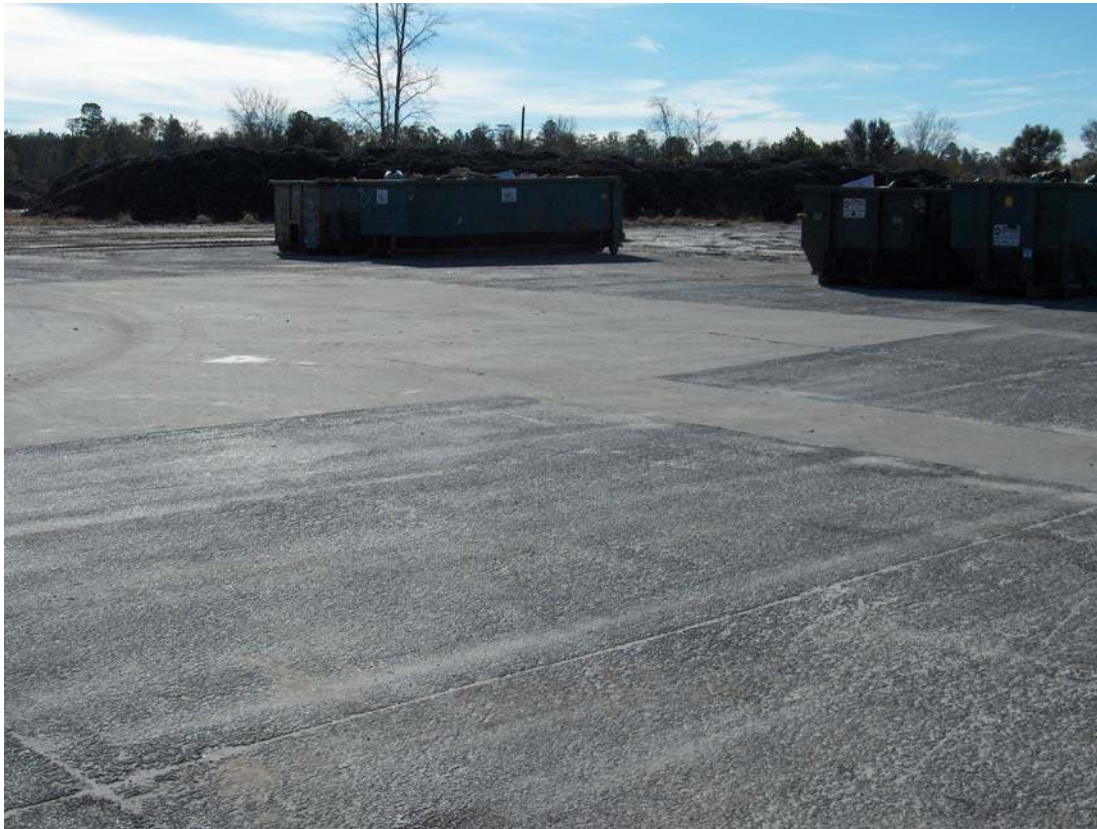
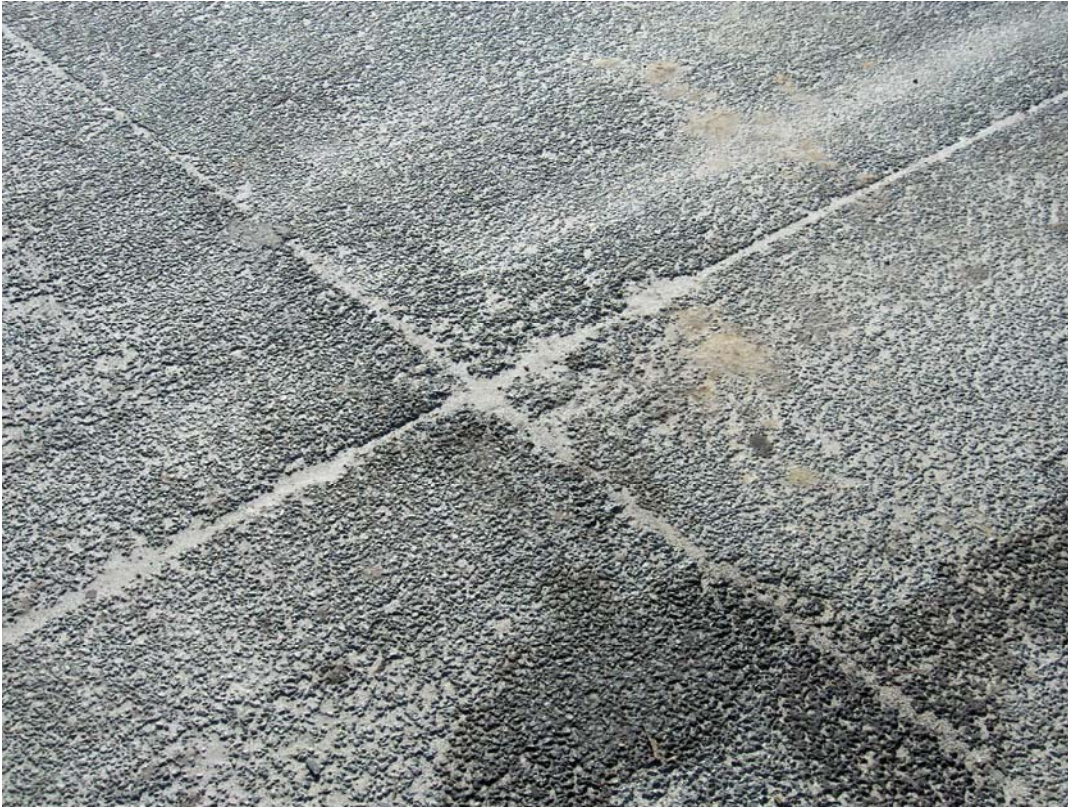
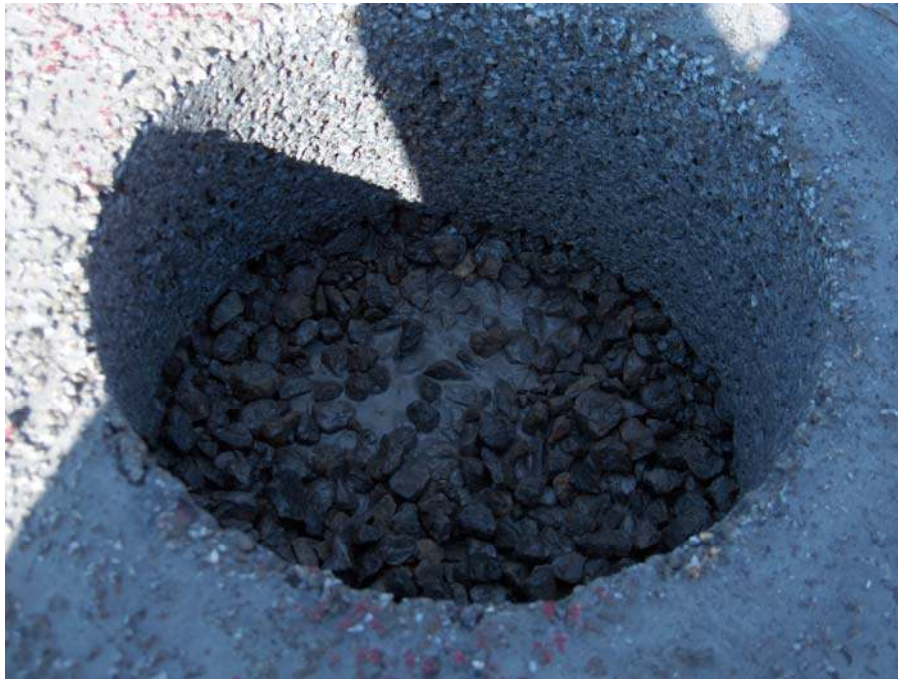
be attributed to varying surficial pore sizes in the pervious concrete due to poor construction techniques. Field system infiltration rates were not measured due to the presence of a gravel reservoir, which the single-ring infiltrometer is unable to penetrate. These results indicate that the subsoil is acting as the limiting factor at this pervious concrete installation, however, a gravel reservoir has added storage to the site to allow a longer recharge time. Laboratory tests indicate the gravel reservoir has a porosity of approximately 0.32 or a storage capacity of approximately 2 inches of water. Photographs depicting the condition of the pervious concrete in this area are shown in Figures 34, 35 and 36.

Figure 34: Effingham County Landfill

Figure 35: Effingham County Landfill Pervious Pavement

Figure 36: Effingham County Landfill Reservoir
