Final Report FDOT Project BD521-02

# Performance Assessment of Portland Cement Pervious Pavement

## Report 2 of 4: Construction and Maintenance Assessment of Pervious Concrete Pavements

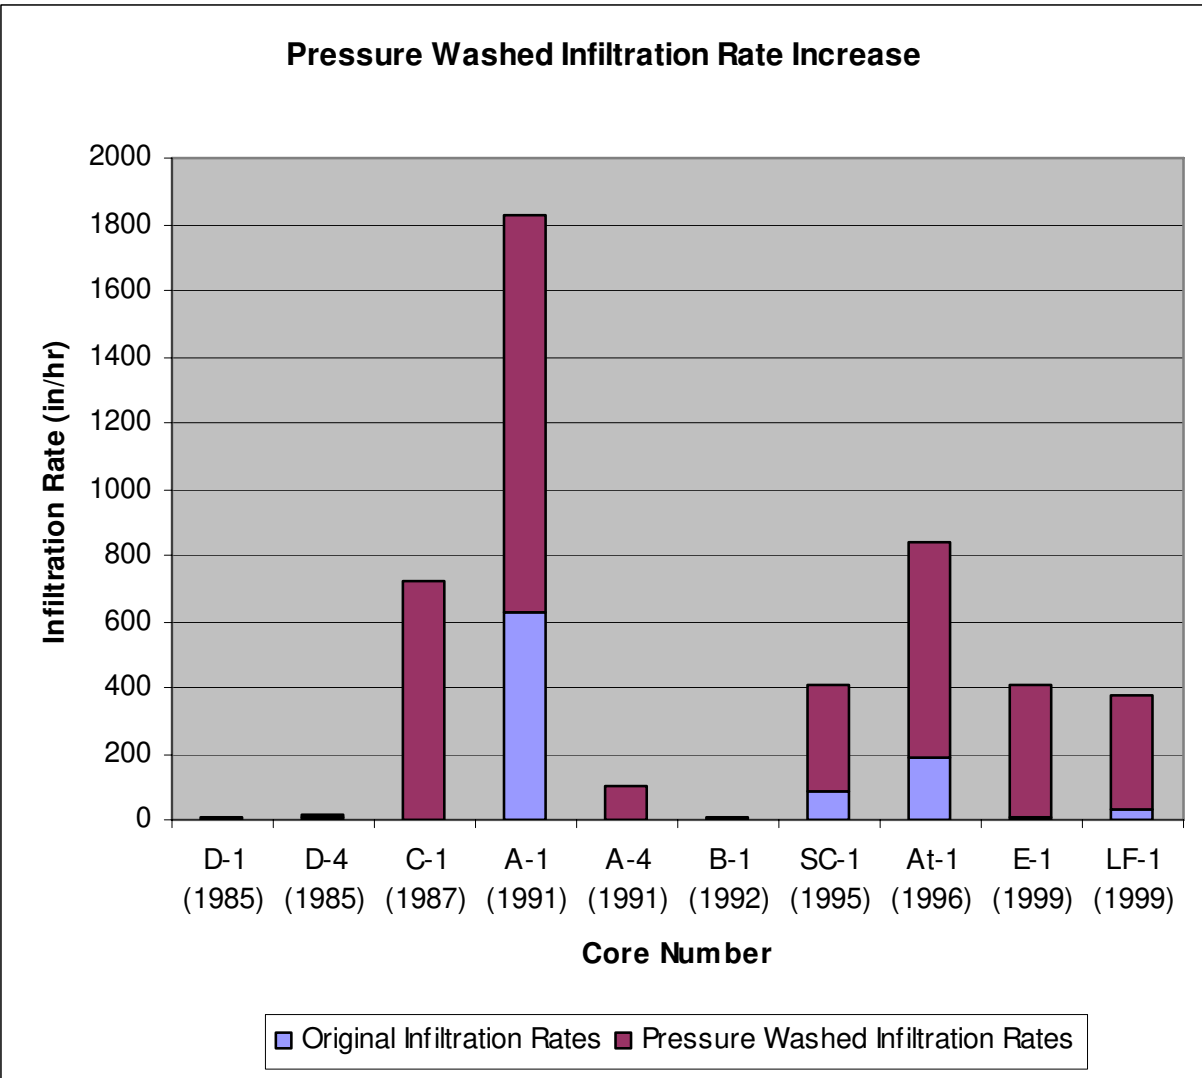
Figure 39: Comparison of Original and Pressure Washed Infiltration Rates

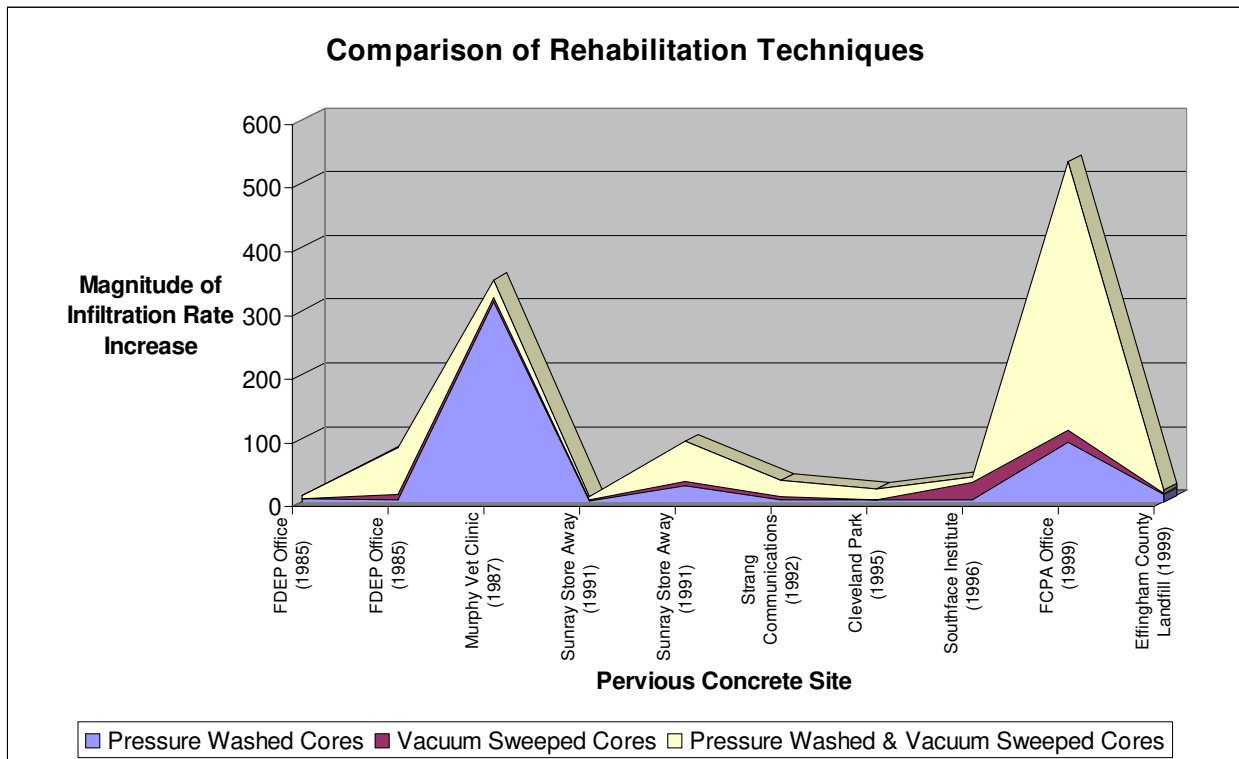
increase in infiltration rates. Pressure washing however did result in the release of sediment and in some cases the pervious aggregate. A site should be tested for release of particulates before pressure cleaning is done. The reason for the significant increase at the FPCA site could have been because the particles blocking the pores were released with added maintenance or the continued maintenance associated with both methods.

Figure 40: Comparison of Effectiveness of Rehabilitation Techniques

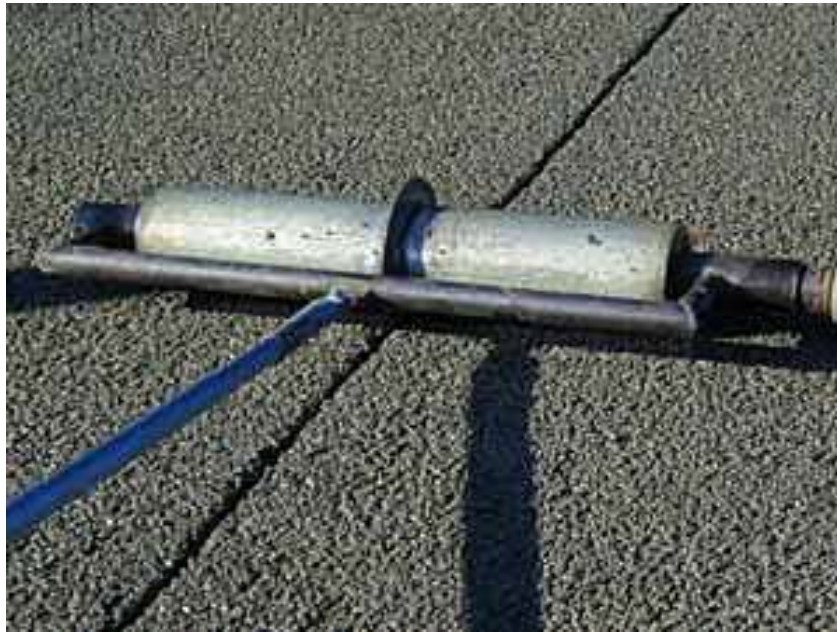
Figure 43: Roller Used to Create Joints in Pervious Concrete
