TITLE PERFORMANCE TESTS OF THE 600-kW, cw, 80-MHz, RADIO-FREQUENCY SYSTEMS FOR THE FMIT ACCELERATOR

SUBMITTED TO 1983 Particle Accelerator Conference  
March 21-23, 1983  
Santa Fe, New Mexico

PERFORMANCE TESTS OF THE 600-kw cw, 80-MHz, RADIO-FREQUENCY SYSTEMS FOR THE FMIT ACCELERATOR\*

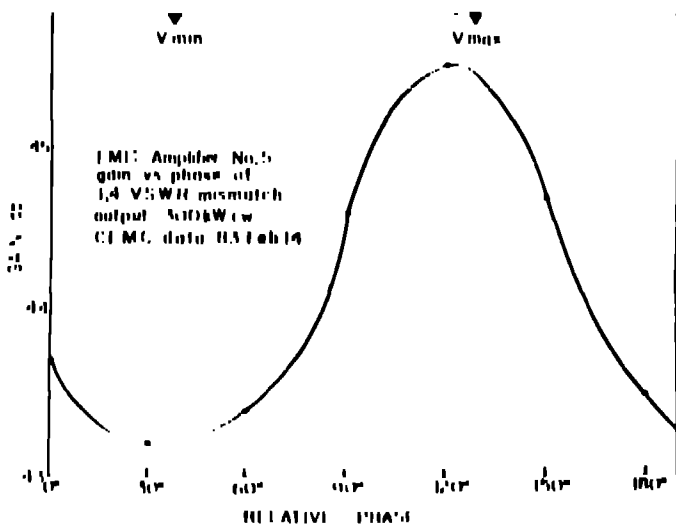
Fig. 2. Gain versus relative phase.

The amplifier gain was at least 40% (1.5 dB) greater than specified for all load conditions tested. Linearity was within the  $\pm 10\%$  limit from 30 to 90% of full-power output. There was an  $\approx 3$ -dB difference in gain between  $V_{MAX}$  and  $V_{MIN}$  on No. 5, although the variation with power level at fixed phase was about the same in all cases. The variation with phase is plotted for No. 5 at the 50% power level (Fig. 2). This variation is responsible for some of the difficulty in controlling amplitude and phase with a resonant load under transient conditions.
