## Preparation of atomically flat surfaces on silicon carbide using hydrogen etching

### Abstract

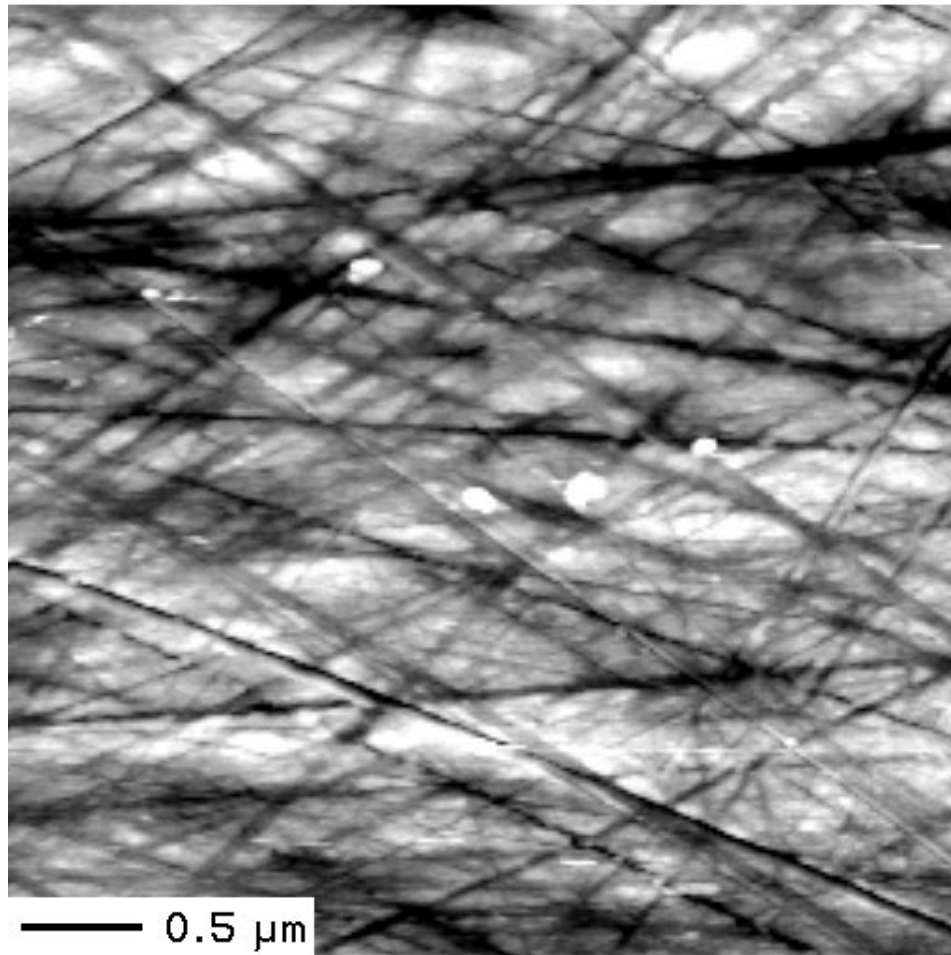
Figure 1 4 μm x 4 μm contact mode AFM image of an as-received 6H-SiC (0001) wafer. 4H-SiC surfaces look similar. Note the high density of scratches on the surface. The greyscale on this image corresponds to a height range of 75 Å.

The as-polished, solvent cleaned 4H- and 6H-SiC (0001) substrates studied by AFM show a large number of deep (about  $75 \text{ \AA}$ ), irregularly directed scratches all over the surface with breadth in the nanometer range, as seen in Fig. 1. Hydrogen etching at about  $1630^\circ \text{C}$  is seen to produce regular arrays of wide (few thousand angstroms) atomically flat terraces separated by steps of unit cell height as can be seen in Fig. [Ref: steps]. (One unit cell of 6-H SiC is  $15.12 \text{ \AA}$  high in the  $c$ -direction, i.e. perpendicular to the (0001) plane. A unit cell of 4H-SiC is  $10.08 \text{ \AA}$  [5]). The steps are found to lie along the  $\langle 1 \bar{1} 00 \rangle$  family of directions. The inset of Fig. 2 shows steps arranged around an etch pit or micropipe, to be discussed in more detail below. The substrates become more transparent with increased etching which we attribute to the diminished number of scratches causing a reduction in the amount of diffuse reflection of light.

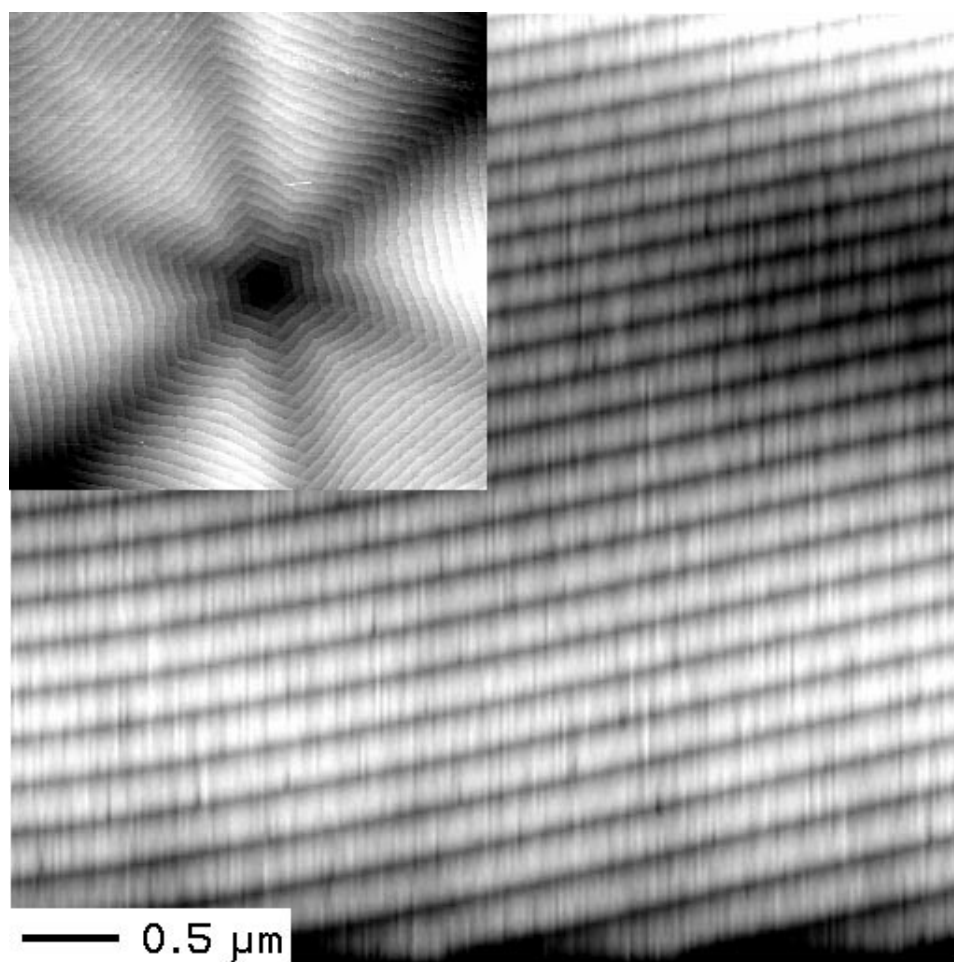
Figure 2 AFM image of a hydrogen etched 6H-SiC (0001) surface. The terraces are about 2500 Å wide and the steps are 15 Å high. The 20 μm x 20 μm inset shows the etched surface of a 4H-SiC wafer. Arrays of steps can be seen on this surface too. These arrays are arranged in a hexagonal pattern around a core that is associated with a 10 Å screw burgers vector. The greyscale ranges for this figure and inset are 5 and 9 Å respectively.

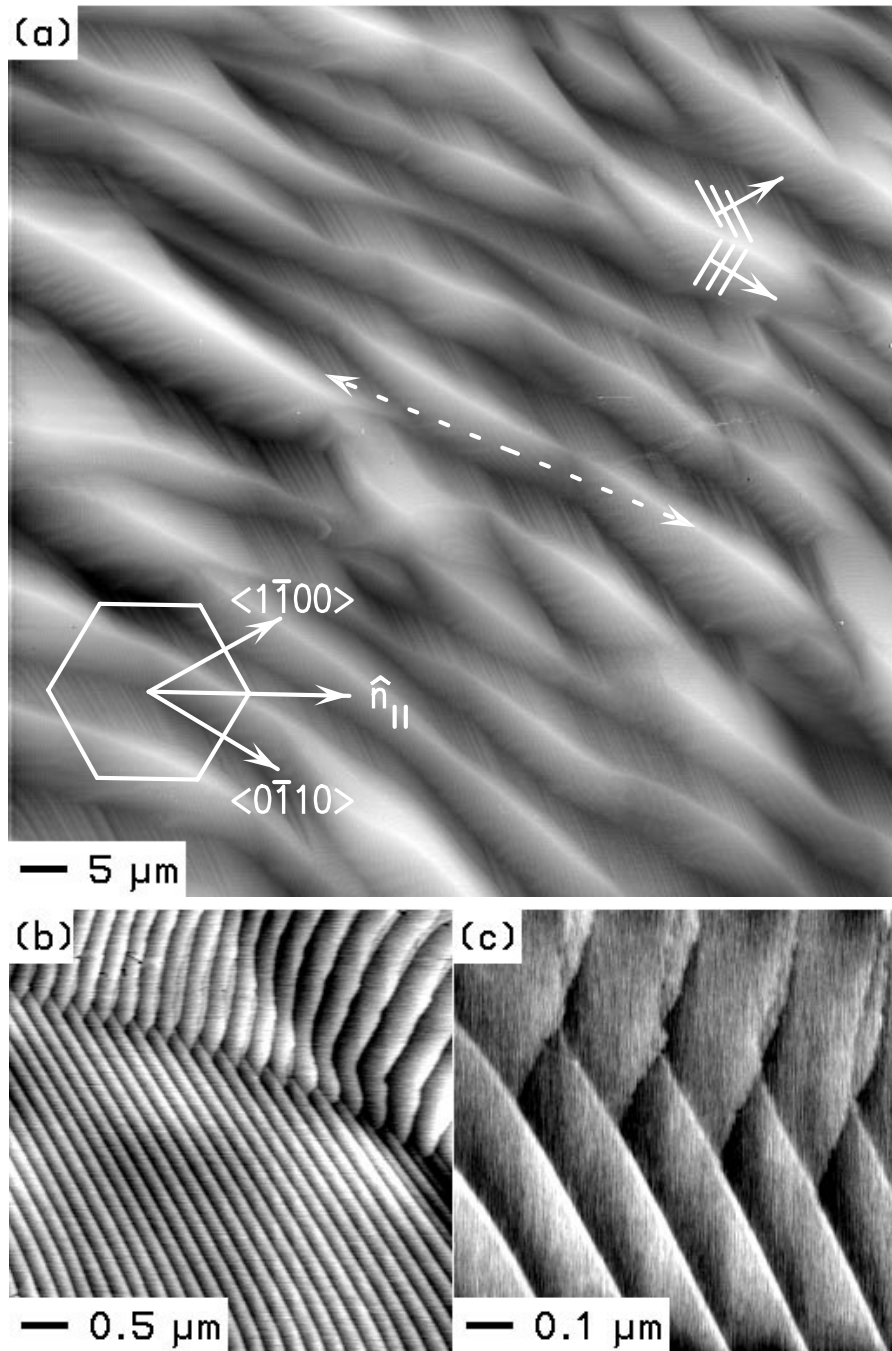
Figure 3 (a) AFM image of a hydrogen etched 6H-SiC (0001) surface showing facets leading to an undulating surface. The faceting arises from the miscut not being directed along a direction in which stable steps exist. Indicated on the image are various step directions on the surface and the (0001) in-plane component of the wafer miscut,  $\hat{n}_{||}$ . (b) Two arrays of steps intersecting at a facet boundary. (c) Close-up of the facet boundary showing the  $60^\circ$  relationship between steps on neighbouring facets. Greyscale ranges are 236, 15 and 14 Å for (a), (b) and (c).

The surface produced on 6H-SiC(0001) is faceted, and the facets form a shallow undulation (facet angle  $\sim 0.1^\circ$ ) on the surface as shown in the large-scale image of Fig. 3 (a). These shallow facets have been observed to exist on all the samples we have etched. Figures 3 (b) and (c) show the arrangement of steps at the intersection of two facets. Steps on neighboring facets are directed differently: the two sets of steps always have an angle of  $60^\circ$  between them, and they have an offset in height in the (0001) direction of  $7.5 \text{ \AA}$ . This height is half a unit cell of 6H-SiC and describes the plane in the unit cell where there is a change in the stacking sequence [5,6]. Hence, we conclude that the surfaces of the terraces on the two facets have different orientations. In general, facets with steps directed differently also have different terrace widths, implying that the angle made by these facets with the (0001) plane is different.

Analysis has been done on Fig. 3(a) producing a value of  $0.25^\circ$  for the miscut of the wafer which is well within the specifications of the supplier. The (0001) in-plane component of the miscut is shown as  $\hat{n}_{||}$  in the figure. For this sample, this vector is only  $2.23^\circ$  off from the  $[1 \bar{2} 10]$  direction.

The calculated direction of the hill-and-valley features is also shown on Fig. 3(a) as a dashed arrow, and is seen to be reasonably consistent with the data.

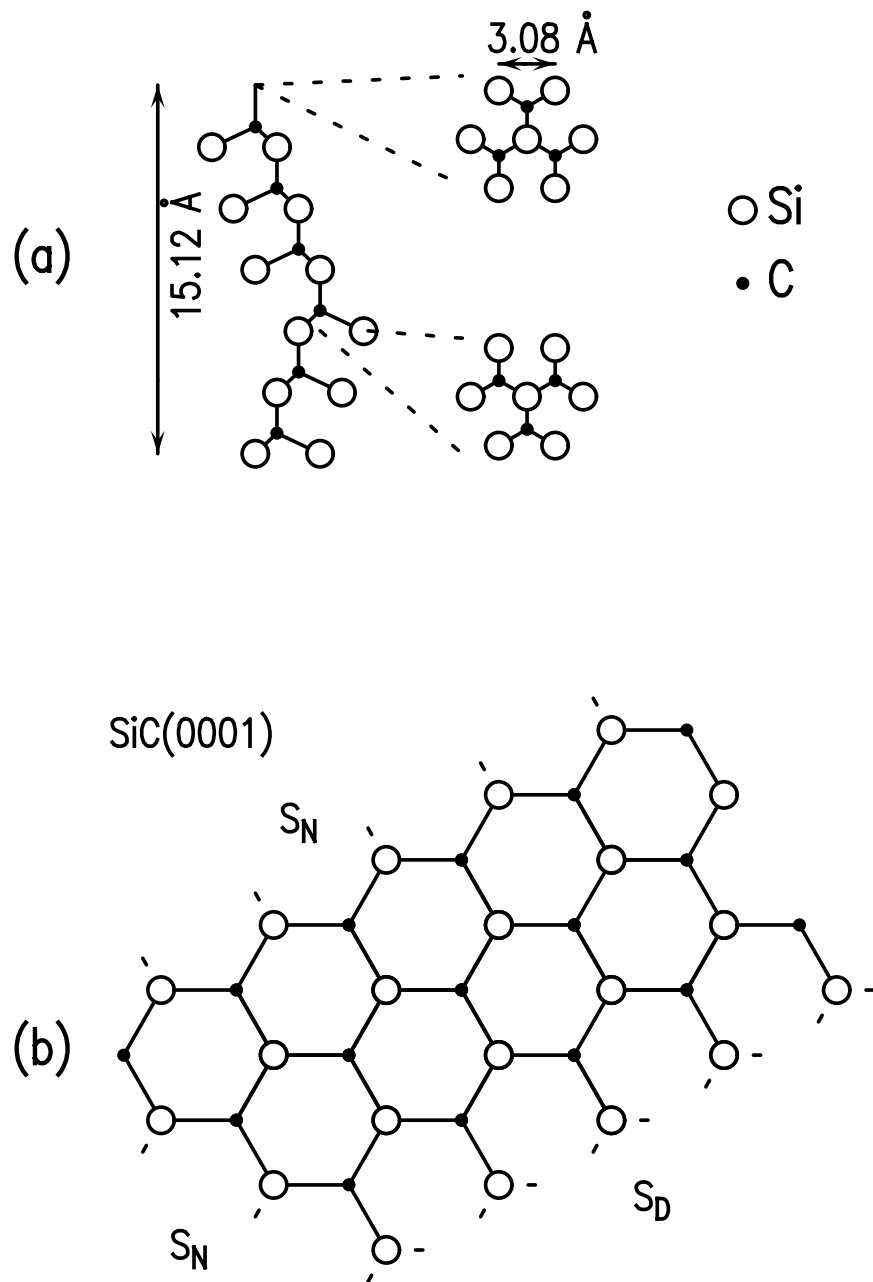
Based on these observations, we propose inverse step flow as a mechanism for the etching process. There are two kinds of steps that can form on the SiC(0001) surface (Fig. 4 (b)) in the  $\langle 1 \bar{1} 00 \rangle$  family of directions, one being of lower energy than the other. On Si(111), these are referred to as  $S_N$  and  $S_D$  steps by Pechman et al. [7]. The structure of the SiC(0001) surface is quite different, yet it is expected that the two kinds of steps will also have different energies thus implying different etch rates for them. These two kinds of steps have an angle of  $60^\circ$  between them.

Etching causes the disappearance of higher energy steps, and as etching proceeds, more material is taken off such steps, making the directions perpendicular to these step-edges the “fast-etch” directions. Across two facets, there is a displacement of half a unit cell in the c-direction between steps, indicative of an orientation rotation of  $60^\circ$  between terraces on the two facets (Fig. 4 (a)). This means that the “fast-etch” directions and the steps are rotated by  $60^\circ$ . As mentioned above, that is what we see in our AFM data across two facets.

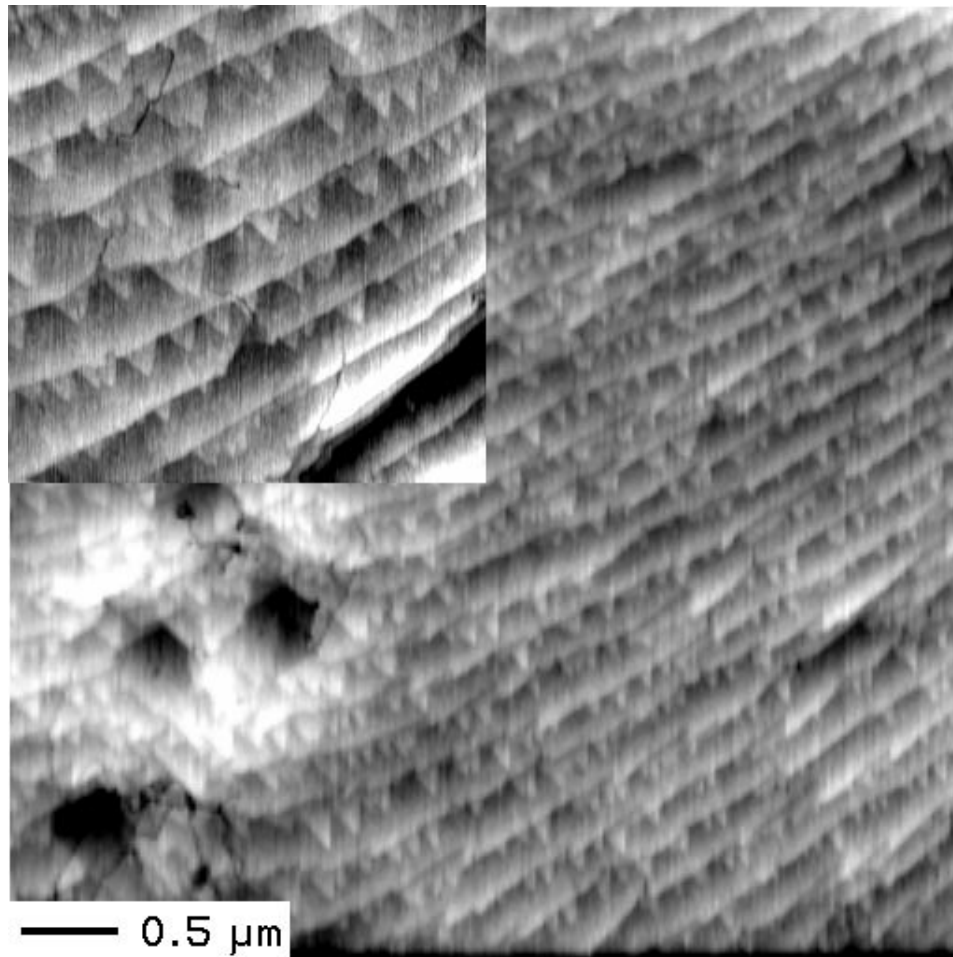
Figure 5 AFM image of an early stage of etching showing rough steps and triangular outgrowths from the steps onto terraces below. Some deep depressions can be seen towards the left which are presumably remnants of deep scratches. The inset is a  $2\ \mu\text{m} \times 2\ \mu\text{m}$  close up of a similar area showing the steps and peninsulas in greater detail. Greyscale corresponds to a height range of  $15.5\ \text{\AA}$  in the figure and  $18.2\ \text{\AA}$  in the inset.

In Fig. 5, we show an atomic force micrograph of a 6H-SiC sample that was hydrogen etched for 1 minute. This is a picture of an early stage of etching. The unit-cell-high steps are seen to be rough. Triangular peninsulas of height half a unit cell protrude from the steps onto the terraces below them. The triangles are observed to have  $60^\circ$  angles at their vertices. These peninsulas can also be understood in terms of “fast-etch” and “slow-etch” directions of the (0001) surface. The etching proceeds in the “fast-etch” direction of one set of bilayers allowing only the more stable steps to survive along one of the slow etch directions. But half a unit cell below (or above), because of the change in stacking, this slow-etch direction becomes a fast-etch direction. Steps in this direction vanish faster leaving behind steps at angles of  $60^\circ$  to it. This leads to the appearance of the triangles with included angles of  $60^\circ$ . The kink at the apex of such a triangle is another instability which leads to preferential etching of these triangles, eventually leaving an array of unit-cell-high steps. The deep depressions seen on this partially etched surface are probably remnants of surface damage that was previously on the surface. Such a surface may later develop into one similar to that in Fig. 6, (which is an area close to that where Fig. 5 was taken) where the depressions have grown smaller and the steps have become smoother. This is expected since if the scratches were made on the surface, they would be widest at the top and as etching proceeds further down, the width of damage should reduce. Eventually the remnants of surface damage vanish entirely leaving surfaces looking like Figs. 2 and 3.

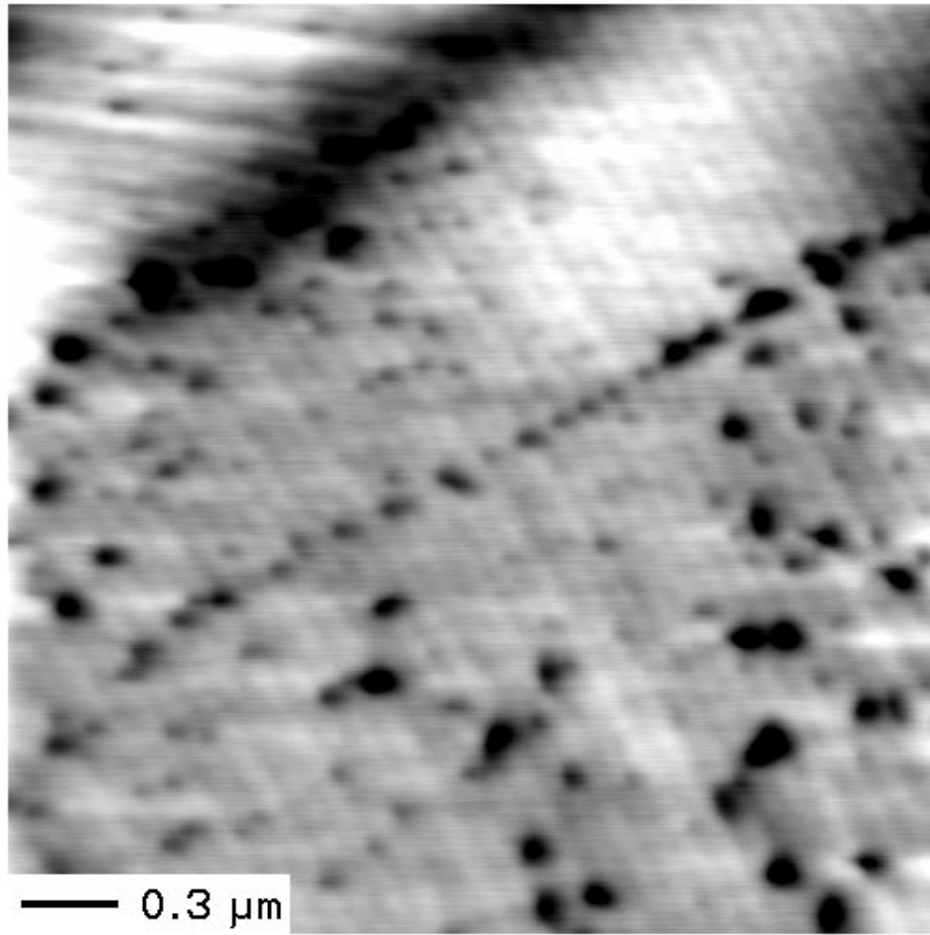
Figure 6 SiC (0001) surface showing incomplete etching. An array of straight, parallel steps is clearly visible. Remnants of scratch marks can be seen as sets of pits arranged in lines cutting across the steps. The greyscale range is 21.2 Å.
