Propulsion Health Monitoring of a Turbine Engine Disk Using Spin Test Data

Prepared for the
Smart Structures and Materials and Nondestructive Evaluation and Health Monitoring 2010
sponsored by the International Society for Optical Engineering (SPIE)
San Diego, California, March 7–11, 2010

This report contains preliminary findings,
subject to revision as analysis proceeds.

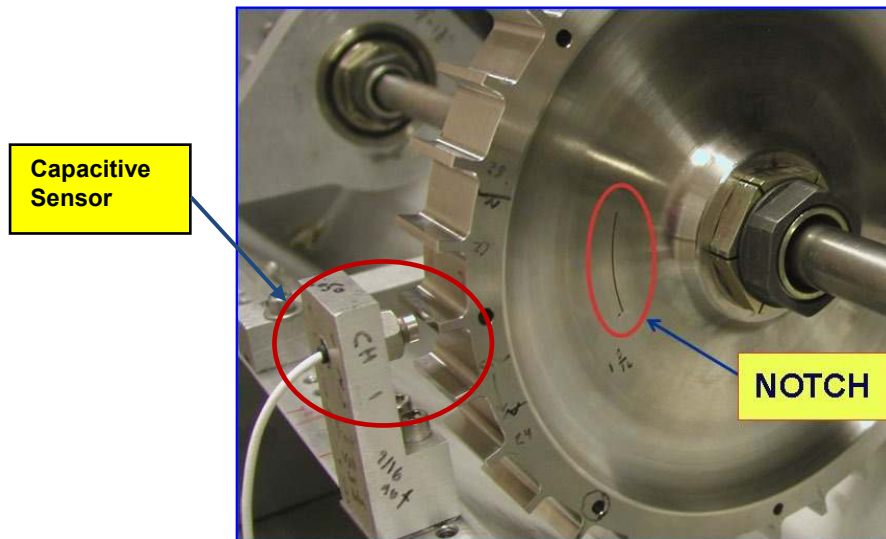
Figure 1 shows the disk specimen and the induced crack-notch along with the tip clearance probes. The test specimen disk has an outside diameter of 23.495 cm (9.25 in.) respectively; a bore and an outside rim thickness of 2.54 cm (1 in.) and 3.175 cm (1.25 in.); the thickness of the web is 0.254 cm (0.10 in.), and the cross section and height of the blades are 3.175- by 0.330-cm (1.25- by 0.13 in.) and 0.838 cm (0.33 in.), respectively. It has rotor like blades, total of 32, evenly spaced around the circumference. Eight holes, 0.508 cm (0.20 in.) diameter each, were drilled through the disk half-way in the rim. The holes were spaced every 45° and they were designed for future studies as possible mass add-on points or notch initiation sites.

Figure 1.—Test disk with a notch.

The notch had a width of 0.381 mm (0.015 in.) as per wire thickness and burn area of the electric discharge machining (EDM) process. The notch region was intentionally selected to be in the rim area due to the fact that the finite element results revealed that this section encounters the highest stress level in the disk during the spin operation (Refs. 1 and 2). Systemic considerations were emphasized to preserve consistency of the operating parameters and other experimental conditions during the removal-reinstallation process of the disk specimen in both situations, baseline no-notch and notch state.

The controlled speed applied during the current testing ranged from a minimum of 1,000 up to a maximum of 10,000 rpm with acceleration-deceleration rates of 60 rpm/second. This insured surpassing the critical speed of 2,610 rpm and leading to post critical state. Experiments covered base line runs with undamaged disk and with damaged disk via artificially induced notch, shown in Figure 1.

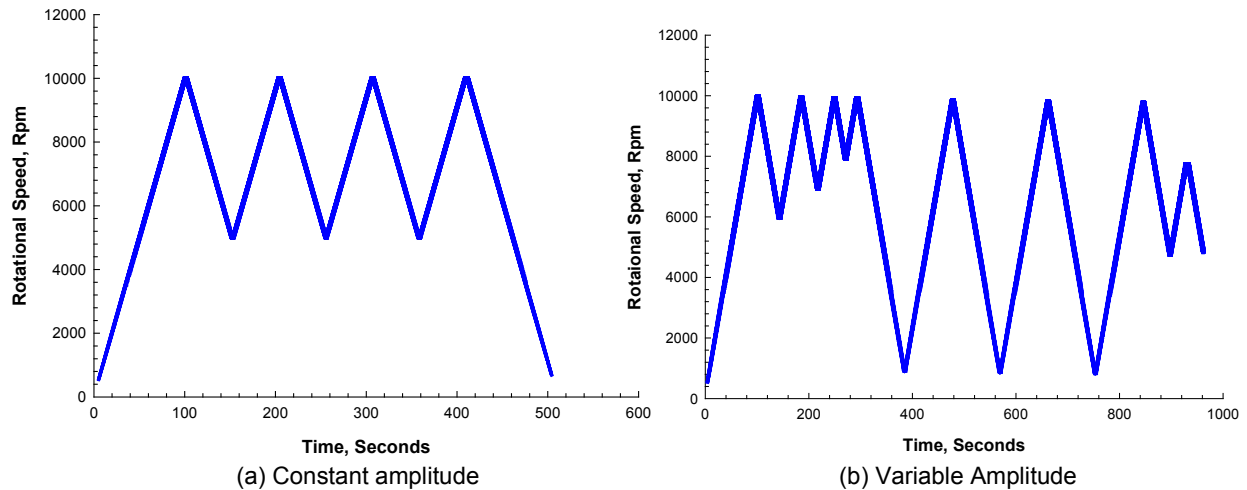
Figure 2.—Simulated engine mission history profiles.

Figure 2 shows the mission history profiles applied in this experimental work for the disks, the baseline unnotched and the notched disk. These profiles were derived on the basis of revolutions per minute data obtained on different flights comprising different flight maneuvers (Ref. 15). Figure 2(a) shows the constant amplitude portion which is one of the test mission profiles applied in the experiment. It clearly demonstrated less aggressive and smoother profile compared to the variable amplitude profile shown in Figure 2 (b), starting with a minimum of 200 rpm up to a maximum of 10,000 and a shutdown to 0 rpm. Meanwhile, Figure 2(b) represents the variable amplitude engine history which reflects steep and sharp changes in the rotational speed across the entire cycle, subjecting the disk to high and complex loading conditions in an attempt to fatigue the disk with the expectation that all existing anomalies would appear in the test data. The speed was varied sharply from a minimum of 200 rpm up to 10,000 rpm at various intervals. Testing the rotor under these conditions provided a good simulation to collect data under various loading conditions which the disk may experience during nontypical operating environment. Furthermore, these experiments supplied valuable assessments for both, the crack detection scheme and the structural durability of the disk materials.

For the constant amplitude cycle (Fig. 2(a)) data analysis, the data was recorded in two sets: “normal” and “notched”. The rotational speed for the disk continuously varied from 5,000 to 10,000 rpm for both normal and notched runs. In this analysis, only the 32 gap measurements were considered. Orca, Inductive Monitoring System (IMS) and One-Class Support Vector Machines (OCSVM) were chosen to evaluate this data. The normal run’s data was randomly divided in half. One half was used for training and the remainder half was used for validation. The means and standard deviations for all 32 channels are calculated for the training data and used to z-score normalize (normalize each channel to have zero mean and unit standard deviation) both the training and testing data sets. The plots, Figures 5 to 8, are the global anomaly scores for each of the algorithms on both the validation normal and the notched runs over time.

An additional data set had rotational speed varying from 1,000 to 10,000 rpm; Figure 2(b) was evaluated using all three algorithms. For the analysis of 1,000 to 10,000 rpm data, the algorithms performed comparably to the 5,000 to 10,000 rpm analysis. However, in the category of false alarm rates when fixing the correct detection at 90 percent IMS appears to have trouble, with a false alarm rate of 100 percent. It also appears that Orca has an edge in this category with a false alarm rate of 1.99 percent where OCSVM is slightly higher at 4.57 percent.

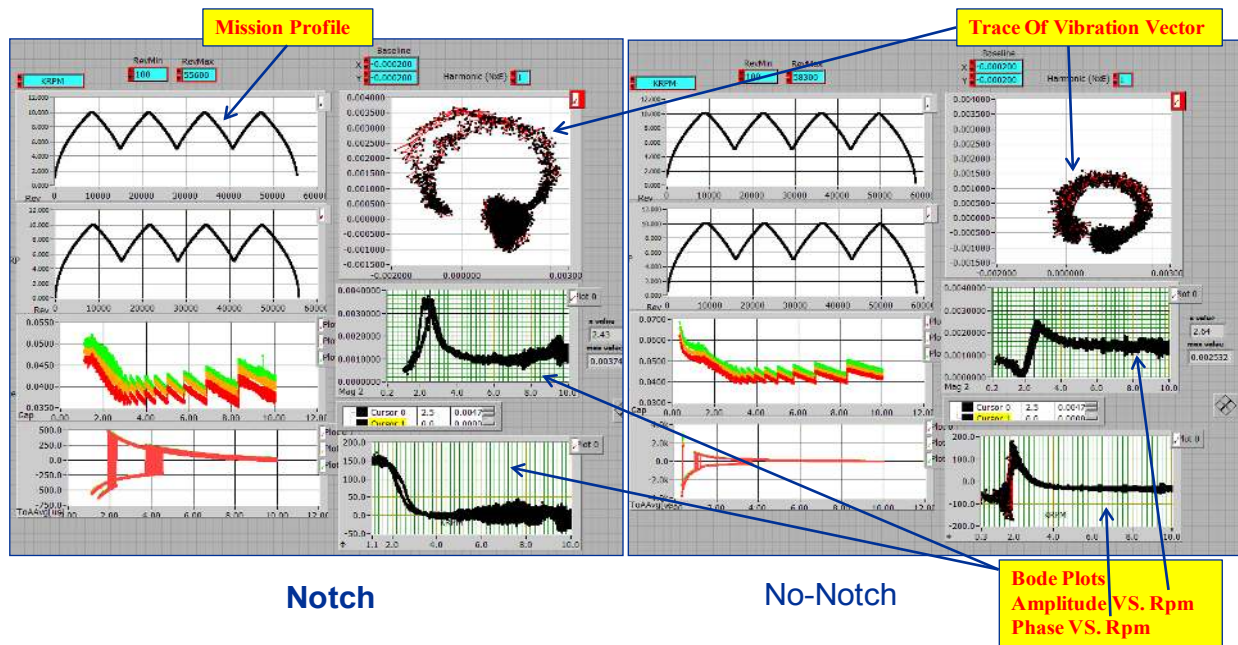
Experimental data under both applied mission profiles are represented in Figures 3 and 4. The data in Figure 3 are produced under the constant amplitude mission for both the baseline no-notch and the notched disks. The mission history is shown along with the trace vibration vector and bode plots for the phase and amplitude response. A clear observation is noted for both, the baseline and the notched disk; a closed loop representation for the trace of vibration vector is seen for the baseline disk while a gap in the loop is present for the notched disk. This behavior offers the first hint that we have a difference in the vibration response for the two structures indicating the presence of some type of anomaly. Such observation has been reported in Reference 7, where a crack in the rotor disk is documented via the presence of distorted trace of the vibration vector distribution and a rise in the phase and amplitude response upon surpassing the critical speed stage.

Figure 3.—Bode Plots—9 minutes comparison test for the disk with and without notch, constant amplitude mission profile.

This conduct is obvious in Figure 3 for the notched disk. A rise in the phase and amplitude response is clearly noted. While a flat and steady decrease in these parameters is shown for the baseline rotor which implies that it is a healthy rotor. Again, similar remarks for the variable amplitude mission history profile are seen in Figure 4. A rise is reported in the phase and amplitude response as soon as the disk crosses the 5,000 rpm level up to the 9,000 rpm where a notable no changes response is apparent. The difference between the data reported for the variable and the constant amplitude profile is confined to a higher blade tip clearance for the variable amplitude (nearly about 22 percent higher). Therefore, examination of the above data verified that the detection scheme applied in the experiment seemed to deliver a reasonable set of results indicating the presence of a defect in the rotor disk. However, this confirmation has to be further documented by conducting more tests for different rotors under similar operating conditions to authenticate that this behavior in the data is strictly due to existing structural defects in the rotor and not due to a system related unbalance.

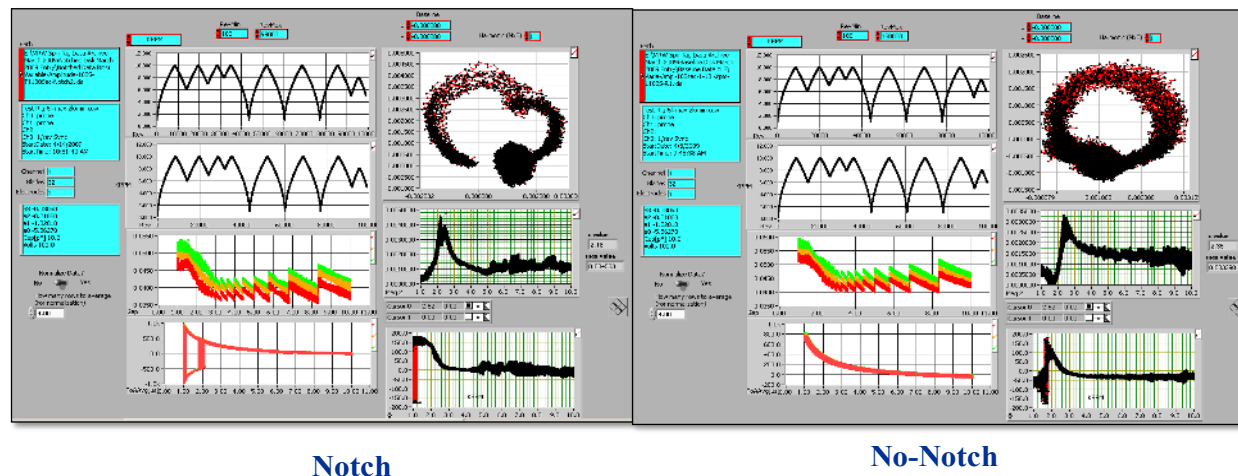
Figure 4.—Bode Plots—9 minutes comparison test for the disk with and without notch, variable amplitude mission profile.

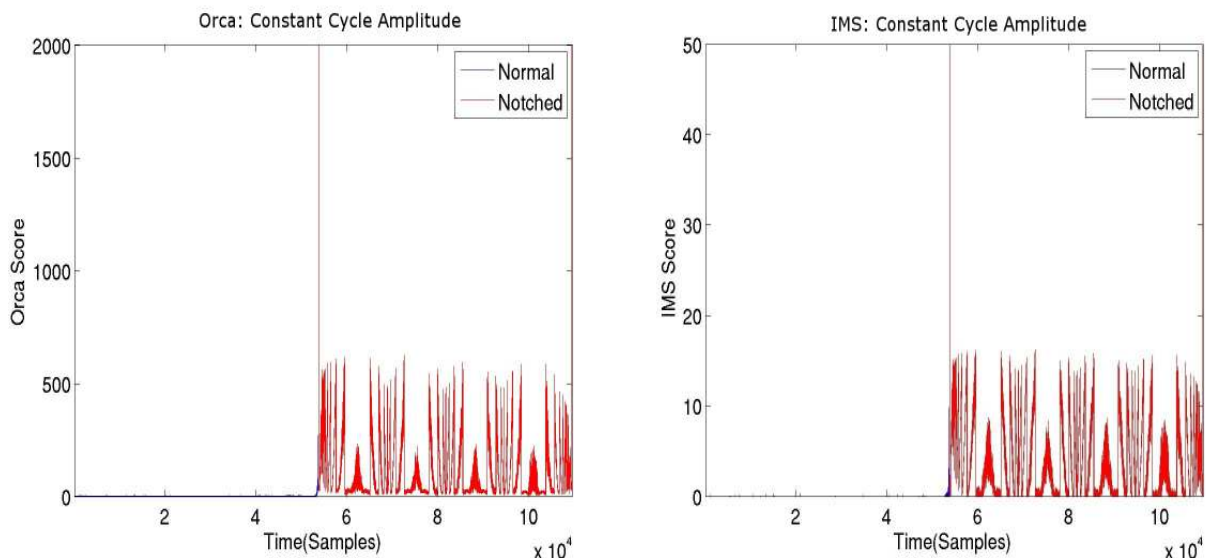
Figure 5 through 8 provides the scores for the three different techniques. In Figures 6 and 8 the anomaly scores are portrayed as positive values and any nominal points are represented as zero. This was done to allow for similar comparison across the algorithms. It is important to note that OCSVM allows some nominal sample points in the training set to be classified as anomalous. This percentage is governed by the Nu parameter, which is set by the user, but for which we set currently at the default value of 10 percent. Due to this characteristic of the algorithm, 10 percent of all nominal data tested may result in anomalous classification. In Tables 1 and 2 the choice for fixing correct classification to 90 percent was to make the comparisons fair between all three algorithms, since OCSVM, in this case, was optimized for a correct classification of 90 percent.

Figure 5.—Results of Data Driven Anomaly Detection Technique; ORCA and Inductive monitoring system (IMS).

Therefore, based on the information reported in Figures 5 to 8, it can be concluded that the detection techniques performed as expected and indications of malfunctions are seen in the scored representations of highly spiked distributions for the notched disk, while no spikes are noted for the baseline no notch disk. This applies to the data reported in Figures 5 to 8. The evaluation of the data reported from these techniques is also tied to the scores produced as a result of the simulation. For instance, the higher the score, the more anomalous is the structure.

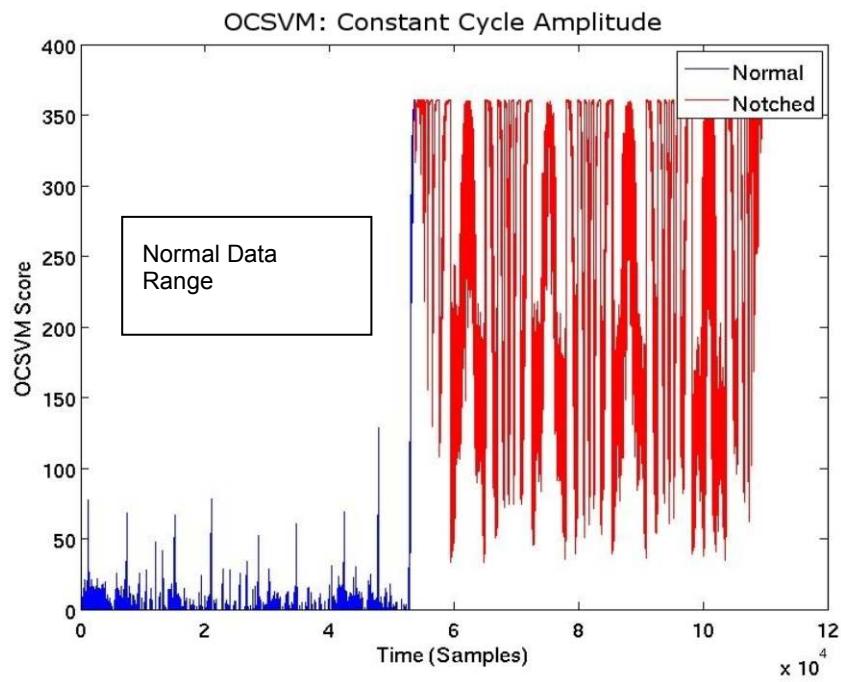
Figure 6.—Results of Data Driven Anomaly Detection Technique; OCSVM Algorithm.

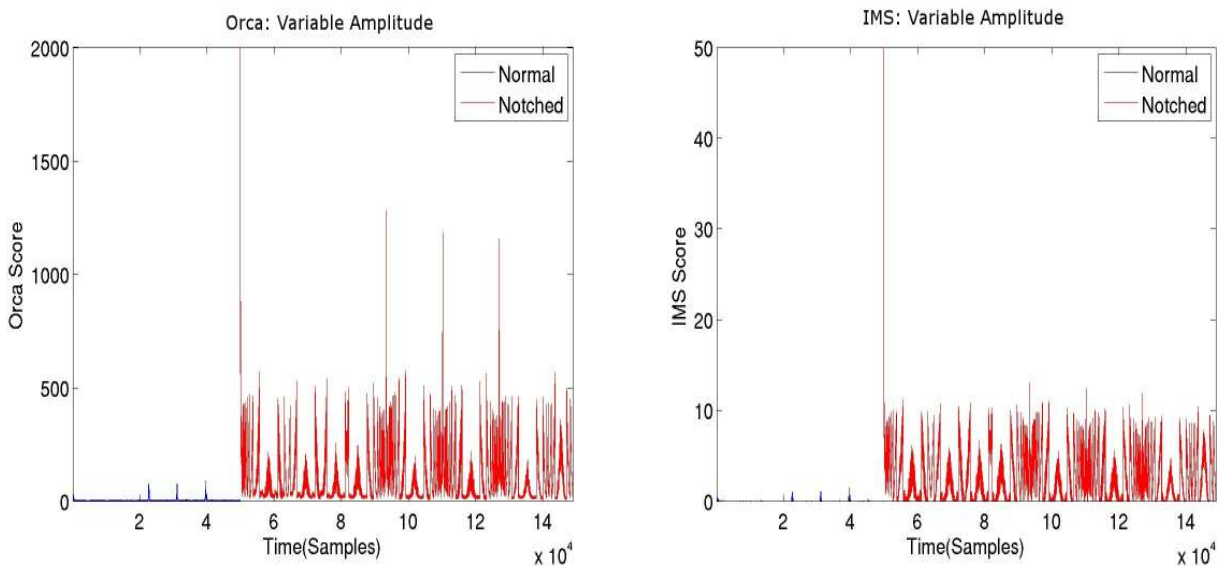
Figure 7.—Results of Data Driven Anomaly Detection Technique; ORCA and Inductive monitoring system (IMS).

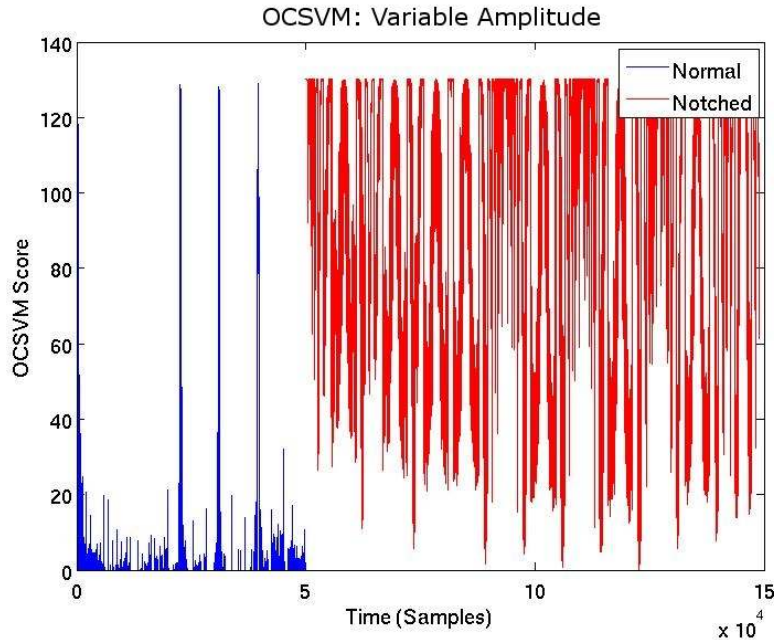
Figure 8.—Results of Data Driven Anomaly Detection Technique; One-Class Support Vector Machines (OCSVM).
