**RAINFALL-INDUCED LANDSLIDES IN HULU KELANG AREA,
MALAYSIA**

**A project report submitted in partial fulfilment of the
requirements for the award of the degree of
Bachelor (Hons.) of Civil Engineering**

**Faculty of Engineering and Science
Universiti Tunku Abdul Rahman**

April 2012

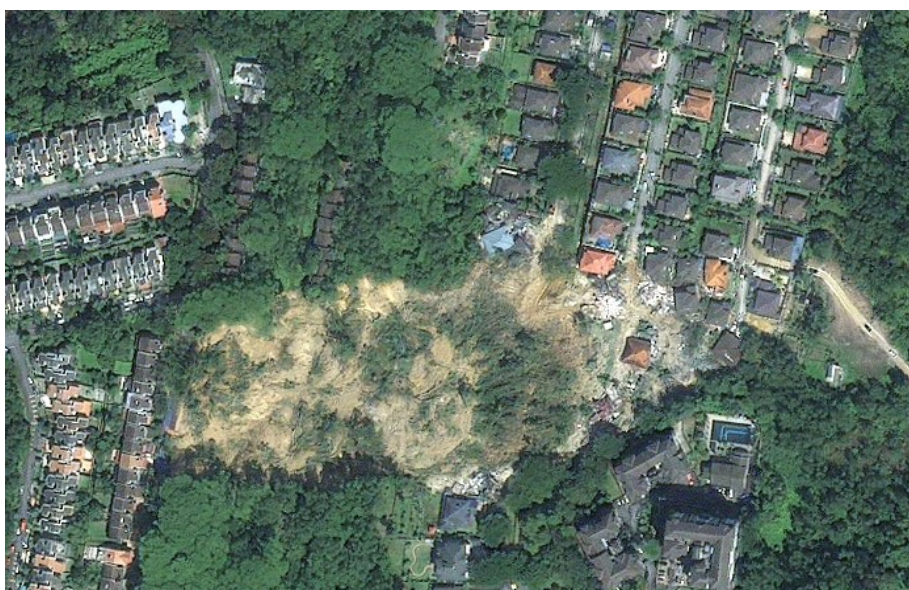
Numerical simulation was carried out on a selected case study to provide an insight into the mechanism of rainfall-induced landslide in this area. The selected case study was known as Bukit Antarabangsa 2008 landslide, which was regarded as one of the largest in Hulu Kelang area over the past decade. The landslide struck at about 3.30 a.m. on 6th December 2008, when residents were mostly fast asleep. Figure 4.15 shows the aerial view of the endangered area of the landslide. The landslide had translated a total soil volume of about 101,500 m³ generating a maximum run out distance of approximately 210 m (Low et al., 2012). Fourteen bungalow houses located at the toe of the slope were destroyed resulting in five fatalities and another fourteen injured.

Figure 4.15: Aerial View of the Bukit Antarabangsa Landslide on 6 December 2008
