River Flood Plains: Some Observations On Their Formation

GEOLOGICAL SURVEY PROFESSIONAL PAPER 282-C

By M. GORDON WOLMAN *and* LUNA B. LEOPOLD

PHYSIOGRAPHIC AND HYDRAULIC STUDIES OF RIVERS

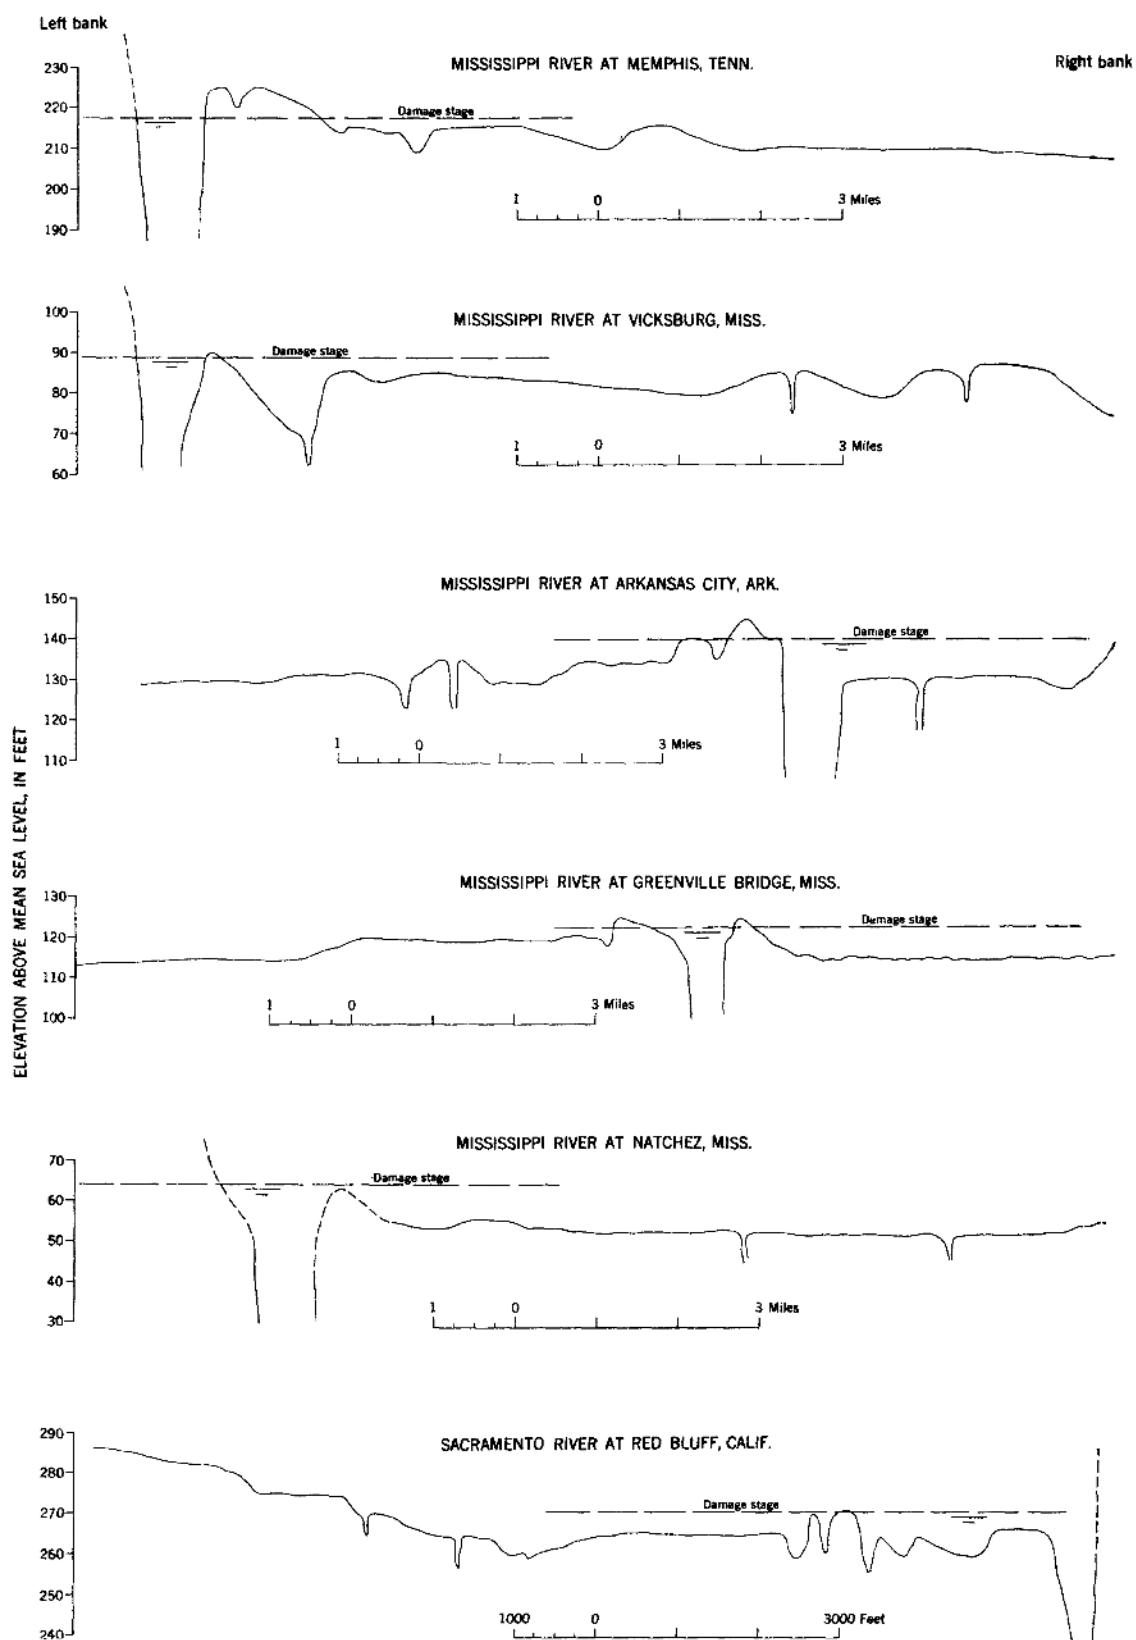
FIGURE 58.—Relation of flood-damage stage to elevation of flood plain at several river cross sections.

In order to establish the relation between the elevation of the flood-damage stage and the mean elevation of the flood plain, an effort has been made to compare the two at a number of cross sections for which data are available. These stations are listed in table 3. The flood-damage stage was obtained from records of the Corps of Engineers (1952) on the Mississippi River and of the Weather Bureau (1941). The mean height of the flood plain at each cross section was determined from profiles drawn from topographic maps having 5-foot contour intervals. Several of these cross sections are shown in figure 58.

The profiles of the Mississippi at Greenville Bridge, Natchez, and at Arkansas City in figure 58, clearly show a difference in elevation between the defined "flood stage" and the mean height of the flood plain. As can be seen on the cross sections, the difference appears to be due to the presence of natural levees adjacent to the river bank which raise the stage at which damage begins. The differences between the two stages are given in table 3. In some cases the damage stage may be equal to or below the elevation of the mean flood plain. In general, however, the damage stage is considerably above the level of the natural flood plain.

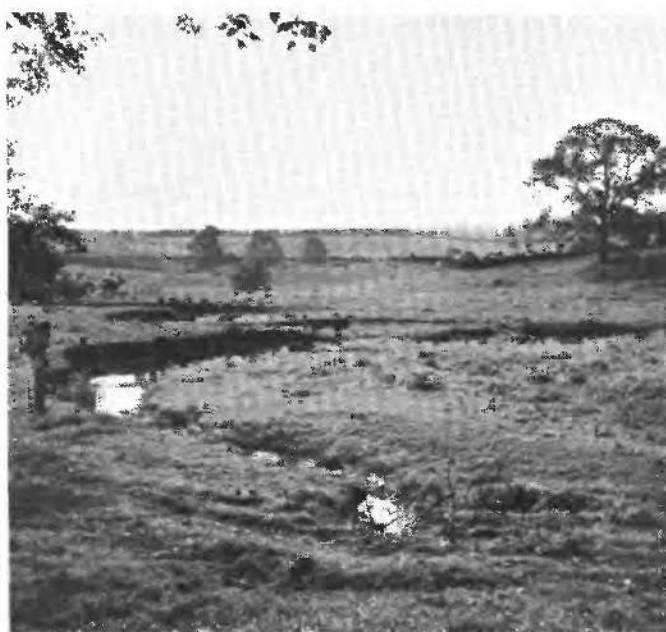
View downstream across the flood plain of Watts Branch near Rockville, Md. Point bar to the right of the channel in middle distance is shown in figure 59.

Figure 59 is a detailed map and plate 1 a photograph of a point bar on a meander of Watts Branch near Rockville, Md. At this point the stream drains about 4 square miles and its flood plain is about 270 feet wide. This flood plain is typical of many rivers in the eastern United States and illustrates the type of deposition and stratigraphy commonly found in this area.

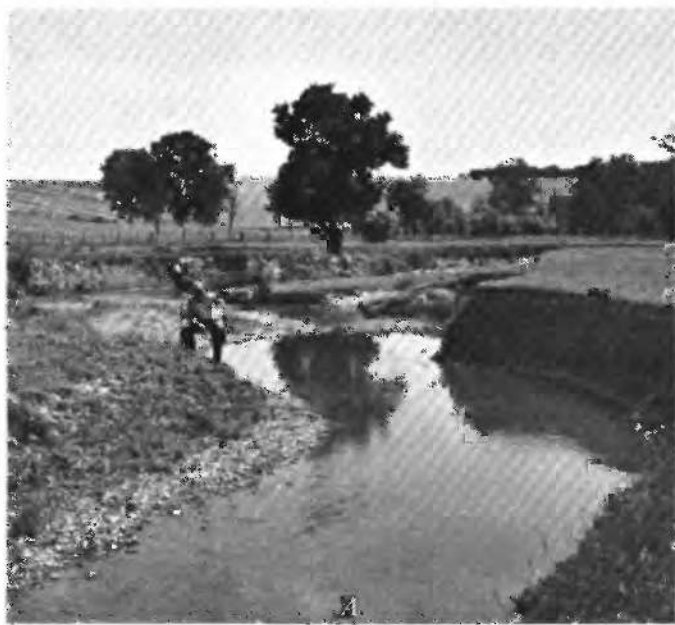
A, Point bar deposits and flood-plain surface adjacent to channel of Seneca Creek near Pratherstown, Md. The surfaces of point bars occur at various elevations up to the general level of the flood-plain surface.

At Watts Branch stations p, m, and n, on the larger of the two point bars in figure 60, are at an elevation very close to that of the flood-plain surface. Plate 2A is a reach of Seneca Creek near Pratherstown, Md., where different point bars composed of a wide variety of material are found to have surface elevations ranging successively from several feet below the flood-plain surface to the height of the surface itself.

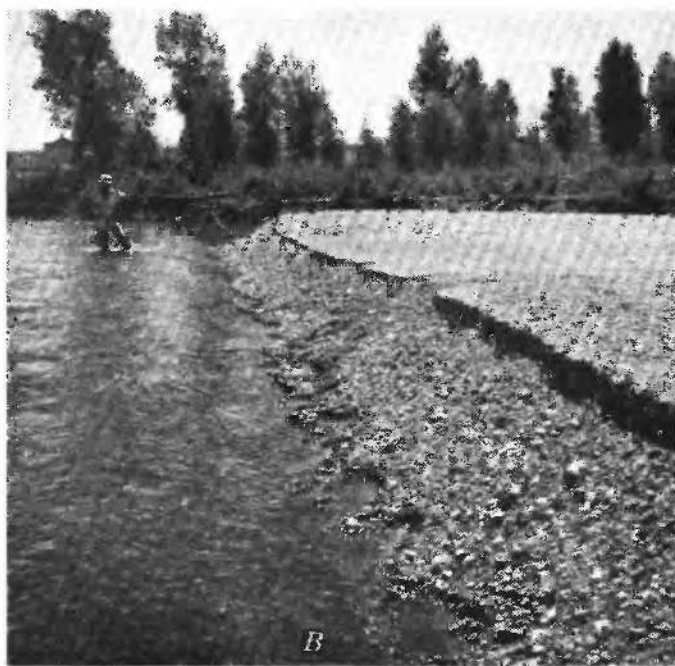
B, Flat-topped gravel bar in the New Fork River, 3 miles below Pinedale, Wyo. This bar occupies a position near the center of the channel of a braided river and emerges as an island at low flow. Bar surface is at same elevation as wooded flood plain seen in background.

Plate 2B shows a gravel bar deposited in the New Fork River near Pinedale, Wyo. This exceedingly flat-topped bar has a composition identical to that found in the flood plain which borders the stream in this reach. Furthermore, its surface is at the same level as the adjacent flood plain. Laboratory observations (Leopold and Wolman, 1957) suggest that such a bar develops by deposition within the channel, often as a linear deposit roughly along the center-line of the channel. As the upper surface of the submerged bar builds up near the water surface, the flat top is developed as a result of planation by currents and eddies when the depth of flow over the bar becomes relatively small. This same accordance of level and similarity of composition of bar and flood plain are also found on the Popo Agie River near Hudson, Wyo. The flood plains of these streams appear to be composed of coalescent bars each deposited originally within the stream channel. Overflow across these coalescent bars tends to leave a veneer of fine material on the gravel surface. This veneer, however, makes up a very small part of the total flood plain. In our study of point bars on Little Pipe Creek near Avondale, Md., the intimate relation between what is clearly a point bar and the level flood-plain surface was shown by a gravel lens that was continuous from the point bar into the adjacent flood plain.

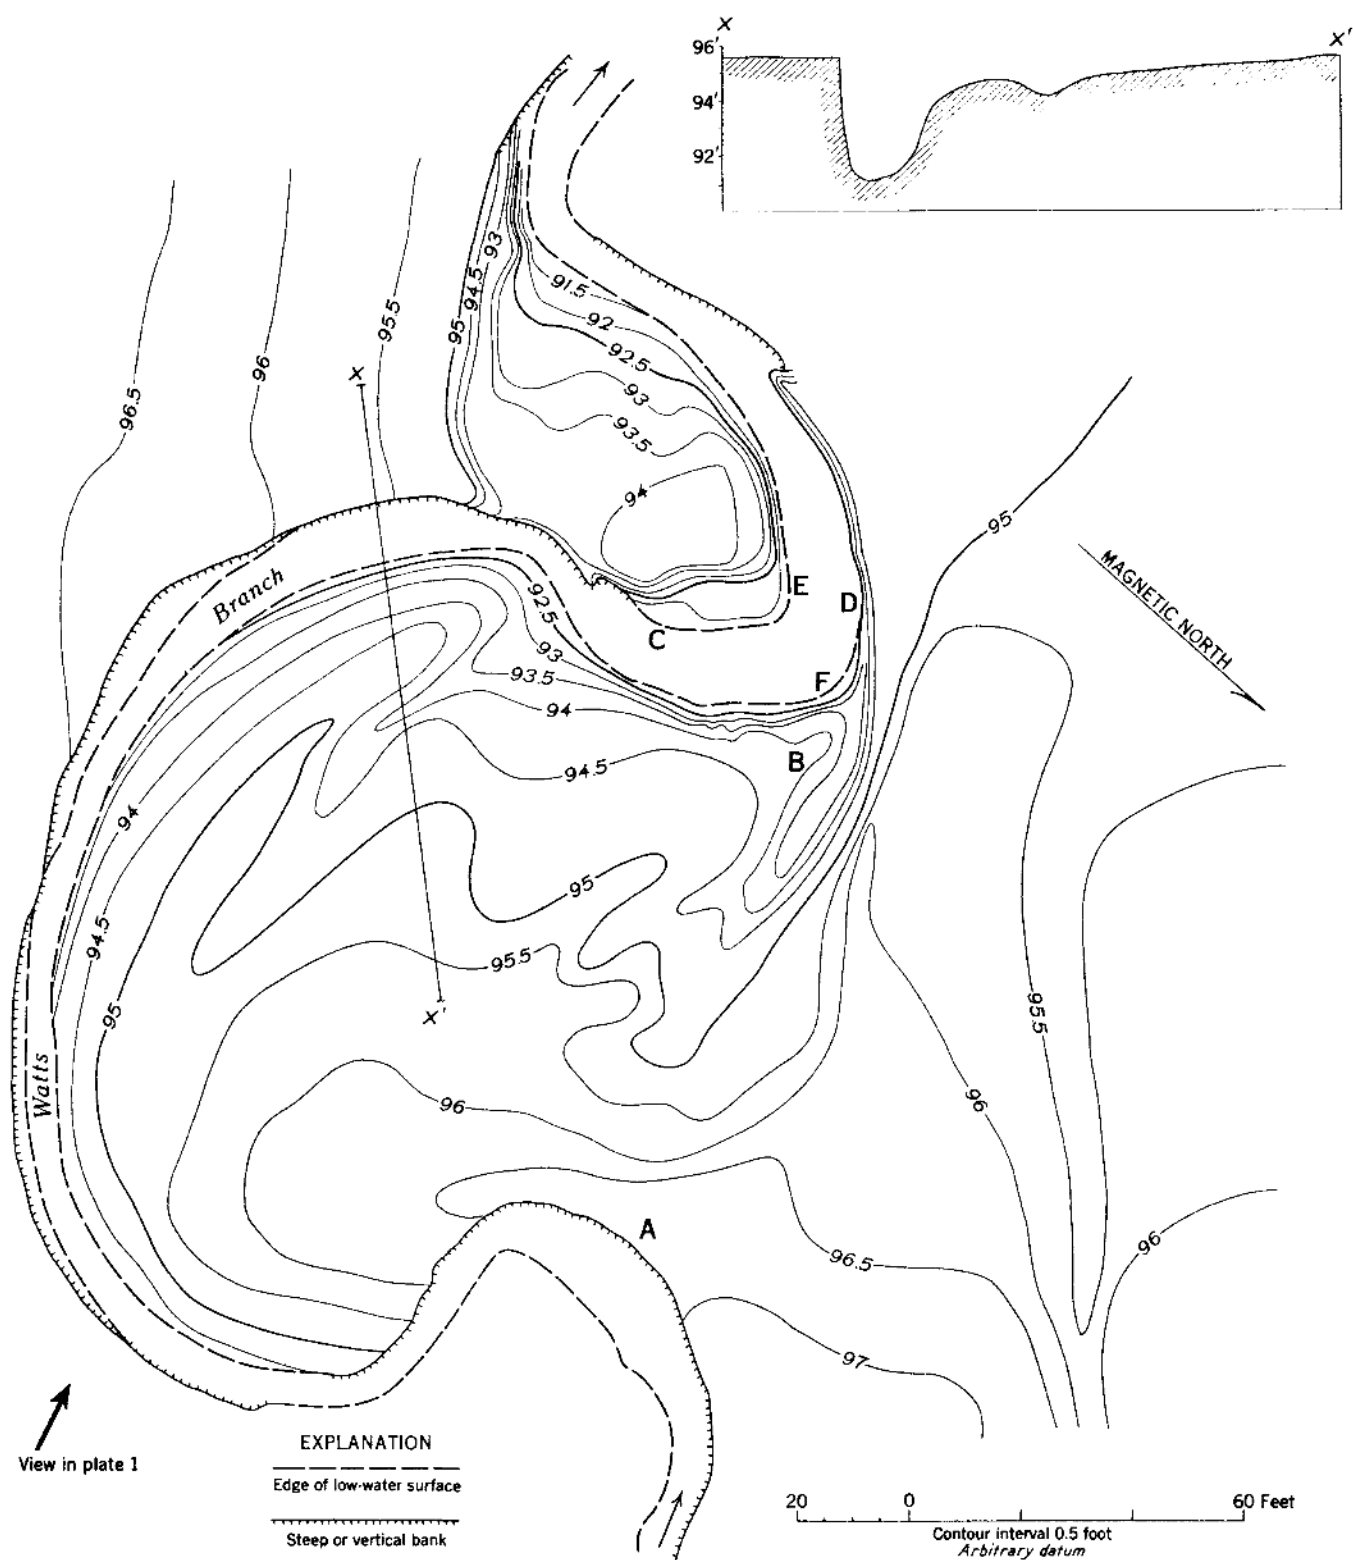
FIGURE 59.—Map and cross section of a typical point bar of the flood plain of Watts Branch, 1 mile northwest of Rockville, Md.

The map of Watts Branch presented in figure 59 might alone suggest that the surface of the point bar is generally lower than the overall flood plain. Our field observations on many rivers lead us to conclude that the point bar is actually built up to the level of the flood plain; that is, the so-called lateral deposit can be found at all elevations from the water surface to the flood-plain surface. The distinction between overbank and lateral deposits becomes quite vague at stages of flow during which water covers the entire point bar. Overbank flow, as used in this study, refers to stages above the level of the cut bank of the existing flood plain.

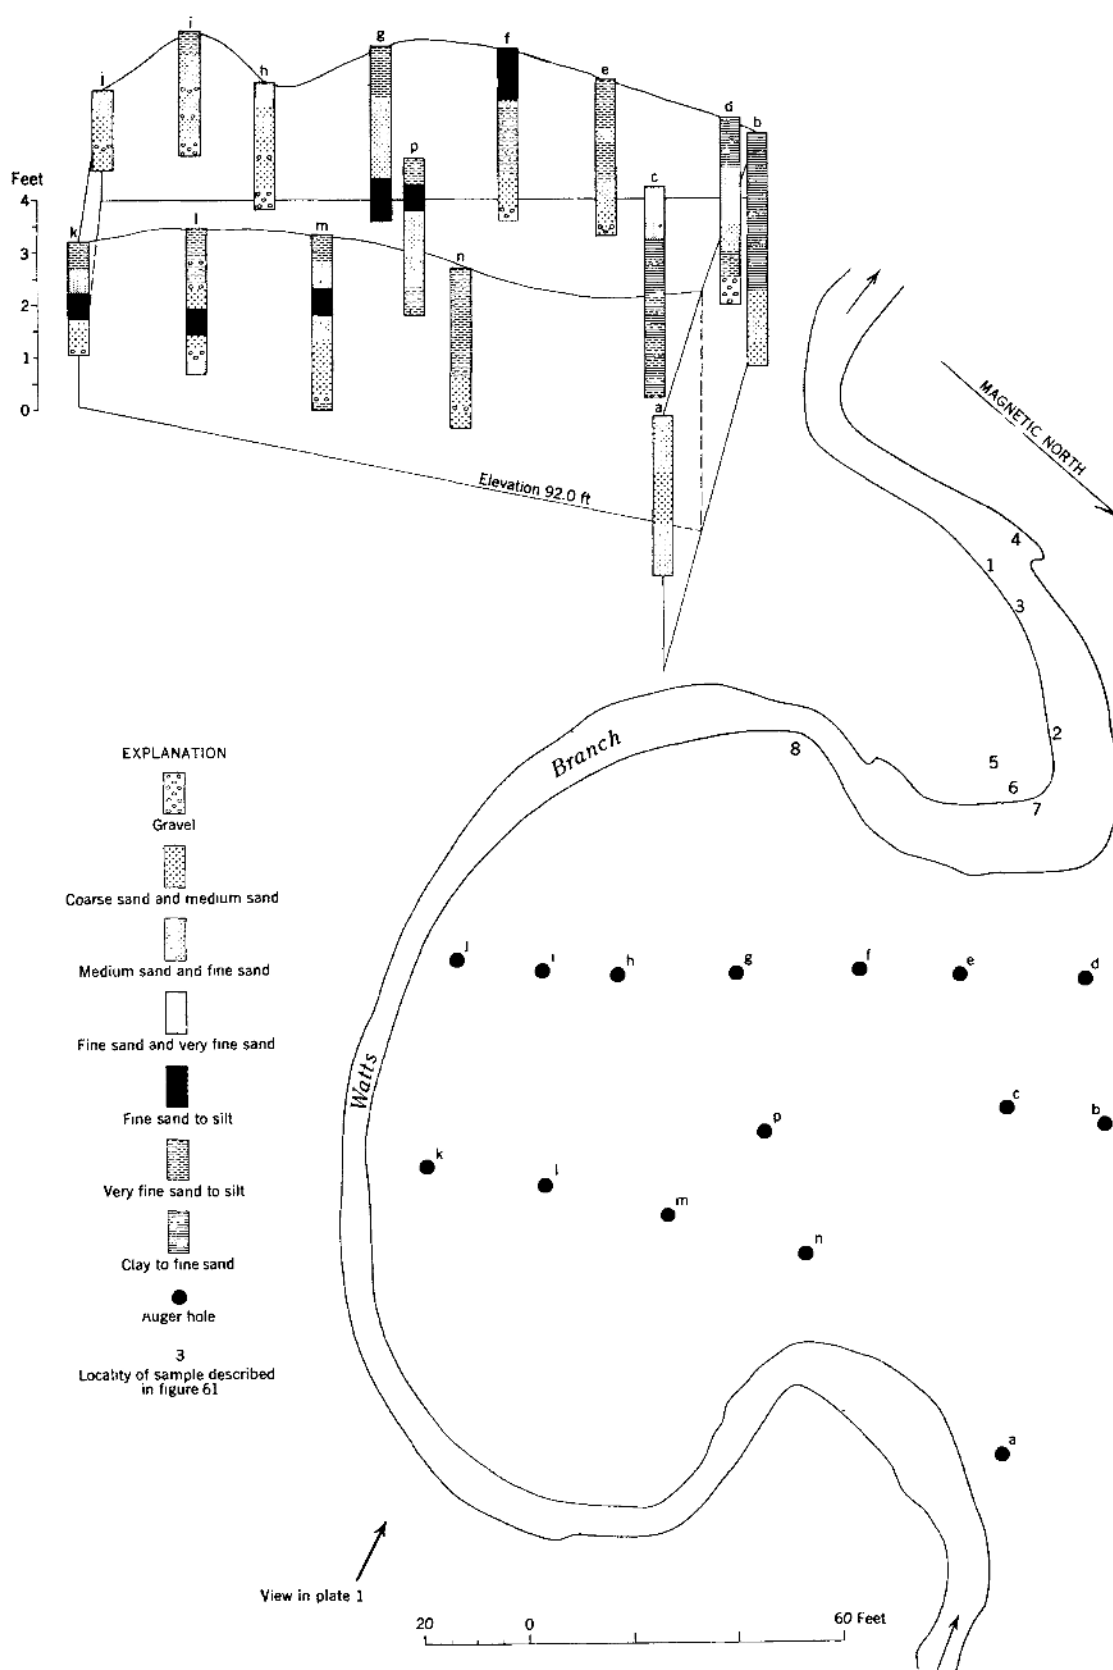
FIGURE 60.--Distribution of materials making up point bar in flood plain of Watts Branch near Rockville, Md. Map and photograph of this location appear in figure 59 and plate 1.

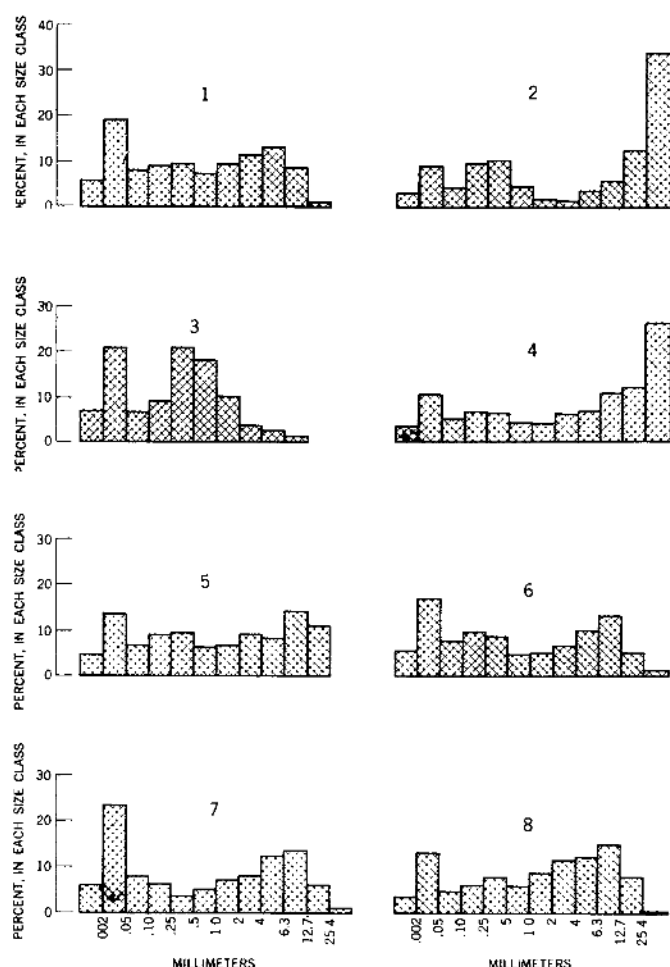
FIGURE 61.—Size distribution of samples from bed of Watts Branch, Rockville, Md., and from adjacent surface near stream margin. Localities of samples shown in figure 60.

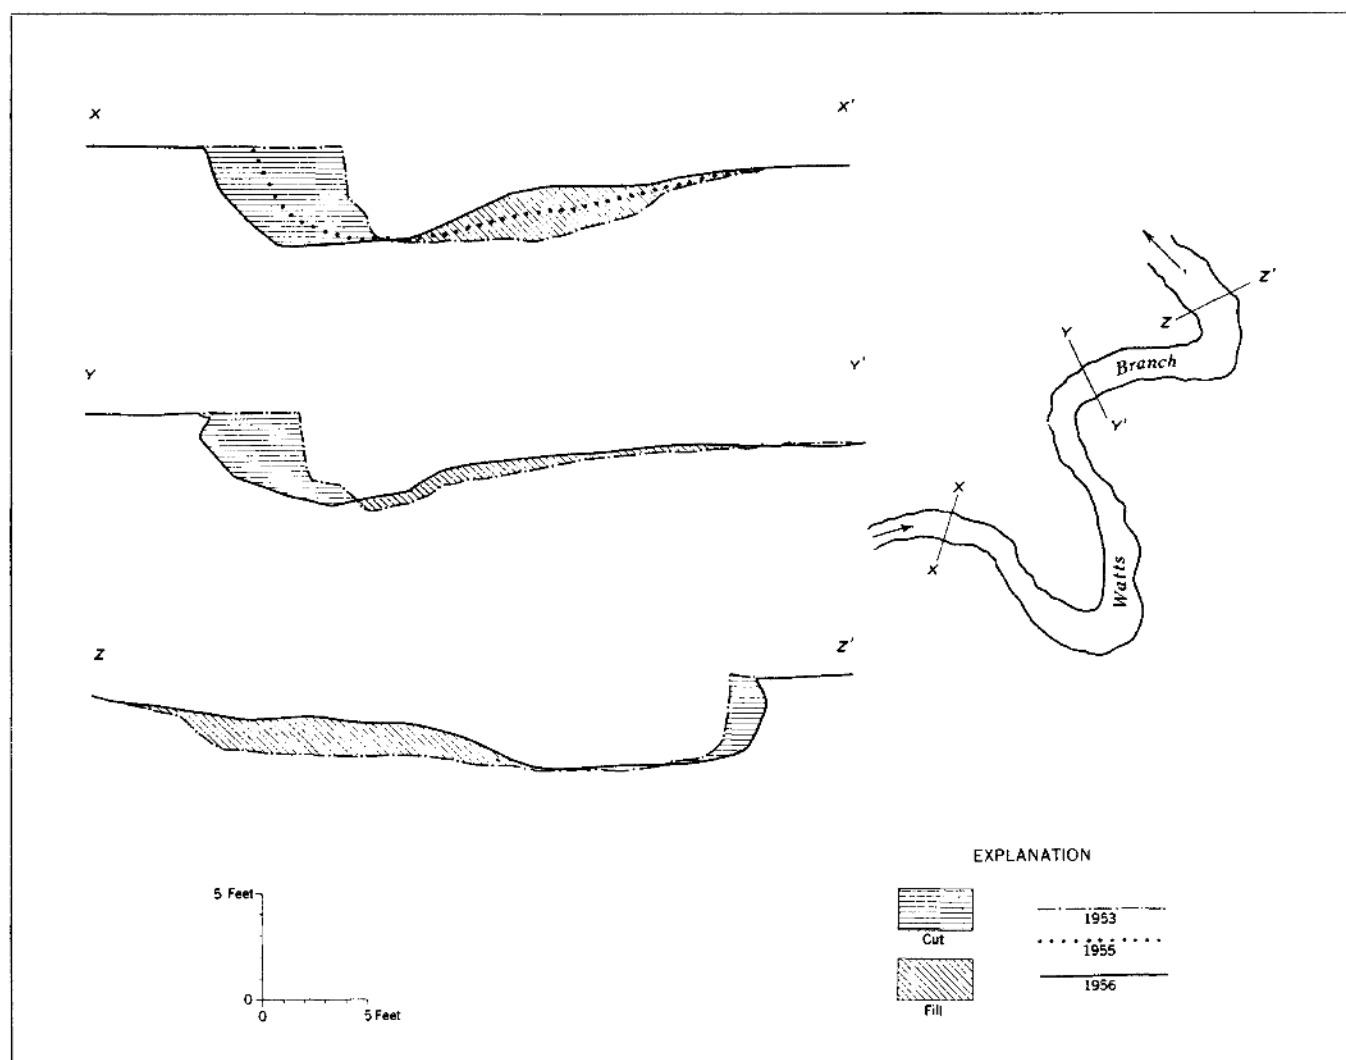
FIGURE 62.—Progressive erosion and deposition in measured cross sections of Watts Branch near Rockville, Md., from 1953 to 1956.

During 3 years of observation and measurement of this point bar on Watts Branch, we have recorded as much as 6 feet of lateral movement of the channel. Cross sections presented in figure 62 show that erosion of the steep or outside bank was accompanied by deposition on the opposite point bar. At cross section *X-X'* the amount of material deposited is roughly equivalent to the amount eroded. At *Y-Y'* erosion has exceeded deposition, while further downstream at *Z-Z'* during the period of observation deposition has exceeded erosion. We would not expect precise equivalence of erosion and deposition at an individual cross section during a short period of time. It is clear, however, that the eroding flood plain is being replaced by lateral or within-channel deposits.

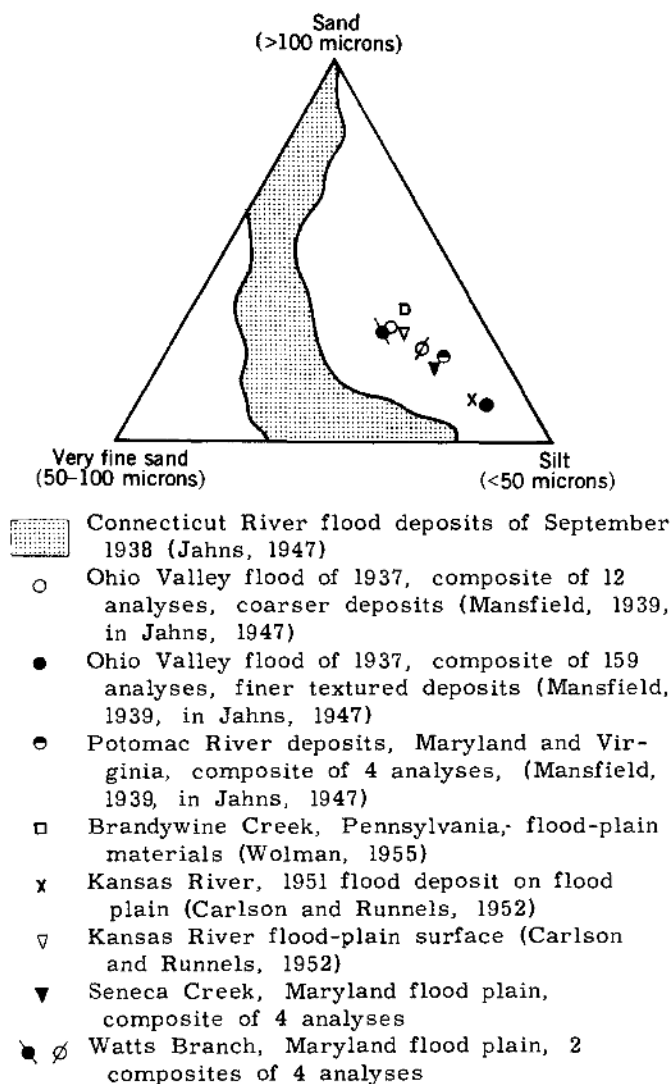
FIGURE 63.—Size distribution of flood deposits and flood-plain sediments (original diagram from Jahns, 1947).

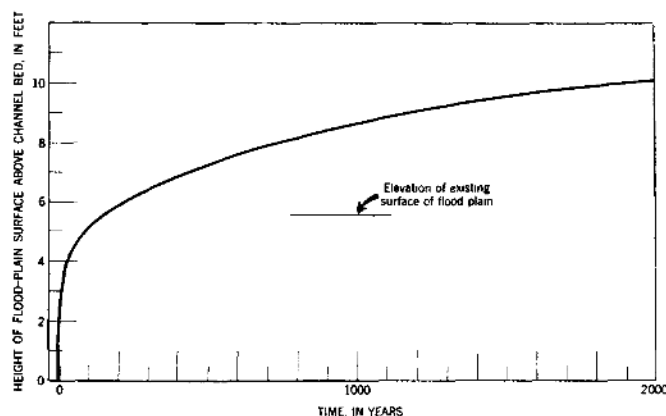
FIGURE 64.—Hypothetical formation and rate of increase in flood-plain elevation by overbank deposition. Graph shows increase in elevation with time on Brandywine Creek at Chadds Ford, Pa.

If a specific thickness of material were deposited on the flood plain every time a river overflowed its banks, it would be possible to compute the rate of rise of the flood-plain surface by the use of flood frequency data. Figure 64 is a plot of hypothetical flood-plain elevation against time on Brandywine Creek at Chadds Ford, Pa. It was constructed in the following way: The average number of days per year on which a given stage is equaled or exceeded was computed from the gaging station records. Assuming that each time the stream overflows a given level it deposits a specific thickness of material, the time required for the surface of a flood plain to reach a given elevation can be computed. In this example it was assumed that each increment consisted of a layer of sediment 0.005 foot thick (see table 5 for reasonableness of this assumption).

The most conspicuous feature in figure 64 is the rapid increase in elevation in the first 10 years. Although the rate decreases somewhat as the figure shows, in 170 years it would have been possible to construct a flood plain to its present height at Chadds Ford. From 80 to 90 percent of this construction would have taken place in the first 50 years.

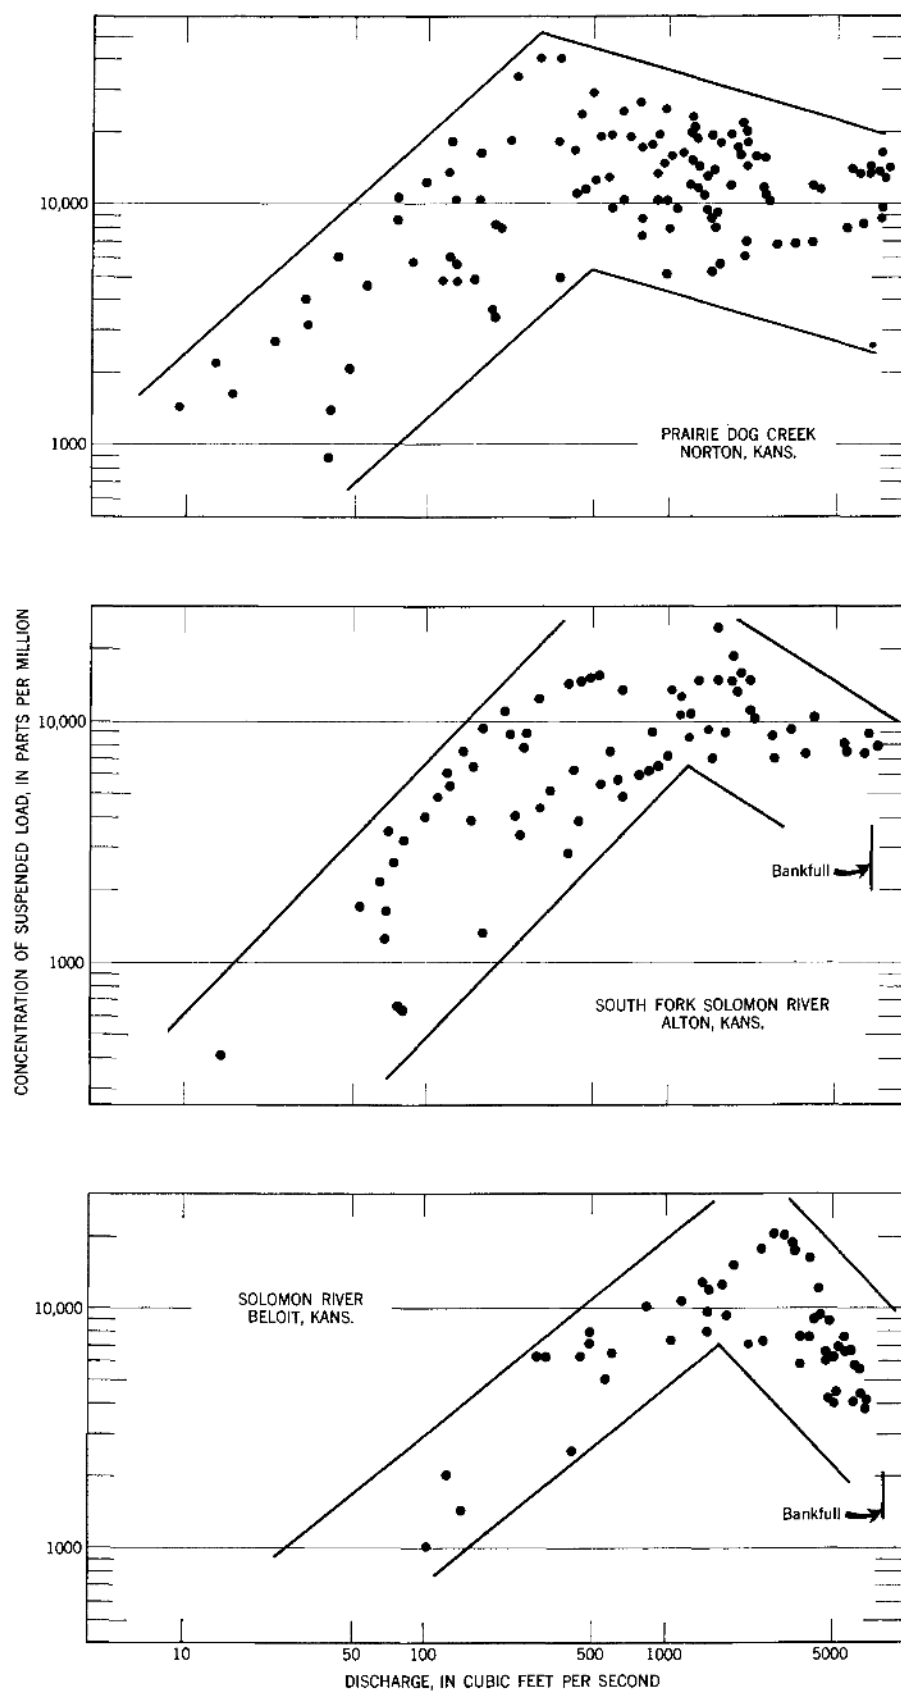
FIGURE 65.—Relation of sediment concentration to discharge in several rivers in Kansas.

It has been suggested that the decrease in concentration may result from deposition on the flood plain as a stream goes out of its banks. In the South Fork Solomon River at Alton, Kans., and in the Solomon River at Beloit, Kans. (fig. 65), the maximum sediment concentration occurs in discharges well below bankfull stage, and thus the decrease of concentration at high flow cannot be attributed to deposition on the flood plain. If we consider the fact that the load is primarily a function of the physiographic and climatic conditions in the contributing drainage area and, although correlated with discharge, is not a function of the discharge itself, it is by no means necessary that the highest concentrations be associated with the highest flows. The fact that high flows may not be associated with the highest sediment concentration may help to account for a paucity of deposition during these periods.

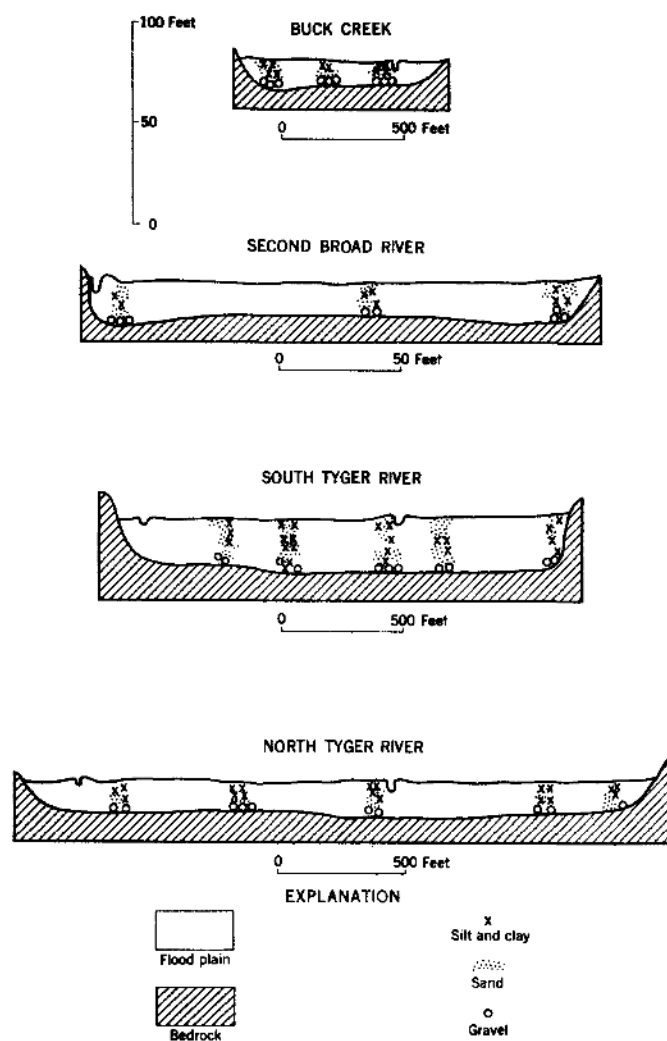
FIGURE 66.—Cross sections of river flood plains in North Carolina and South Carolina.

At first glance it might seem as if these sections are actually aggraded ones rather than stable, alluvial sequences. The following analysis, however, indicates first, that the distinction between the two is not easily made, and second, that the flood plains in figure 66 may well represent a single stable deposit.

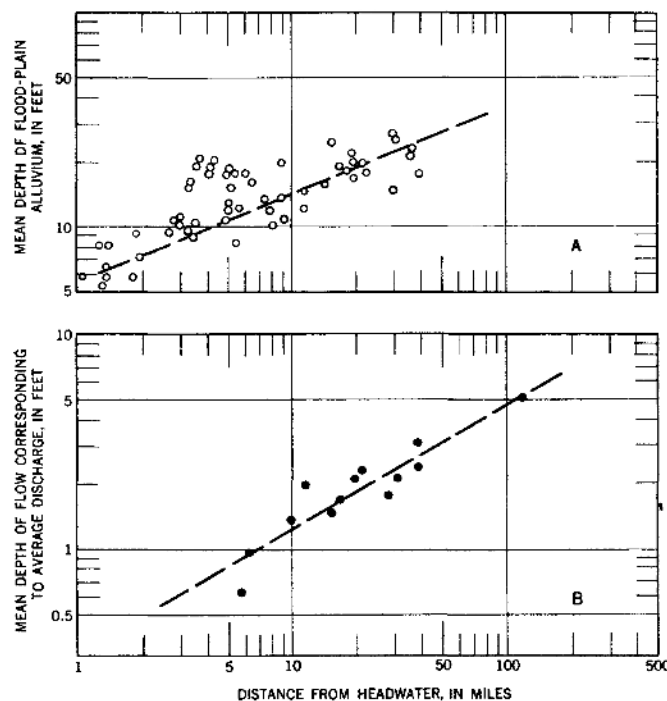
FIGURE 67.—Relation of distance from headwater divide to mean depth of flood-plain alluvium and to mean depth of flow at average discharge at selected localities in North Carolina and South Carolina.

Figure 67A is a graph of the depth of fill in valleys in the North and South Carolina region, plotted against the length of the valley from its headwaters to the given cross section. Although there is considerable
