# Roughness Characteristics of Natural Channels

By HARRY H. BARNES, JR.

U.S. GEOLOGICAL SURVEY WATER-SUPPLY PAPER 1849

*Color photographs and descriptive  
data for 50 stream channels for  
which roughness coefficients have  
been determined*

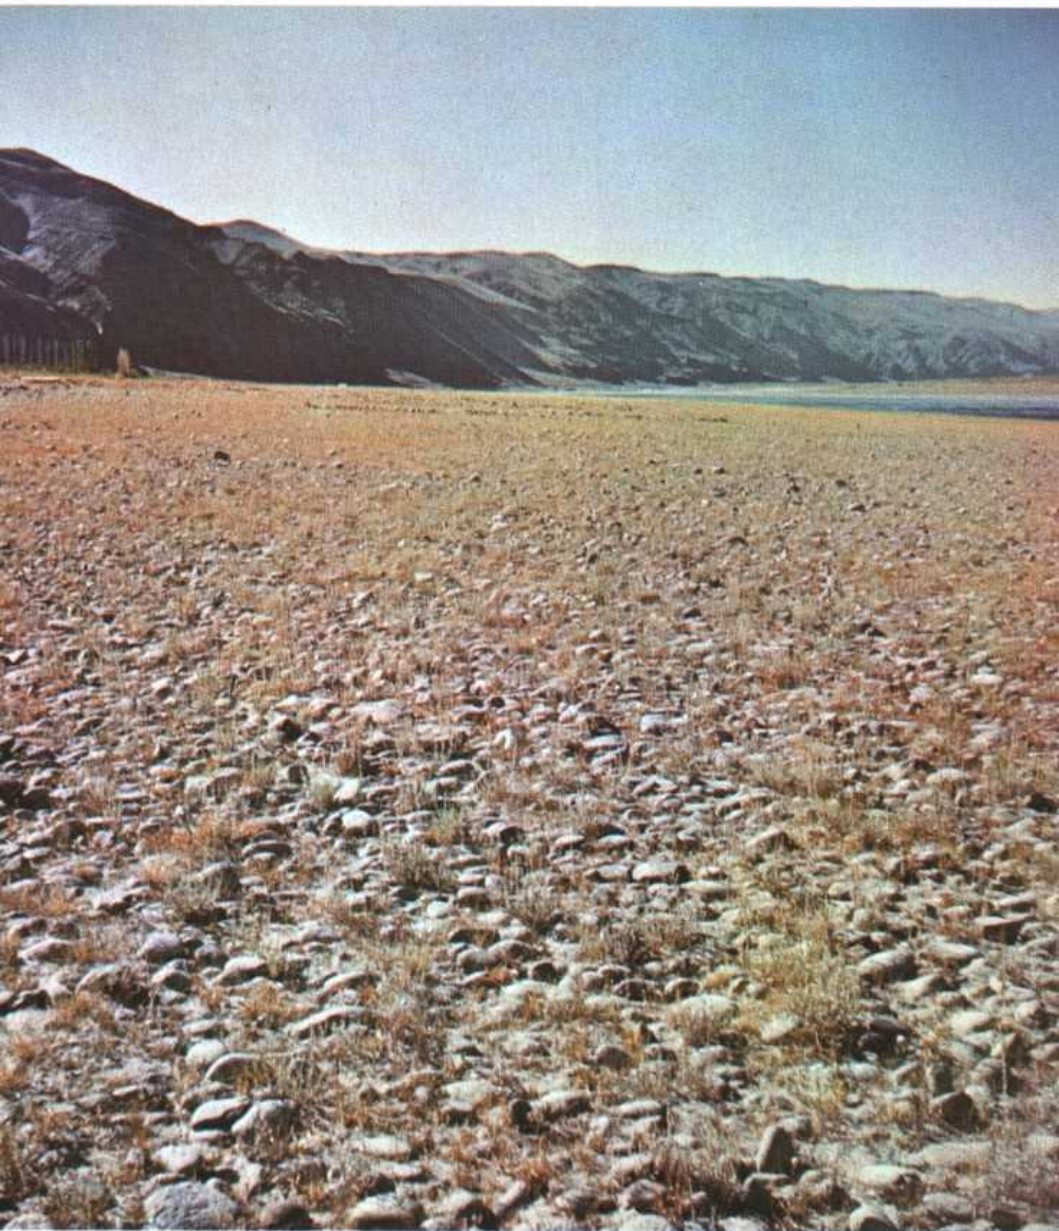
No. 67 upstream from top of bank at section 3,  
Columbia River at Vernita, Wash.

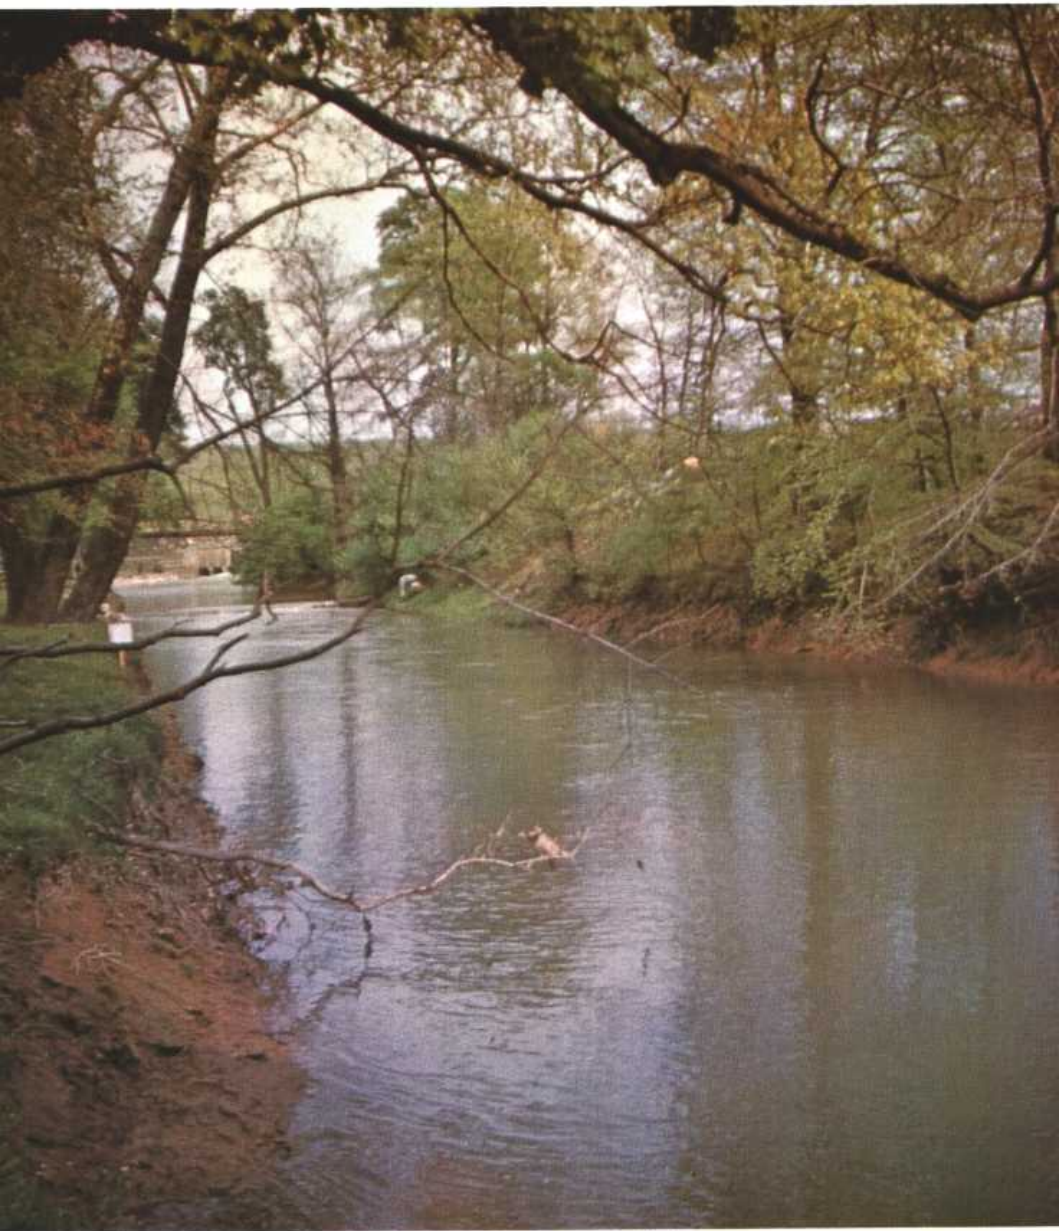
No. 329 upstream from right bank at section 2,  
Indian Fork below Atwood Dam, near New Cumberland, Ohio.

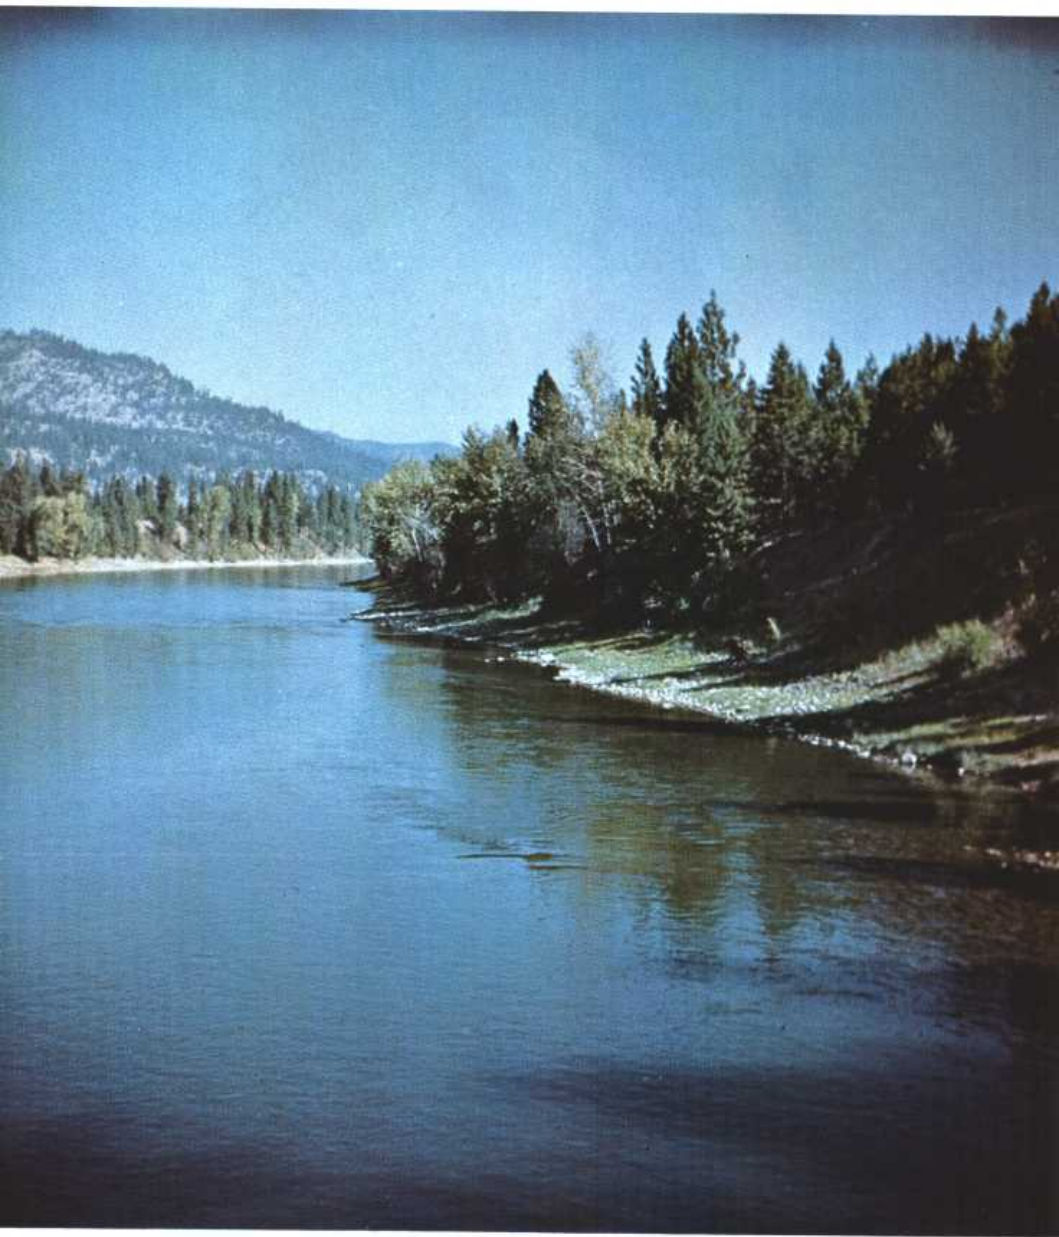
No. 22 downstream along right bank from section 2,  
Clark Fork at St. Regis, Mont.

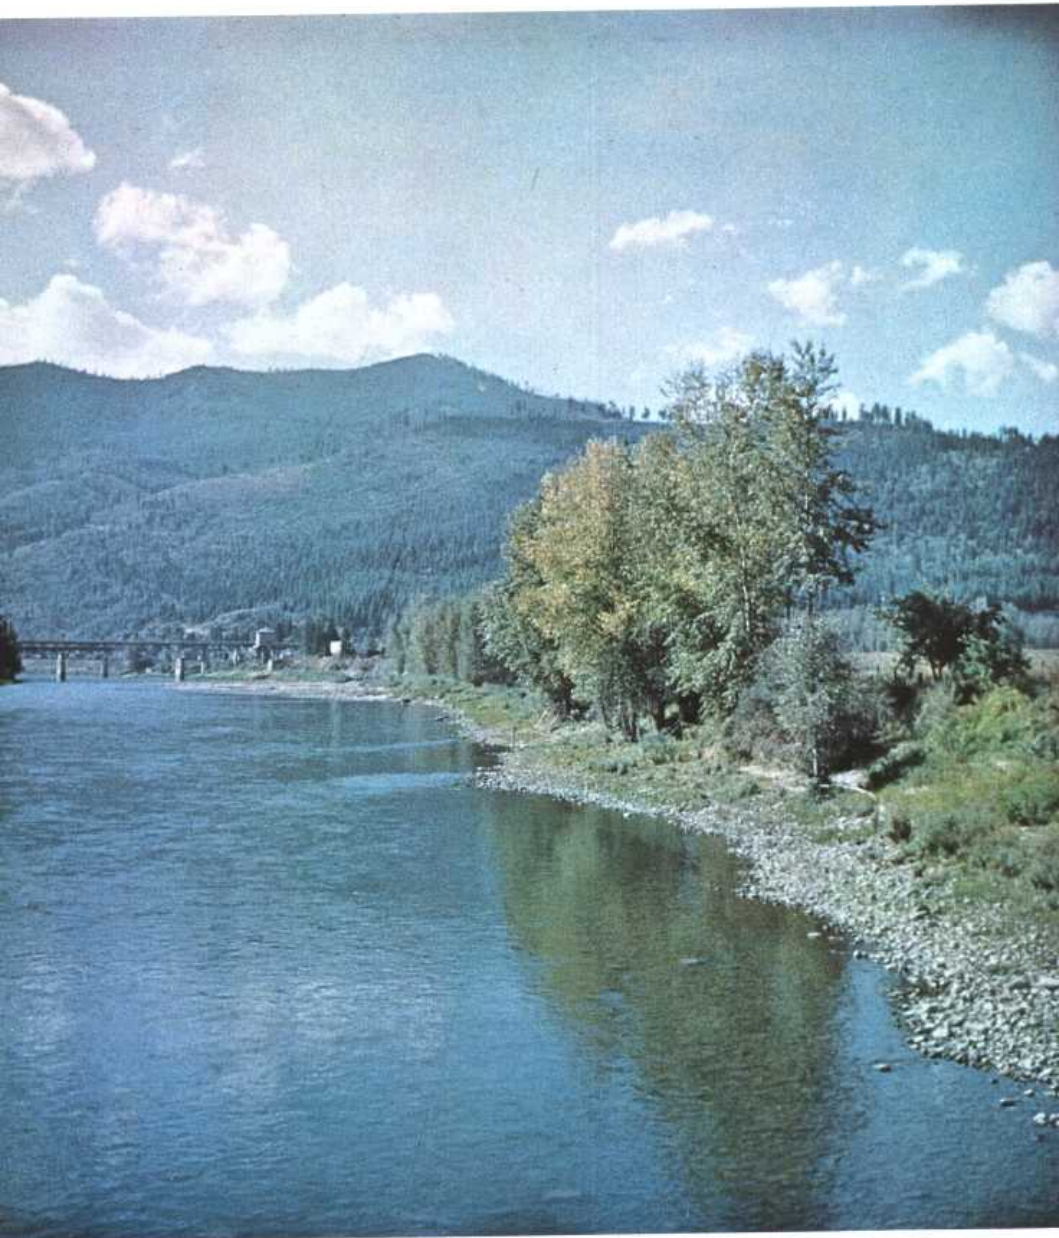
No. 23 upstream along left bank from section 2,  
Clark Fork at St. Regis, Mont.

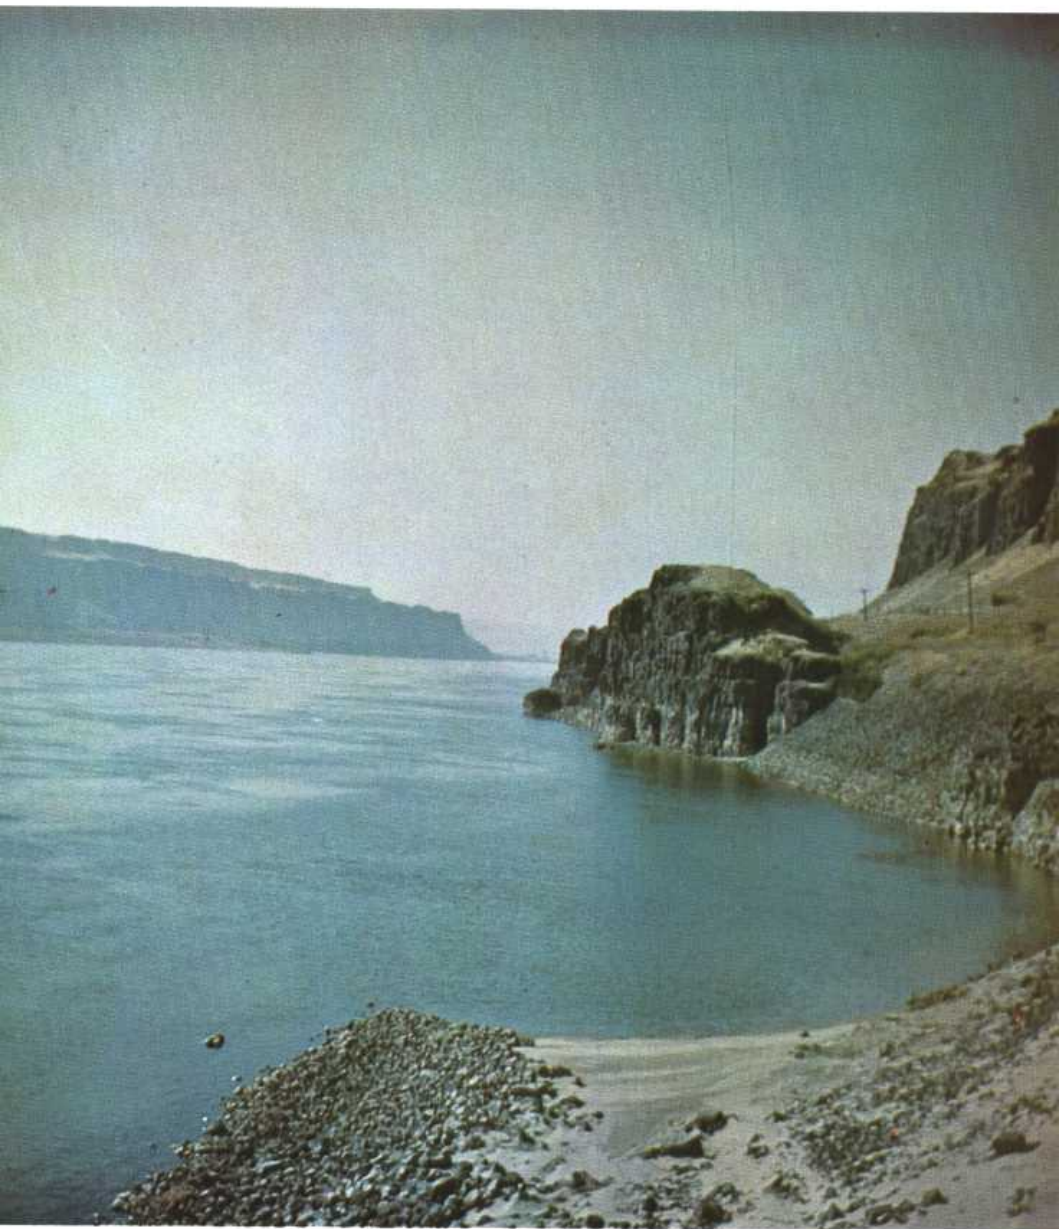
No. 47 downstream along right bank from above section 1,  
Columbia River at The Dalles, Oreg.

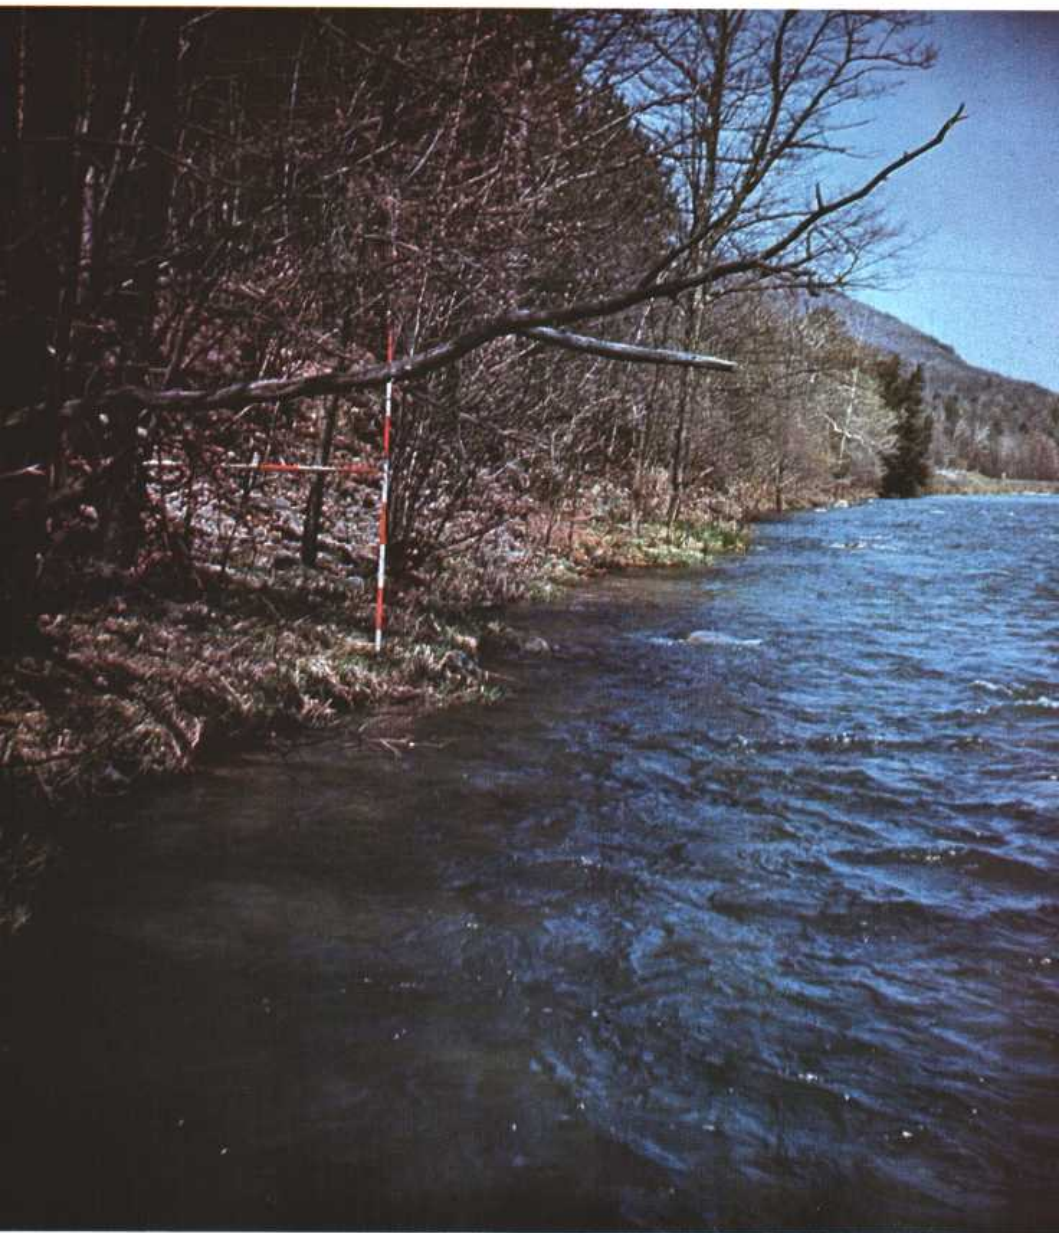
No. 354 upstream along left bank from section 2,  
Esopus Creek at Coldbrook, N.Y.

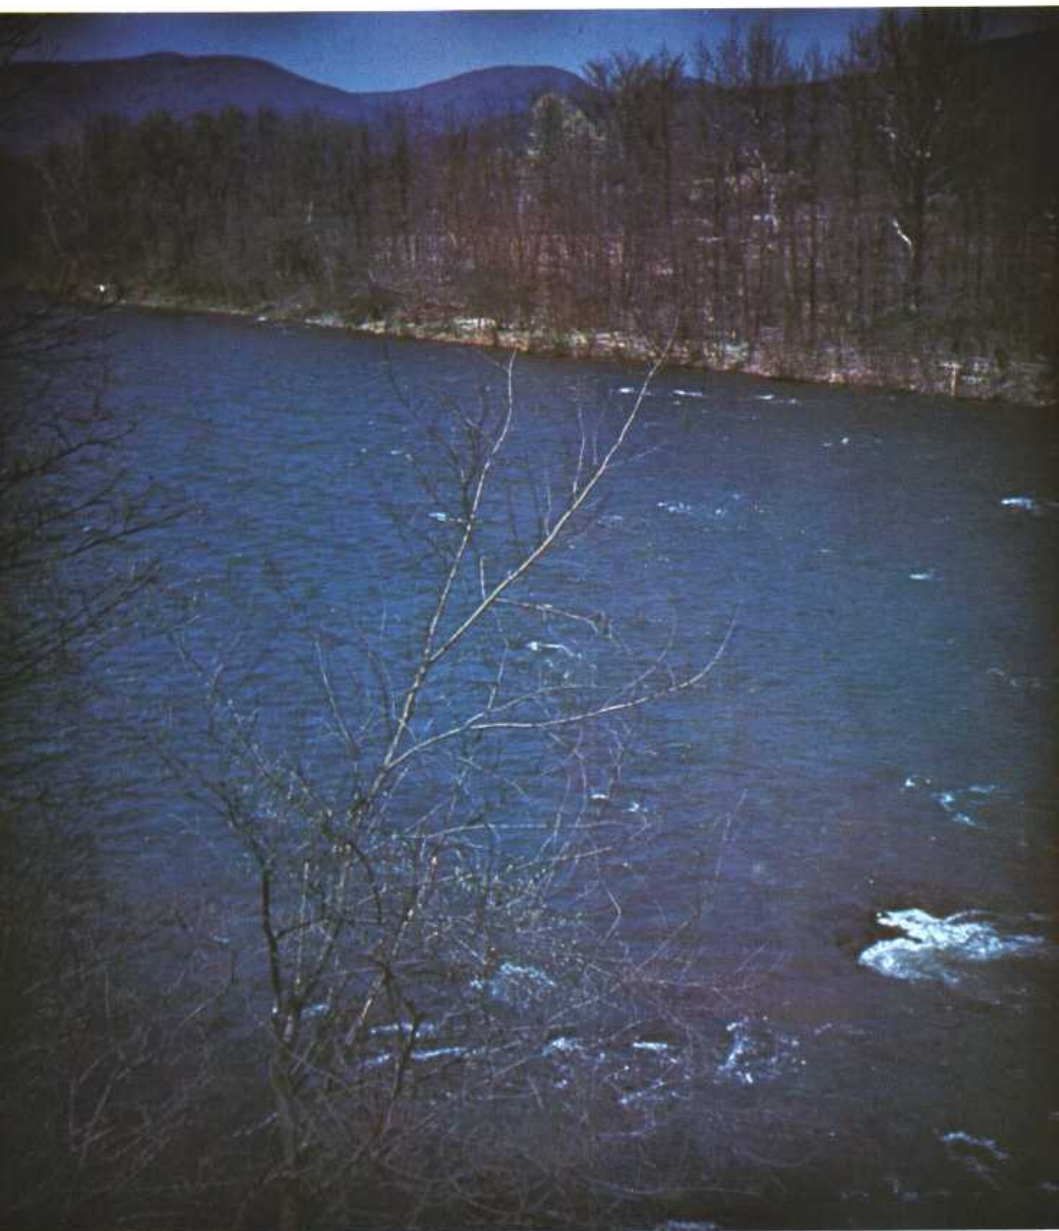
No. 357 upstream from right end of bridge below reach,  
Esopus Creek at Coldbrook, N.Y. (at Highway 28-A).

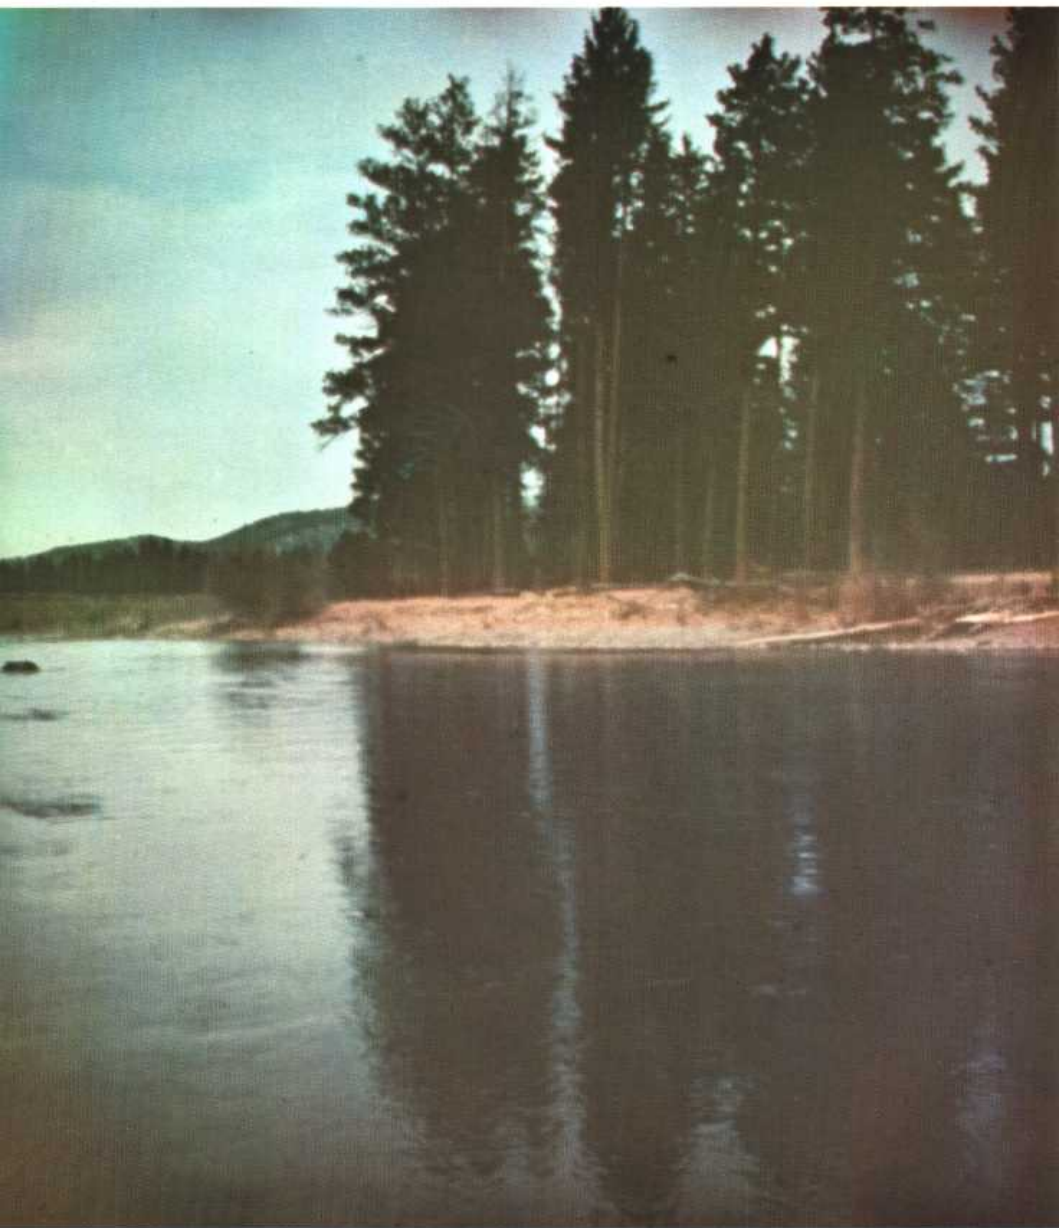
No. 1 downstream from left bank above section 1,  
Blackfoot River near Ovanda, Mont.

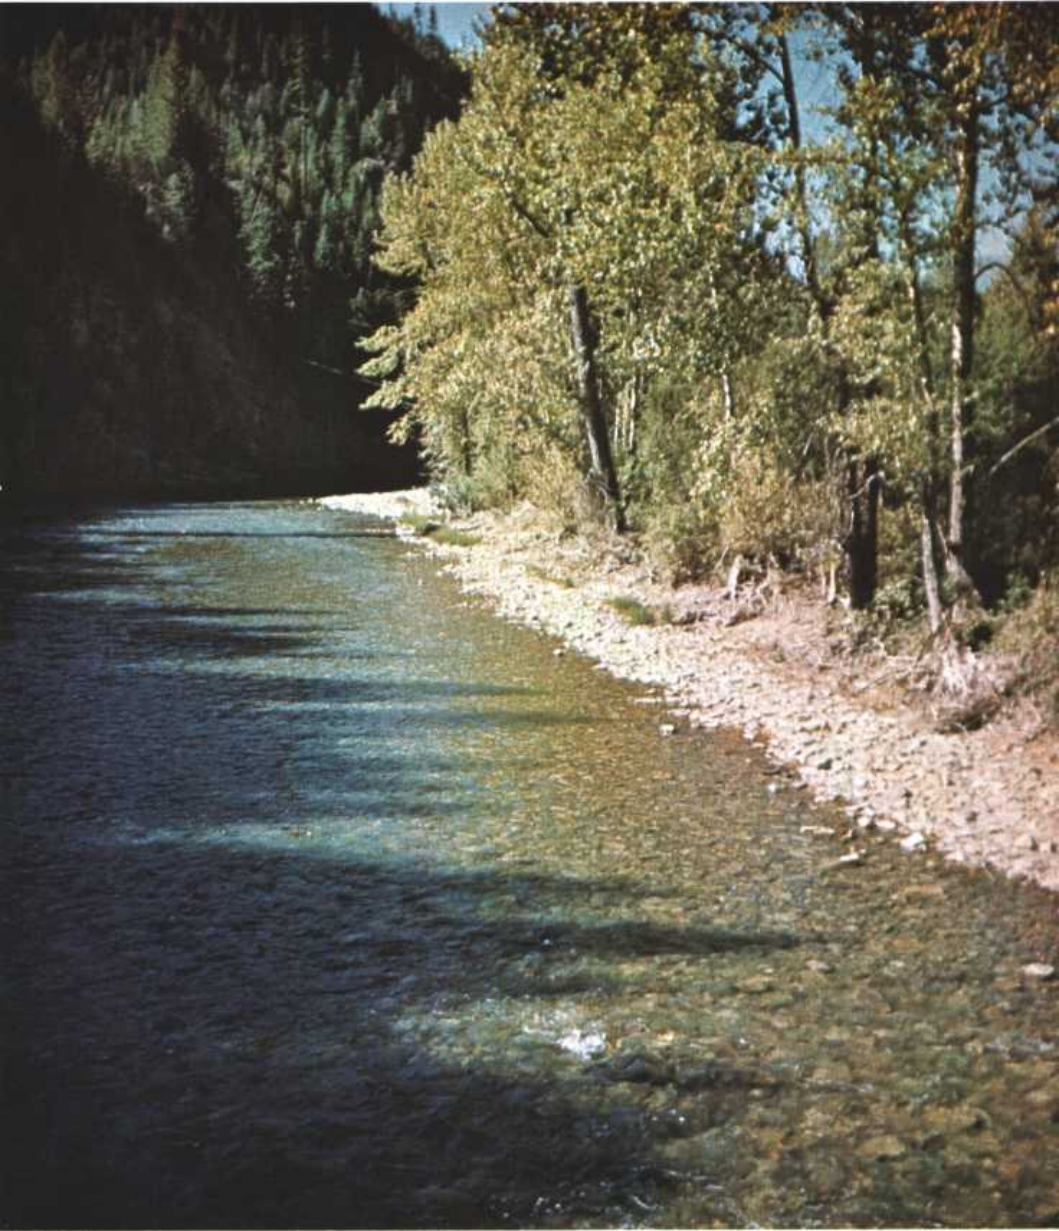
No. 36 downstream along right bank at section 1,  
Coeur d'Alene River near Pritchard, Idaho.

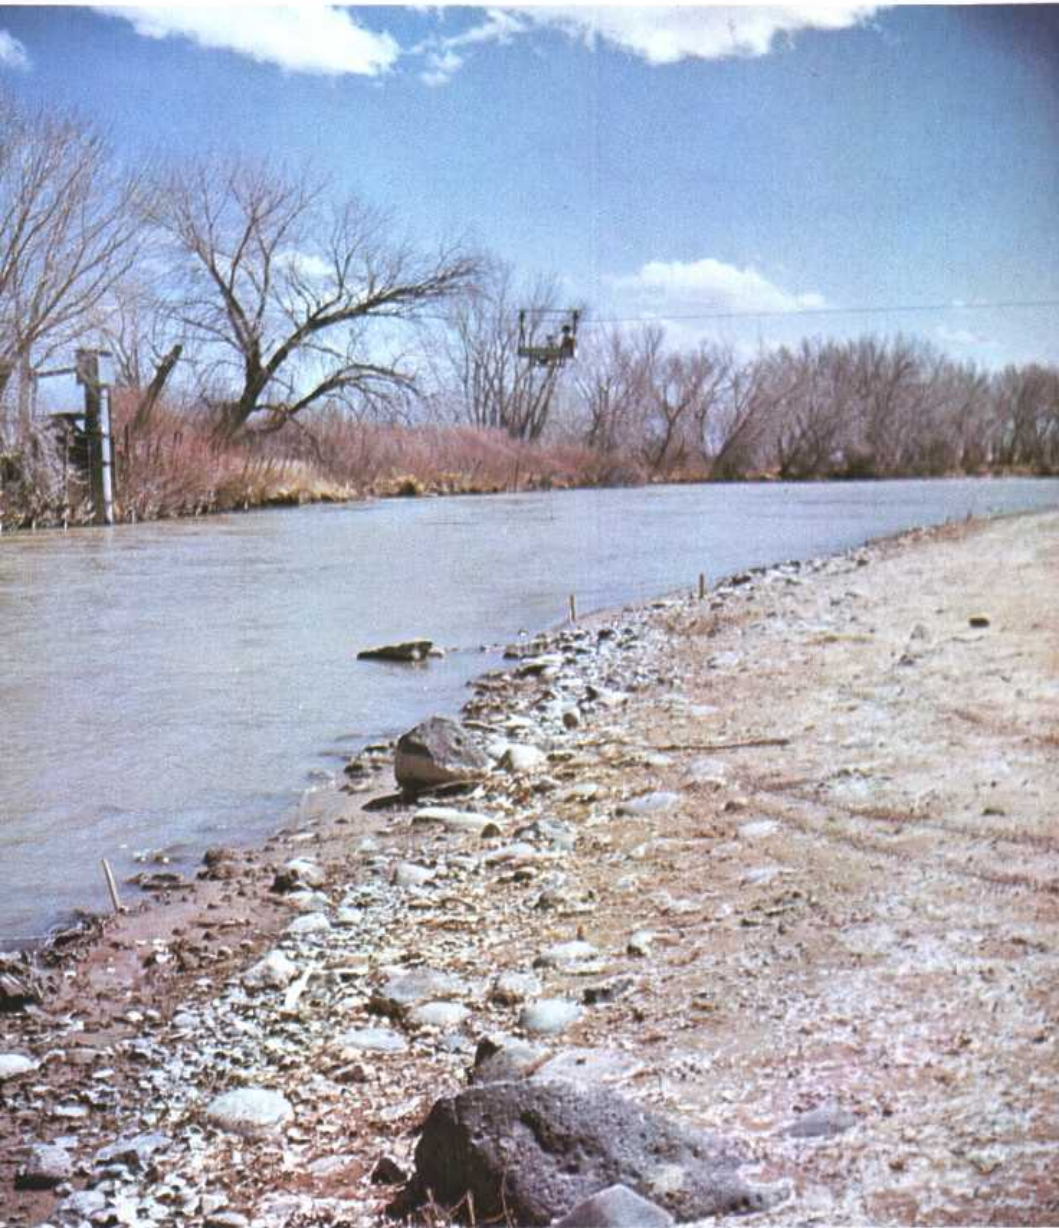
No. 550 downstream from right bank at section 1, Rio Chama  
near Chamita, N. Mex.

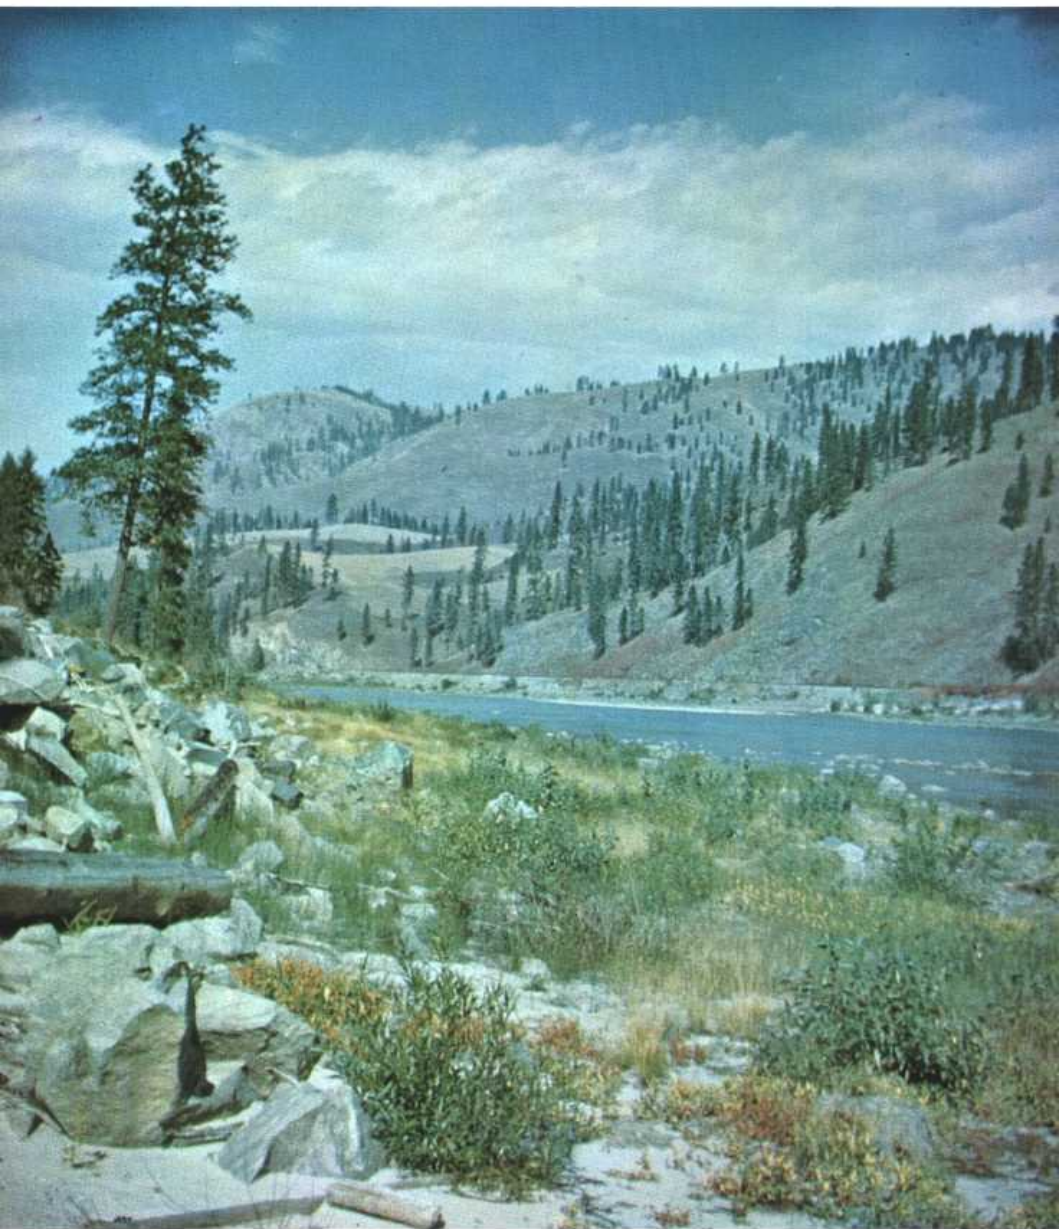
No. 29 downstream along left bank from above section 1,  
Clearwater River at Kamiah, Idaho.

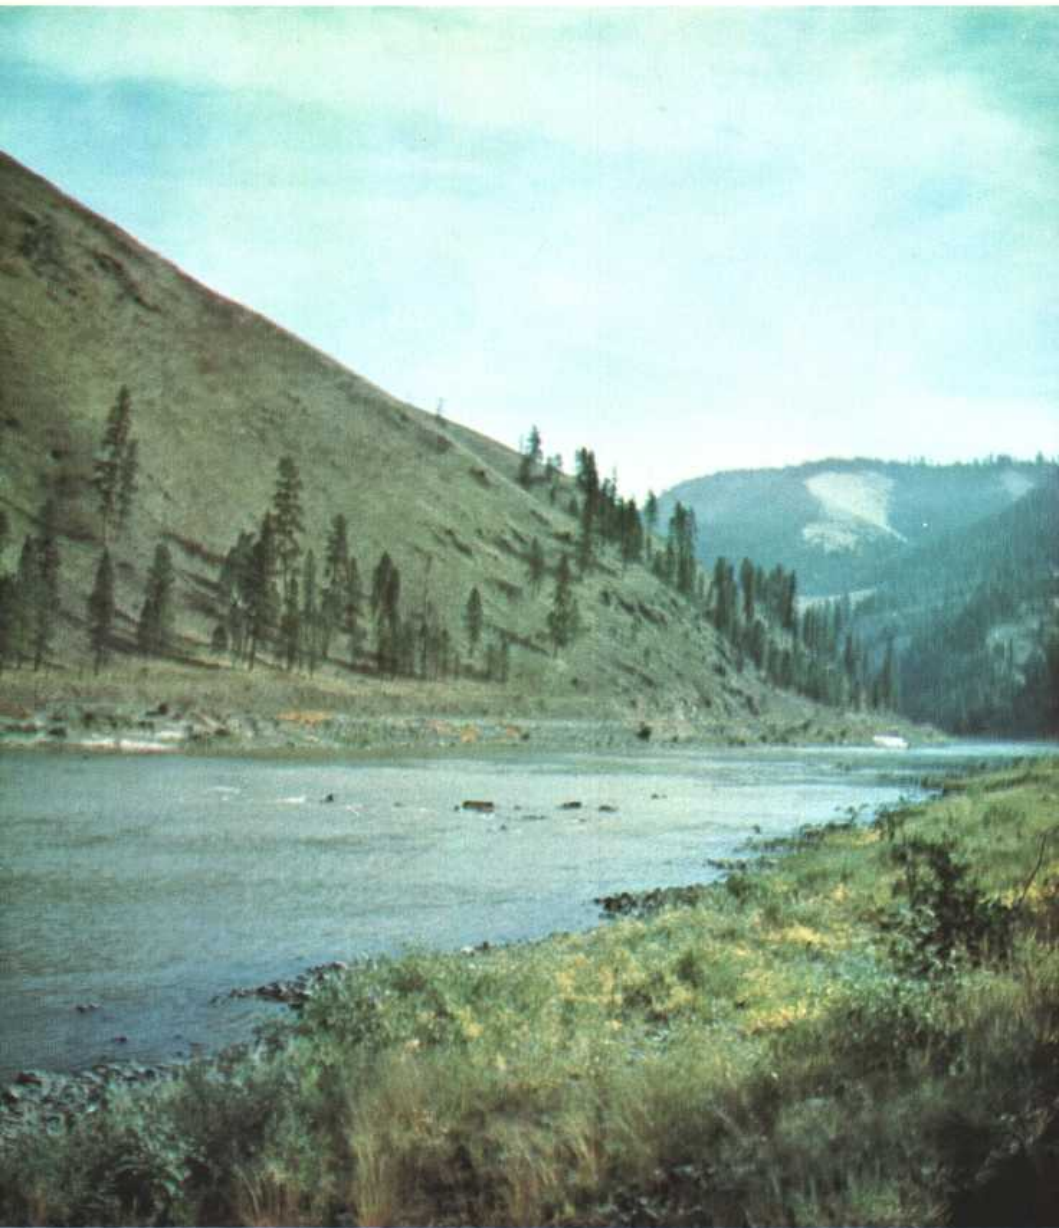
No. 32 upstream from left bank at section 3. Clearwater River  
at Kamiah, Idaho.

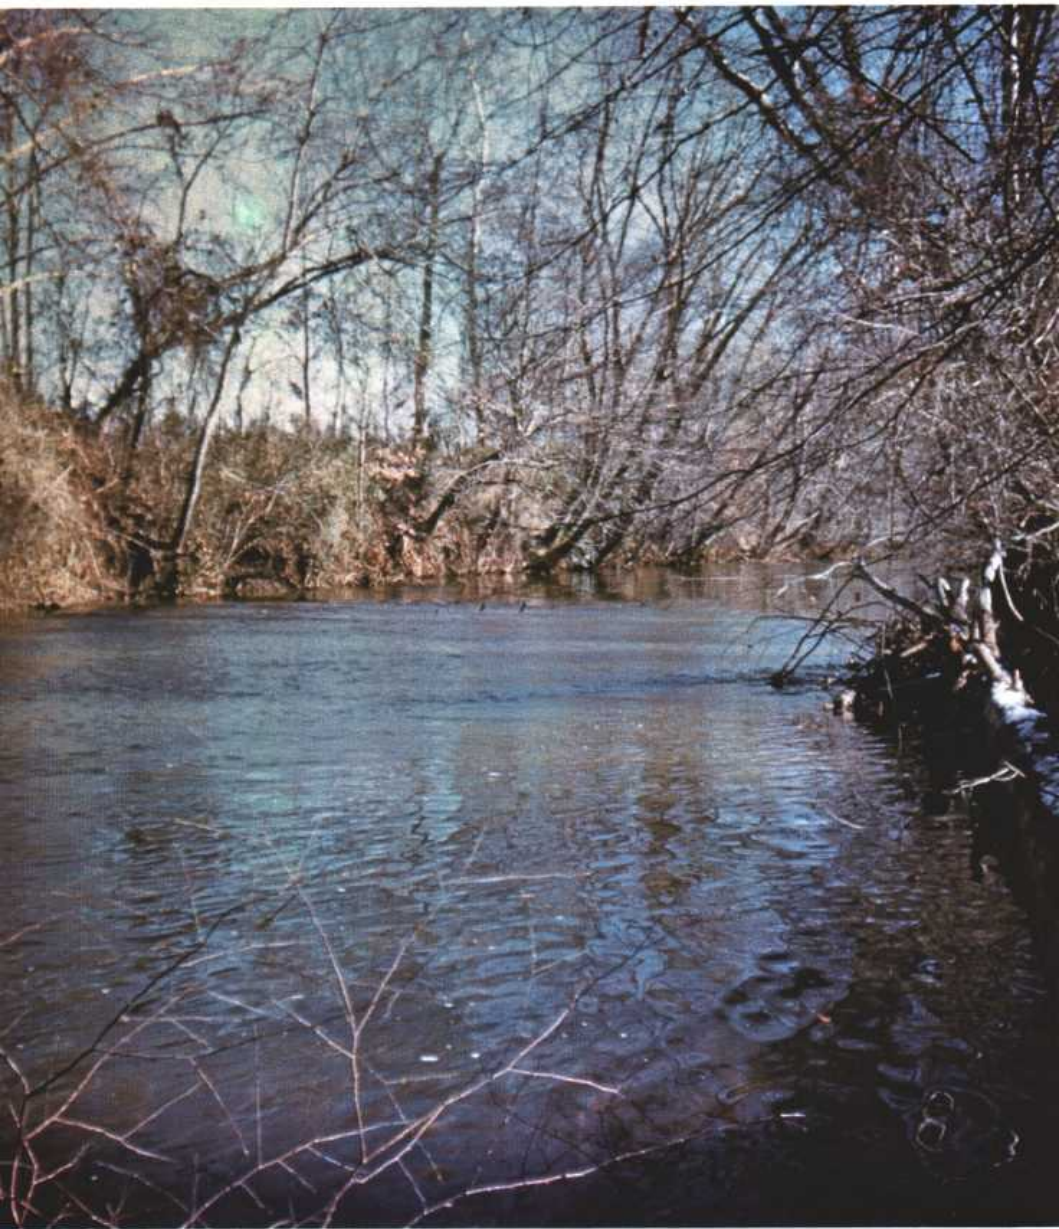
No. 1167 downstream from right bank above section 9, Etowah River near Dawsonville, Ga.

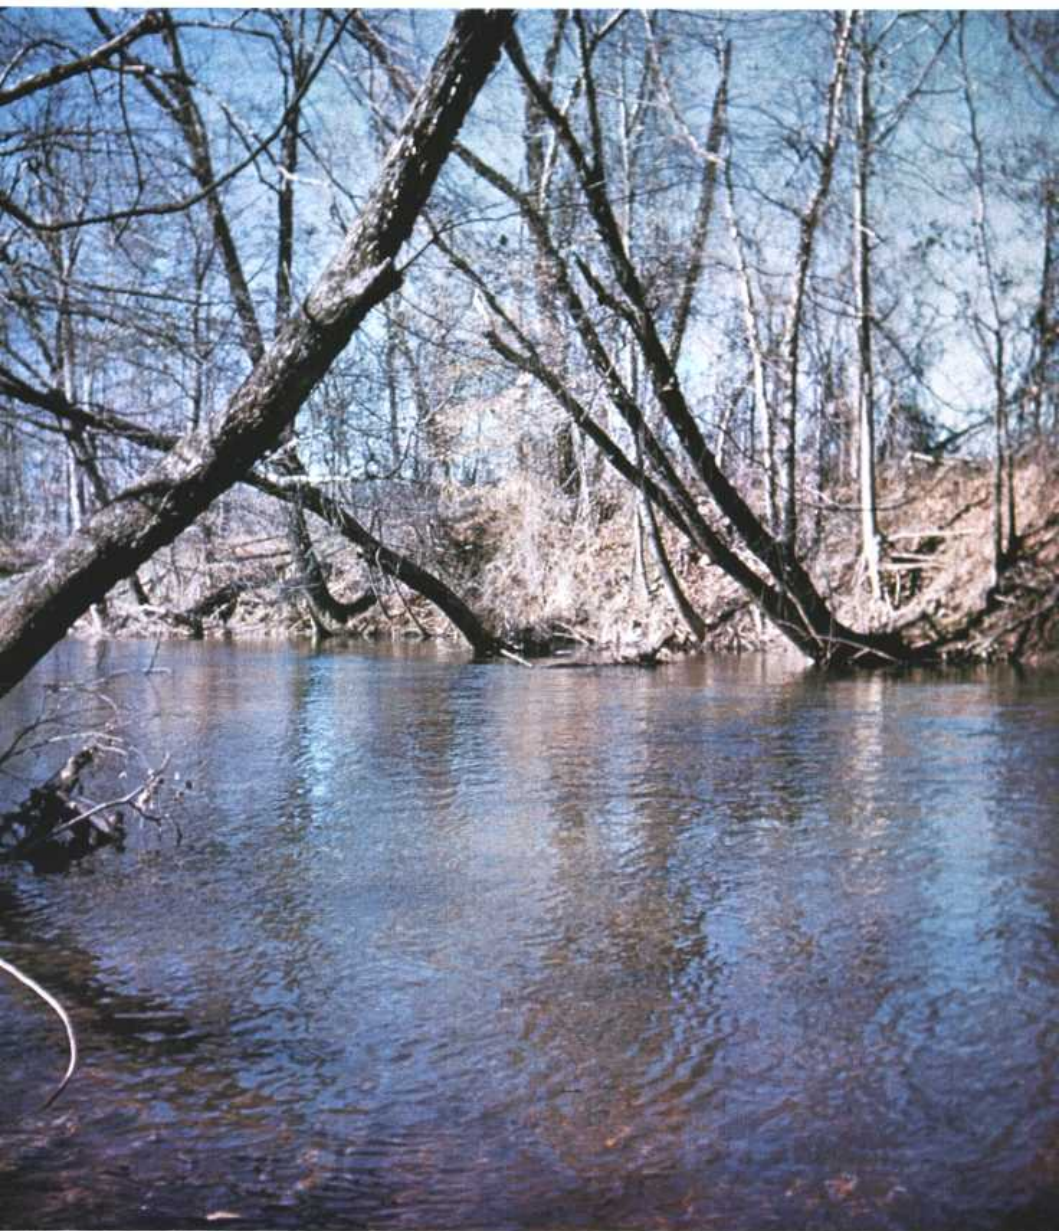
No. 1168 upstream from right bank at section 11, Etowah River near Dawsonville, Ga.

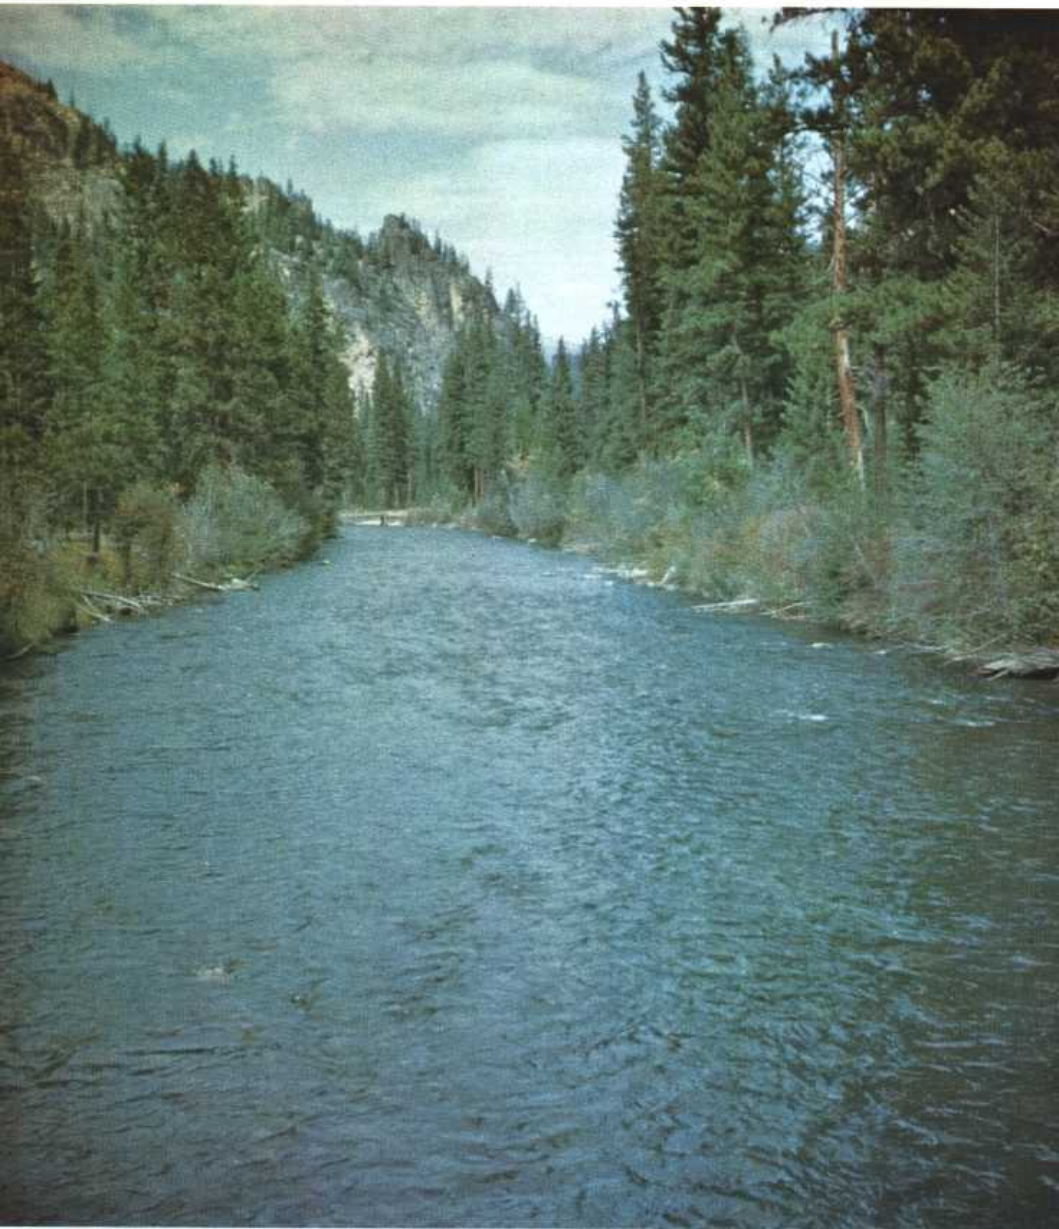
No. 175 downstream from section 1, West Fork Bitterroot  
River near Conner, Mont.

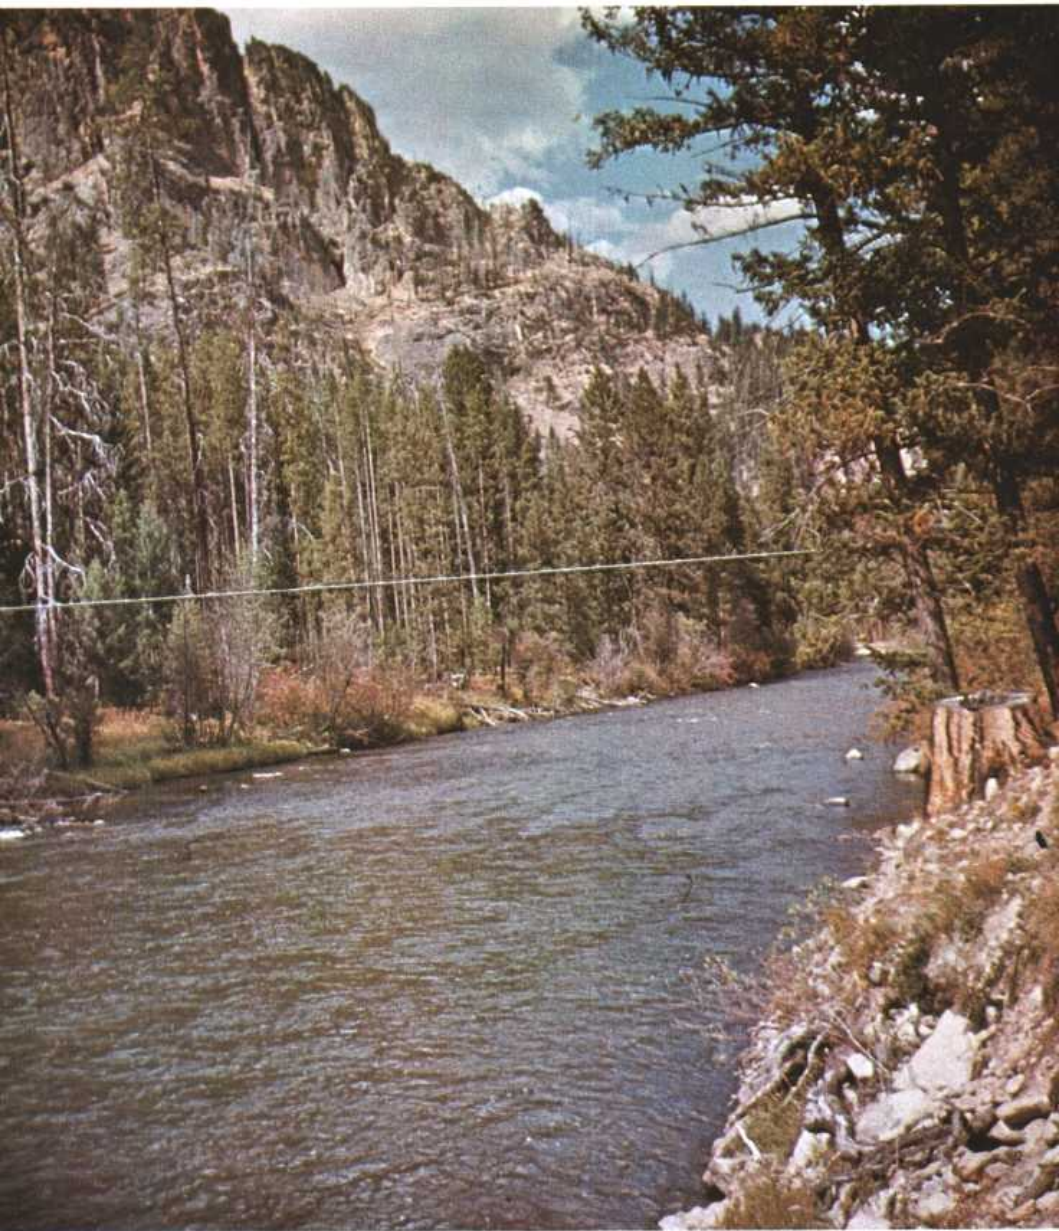
No. 177 downstream from right bank above section 1, West Fork Bitterroot River near Conner, Mont.

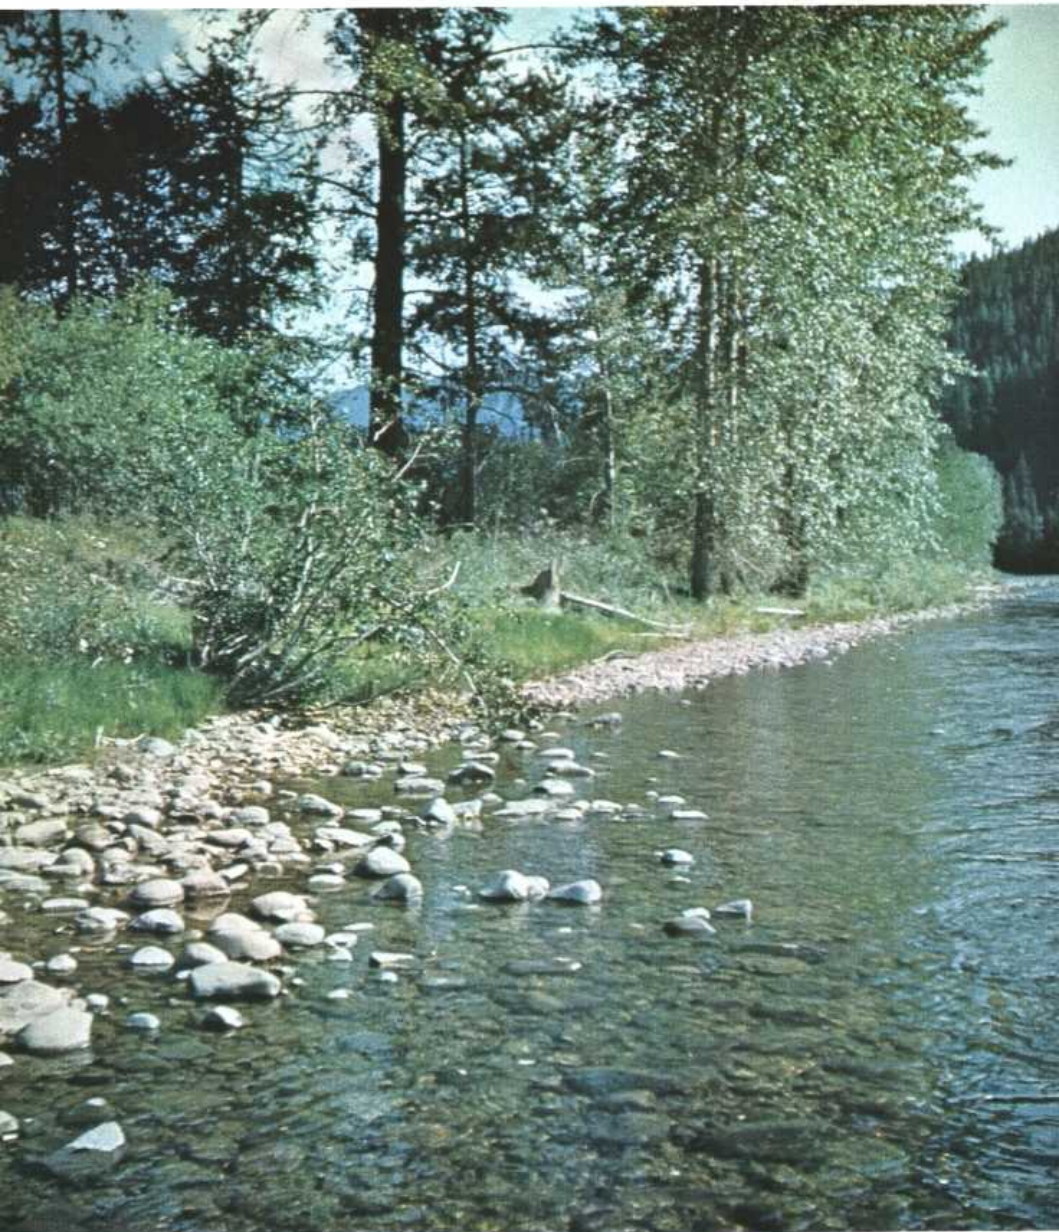
No. 126 downstream along left bank at section 3,  
Moyie River at Eastport, Idaho.
