# Roughness Characteristics of Natural Channels

By HARRY H. BARNES, JR.

U.S. GEOLOGICAL SURVEY WATER-SUPPLY PAPER 1849

*Color photographs and descriptive  
data for 50 stream channels for  
which roughness coefficients have  
been determined*

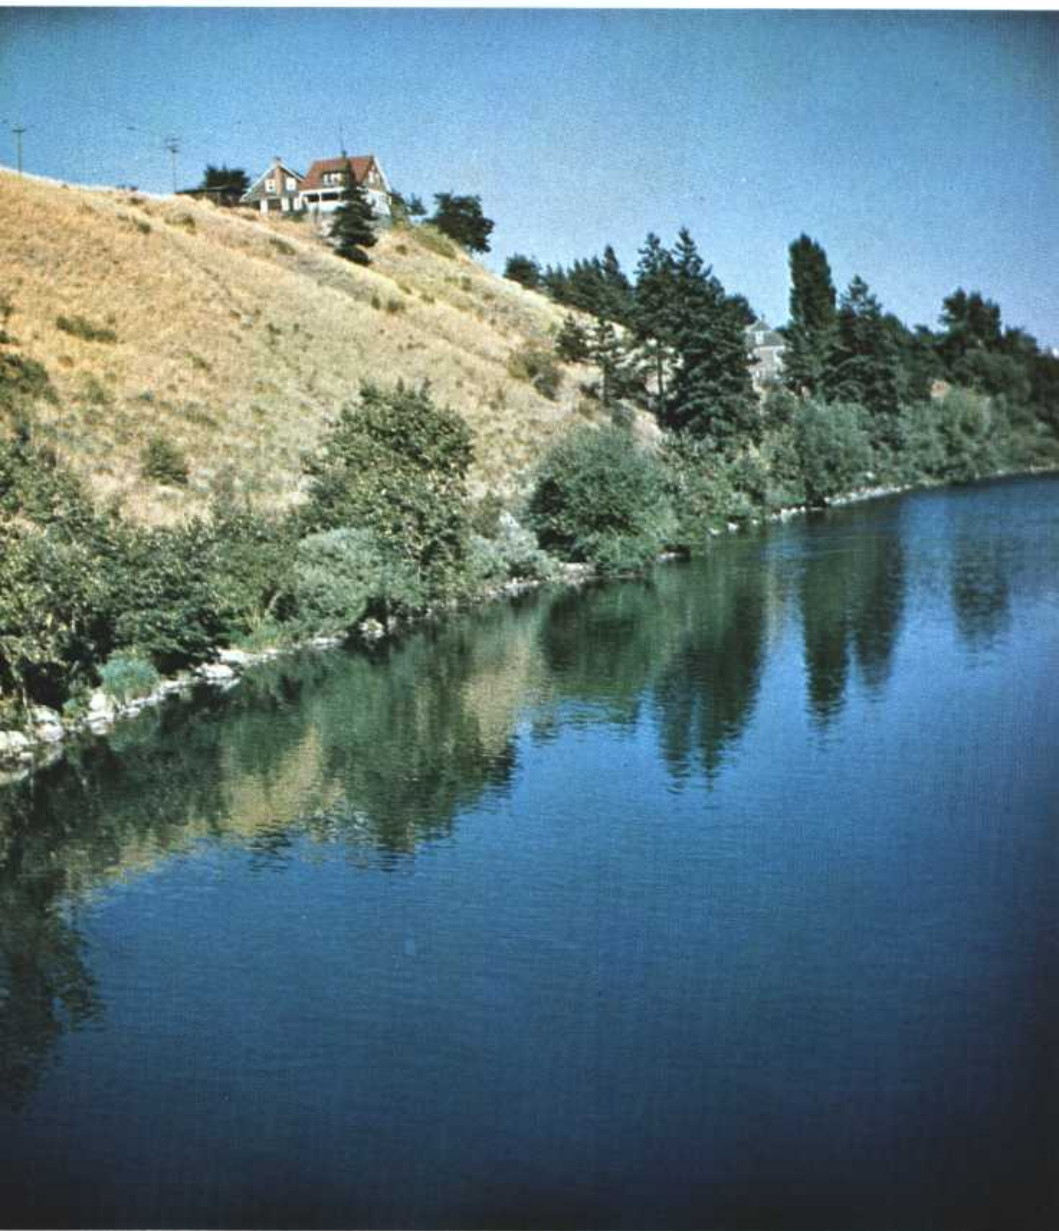
No. 162 upstream along right bank from section 4, Spokane River at Spokane, Wash.

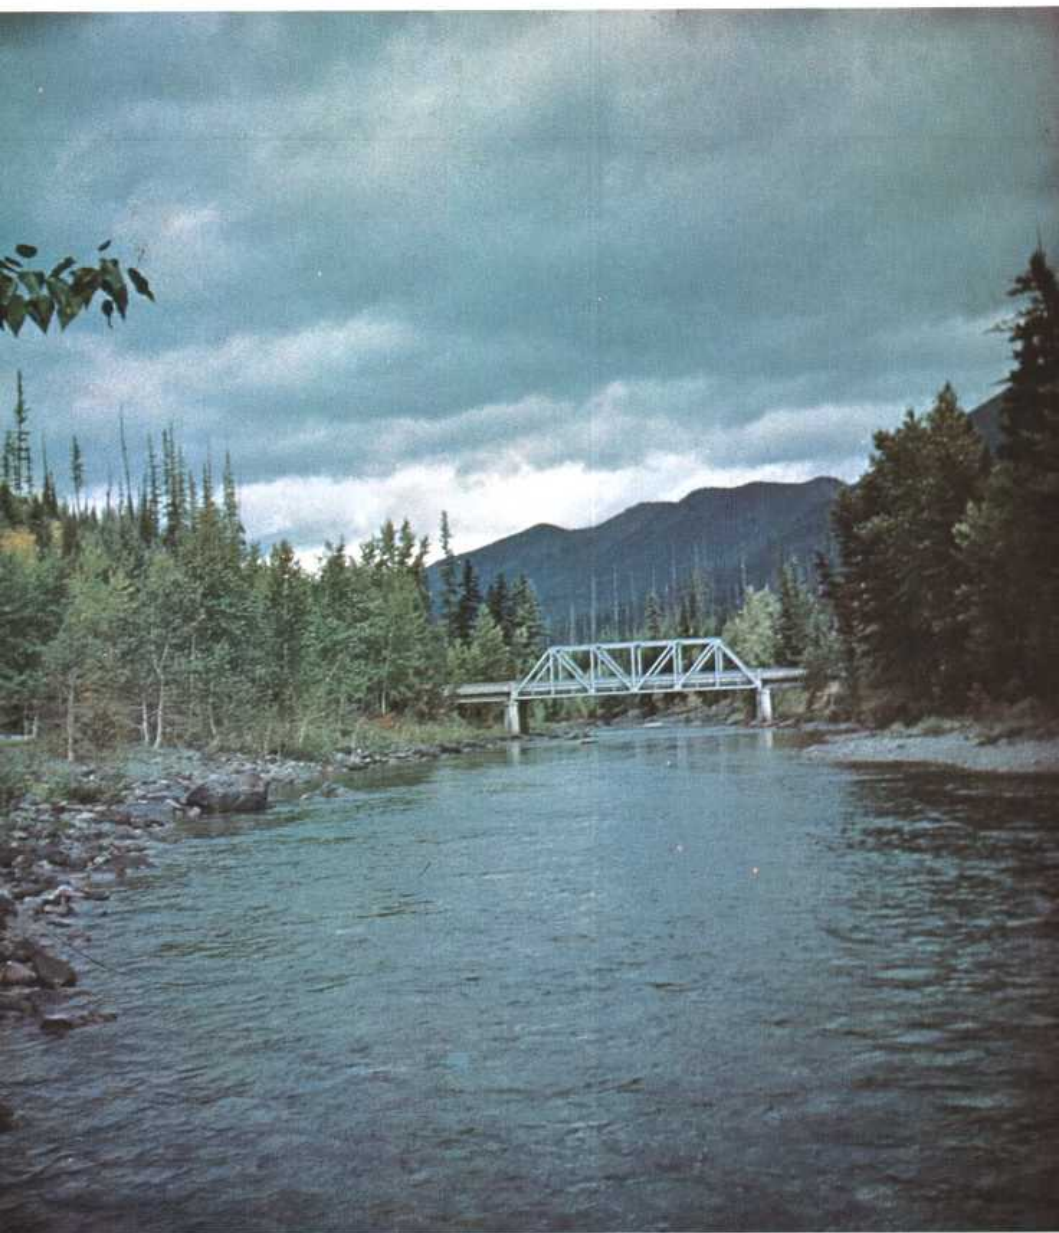
No. 117 downstream from section 1, Middle Fork Flathead River near Essex, Mont.

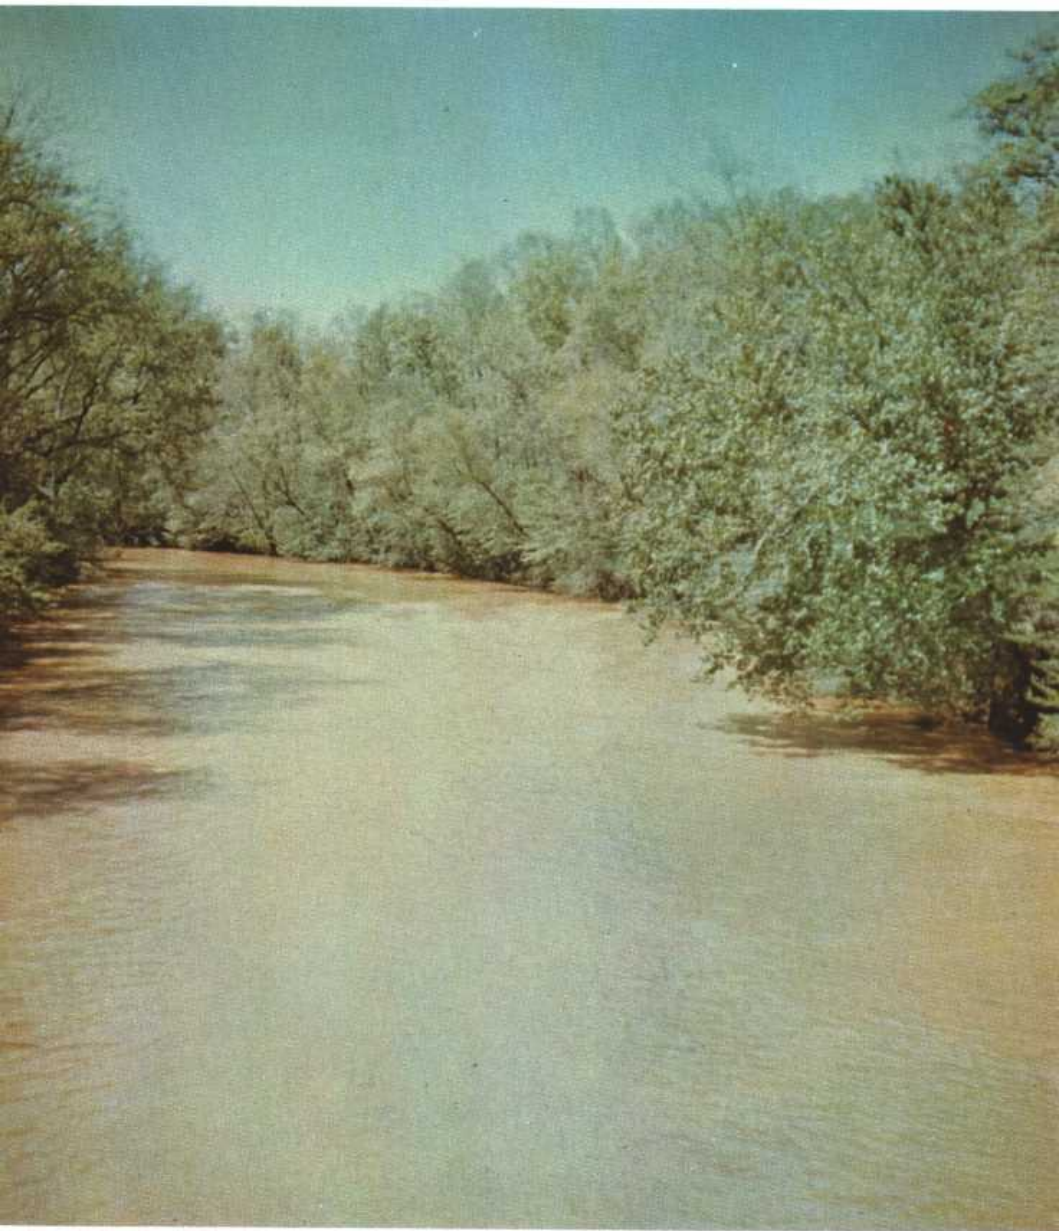
No. 1174 downstream from above section 4, Middle Oconee  
River near Athens, Ga.

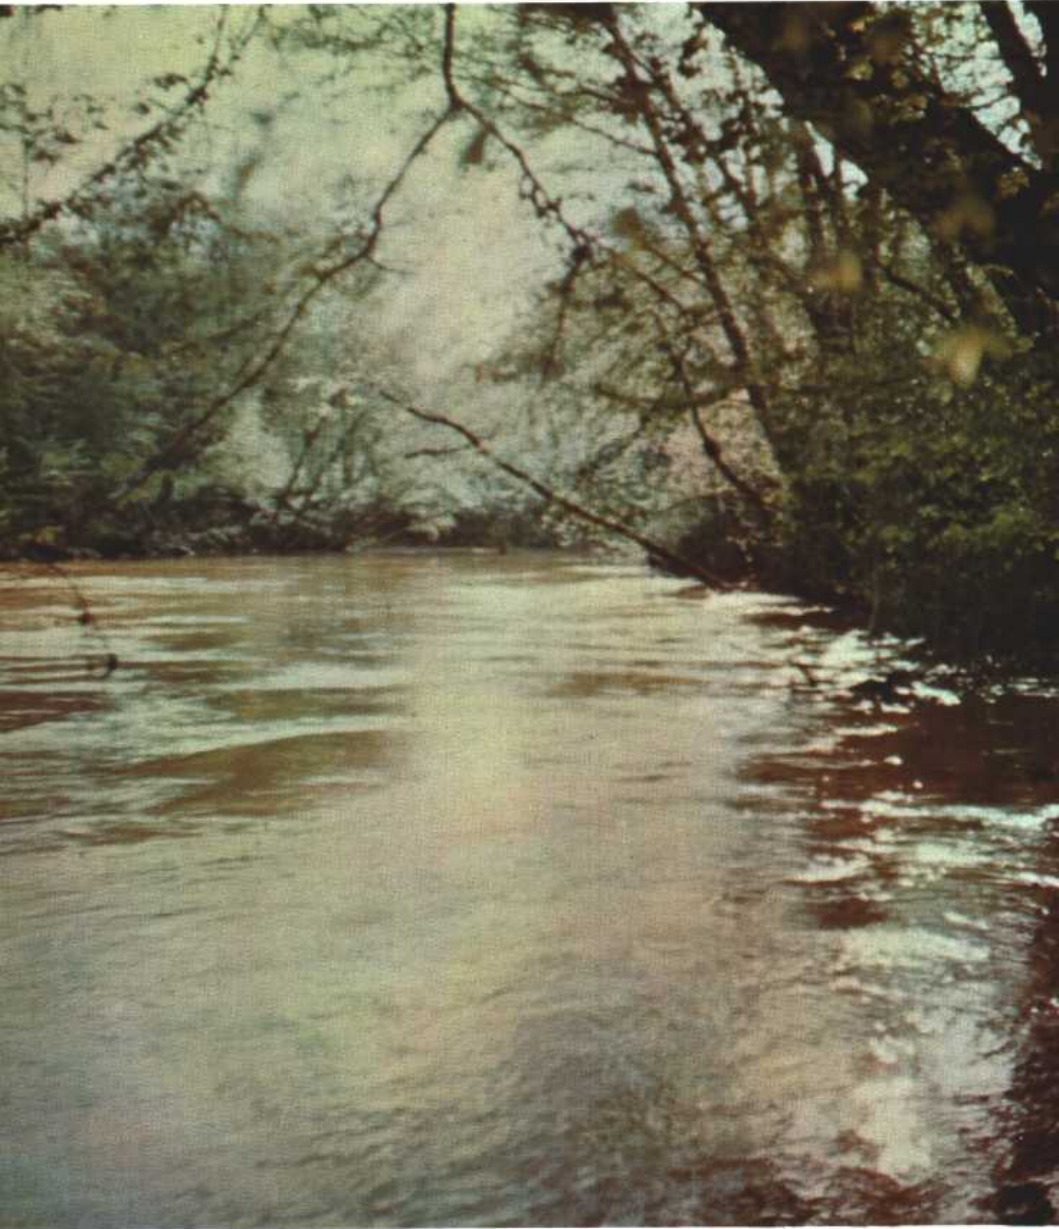
No. 1175 upstream from right bank at section 7, Middle Oconee River near Athens, Ga.

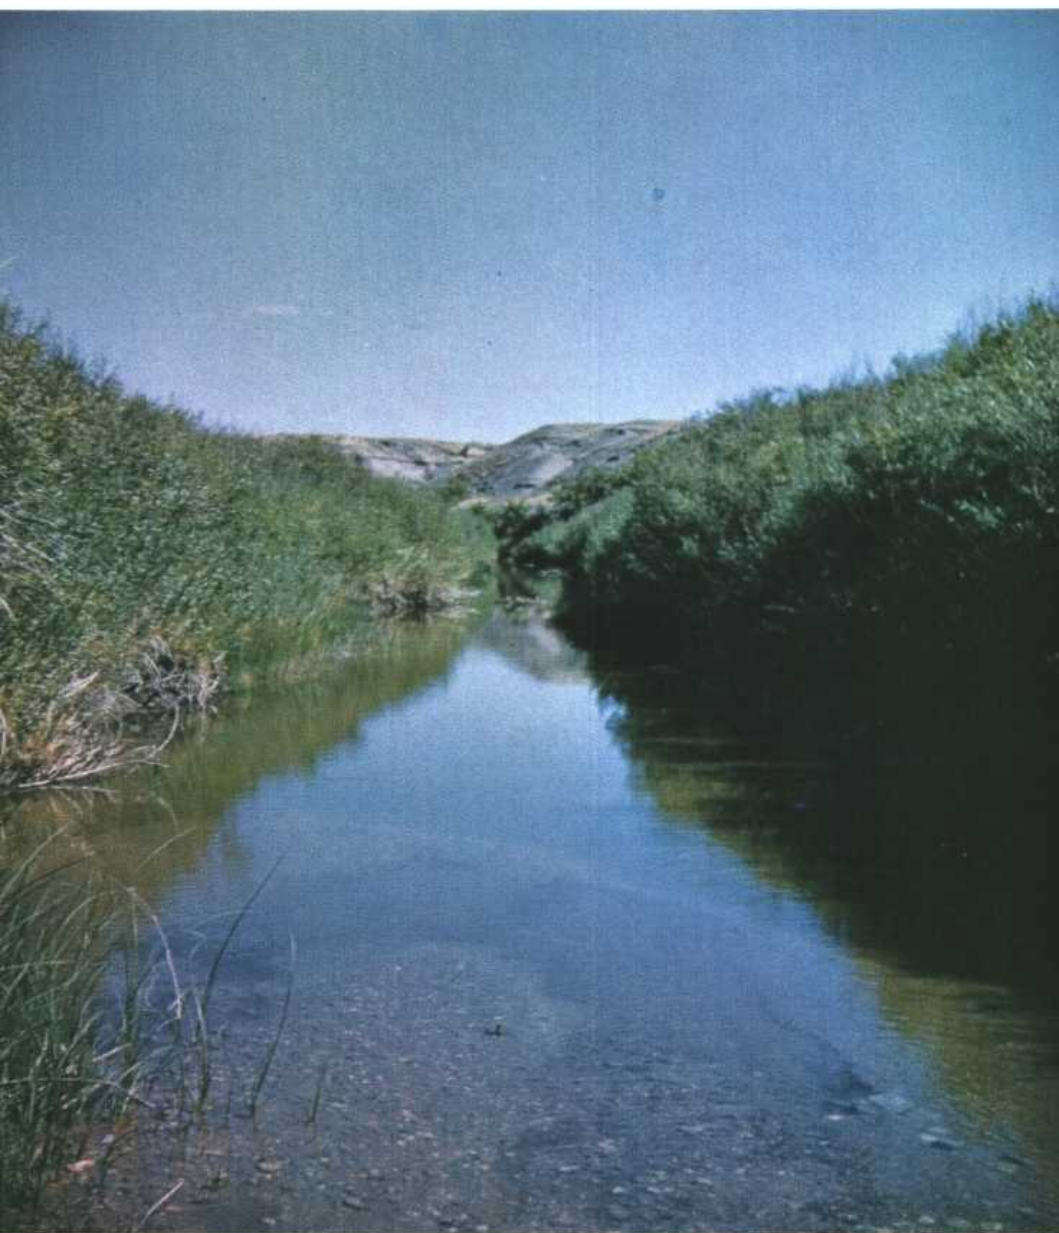
No. 962 downstream from above section 1, Beaver Creek  
near Newcastle, Wyo.

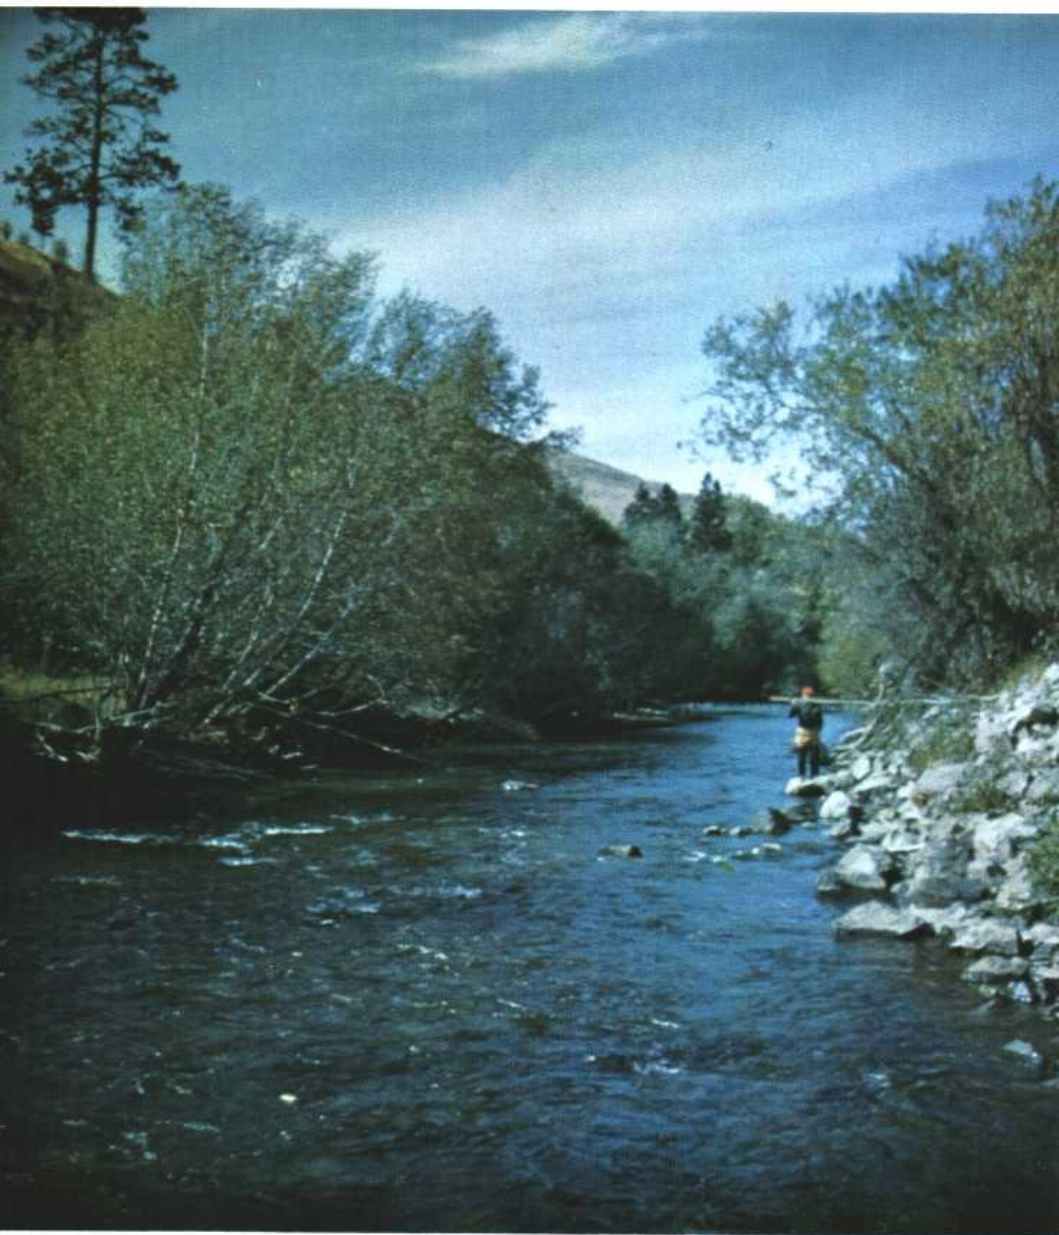
No. 10 downstream along right bank from above reach,  
Catherine Creek near Union, Oreg.

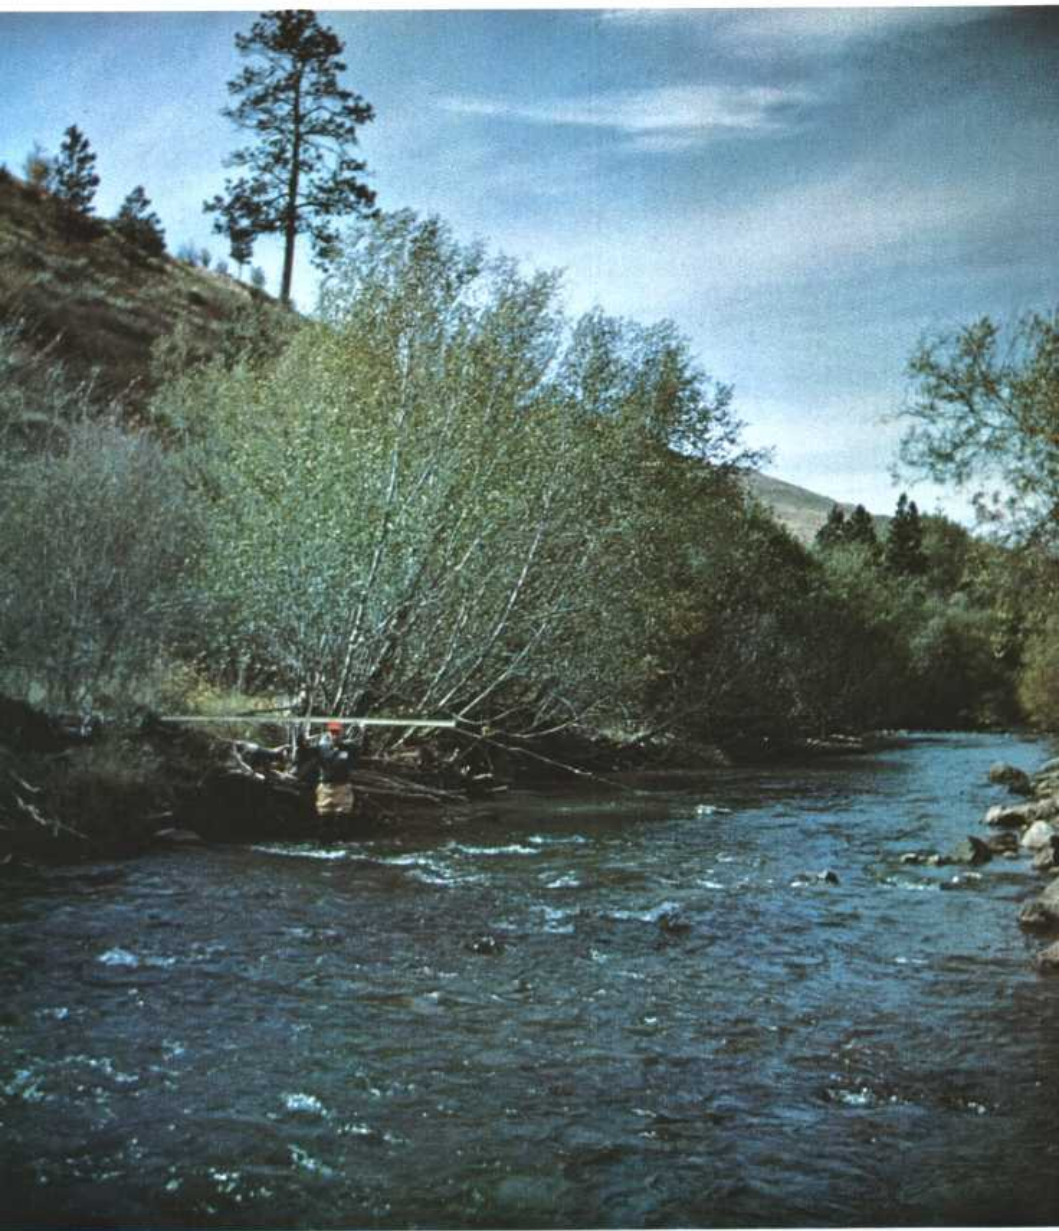
No. 11 downstream along left bank from above reach,  
Catherine Creek near Union, Oreg.

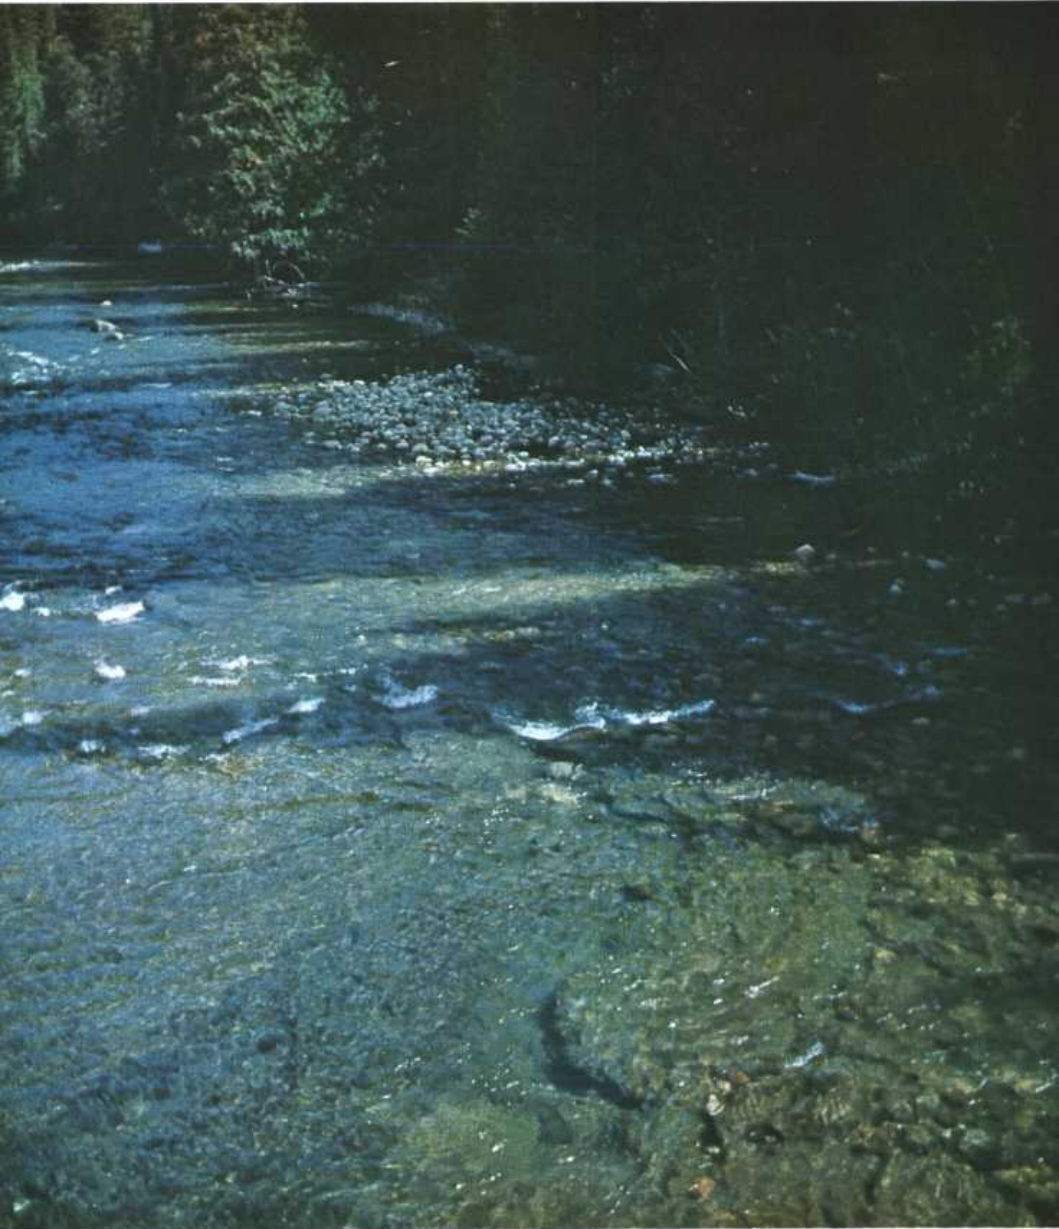
No. 15 downstream along right bank from section 2, Chiwawa River near Plain, Wash.

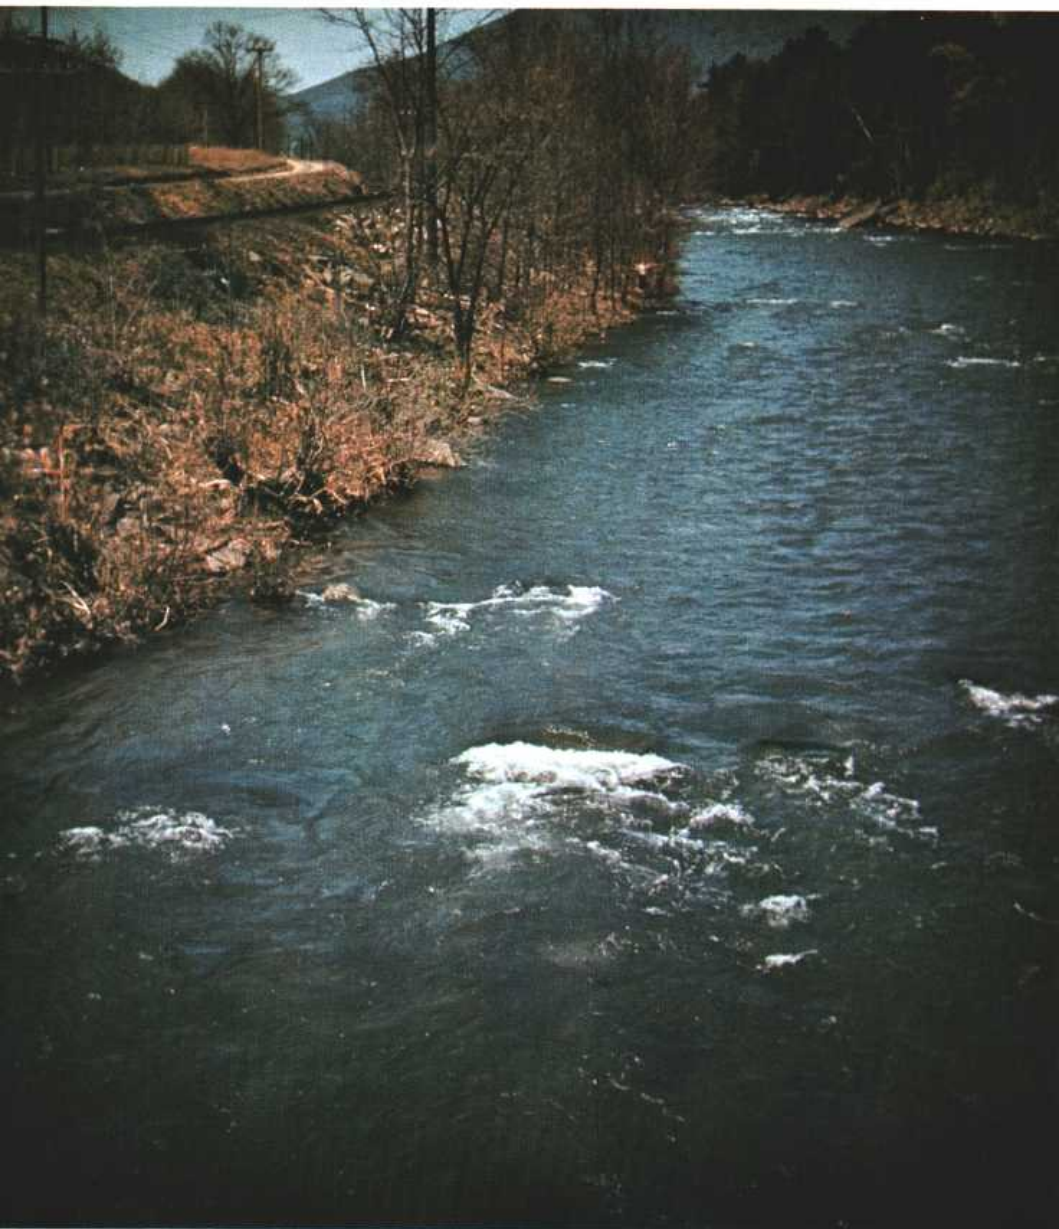
No. 358 upstream along right bank from below reach,  
Esopus Creek at Coldbrook, N.Y.

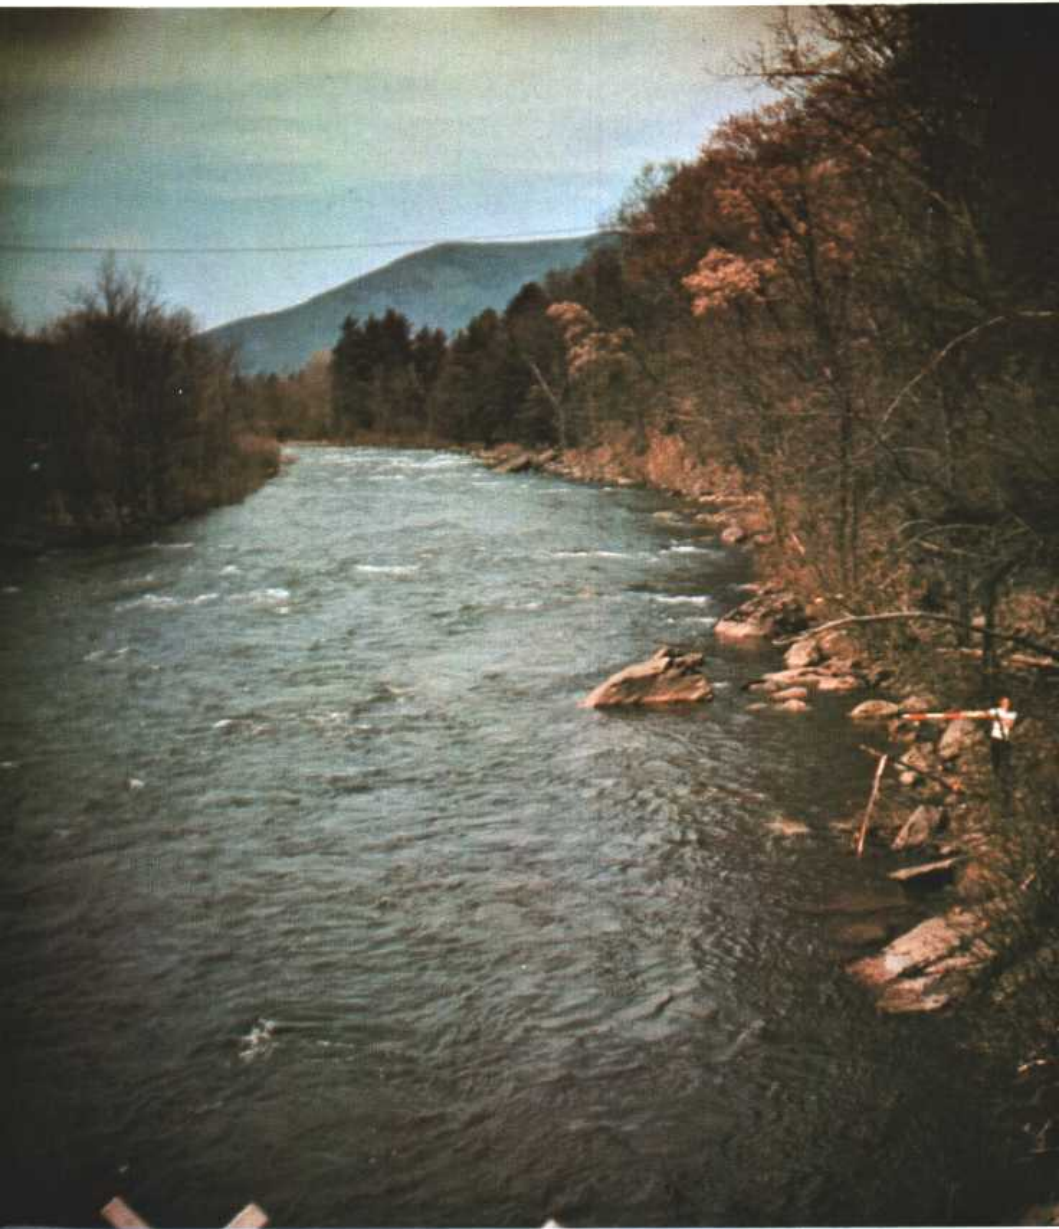
No. 359 upstream along left bank from below reach,  
Esopus Creek at Coldbrook, N.Y.

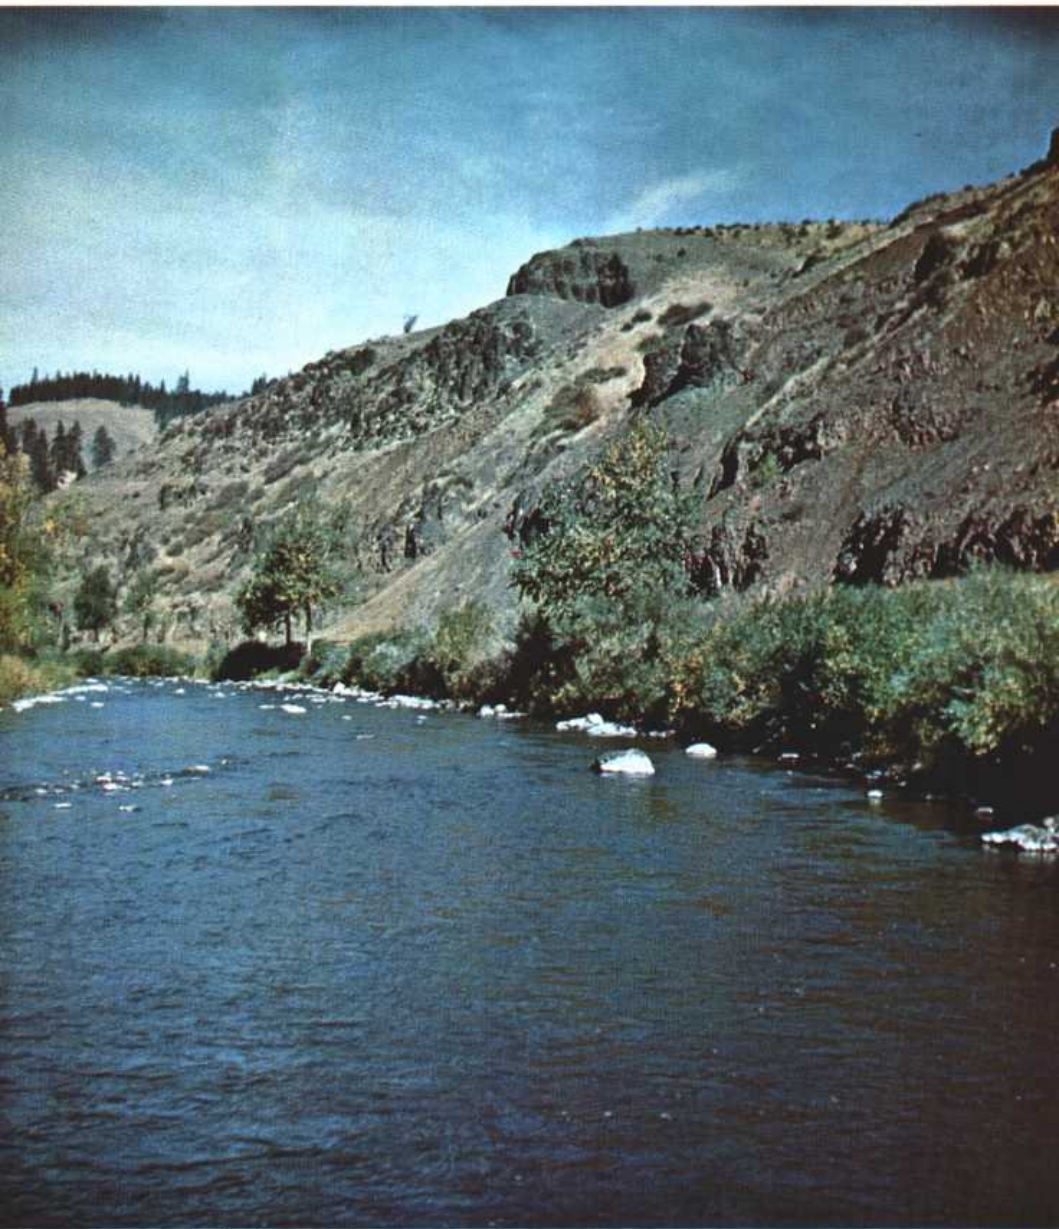
No. 78 upstream along left bank from channel below section 3,  
Grande Ronde River at La Grande, Oreg.

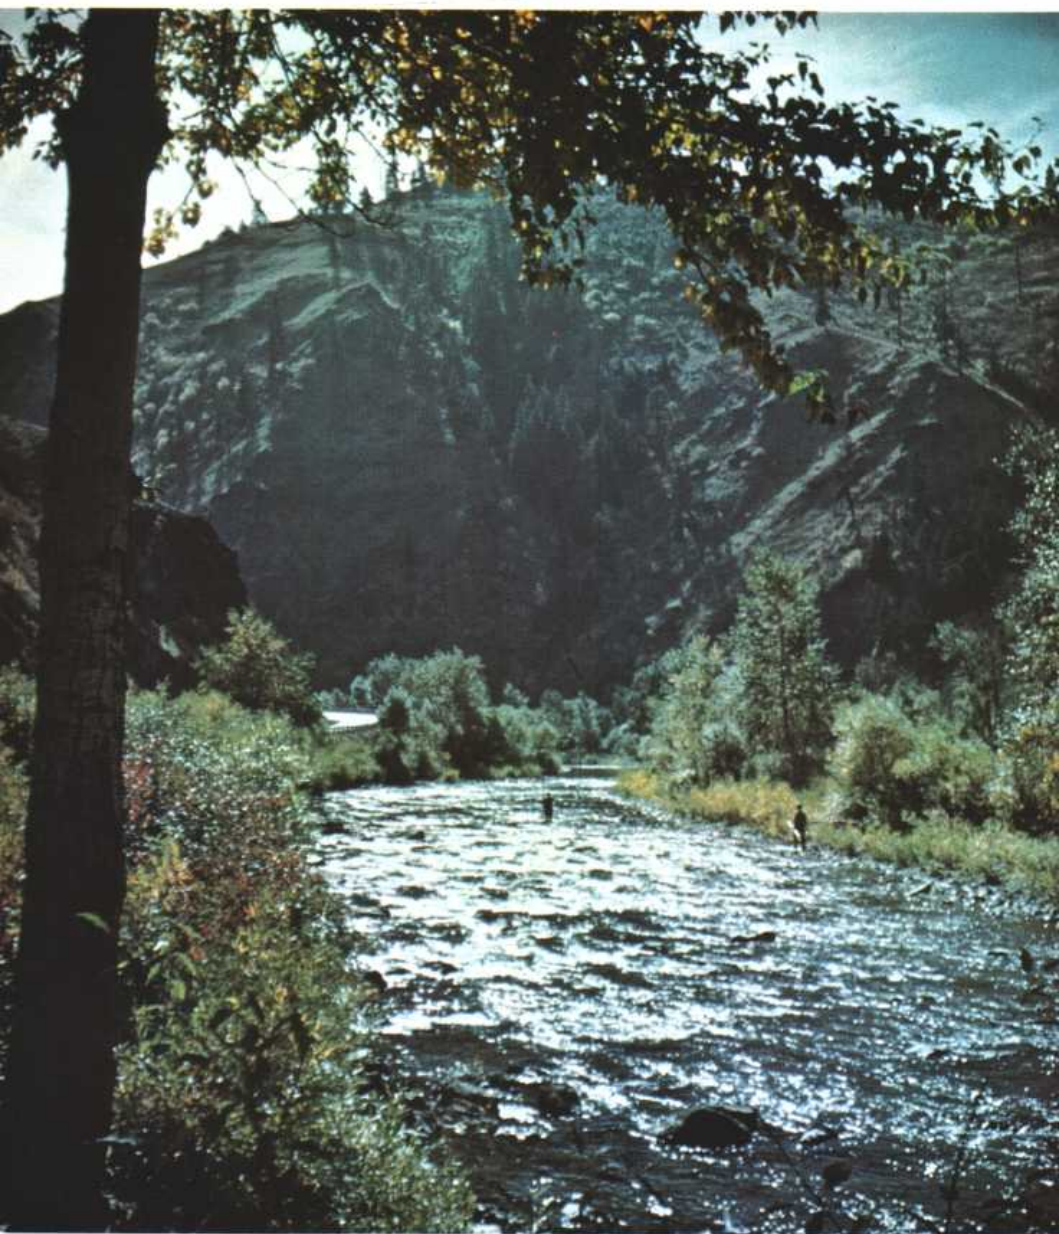
No. 80 downstream from left bank above section 1,  
Grande Ronde River at La Grande, Oreg.

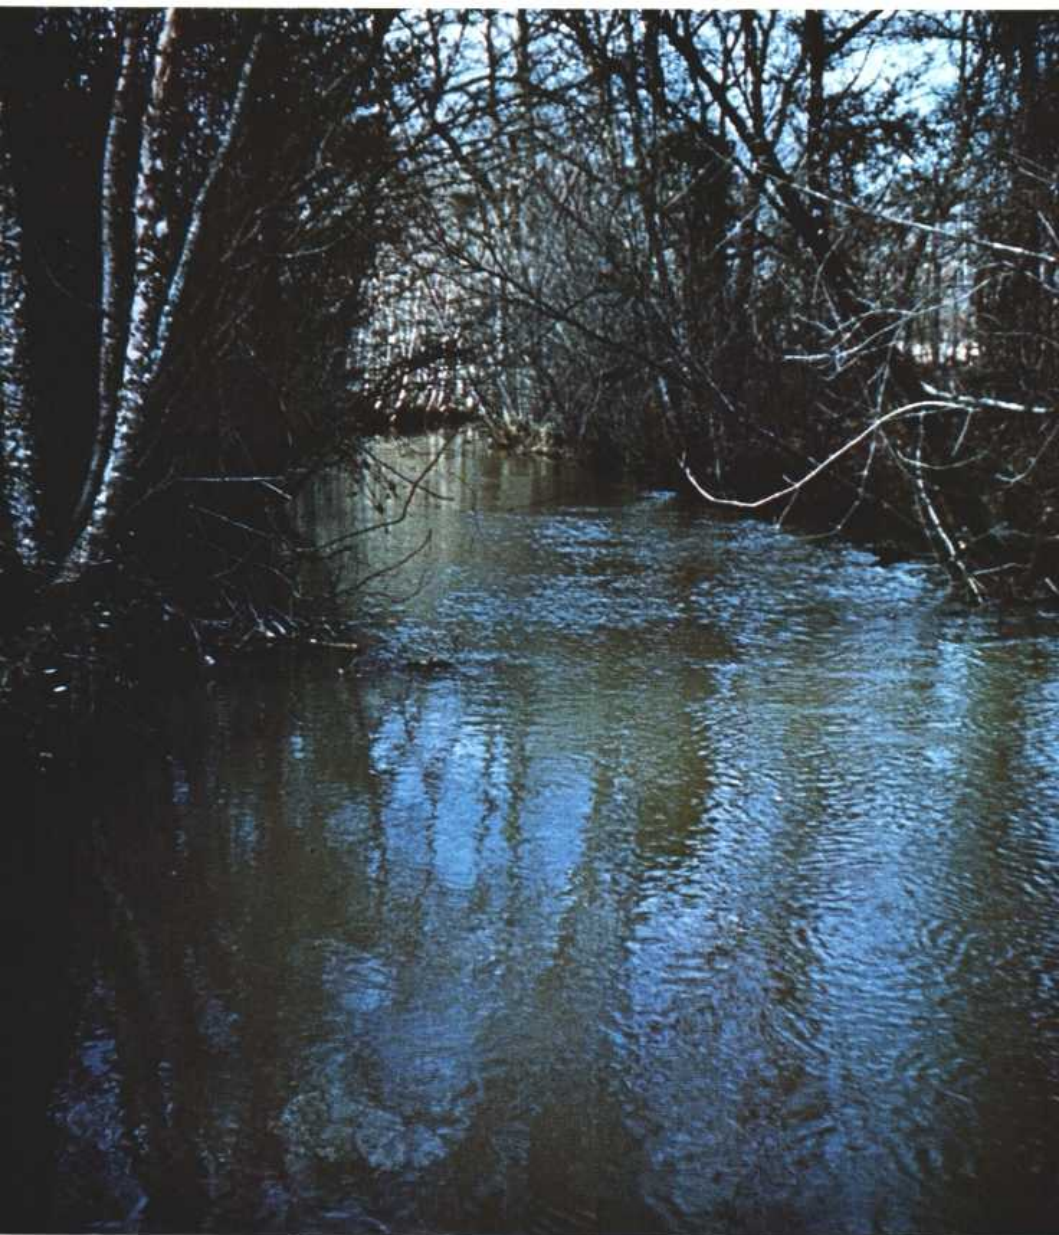
No. 1177 downstream from left bank at section 2,  
Murder Creek near Monticello, Ga.

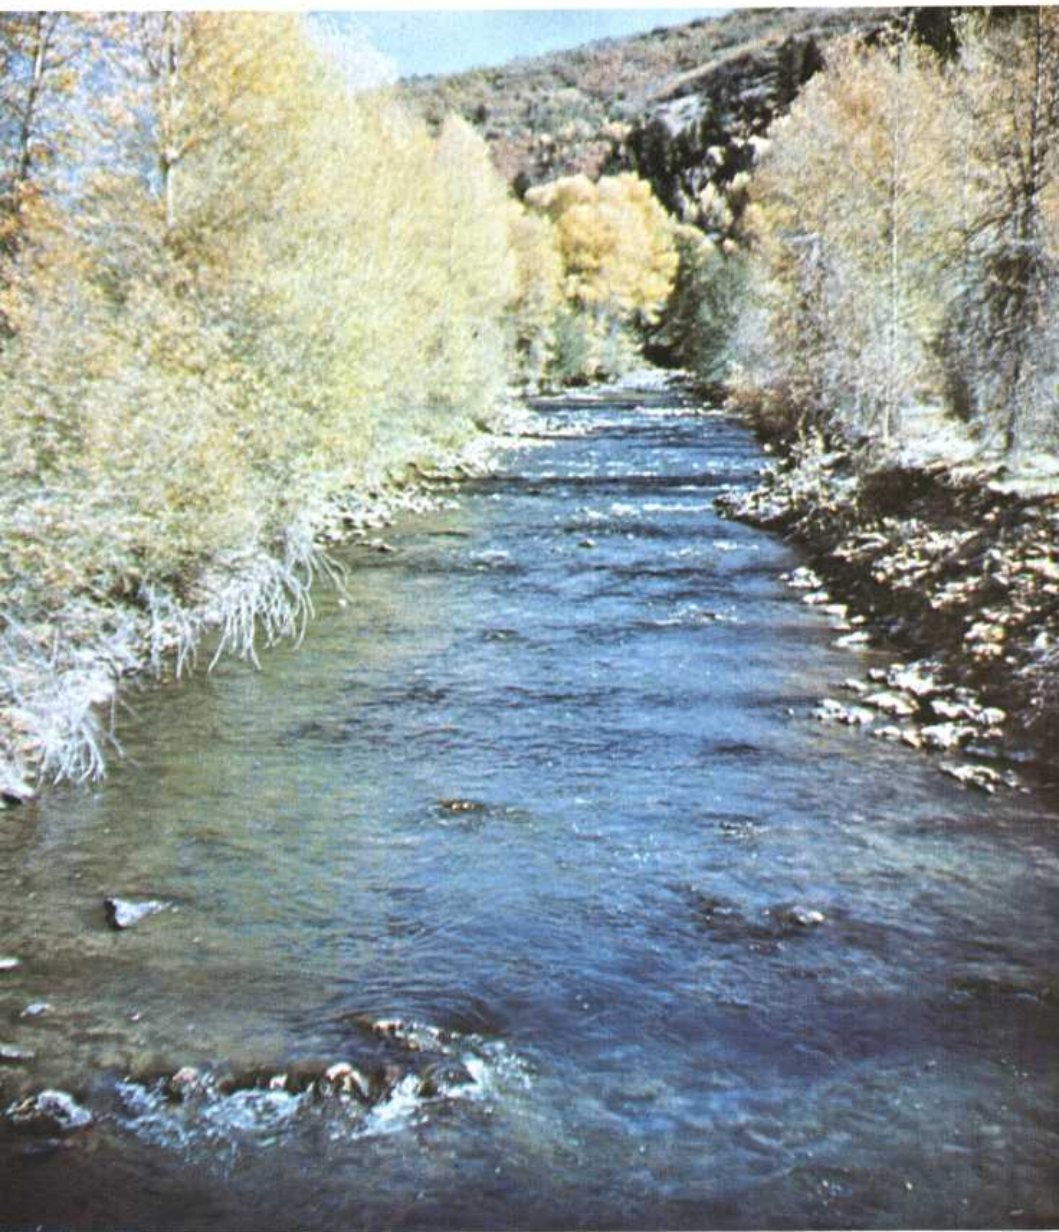
No. 770 upstream from section 3, Provo River near  
Hailstone, Utah.

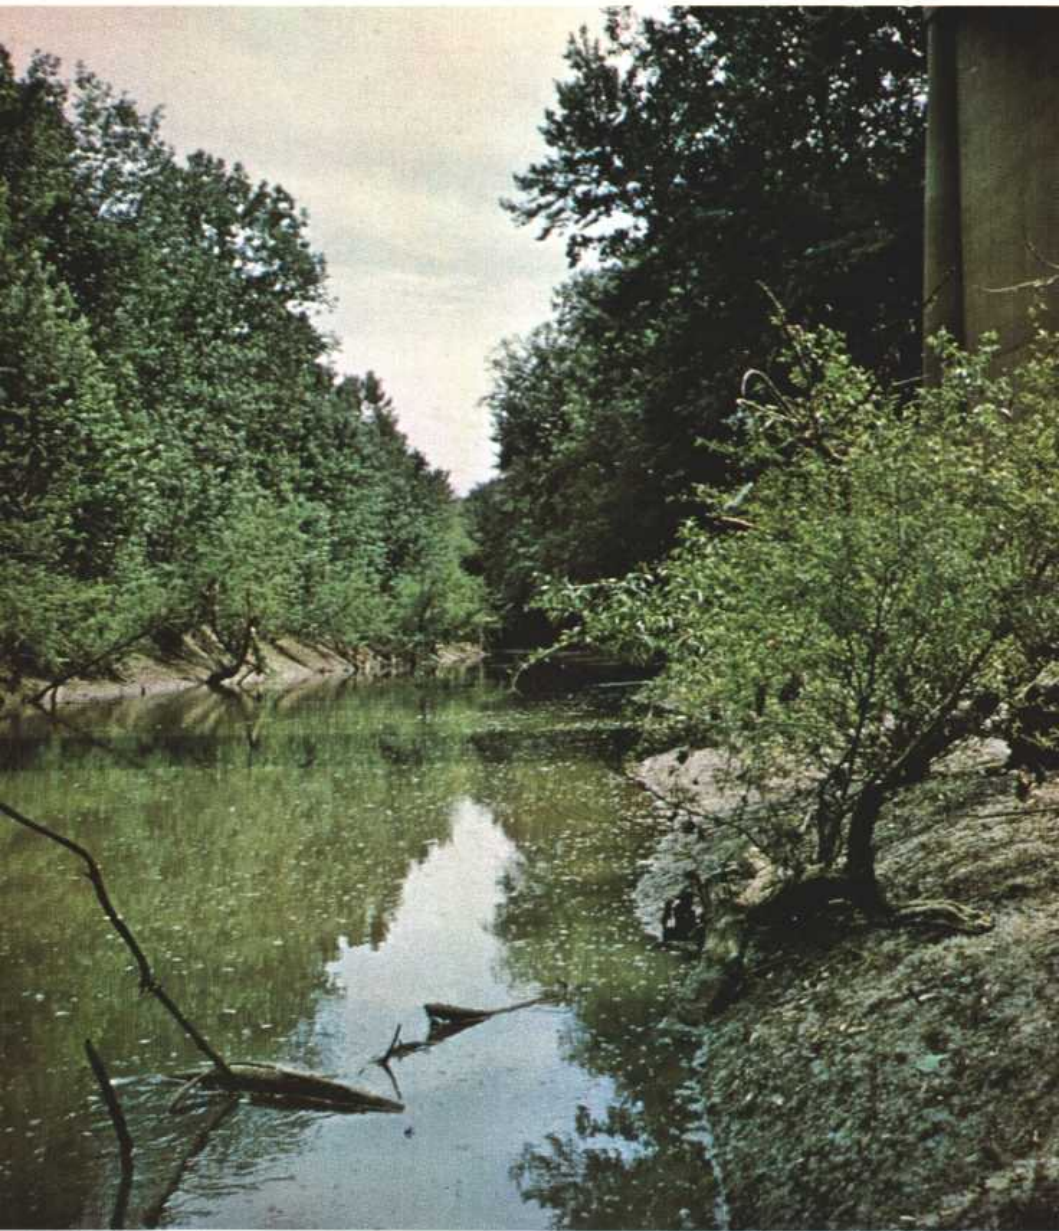
No. 1190 upstream from left bank below section 6,  
Rolling Fork at Boston, Ky.

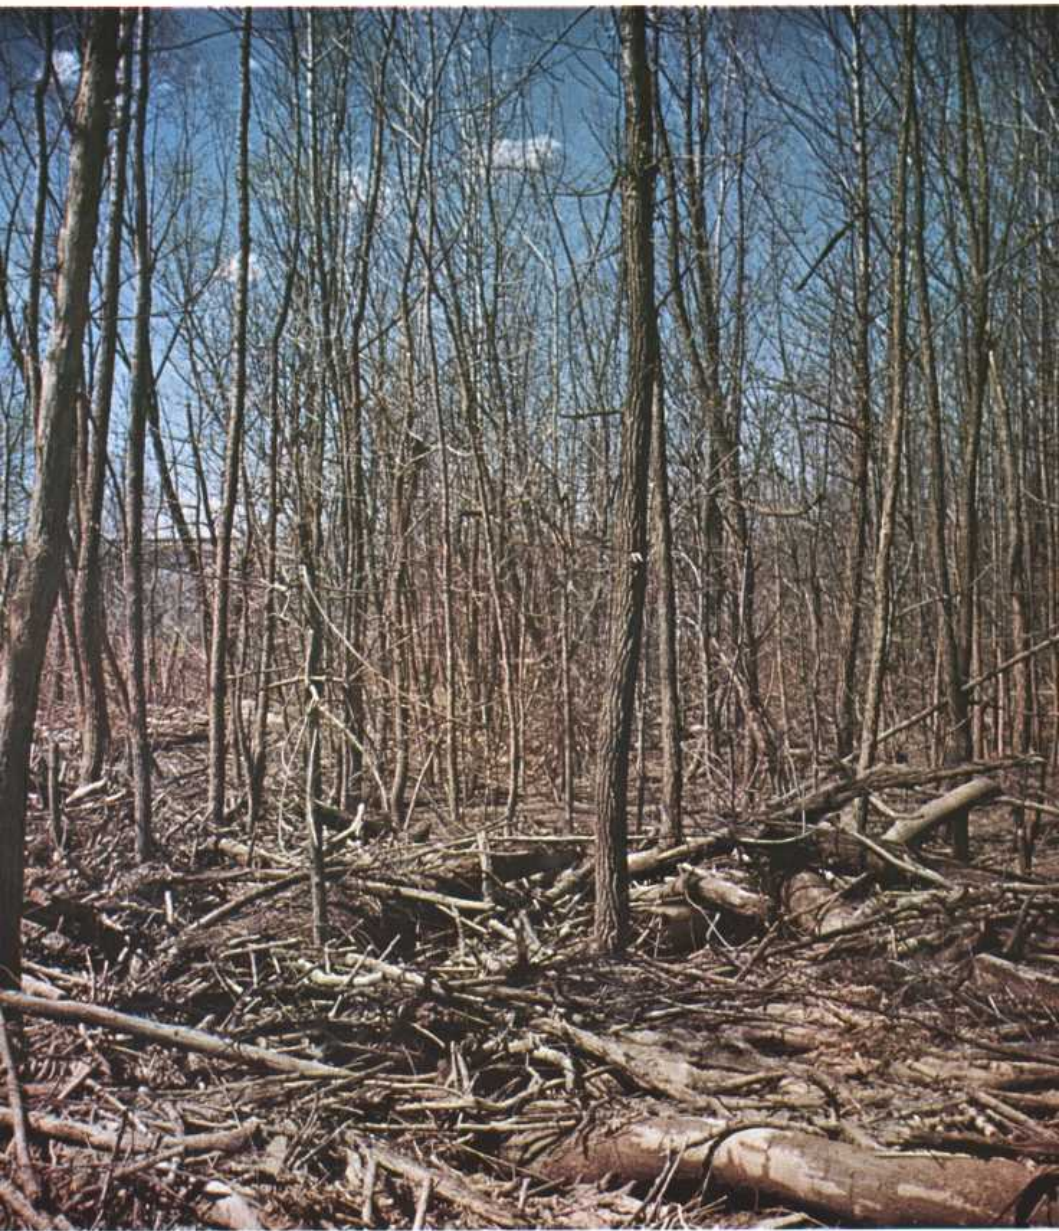
No. 391 downstream through right overflow from section 2,  
Rolling Fork at Boston, Ky.

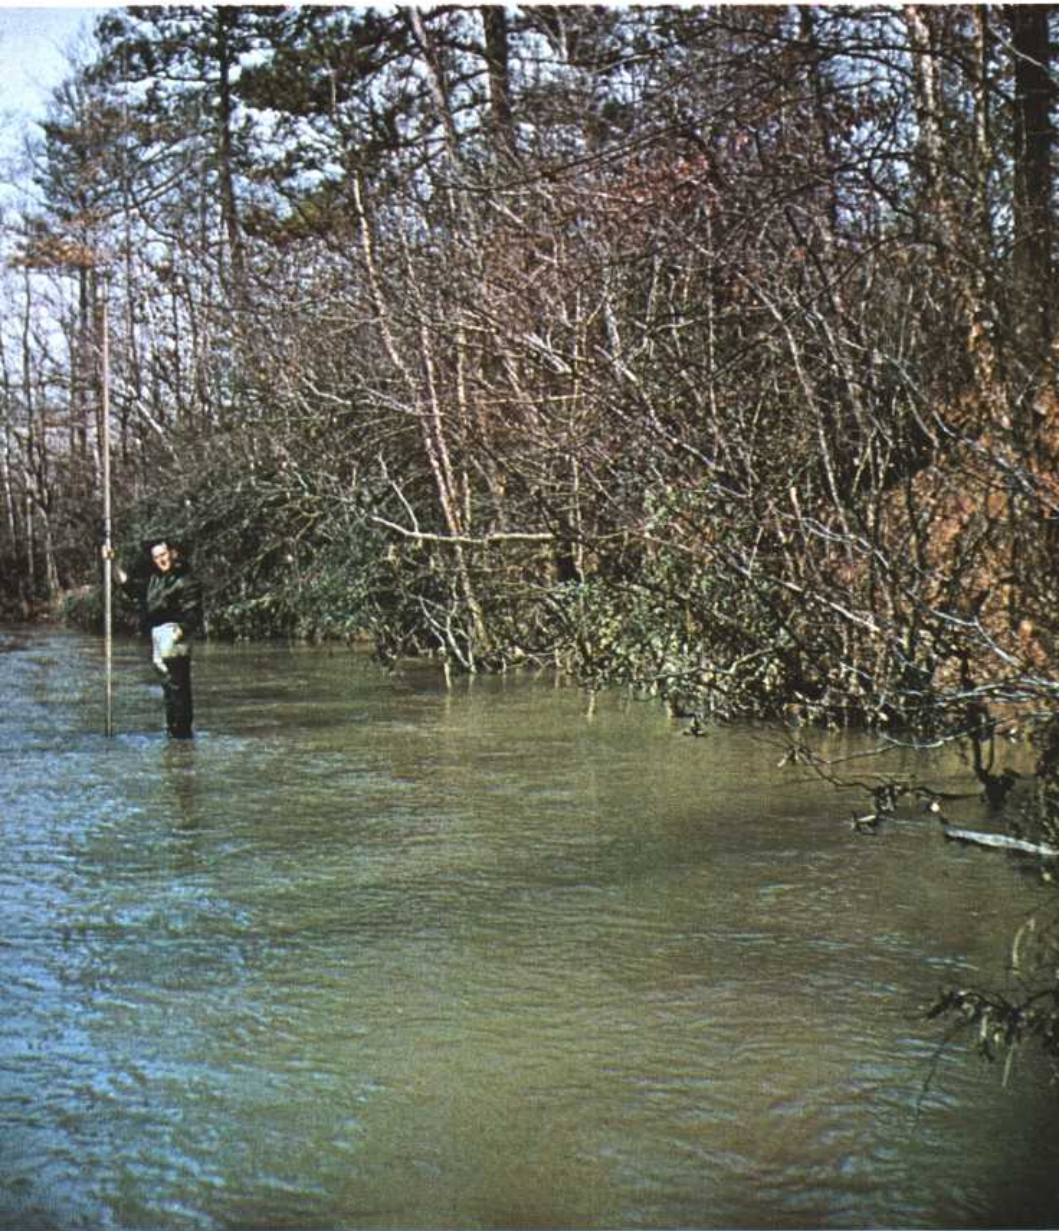
No. 1179 upstream from section 2,  
South Beaverdam Creek near Dewy Rose, Ga.
