# Roughness Characteristics of Natural Channels

By HARRY H. BARNES, JR.

U.S. GEOLOGICAL SURVEY WATER-SUPPLY PAPER 1849

*Color photographs and descriptive  
data for 50 stream channels for  
which roughness coefficients have  
been determined*

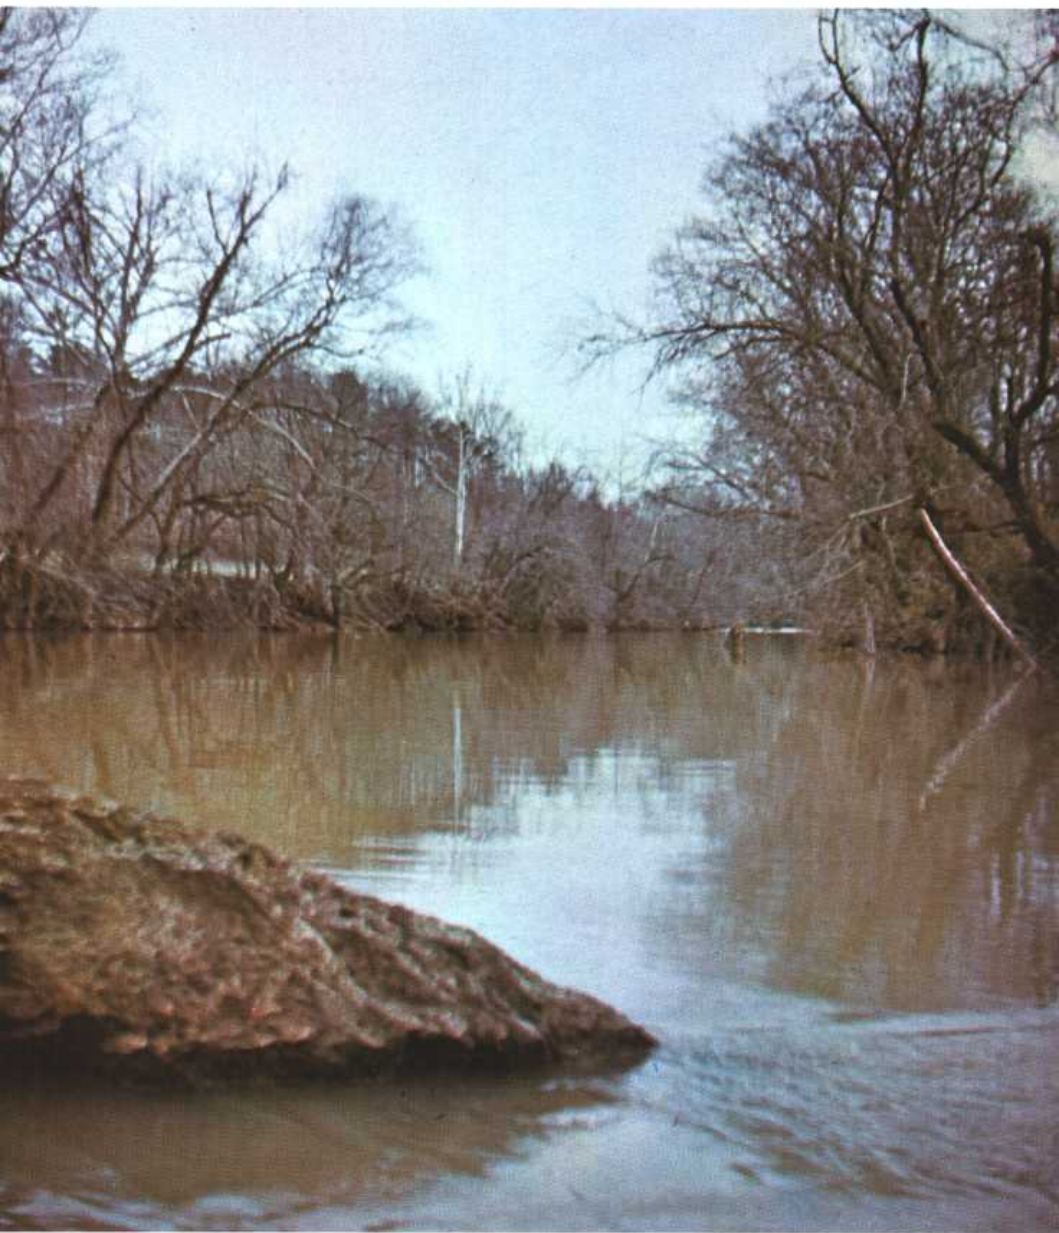
No. 1180 upstream from section 7, Deep River at  
Ramseur, N.C.

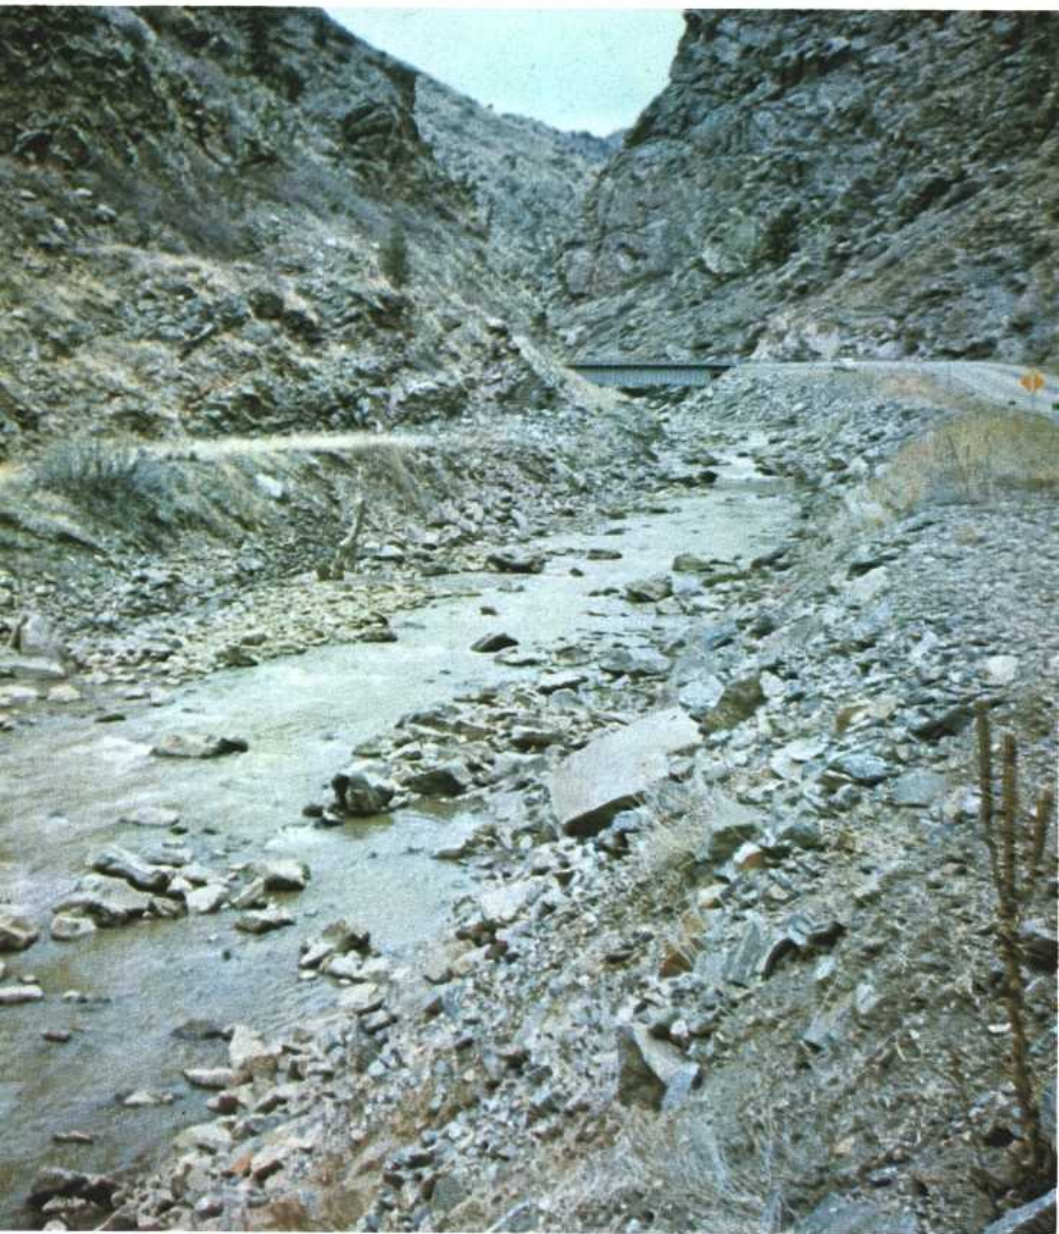
No. 1198 upstream from section 16, Clear Creek near Golden, Colo.

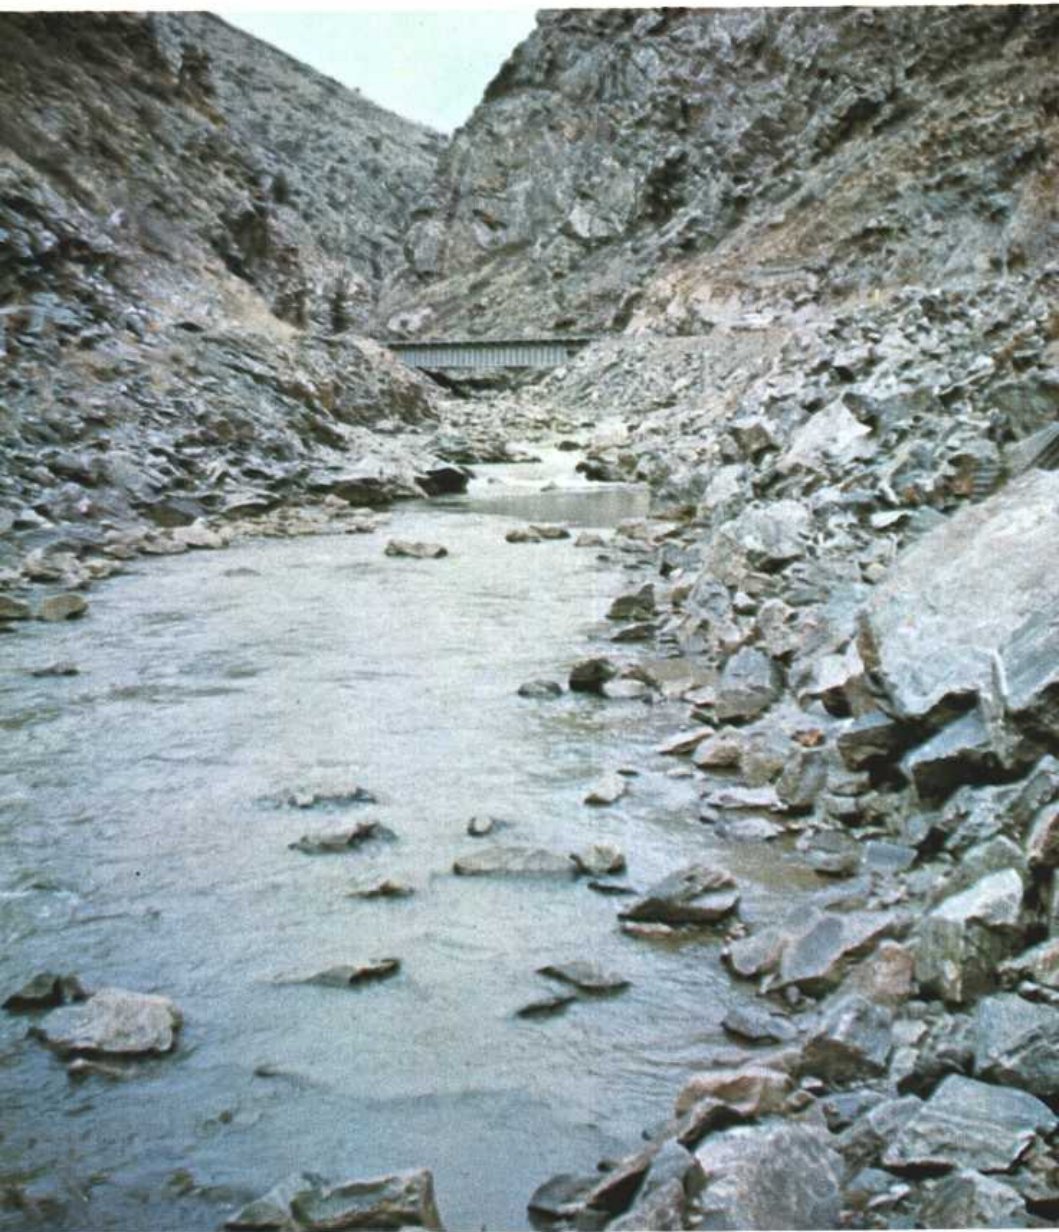
No. 1199 upstream from left bank at section 15,  
Clear Creek near Golden, Colo.

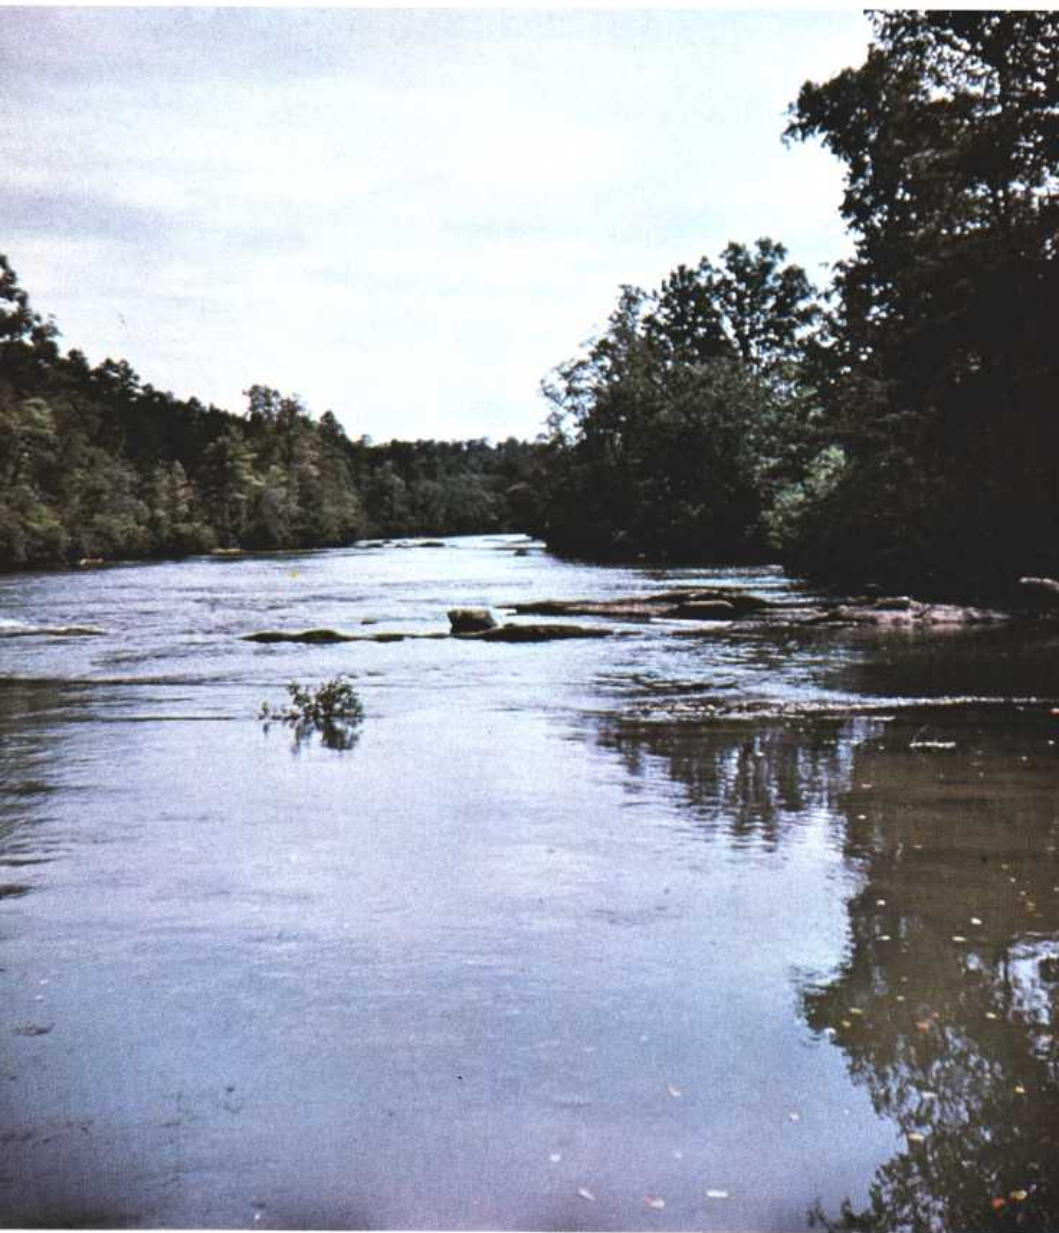
No. 1186 downstream from above section 2,  
Chattahoochee River near Leaf, Ga.

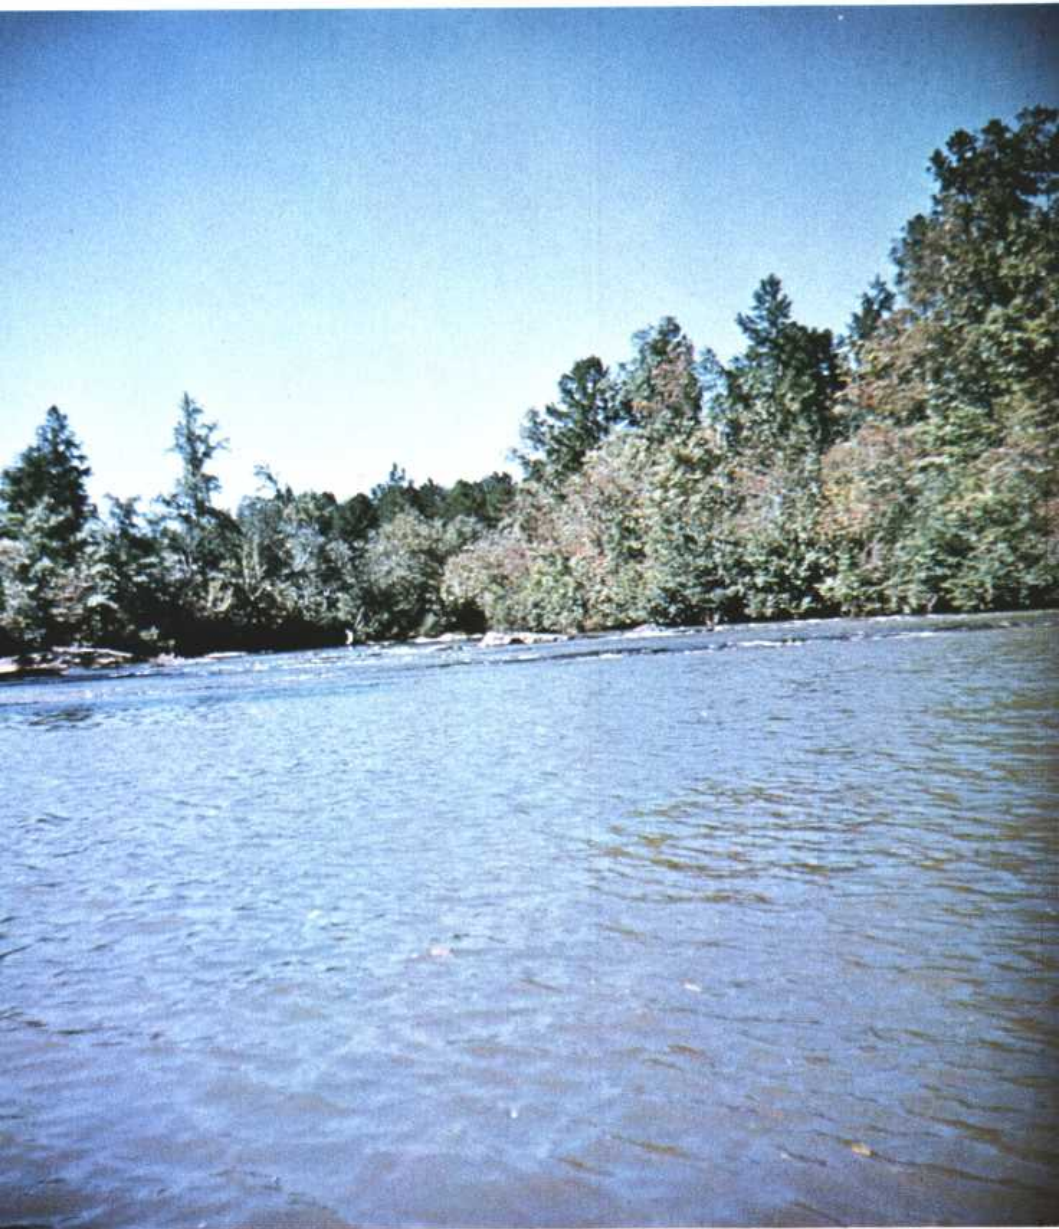
No. 1187 upstream from section 4,  
Chattahoochee River near Leaf, Ga.

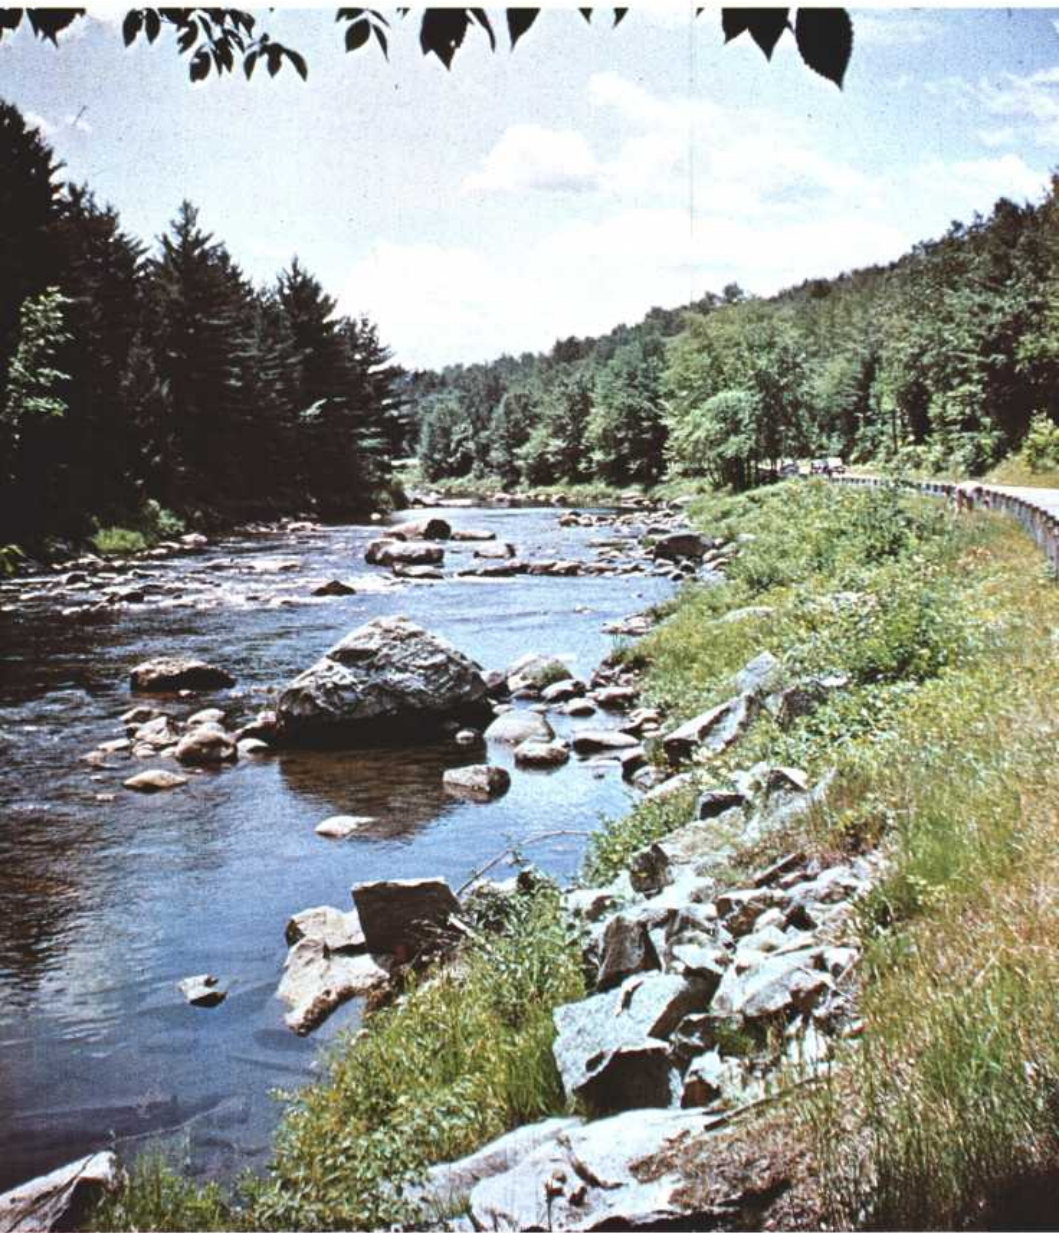
No. 698 upstream along left bank from below section 2,  
East Branch Ausable River at Au Sable Forks, N.Y.

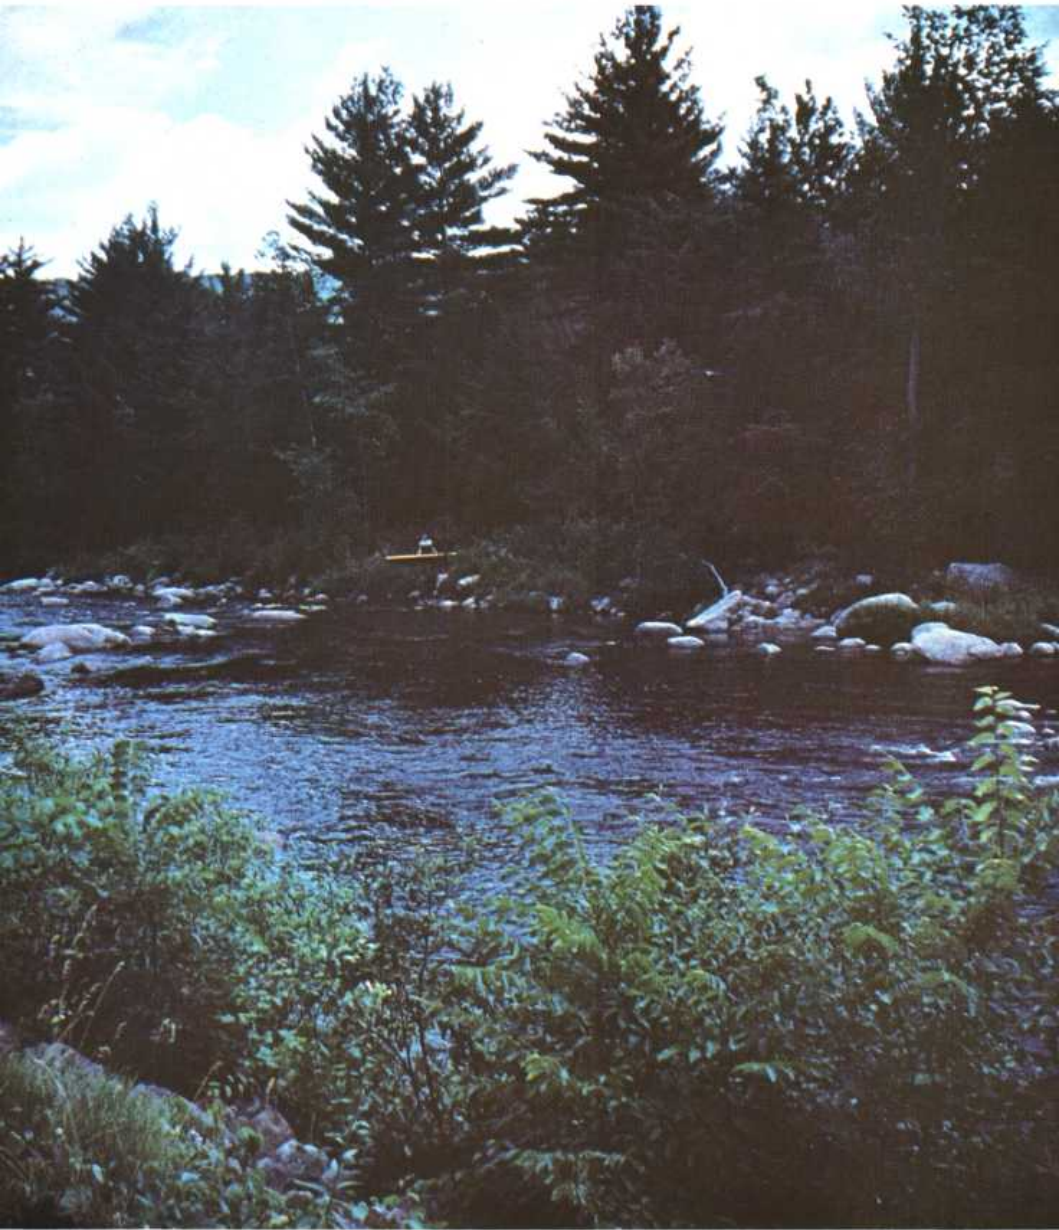
No. 700 downstream from left bank at section 1,  
East Branch Ausable River at Au Sable Forks, N.Y.

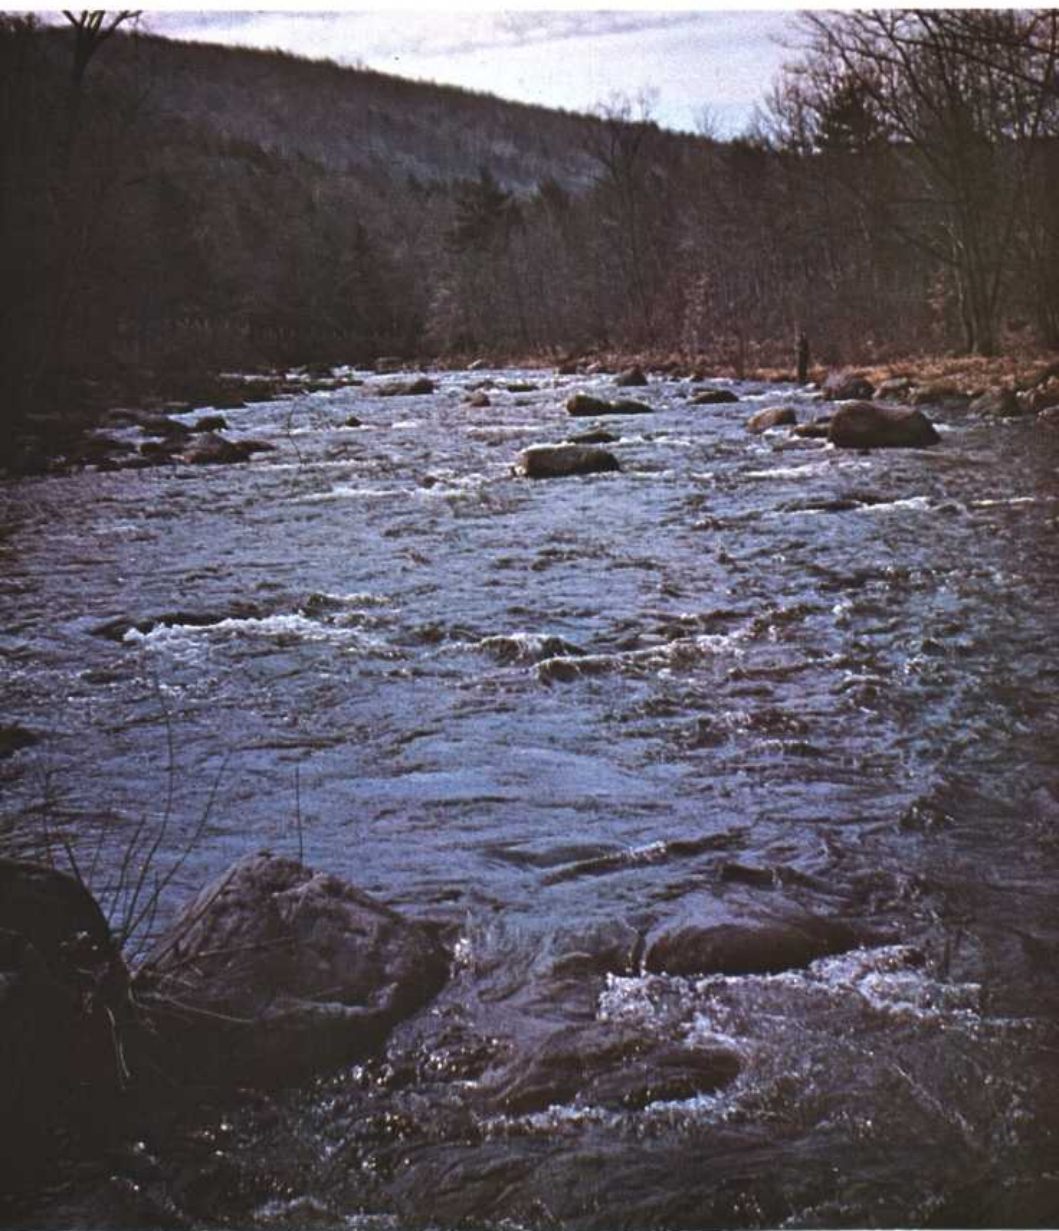
No. 316 upstream from below section 2, Middle Branch  
Westfield River at Goss Heights, Mass.

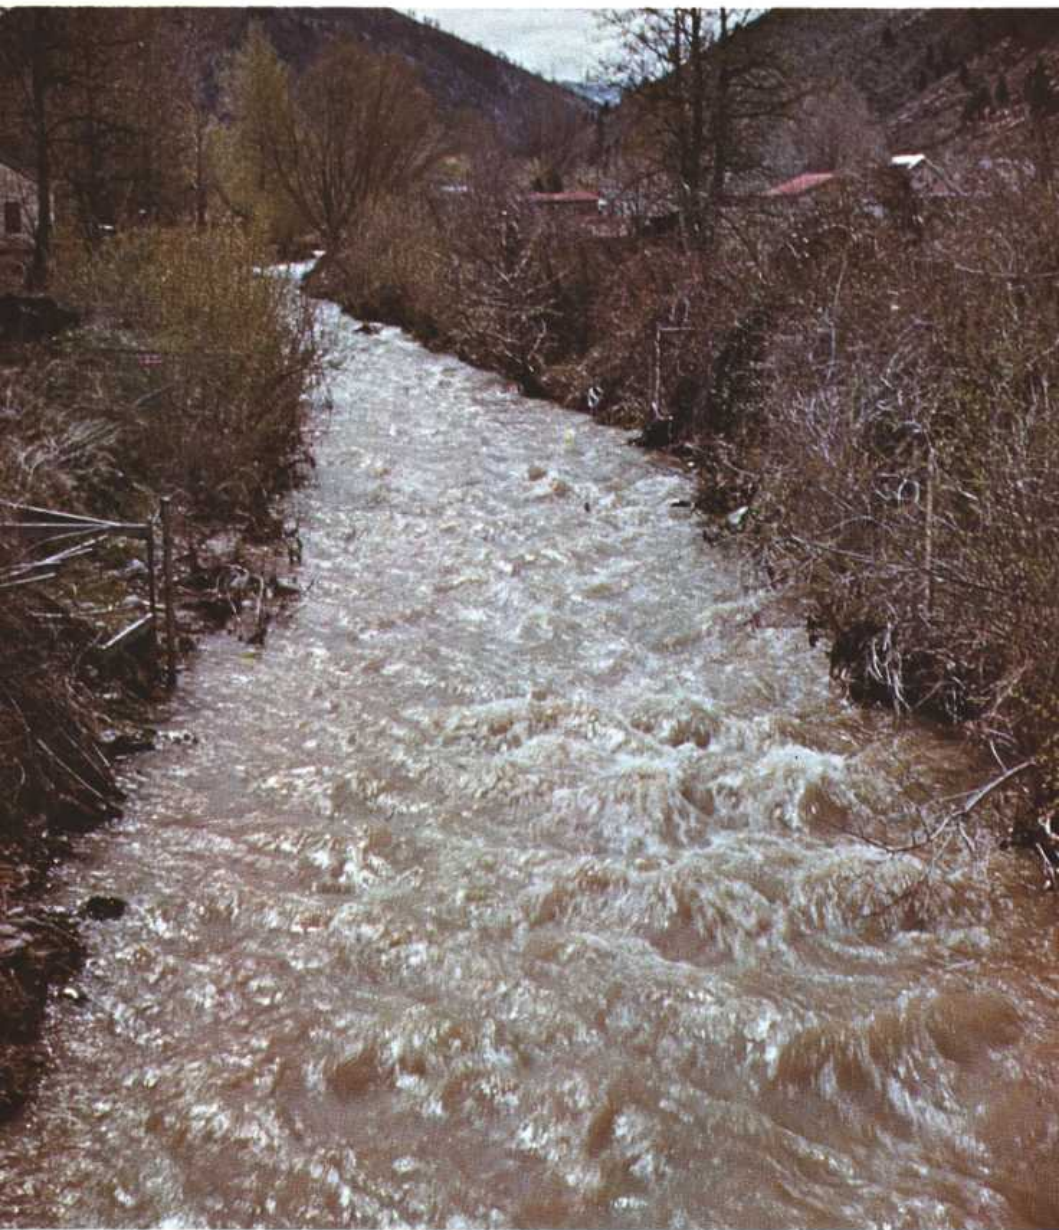
No. 1184 upstream from below section 3, Mission Creek  
near Cashmere, Wash.

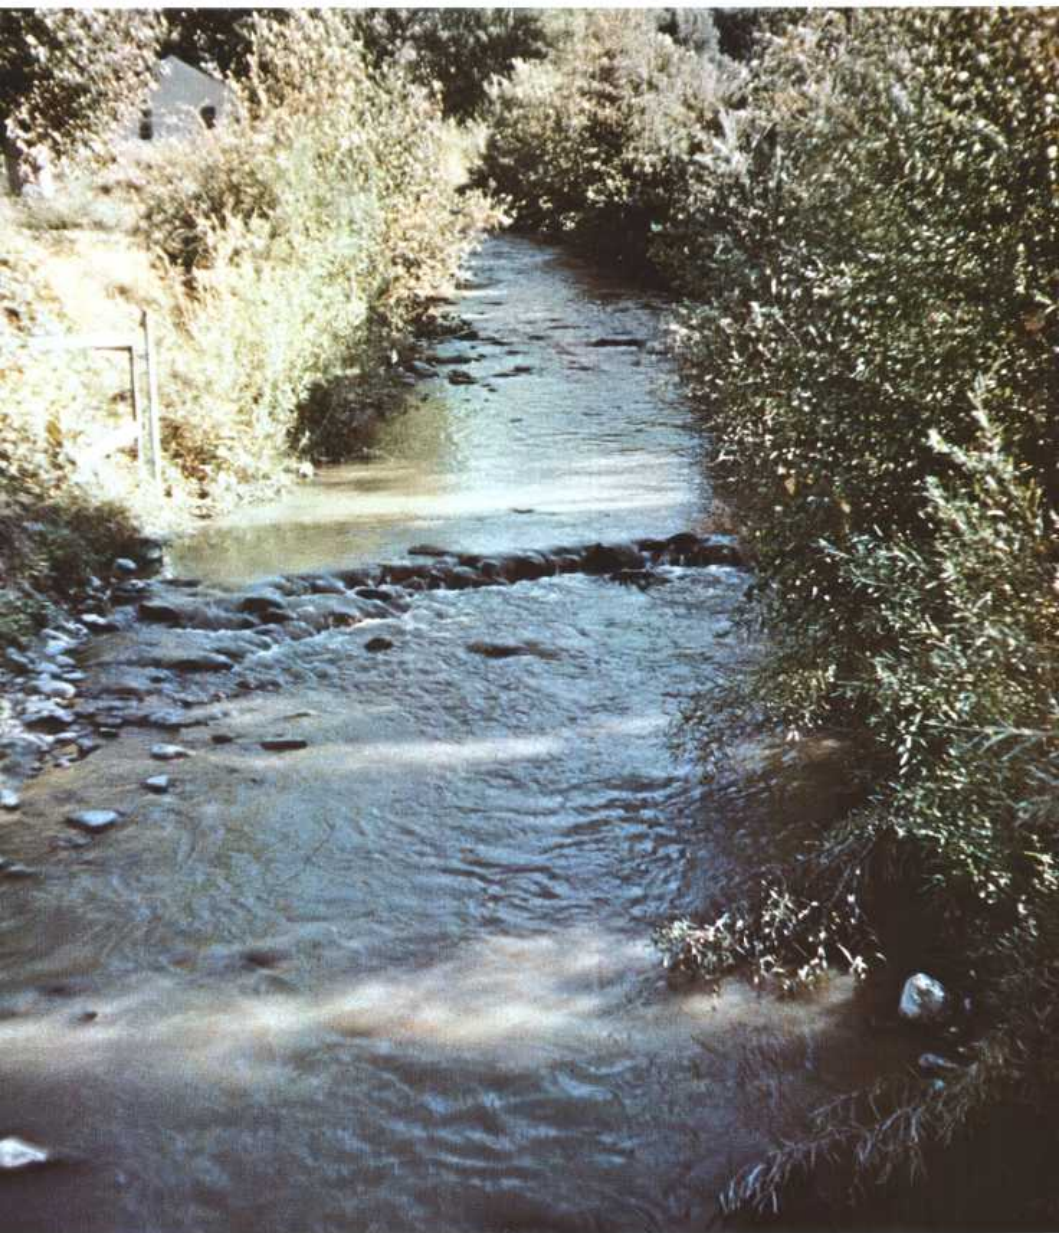
No. 1185 upstream from below section 3, Mission Creek  
near Cashmere, Wash.

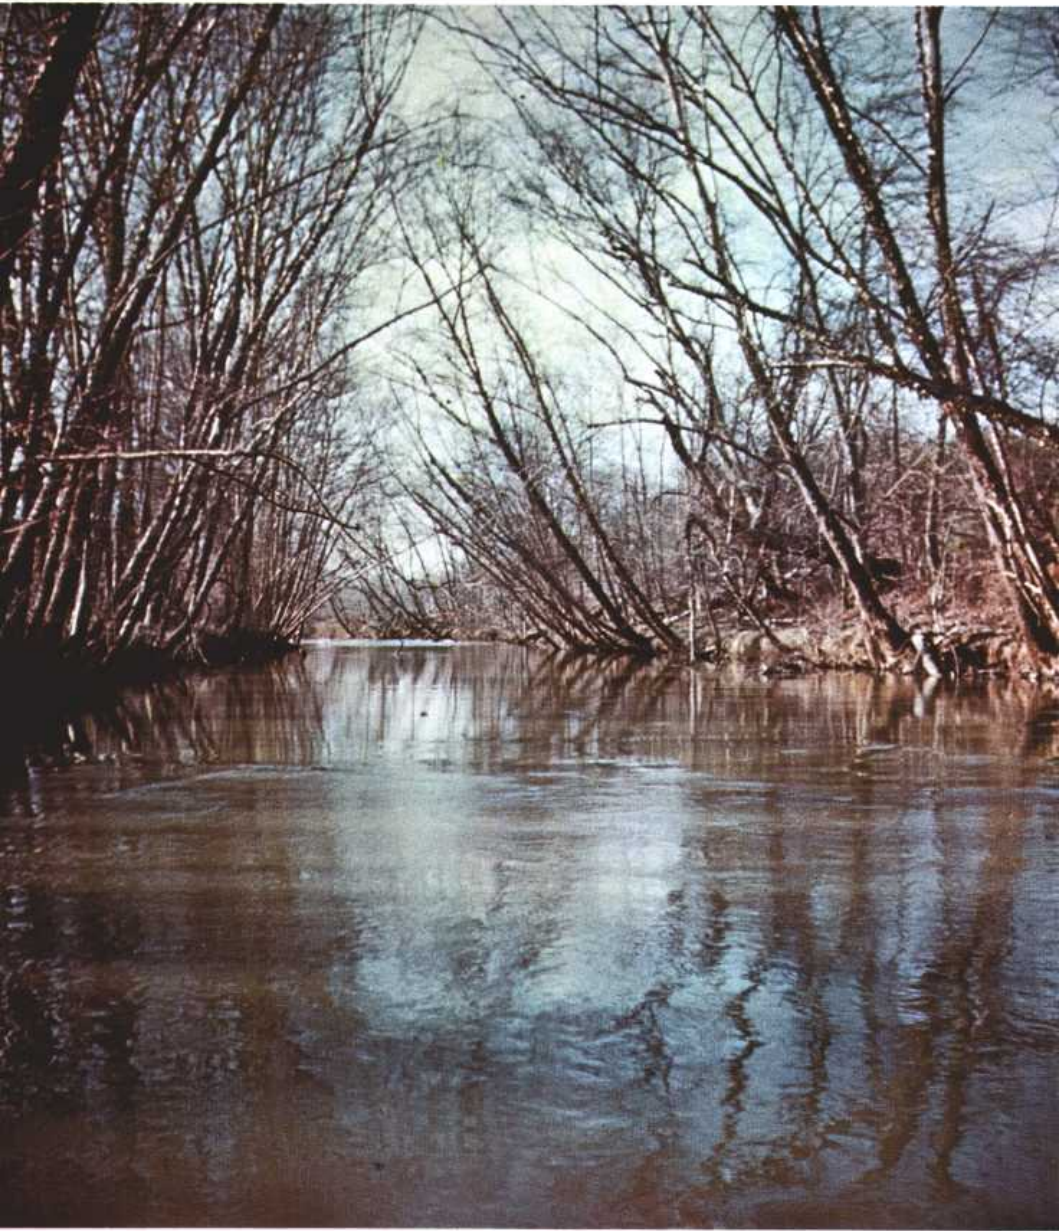
No. 1182 upstream from section 6, Haw River near  
Benaja, N.C.

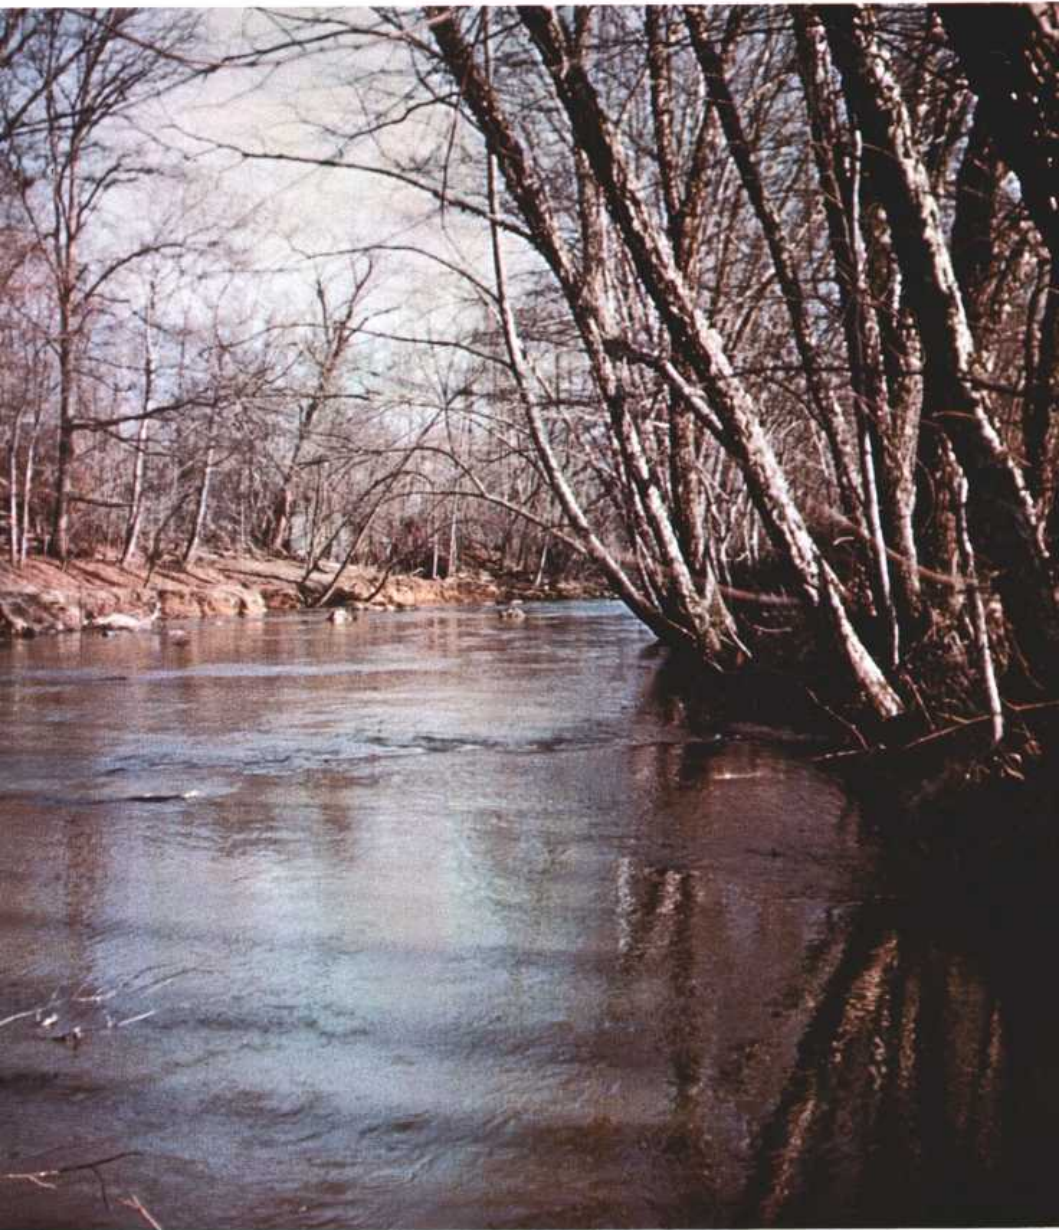
No. 1183 downstream along right bank from section 6,  
Haw River near Benaja, N.C.

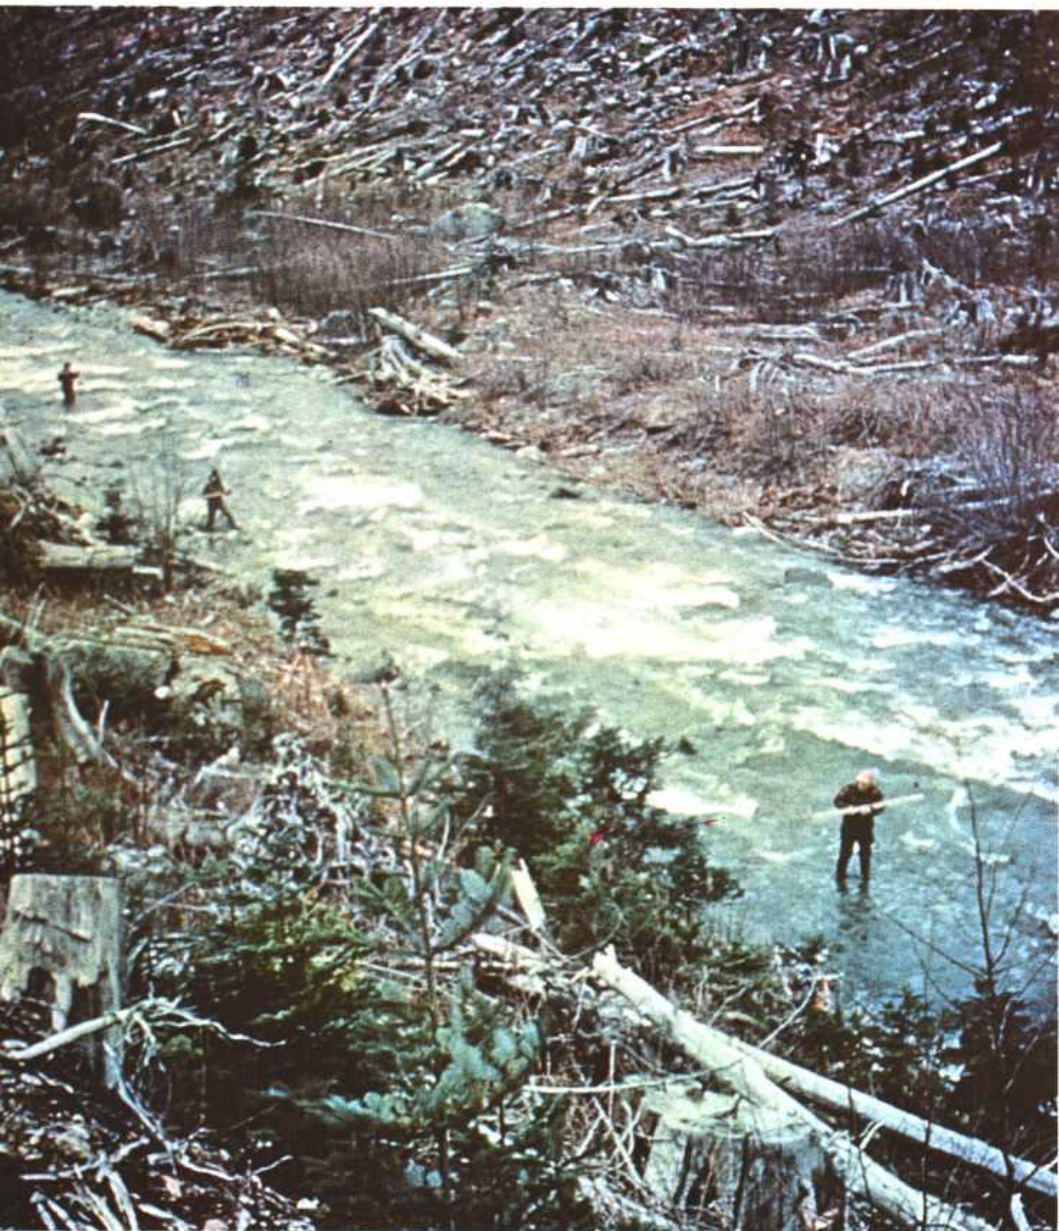
No. 1188 downstream from left bank above section 1,  
North Fork Cedar River near Lester, Wash.

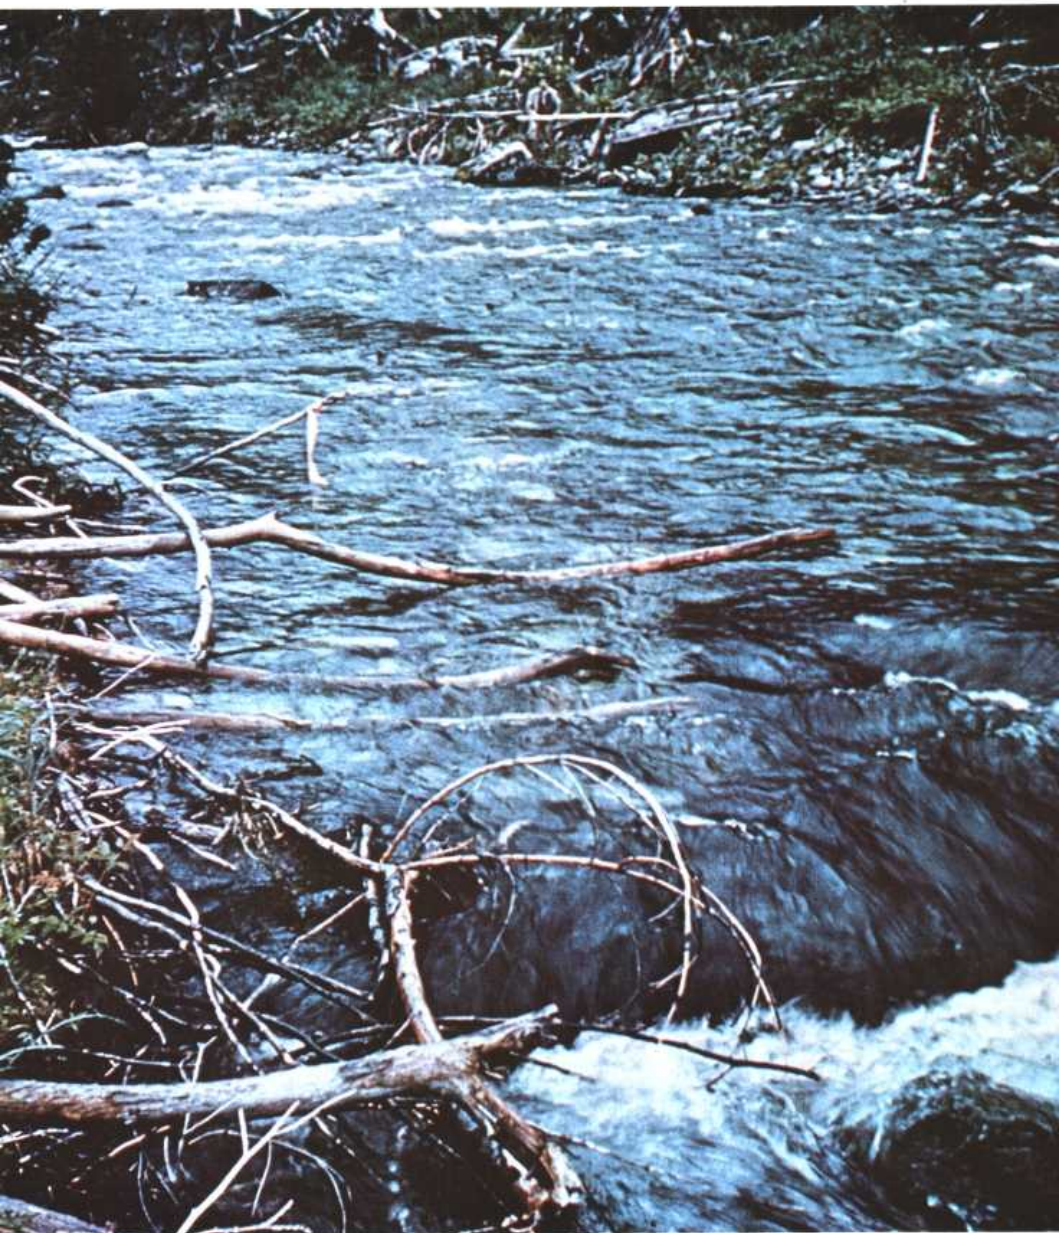
No. 1189 upstream from right bank below section 3,  
North Fork Cedar River near Lester, Wash.

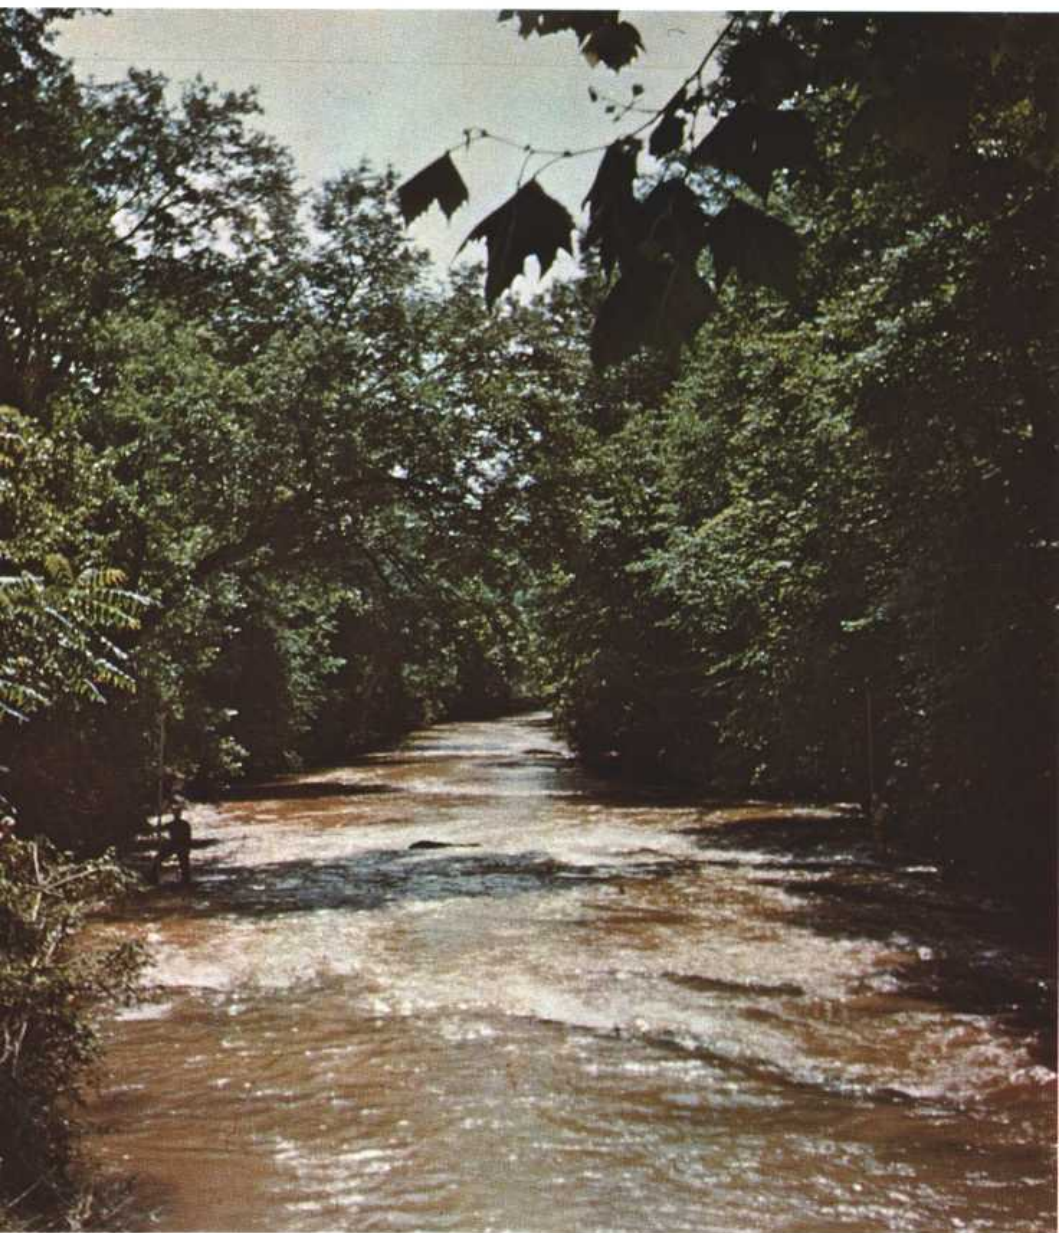
No. 431 downstream from above section 1, Hominy Creek  
at Candler, N.C.

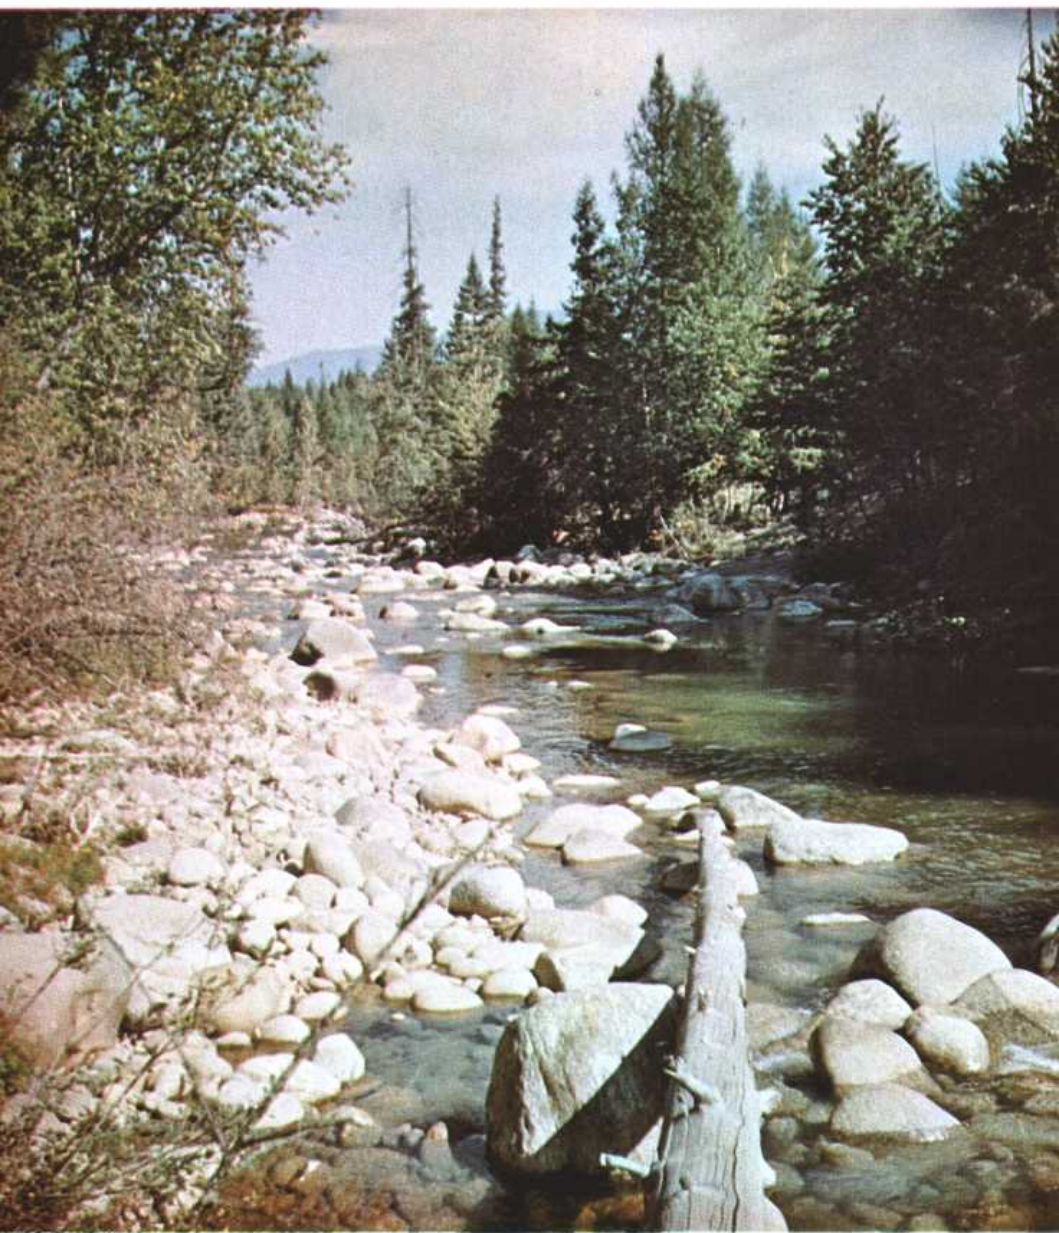
No. 5 downstream from left bank above section 1,  
Boundary Creek near Porthill, Idaho.

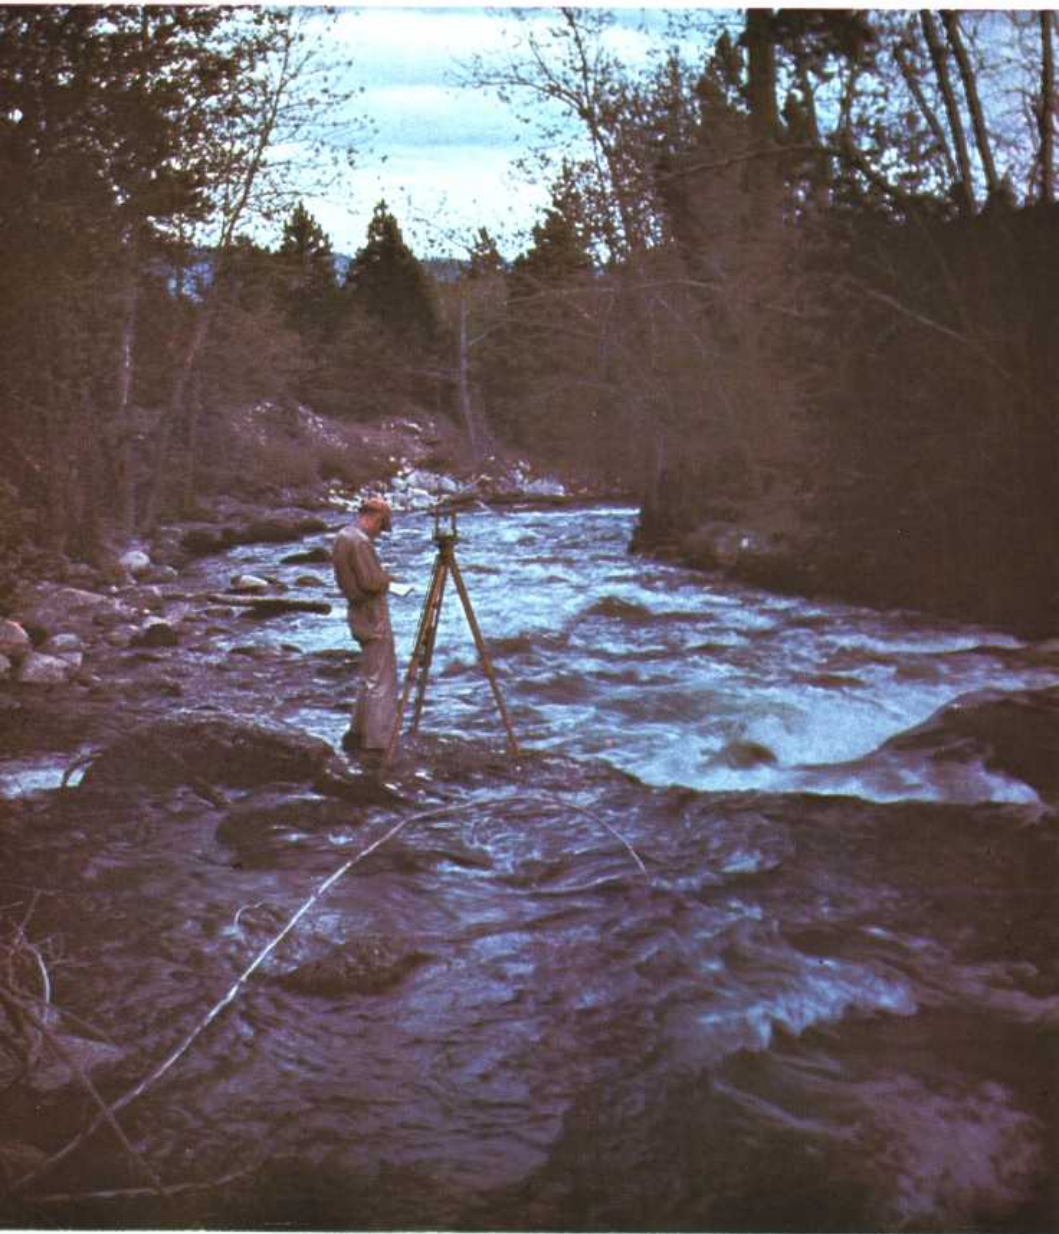
No. 131 downstream from above section 2,  
Rock Creek near Darby, Mont.
