RUBBER OXIDATION AND TIRE AGING - A REVIEW

JOHN M. BALDWIN,* DAVID R. BAUER

EXPONENT FAILURE ANALYSIS ASSOCIATES, 39100 COUNTRY CLUB DRIVE, FARMINGTON HILLS, MI 48331

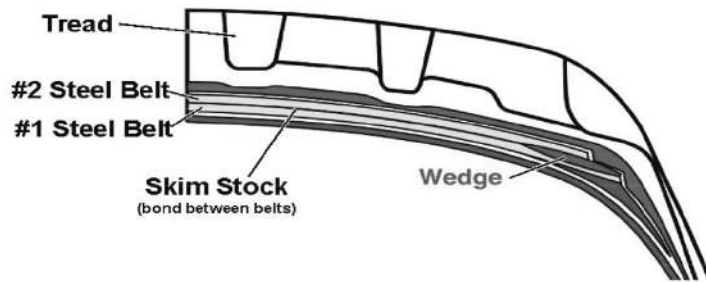
FIG. 1. — Anatomy of a typical radial tire showing skim and wedge rubber.

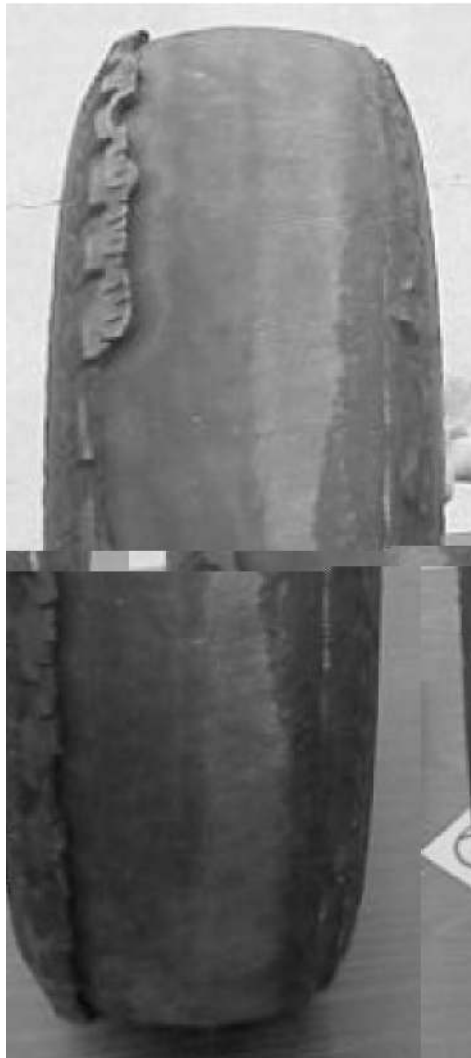
FIG. 2. — Tire carcass after a complete tread separation. (reprinted from Ref. 1 – the NHTSA ODI report EA 23).

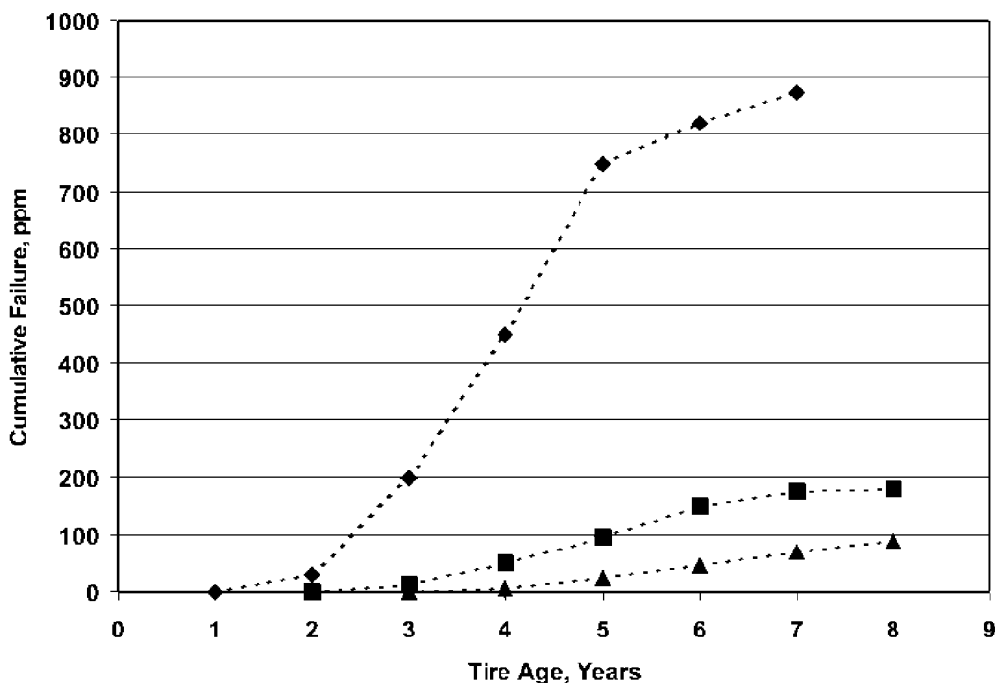
FIG. 3. — Cumulative failure frequency for a recalled tire manufactured in 3 different plants.

The failure rate plot of Figure 3 used time as the key aging parameter, rather than mileage. As noted above, conventional wisdom was that aging was caused by driving. If this premise were correct, mileage, not time would be the correct variable for aging. To develop and validate a laboratory test for tire aging, it was first necessary to determine the nature and kinetics of aging of non-recall tires in the real world. Along with measurements of rubber aging, it is also necessary to relate tire aging to actual tire performance metrics. Finally, if tire aging was found to be a general phenomenon, it would be important to establish how rubber composition and tire construction influence aging rates. Answering these questions drove the next phase of research on tire aging.

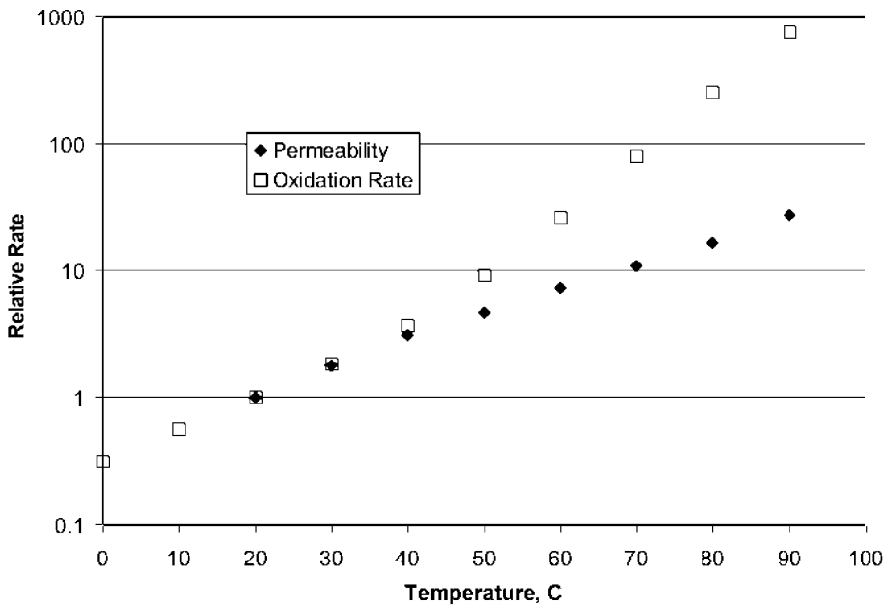
FIG. 4. — Relative temperature dependence of permeability and oxidation rate for natural rubber.

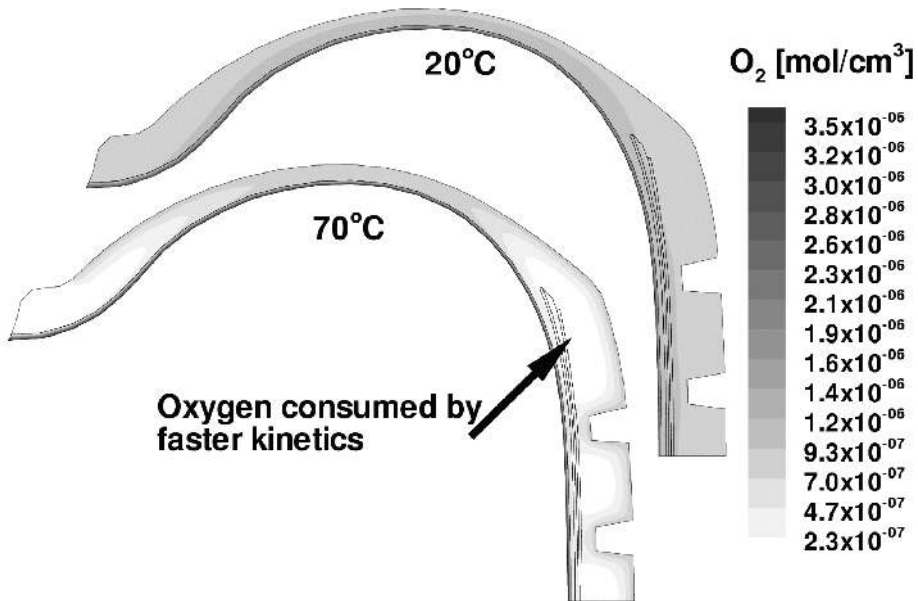
FIG. 5. — Distribution of oxygen concentration in a tire at different temperatures. The lack of oxygen in the thick sections of tread in the tire at 70 °C is due to consumption of oxygen in the rubber nearest the air cavity by diffusion limited oxidation.

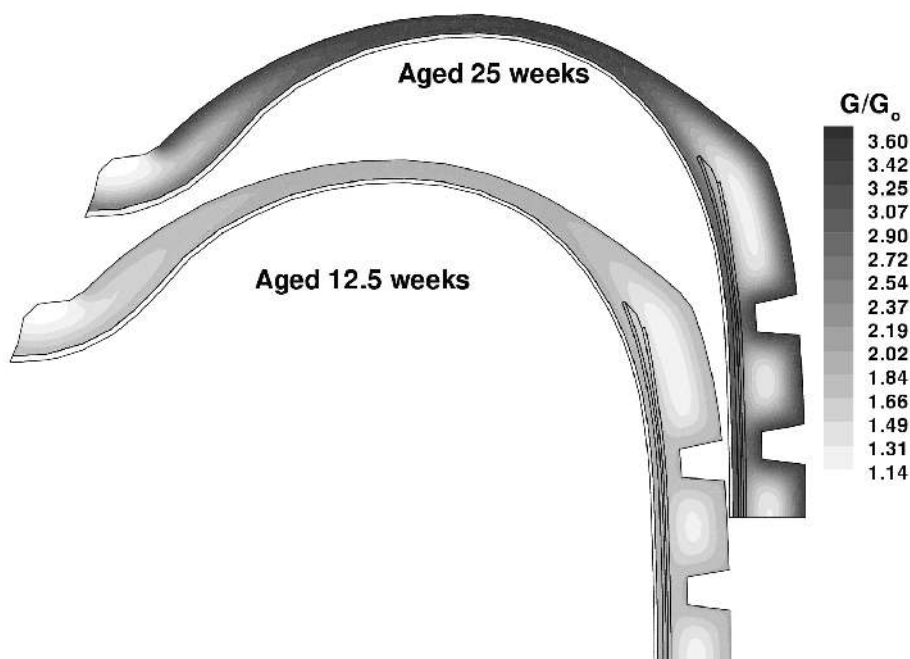
FIG. 6. — Distribution of changes in rubber modulus with oxidation at 70 °C. The lack of change in modulus in the thick sections of tread indicates oxygen starvation in this region. Note that the skim and wedge rubber is oxidizing at 70 °C.

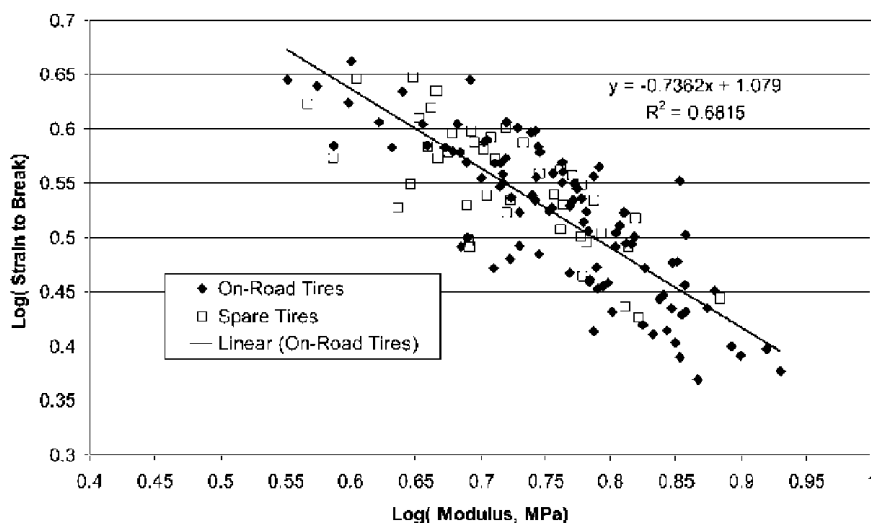
FIG. 7. — Ahagon plot of on-road and spare tires retrieved from the field. Both data sets indicate oxidative aging.

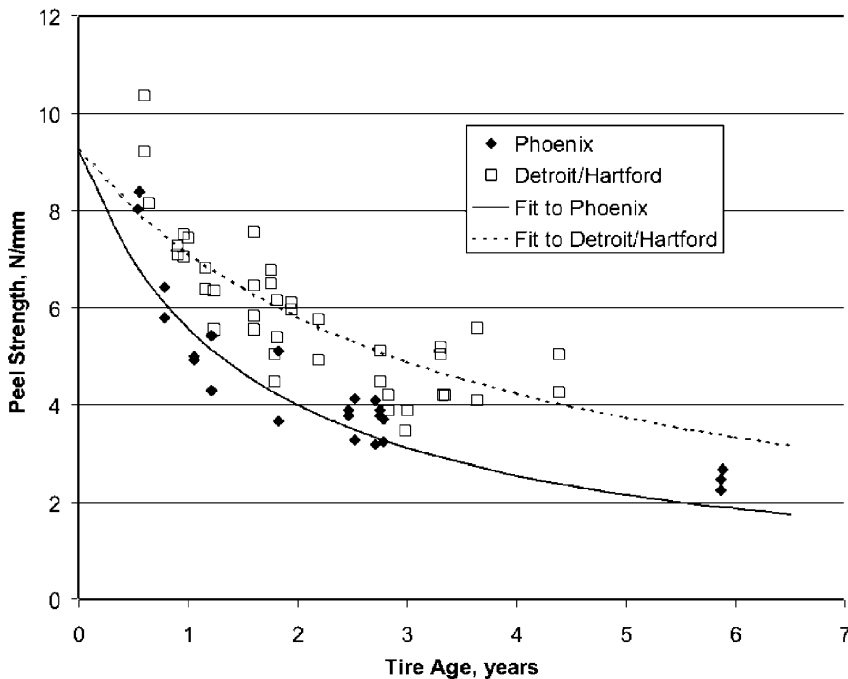
FIG. 8. — Loss of skim rubber peel strength versus aging time for a single tire type retrieved from different locations.

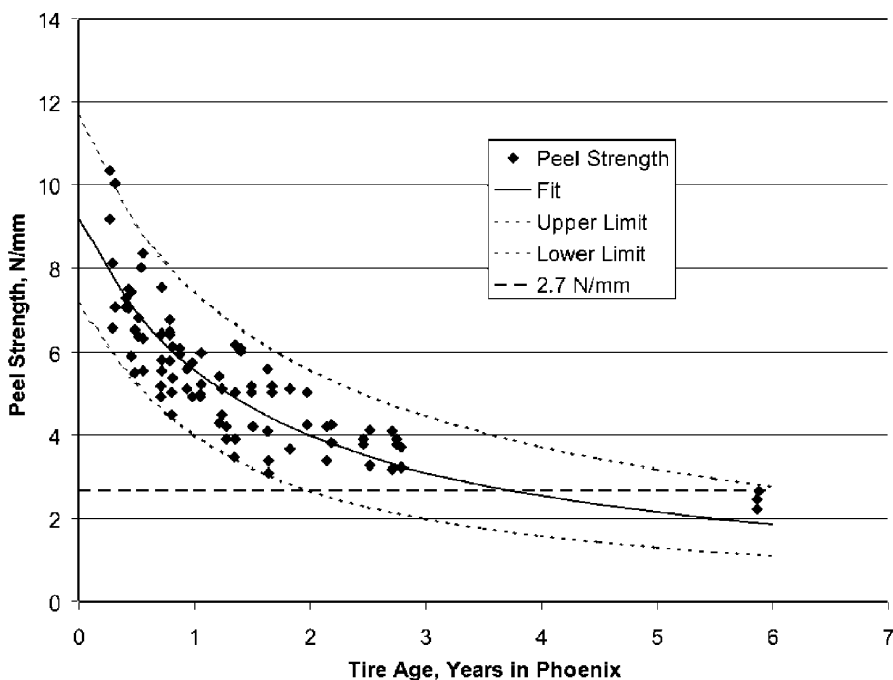
FIG. 9. — Tire aging results from a single tire. Data from different locations have been combined using shift factor analysis. The data can be fit to Equation 2 to derive an aging rate for that particular tire. The variability of field aging is also illustrated in this figure.

One important factor that is apparent from the field aging data (see Figure 9) is that that field aging behavior is highly variable. The average values for peel strength and elongation-to-break can be calculated from their average initial values and the average aging rate using Equation 1. The variability that is observed can be accounted for by considering variations in both the initial properties and, what is more important, in the aging rate. The upper and lower limits can be esti-

mated by assuming that both the initial properties and the aging rate are distributed normally about their average values with standard deviations of ~8% and 17% respectively. These upper and lower limits are shown in Figure 9. The lower limit value is particularly important since this represents the “worst-case” tire at any given age. It is this worst-case tire that will likely fail first. An average tire has to be aged almost twice as long as the worst-case tire. This result will be important in the development of accelerated tests to predict tire aging failures.

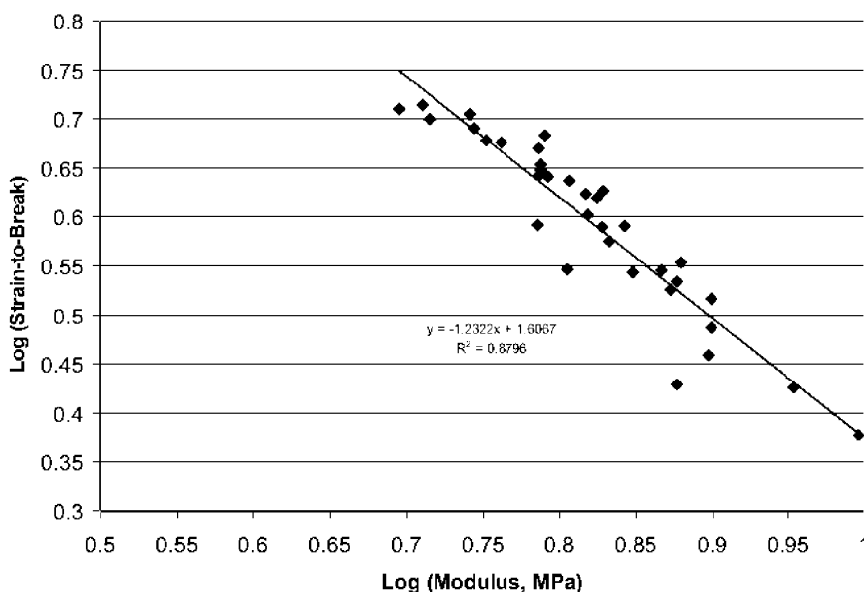
FIG. 10. — Ahagon plot of oven aged tire.

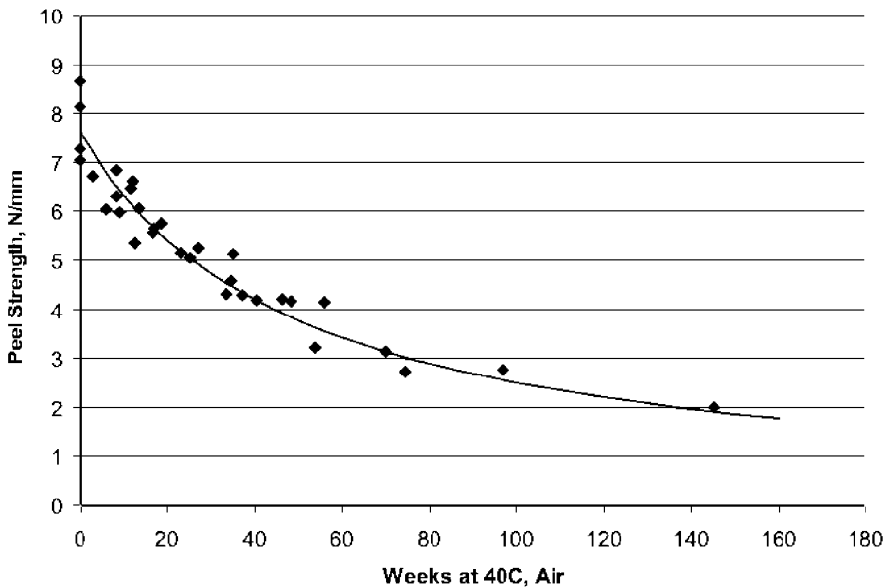
FIG. 11. — Peel strength versus aging time at 40C, air inflation. The shift factors for 50, 60, and 70 °C are 2.8, 4.5, and 11.7 respectively. The shift factor for 50/50 N₂/O₂ is 1.38.

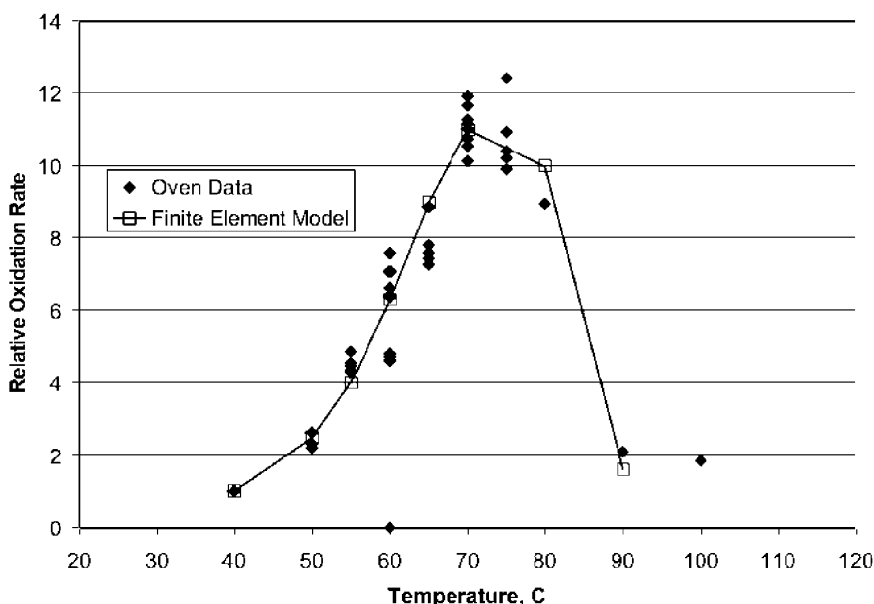
FIG. 12. — Dependence of rubber oxidation on oven temperature.

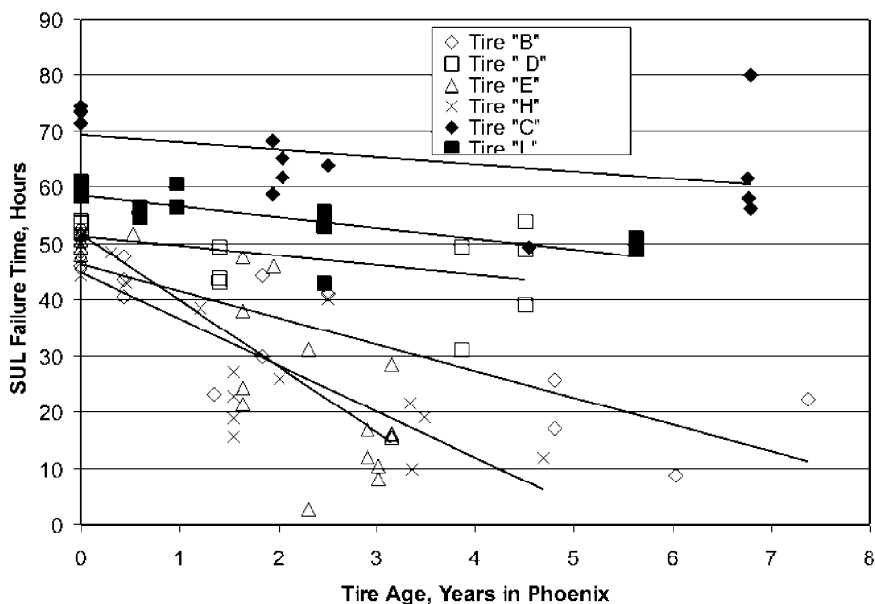
FIG. 13. — Time to failure in stepped-up-load (SUL) testing versus aging time in Phoenix.

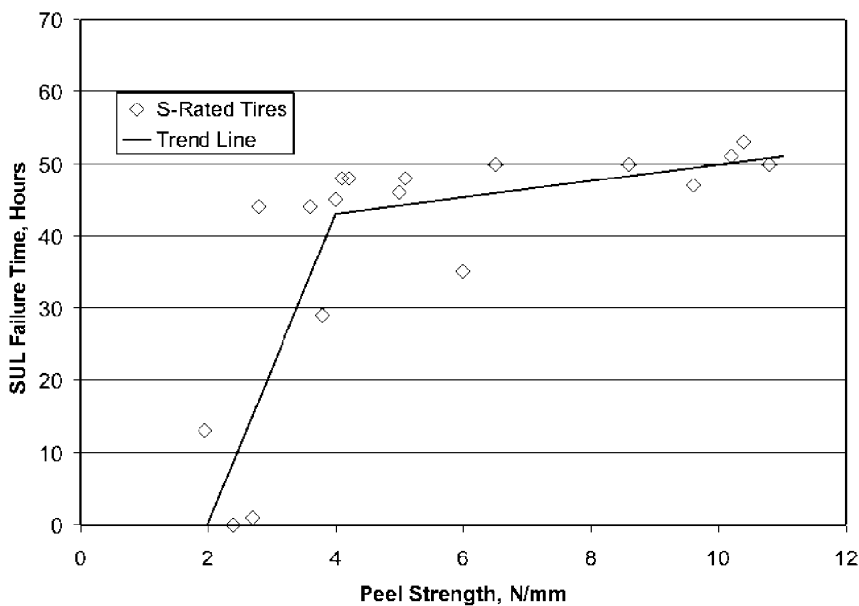
FIG. 14. — Correlation of SUL time to failure and peel strength after oven aging.

rated tires were relatively independent of rubber property loss until that loss reached a critical value at which point the SUL drops abruptly with decreasing peel strength and/or elongation-to-break. The result for peel strength is shown in Figure 14. Once the value for peel strength drops below its critical value, and the failure time begins to decrease, the failure time rapidly drops below 34 hours, which is the requirement for new tires in FMVSS 139. Thus, requiring an aged tire to pass the 34 hour requirement insures that the rubber properties remain above the critical value. Superimposing the NHTSA field data onto the oven trend lines indicates that the SUL failure time in the field aged tires is lower than in the oven aged tires at any given level of aging (as defined by property loss). This is most likely a result of the formation of cracks at the belt edge during field aging that do not occur in oven aging. Due to the strong correlation between skim and wedge rubber oxidation, it is not clear whether the loss of one of the properties is more important or if both are important in determining tire aging behavior. It is also not clear whether % retention or absolute values correlate better with SUL. Nevertheless, SUL testing of oven aged tires can provide a means to rank tire aging performance.

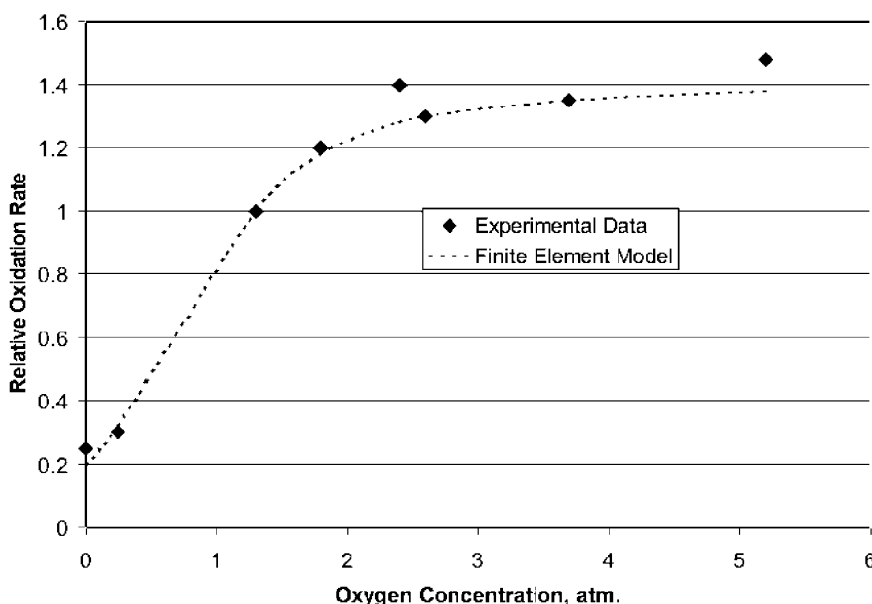
FIG. 15. — Relative oxidation rate of skim rubber versus oxygen concentration. The data is normalized to air inflation.
