Seismic Structural Health Monitoring in some European countries

This paper compiles and describes the national initiatives and projects on seismic Structural Health Monitoring (SHM) active in a number of European countries. Sensors networks and typical layouts, data processing techniques and policies adopted for the management of alerts are described for the different national programs. The different policies adopted for the access to data are also described. For the different countries applications to buildings, bridges or cultural heritage constructions are used to describe in detail the SHM systems installed in Italy, France, Greece and Portugal.

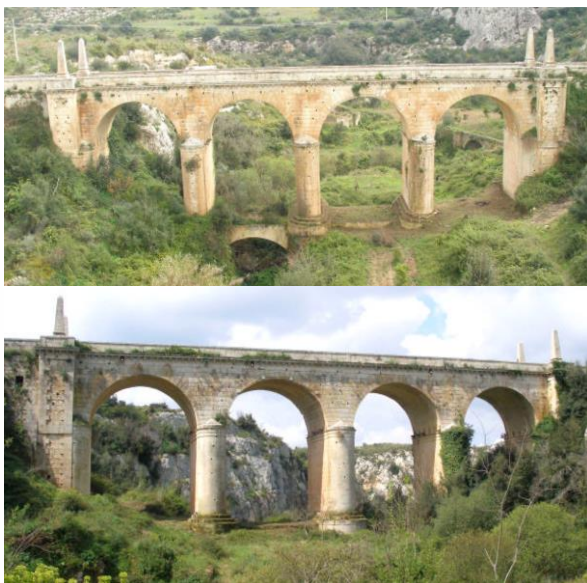
Figure 2- Santa Chiara bridge: general view (left) - sensor layout (right)

Each of the civil structures belonging to OSS is equipped with a number of Force-Balance Accelerometers (FBA) for measuring and recording the seismic dynamic response of that structure to both weak and strong earthquakes. The working range of accelerometers is set according to local seismic hazard. Typically either ± 0.5 g (g is the gravity acceleration) or ± 1.0 g range is chosen for accelerometers on the ground and, correspondingly, either ± 1.0 g or ± 2.0 g range for accelerometers on the structure, to account for structural dynamic amplification. All systems acquire continuous data and store it in a temporary memory. When at least 70% of the signals exceeds a predetermined amplitude threshold, generally 0.001 g, the data are copied to a permanent memory and immediately sent to the DPC server through a dedicated internet connection. The typical sample rates for digitizing is 200 and 250 Hz. Regarding the number and position of the sensors installed, for buildings it is possible to identify some general criteria underlying the choices made in the system design, so that well defined types of systems can be identified. For bridges and dams the design of the accelerometers' layout is performed ad hoc for each specific case. In Figure 2 (left side) a general view of the "Santa Chiara" arch masonry bridge (Noto - Sicily) is shown and the sensor layout is presented on the right side of the same figure. The sensor layout (represented as black arrows) has been designed for monitoring both the lateral vibration of the piers and the vertical and lateral vibrations of the arches.

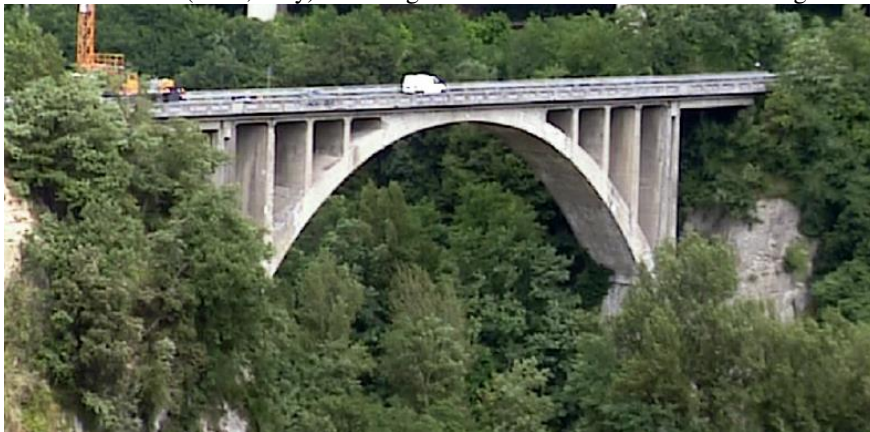
Figure 7. The Zingone bridge

Data recorded by the OSS are available on request and can be used for scientific purposes. In the following are reported some examples. The first one concerns data recorded on the Zingone Bridge (Figure 7), a fixed arch reinforced concrete bridge located in Mercato Saraceno (Forli, Italy) featuring a reinforced concrete of 54.9m length with a rise of 15.6m.

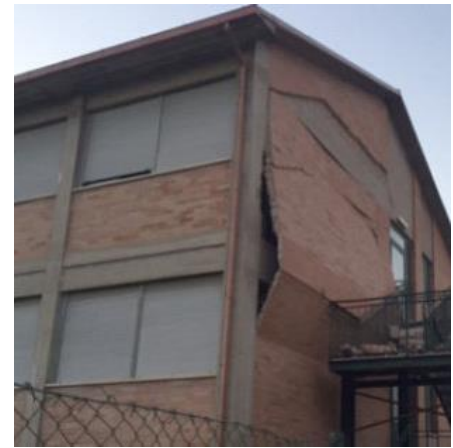
Figure 10. a) Norcia school. Sensor's layout; b) damages after August 2016 earthquake

The second example is the Norcia School that, since 2002 is monitored by the OSS with the network of accelerometers shown in Figure 10. In 2010, was strengthened with dissipative braces in the longitudinal and transversal directions and in August 2016 was struck by the Central Italy earthquake. Between 2002 and 2017 several earthquakes have been recorded by the OSS sensors. In Figure 10b and Figure 11a and b are reported some of the damages to non structural elements after the 2016 earthquakes.

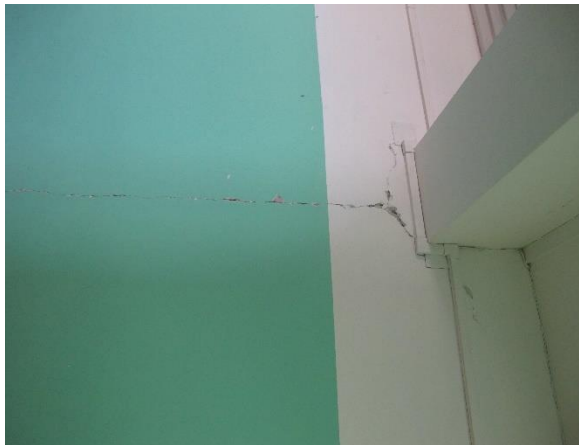
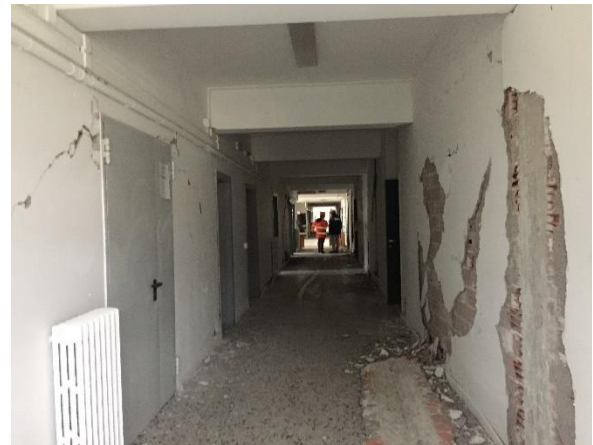
a) August 24, 2016

b) November 3, 2016

Figure 11. Damages to non structural elements during the earthquakes in 2016

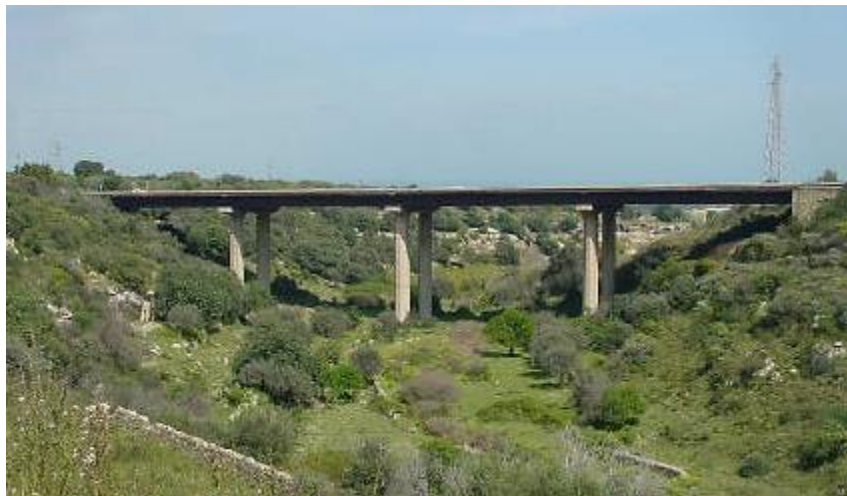
Figure 13. West side elevation of the Cusumano bridge

A further example is relevant to the Cusumano bridge (Figure 13), located near Prioro Gargallo, in Sicily. Data recorded by the OSS enabled the calibration of a numerical model of the bridge. This model has been used to apply a pre-posterior Bayesian analyses for the computation of the Value of the Information retrieved by the network of sensors for the seismic emergency management of the bridge (Giordano et al.).

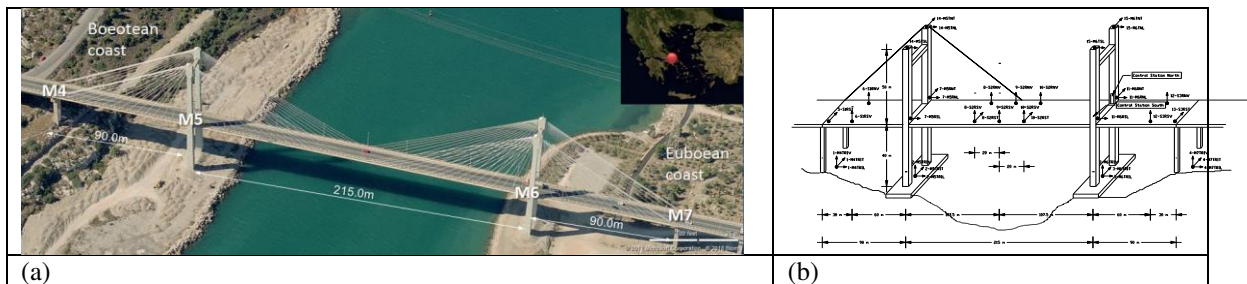
Figure 26. (a) The Cable-stayed section of the Evripos Channel bridge (b) instrumentation layout

Chalkis Cable-Stayed bridge. In 1994 ITSAK instrumented the 395m long Cable-Stayed section of the bridge at Evripos Channel, Greece (Figure 26a), with a permanent accelerometer network of 42 sensors supported by three interconnected 12-bit recording units (Figure 26b). In 2012 the system was upgraded with a new 36-channel, 24-bit recording station that also allowed real time telemetry over Ethernet.

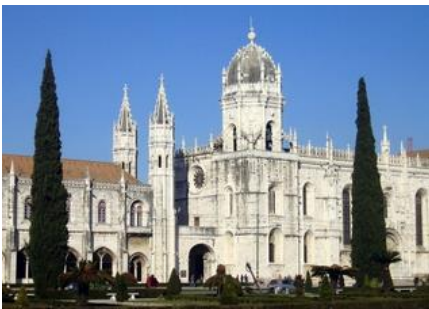
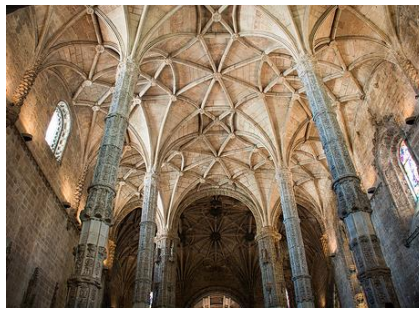
Figure 32 – Church of Jerónimos Monastery: (a) exterior view; (b) nave ribbed vault.

The Church of “Santa Maria de Belém” is a limestone masonry structure built during the XVI century and located inside the majestic Monastery of Jerónimos in Lisbon, one of the regions with the highest seismic hazard in Portugal. The church features a cruciform shape with a single nave of 70 m length crossed by a transept of 40 m width, and an average height of 24 m. A single bell tower of 50 m height rises in the corner between south and west façades. Two rows of slender octagonal columns with a free height of 16 m and a radius ranging from 1.04 m to 1.88 m provide support to the barrel vault of the longitudinal limb, allowing to reduce the large free span of the nave (Figure 32) The seismic performance of the structure during the strong earthquake of 1755 was impressive. No severe damage was registered in that occasion in the whole compound. On the contrary, the subsequent shake of 1756 caused the collapse of one of the columns supporting the vaults of the church (with subsequent ruin of the nave) and also the partial collapse of the vault of the higher choir (Lourenço et al. 2007, Masciotta et al., 2016). Following these events, during the XIX century changes were made in the structure of the two towers and in the roof. The effect of these changes on the seismic performance of the structure remained an open issue (Lourenço et al. 2007). Hence, several studies and numerical simulations have been performed in the last decades to investigate the structural behaviour of this church (Lourenço et al. 2007, Oliveira et al. 2005). In addition, to keep under control the health state of the monument and mitigate the seismic risk, a simplified monitoring system has been installed in the church since 2005. The type and location of sensors have been chosen according to the features to be extracted and in conformity with the directions of IGESPAR, former IPPAR (Portuguese Authority for the Architectural Heritage), with the purpose of minimizing the visual impact of the systems in the church (Masciotta et al. 2016).

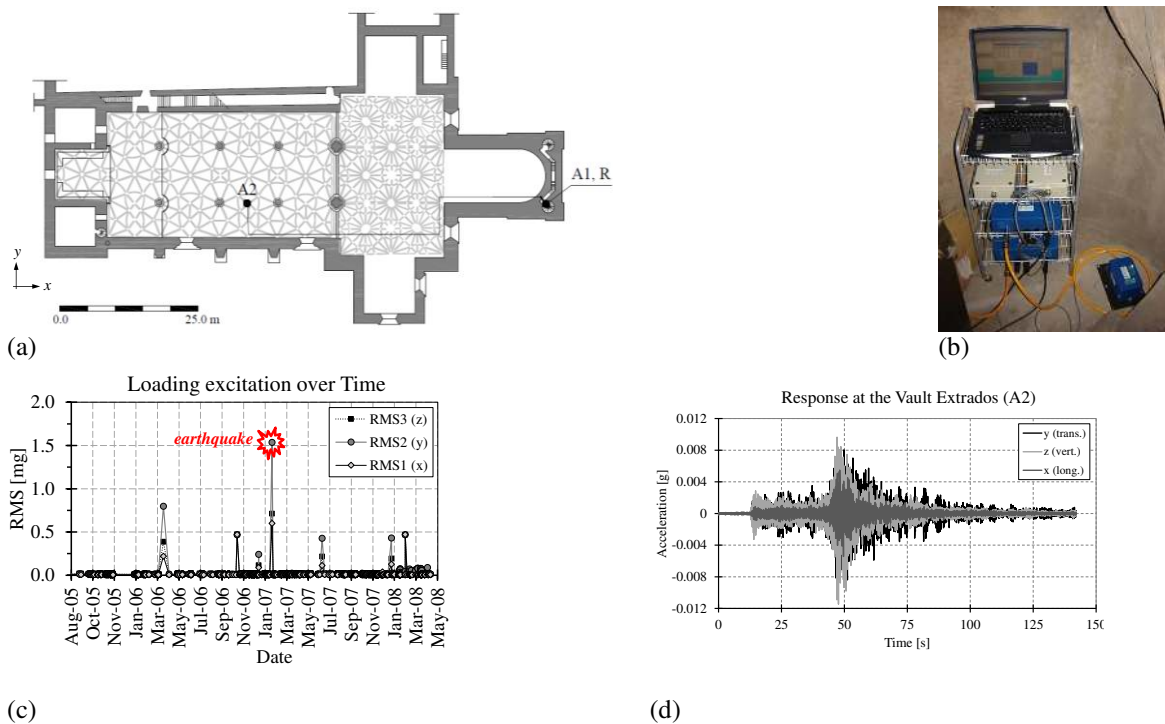
Figure 33 SHM system of the Church of Jerónimos Monastery: (a) sensors location; (b) battery of recorders and accelerometer at the base level; (c) ambient excitation before, during and after the earthquake of 12/02/2007; (d) response of the church at the vault extrados during the seismic event.

The SHM system is composed of two strong motion recorders and two tri-axial force balance accelerometers (Figure 33a-b), one (A1) located at the base of the structure near the chancel and connected to the master recorder, and the other one (A2) installed on the nave extrados and connected to the slave recorder. The recorders are mutually interconnected and synchronized for both triggered and programmed events. A predefined amplitude threshold of 0.5 mg is set in all 3 directions for the sensor at the base. As for the sensor at the nave extrados, thresholds of 1 mg and 5 mg are assigned in x (longitudinal) and y/z (transversal/vertical) directions, respectively. Anytime the amplitude level of the signals exceeds the predefined thresholds, data are recorded and stored to a permanent memory. Besides, monthly and seasonal programmed events of 10 minutes are registered to follow frequency trends over time and separate possible environmental fluctuations. According to the results of previous Operational Modal Analysis (OMA), the sampling rate adopted for digitizing the signals is 100 Hz for all events. On 12 February 2007 at 10:35 am, a moderate earthquake of magnitude $M_w = 6.1$ and with epicentre offshore Southwest Iberia occurred. The Monastery felt the ground shaking and its response was acquired by the strong motion recorders installed in the church (Figure 33c-d). No severe damage took place, but a slight drop in the modal frequencies as well as a change of the frequency-temperature correlation were observed after the occurrence of the seismic event.
