NASA Technical Memorandum 106456

Army Research Laboratory Technical Report ARL-TR-10

Simultaneous Pressure Measurement and High-Speed Photography Study of Cavitation in a Dynamically Loaded Journal Bearing

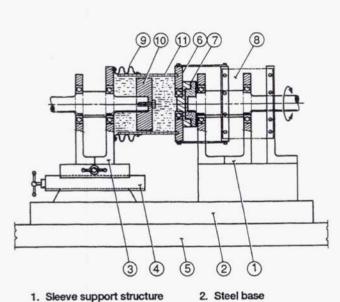
Figure 1.-Schematic of test apparatus.

- 1. Sleeve support structure
- 3. Journal support structure
- 5. Machine table
- 7. Dynamic eccentricity device
- 9. Bellow seal
- 11. Sleeve

4. Cross slide

10. Journal

6. Sleeve mounting plate

8. Flexure mechanism

A schematic of the bearing test rig is shown in figure 1. The rig consisted mainly of a journal and a sleeve. The sleeve support structure was fixed to a steel base; the journal support structure was anchored to a cross slide, which was fixed to the base. The base was clamped down on a sturdy, flat machine table whose level was adjustable. Details on the alignment of the rig, the method of generating the static and dynamic eccentricities, the transparent sleeve and photographic setup, the lubricant supply and sealing of the rig, etc. are as described in reference 3. The modifications made to accommodate the pressure measurement are as follows:

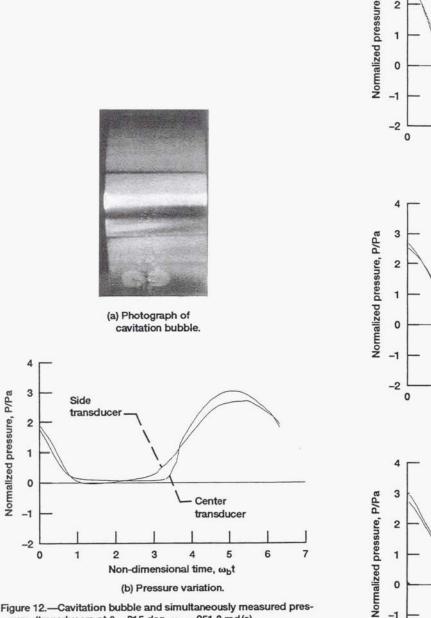
(a) Photograph of cavitation bubble.

The photographs in figures 11(a) and 12(a) were extracted from a movie where the transducers were placed at $\theta = 315^{\circ}$. In the case of figure 11 the side transducer did not experience cavitation and it registered a tensile stress when its neighbor, the center transducer, was cavitated. As the cavitation region spread, its influence began to reach the side transducer. In the situation shown in figure 12, the side transducer might be described as at the verge of becoming cavitated.
