SOME FUNDAMENTAL FRACTURE MECHANISMS APPLICABLE TO ADVANCED FILAMENT REINFORCED COMPOSITES

SOME FUNDAMENTAL FRACTURE MECHANISMS APPLICABLE TO ADVANCED FILAMENT REINFORCED COMPOSITES*

R67SD51 September 1967

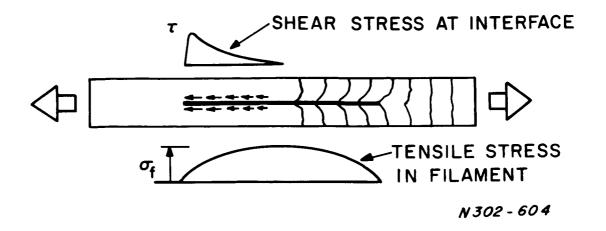
Figure 1. Variation in Interface Shear and Filament Tensile Stress

To understand the conditions which contribute to the fracture process, it is first necessary to establish the stress state in the matrix while the composite is loaded in tension. For this analysis it is useful to consider the stress variations described in Figure 1.

In addition to the variation of shear stress along the interface, there is a stress gradient normal to the filament axis which has been determined from the photoelastic investigations referenced above. This variation is best described by plotting the tensile stress trajectories in the matrix as determined by Tyson and Davies (3). In Figure 2, the direction of the tensile stresses is tangent to the trajectories at a given location and the magnitude of the tensile stress is proportional to the proximity of the trajectories. The figure shows that the greater concentration of stress transfer from matrix to filament occurs near the end, while at the center of the filament (element A), the matrix is virtually unstressed, since the stiffer filament carries most of the load. At element B (slightly removed from the geometric discontinuity of the end), the stress state is nearly pure shear and the tensile stress trajectory makes an angle of approximately 45° with the filament.

At element C there is considerable tensile stress in the matrix parallel to the filament axis in addition to shear stress at the interface. The inclination of the principal stress trajectory to the filament is therefore small at the ends.

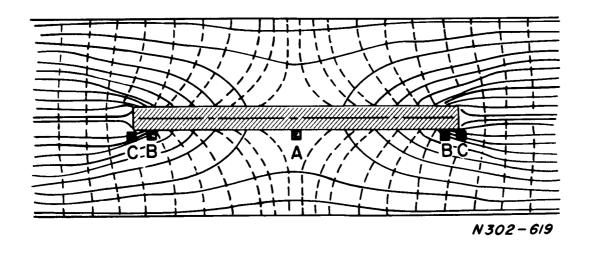
Figure 2. Tensile Stress Trajectories in the Matrix (Reference 2)

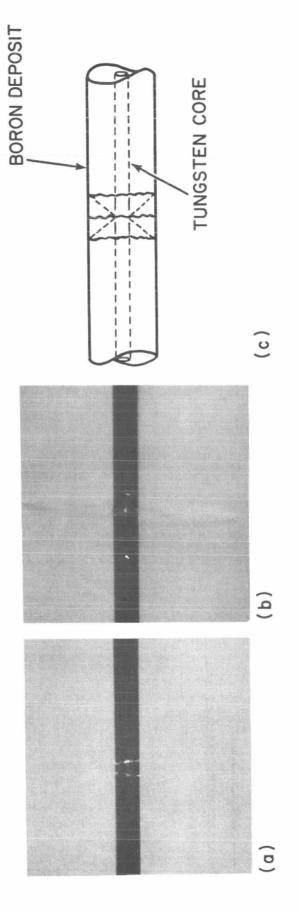
Fracture of a Boron Filament in Epoxy Novalac (a) Low Energy Fracture (58X) (b) High Energy Fracture (58X) (c) Schematic View of Fracture Pattern Detail Figure 3.

In some instances, the filament fractures at low load at a point of weakness and insufficient energy is released to produce a matrix crack. This condition may be termed a low energy fracture and is illustrated in Fig. 3A, while a somewhat higher energy fracture results in a disk-shaped crack as illustrated in Fig. 3B. The terms "low-energy" and "high-energy" failure are used here to make an inferred distinction between manifestly different combinations of filament matrix behavior. When a brittle filament fractures, the elastic strain energy, which is in excess of that required to create the fracture surface (in the filament), is instantaneously released and must be absorbed or transmitted by the matrix in the vicinity of the filament failure. For a given filament, the magnitude of this energy pulse will

The most common form of fracture in a boron filament shown in Figure 3C is comprised of two cup-cone fractures emanating from the filament substrate and a single normal plane of fracture in the center section. This fracture pattern can result in more than one crack emanating from the filament into the matrix at the time of initial filament fracture as shown in Figure 4a.* Once the sudden crack initiation process has occurred, the the propagation is determined by the new state of stress in the region of the crack tips. This stress state is very nearly that described previously for the end of a filament except that there are two such ends back to back and the end geometry is somewhat more complicated. Since there is no direct tension on the newly formed ends, a pure shear condition exists at the

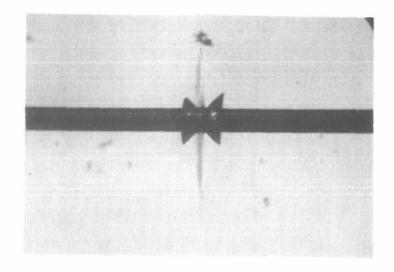
Figure 4. Multiple Crack Site at Filament Fracture in Epoxy Novolac
(a) Photograph at 58X (b) Schematic Diagram of Most Probable
Stress Trajectories which occur for single and multiple crack
sites.

interface a short distance from the fracture location. The disk-shaped crack separates the two end stress patterns and represents a free surface across which no tensile stress can be transmitted. Tensile stress trajectories are again a useful tool for describing the change in stress transfer when a fracture has taken place. In the case of a low energy break where no significant initial cracks are formed, the stress trajectories at the break might appear as shown in Figure 4b, extending by as much as 10 to 15 filament diameters from the break in each direction. When a high energy fracture exists and a disk-shaped crack is formed, the trajectories which would normally pass through the crack region are no longer effective and the pattern must change. This essentially results in a pattern of stress concentration at the crack tip and a region immediately adjacent to the crack source which is virtually unstressed. This is the region in which the inclined cracks have been formed and hence the inclined cracks are to some extent shaded by a larger disk crack, preventing them from propagating as quickly as the disk crack. When the disk-shaped crack does not extend further into the matrix than the inclined cracks (which form truncated cones), then there is a stress field at the tip of the inclined cracks and they begin to propagate in that field.

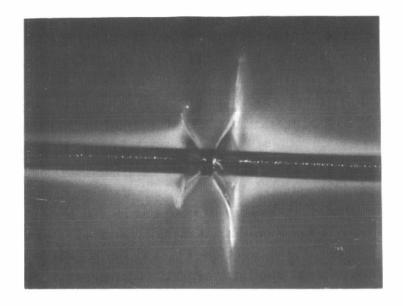
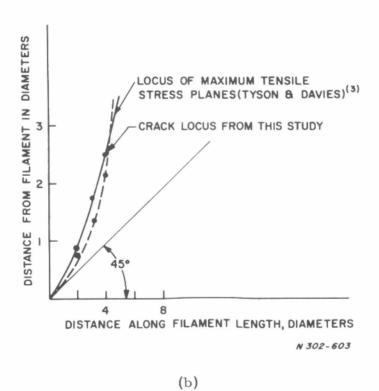
Figure 5. Propagation Pattern for Inclined Crack in Epoxy Novalac (a) Photograph at 58X (b) Crack Locus Compared to that of Tyson & Davies (5)

The direction of propagation of the disk-shaped crack in the absence of other filaments is more or less normal to the filament axis. This is the locus of planes of maximum tensile stress in the matrix of the filament fracture and is what one might expect, given the tensile stress trajectories. When the disk shaped crack does not shade them, the inclined cracks also propagate in a direction normal to the tensile stress trajectories. This results in a curved crack becoming nearly normal to the filament within a radial distance of 3 or 4 diameters from the interface. Figure 5a illustrates this at a location of low energy fracture (note the absence of a disk). Figure 5b shows a plot of the crack locus superimposed on the typical cress trajectories constructed from the data of Tyson and Davies (3). In the photo of Figure 5, the two inclined cracks begin propagating simultaneously, but at some point in the propagation process, one crack overshoots sufficiently to

shade the other. At that point, the larger crack dominates and the smaller crack does not have sufficient stress at the tip to continue.

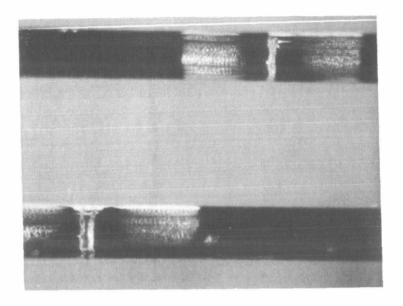
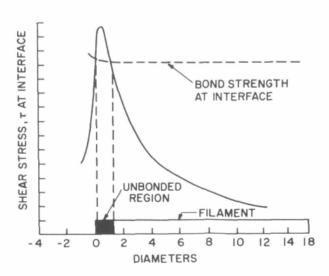
Figure 6. Localized Bond Failure Occurring Near Filament Fracture (a) Photograph at 116X (b) After Schuster and Scala (4)

When the matrix is quite ductile and capable of resisting the tendency to crack initially, a bond failure may occur at the interface. This shear failure at the interface occurs near the filament end but not immediately at the end. The light areas in Fig. 6a represent the unbonded region. Schuster and Scala (4) have shown that the shear stress along the interface does drop off near the end of the filament as shown in Fig. 6b. One possible reason for increased bond strength near the end may be the radial contact pressure at the filament ends due to a possible vacuum in the fracture volume. This increased radial pressure should provide better shear strength just as increased normal force provides greater friction force.

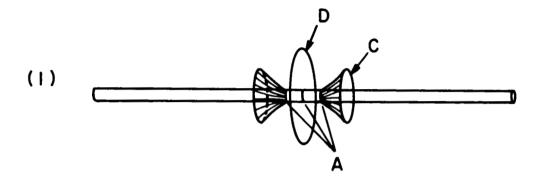
Figure 7. Summary of Failure Modes in a Single Filament

To summarize the failure sources resulting from filament fracture, one can construct the model shown in Fig. 7. As the filament is loaded through shear at the interface, it may do one of three things:

- (1) Having sufficient bond strength and matrix tensile strength, the filament fractures at point A. This may result in a disk-shaped crack D, two inclined conical cracks C, both, or neither.
- (2) If the bond strength is not sufficient to load the filament to fracture, it may simply unzip at the interface B. The shear stress pattern shifts along the interface toward the center of the filament and the process continues until no force is transferred to the filament other than friction at the unbonded interface.
- (3) If the bond strength is sufficient to transfer load to the filament and if the matrix is weak in tension, a tensile crack C may propagate in the high shear transfer region before the filament fractures. This crack can then propagate becoming more normal to the filament as it leaves the region of high shear stress in the matrix.

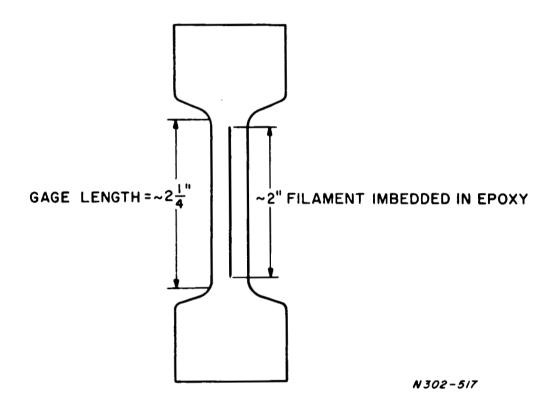
Figure 8. Schematic Representation of a Single Filament Unreinforced Composite.

Tensile tests were made on single-filament-epoxy specimens (Fig. 8) at different strain rates, and the results demonstrate that certain dynamic aspects of the (previously discussed) matrix fracture phenomena can have a profound effect on mechanical behavior.

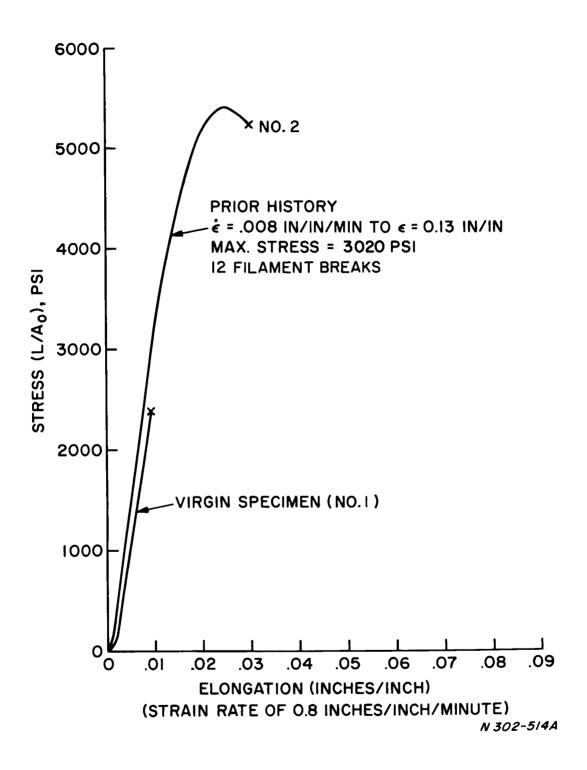
Figure 9. Stress-strain Behavior of Virgin and Pre-strained Epoxy Specimens Strained at 0.8 in/in/minute.

One pair of (duplicate) specimens was pre-strained at a nominal strain rate of 0.008 in/in/min until at the maximum load (of the load-deflection curve) there was 10-13% elongation. These specimens were then unloaded for examination under the microscope, and the number of filament breaks was determined to be 12 in one case and 13 in the other (Table I). The pre-strained (cracked) specimens and, for comparison, a pair of virgin specimens were then tested to failure at a 100-fold higher strain rate (0.8 in/in/min). Representative stress-elongation curves (at the higher strain rate) for pre-strained and virgin specimens are shown in Fig. 9. The critical observation here (evident from Fig. 9 and Table I) is that, at the higher strain rate, the specimens with many internal cracks already present were both stronger and more ductile than virgin specimens (twice the strength and three times the elongation to failure).

The photomicrographs in Figure 10B and D show the profiles of typical non-catastrophic disk-shaped tensile cracks originating at failures in the higher strength portion of the filament. In these specimens, such cracks had a minimum size of about 0.03 inch diameter which indicates that, while forming, they grow very rapidly. The new surface produced in this initial stage of crack propogation is, by virtue of the intense stress concentration and high speed, very smooth. This smoothness is evident for both catastrophic (Figure 11, A and B) and for first stages of non-catastrophic cracks (Figure 11, C and D). After the sudden energy release has been absorbed in creating the smooth fracture surface, non-catastrophic cracks slow down and the rate of propagation is eventually governed by the crack configuration and the externally imposed strain rate. The more slowly moving crack tip is preceded by some inelastic deformation and can propagate on slightly different levels when it is energetically advantageous to do so. This stage of crack propagation is characterized by the radial markings evident in Figure 11, C and D. Such cracks continue to grow until they become super-critical in size and self-propagating; that is, the specimen fails under conditions of decreasing load (as shown in the upper stress strain curve in Figure 9).

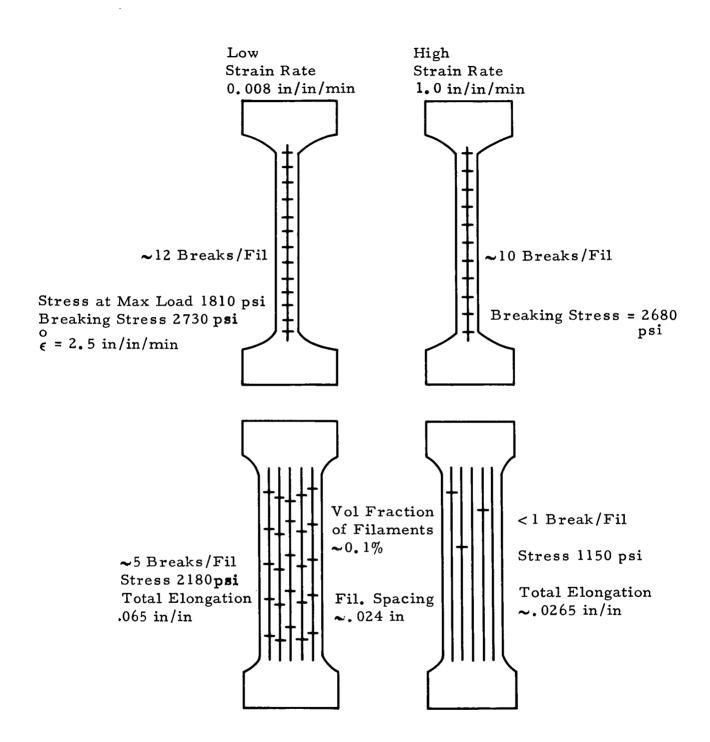
Figure 13. The Effect of Strain Rate and Filament Spacing on the Number of Breaks/Filament

is a rapid sequence of high-energy filament fractures beginning from one disk shaped crack. From these data it is clear that the influence of matrix cracking on composite failure increases with strain rate, and this is not accounted for in rule of mixture predictions. While it is difficult to take it into quantitative account, it would seem reasonable to suppose that the critical strain rate is that at the tip of the propagating matrix crack. This would be governed by the amount of energy and its rate of release during filament fracture and upon the strain rate sensitivity of the matrix.

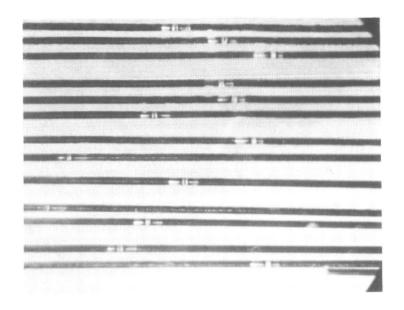
Figure 14. Patterns Typical of Bond Failure at Filament Fractures (17X)

For sometime a good deal of effort has been applied to improving the bond strength between matrix and filaments with the intention of obtaining better stress transfer at the interface. At first glance, this appears to be a logical step toward improving the reinforcing mechanism and therefore developing higher strength in composites. Certainly, the bond strength must be sufficient to load the filaments to their fracture strength. However, if the bond strength is greater than that needed to fracture the filament it will cause the matrix to fail in tension at the filament fracture site. This matrix crack then causes premature fracture of adjacent filaments and the gross strength of the composite may, in fact, be reduced. It would be far more desirable to provide just enough bond strength to fracture the average strength filaments and no more. At this level of bond strength, the matrix would unbond at the newly formed ends rather than fracturing normal to the tensile stress trajectories. Figure 14 shows such a failure process with the detail of a single fracture shown previously in Figure 6A. When the bond strength and the tensile strength of the matrix are very nearly matched, the optimum condition results. Each time an inclined matrix crack begins, the filament unbonds and the inclined crack is retarded. This results in an unbonded surface intermittently punctuated with inclined cracks which have been arrested. This unbonded surface is illustrated in the bottom filament, Figure 15. Note that the filament in the center produced a disk crack and then unbonded.

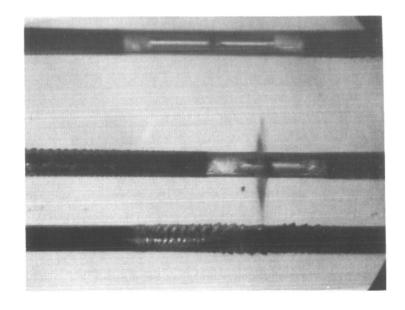
Figure 15. Unbonded Region Where Tensile Failure Has Been Retarded (58X)

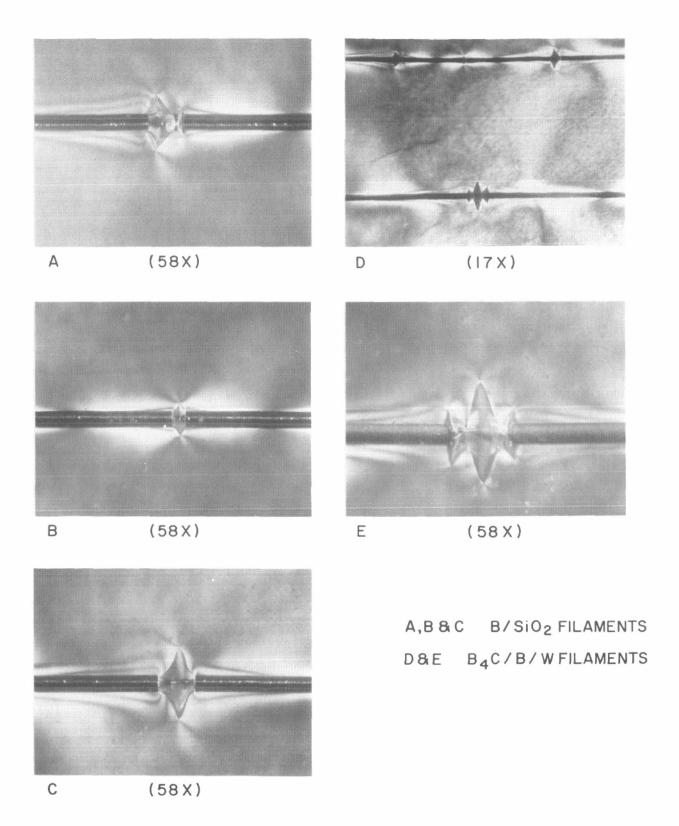
Figure 16. Photographs of Filament Fractures Under Load.

In most of the figures presented on previous pages, the photographs have been taken after load removal. To better appreciate the crack geometry under loading, Figure 16 illustrates several different fracture modes occurring in two specimens while the load is applied. Note that cracks open considerably during load application into configurations more descriptive of the stress trajectories alluded to previously. Upon release of the load the cracks close and the geometry is changed considerably. Figure 16 shows four separate filament fractures, each with a different matrix crack pattern. The first photo (#A) shows two inclined matrix cracks with no accompanying disk shaped crack. Photo (#B) shows the beginning of a disk shaped crack. Photo #C shows a larger single disk in the open position. The geometry gives a more accurate estimate of the stress trajectories of transfer around the crack. Photos D & E show both disk and inclined cracks in an open position. In these photos it is obvious that the inclined cracks are not shaded by the disk to nearly the degree that would appear in the unloaded condition. All the photos are illuminated with polarized light, but no attempt was made here to analyze the specimens photoelastically.

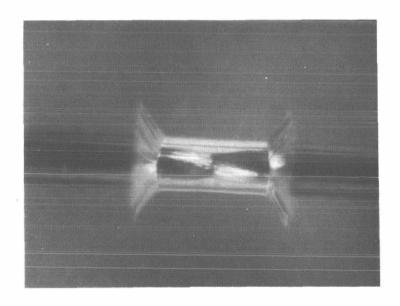
Figure 17. Example of the Necking and Simultaneous Debonding of Tungsten Wire in an Epoxy Matrix (116X)

A step toward alleviating this condition is to reduce the sudden energy release mechanism. A single test was conducted with a tungsten filament as the single reinforcing filament. This filament was reported to have negligible ble ductility as measured in a standard tensile test but necked considerably when loaded in the matrix (See Figure 17). The flow type failure of the tungsten filament prevented the sudden release of energy normally encountered at fracture of a boron or silicon carbide filament. This suggests that a filament of boron on a ductile substrate could deform sufficiently to retard a sudden energy release. Boron on silica might provide an analogous capability by virtue of the low modulus of the silica core.
