Stress Development of a Super-tall Structure During Construction: Field Monitoring and Numerical Analysis

ABSTRACT

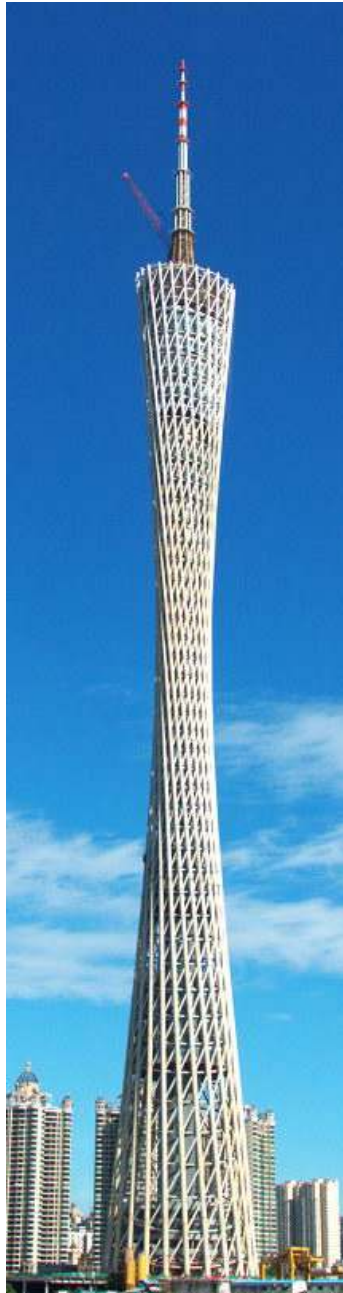
Fig. 1. Perspective view of Guangzhou New TV Tower in July 2009

The Guangzhou New TV Tower currently nearing completion is a super-tall structure with a height of 610 m and is the tallest building of its type in the world. It is being built to broadcast the 16th Asian Games due to be held in Guangzhou from November 12 to 27, 2010. It will subsequently be used as office space and for entertainment, dining, tourism, and the transmission of television and radio programs. The structure consists of a main tower (454 m) and an antenna mast (156 m). Fig. 1 illustrates the perspective view of the tower in July 2009 when the entire structure was topped out and non-structural construction activities (such as the erection of a curtain wall and interior decoration) were still ongoing.

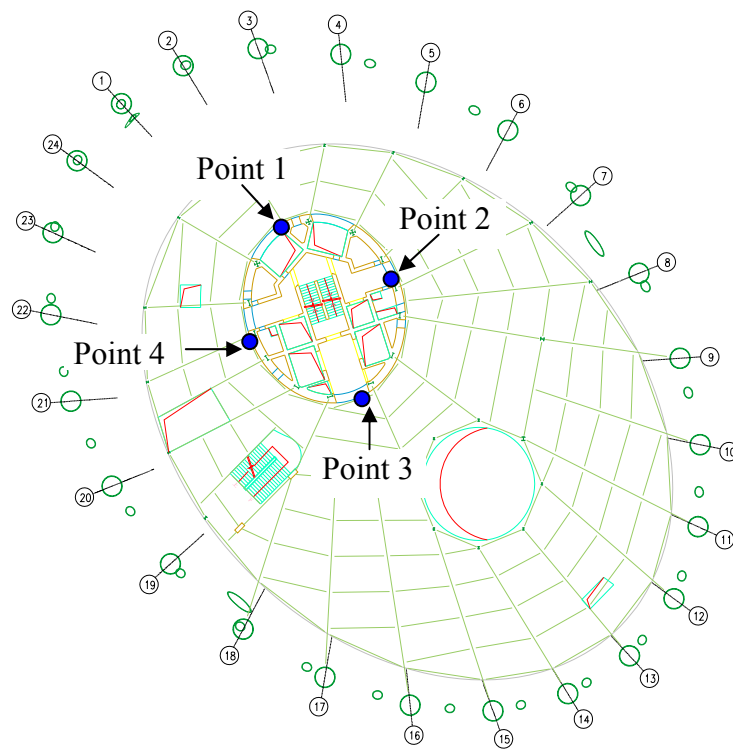
Fig. 4. Location of strain and temperature monitoring points in one critical section

In the inner tube, a 45-degree strain rosette was installed at four points (denoted as points 1 ~ 4 in Fig. 4) in each critical section with each rosette consisting of three Geokon vibrating wire strain gauges (Geokon 4200) to measure the strain and temperature of the concrete wall. Fig. 4 shows the positions of the strain gauges in the plan and Fig. 5 shows the installation of a typical strain rosette in the RC wall of the inner tube with firm protection. Fig. 5(a) is a photograph of an original Geokon 4200 gauge. To measure the strain of the concrete rather than that of the rebar, the vibrating wire strain gauges were coated using two semi-cylinders with a diameter of 40 mm with concrete being poured into the day before the concrete was poured. To minimize the shrinkage effect, the concrete used for coating is the same as that used in the structure. About seven to eight hours later, the semi-cylinders were removed and the coated gauges were ready for installation as shown in Fig. 5(b). All the gauges were inspected and tested using a portable readout box. A strain rosette was then attached to the rebars (Fig. 5(c)) to avoid movement while concrete was poured and to measure the strain in three directions at each point. The cables were then protected by stainless galvanized steel pipes embedded in the concrete floor (Fig. 5(d)). This protects the cables from causal damage. The strain and temperature at each of the points were taken in the days immediately after the concrete was poured. During the first few days, the temperature varied significantly due to hydration. Strain also developed due to initial shrinkage and stress redistribution, phenomena which are hard to predict. The strain reading taken

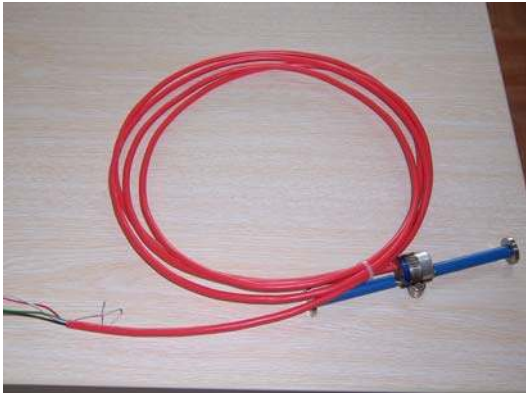
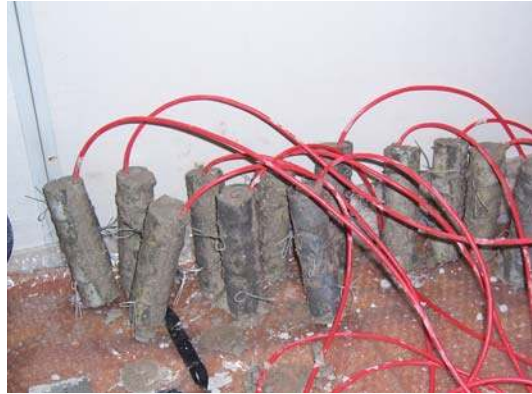
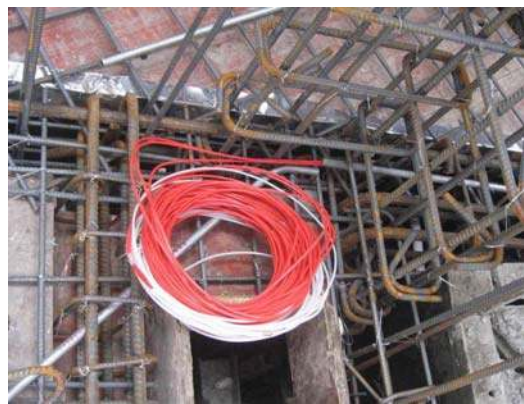
(a) Original vibrating wire strain gauge

(b) Concrete coating

(c) A strain rosette in the inner tube

(d) Protection of cables

Fig. 5. Installation of vibrating wires

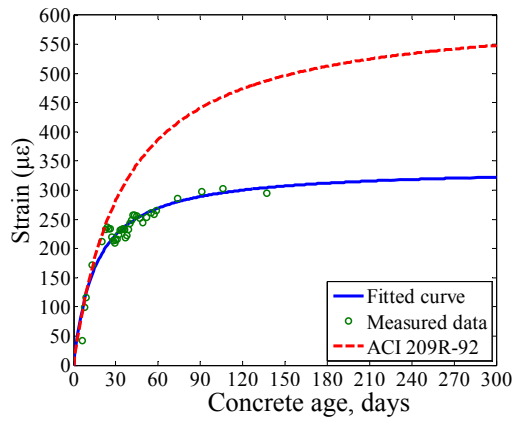
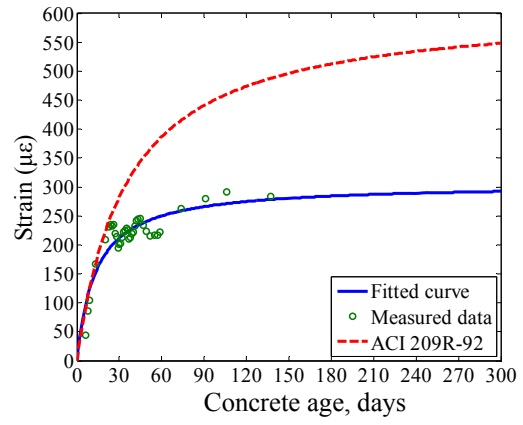
Fig. 6. Shrinkage of concrete

those affecting the structure. Fig. 6 shows the shrinkage strain measured at the two grade C60 specimens together with the predictions suggested by the ACI code (ACI 209 R-92, 1992). The figure clearly shows that the ACI code overestimates the shrinkage strain of the concrete used in the tower. The measurement data are fitted with the ACI formulae as

where $(\varepsilon_{sh})_t$ is the shrinkage strain at time t , $(\varepsilon_{sh})_u$ is the final shrinkage strain, α and β are two parameters to fit, and $k_1 \sim k_7$ are the coefficients representing various conditions including curing, ambient humidity, size, fine aggregate percentage, cement content, and air content. The seven coefficients ($k_1 \sim k_7$) have the same form as those of the ACI formulae (ACI 209 R-92, 1992) and only α and β are fitted. The fitted values of α for the two specimens are 15.5 and 13.3 and those for β are 433 $\mu\varepsilon$ and 389 $\mu\varepsilon$, giving average values of 14.4 and 411 $\mu\varepsilon$, respectively, much smaller than the ACI code values of 35 and 780 $\mu\varepsilon$.

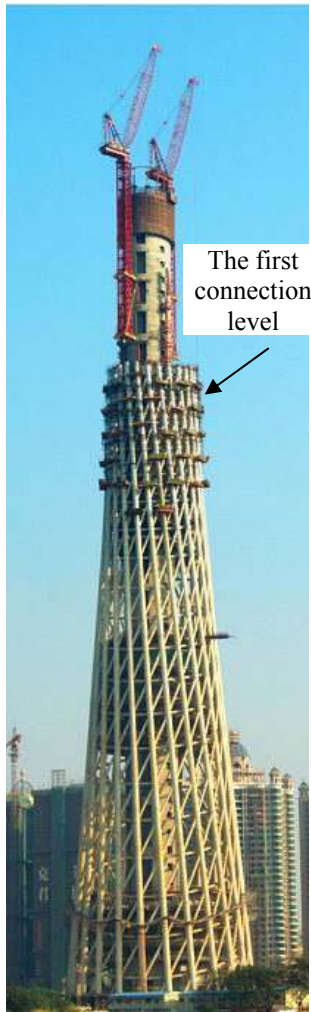
Fig. 8a. One of the critical stages of construction

The inner tube of the tower was constructed earlier than the outer tube of the tower according to progress in construction. The completed inner tube is higher than the outer tube to allow cranes attached to the inner wall to lift CFTs and other components into place. As a result, the top section of the inner tube can be treated as a cantilever part and its bottom is supported by the floors (or connection girders) connected to the outer tube. Fig. 8a illustrates an extreme situation when the inner tube is about 60 m higher than the outer tube and the two tubes are linked by the connection girders at a height of 204 m (which is denoted as the first connection level). There are four connection levels in total as illustrated in Fig. 2. In this situation, the stresses at the first connection level (the bottom of the cantilever part) were of concern to the designer and the contractor and needed to be examined carefully.

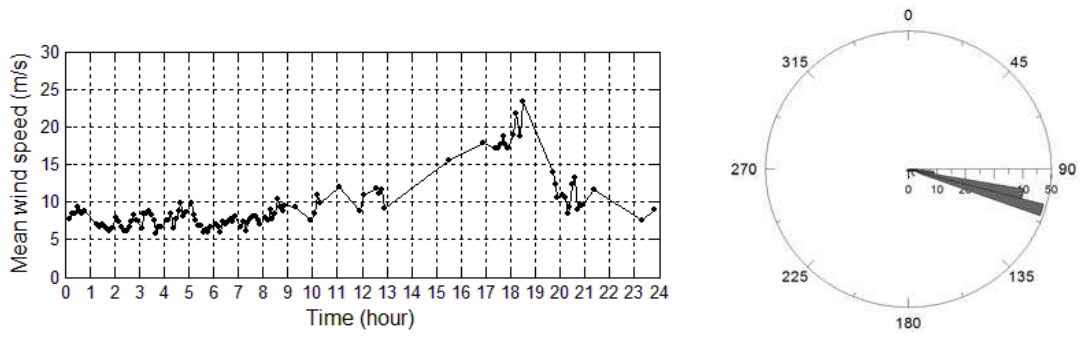
Fig. 9. Two-minute mean wind speed at the top of the tower (left) and wind rose diagram (right) during Typhoon Neoguri on April 19, 2008

The tower is located in a typhoon-prone area in which four typhoons struck in 2008. The real-time monitoring system installed in the tower recorded structural responses to all of these typhoon events. For example, Typhoon Neoguri hit the Guangzhou area on April 19, 2008. The anemometer installed at the top of the tower (at a height of 375 m) measured the 2-minute mean wind speed as 23.3 m/s and the 3-second maximum wind speed as 28.1 m/s. Fig. 9 plots the 2-minute mean wind speed and shows the corresponding wind rose diagram. It can be seen that the maximum wind speed occurred between 18:00 and 19:00.

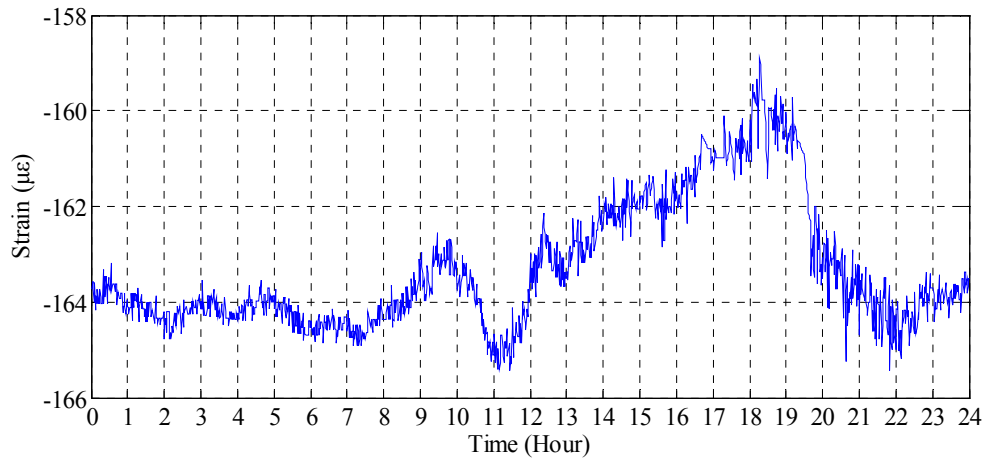
Fig. 10. Vertical strain responses at point 2 (upper) and point 4 (lower) at a height of 121.2 m during Typhoon Neoguri on April 19, 2008

Fig. 10 shows the vertical strains measured at point 2 and point 4 on the 121.2 m cross-section during the same typhoon. It can be observed that large strain variations occurred between 18:00 and 19:00 when the wind speed reached its maximum. To illustrate the typhoon responses at various heights on the tower, changes in the principal stresses recorded at four monitoring points on different sections of the tower are compared in

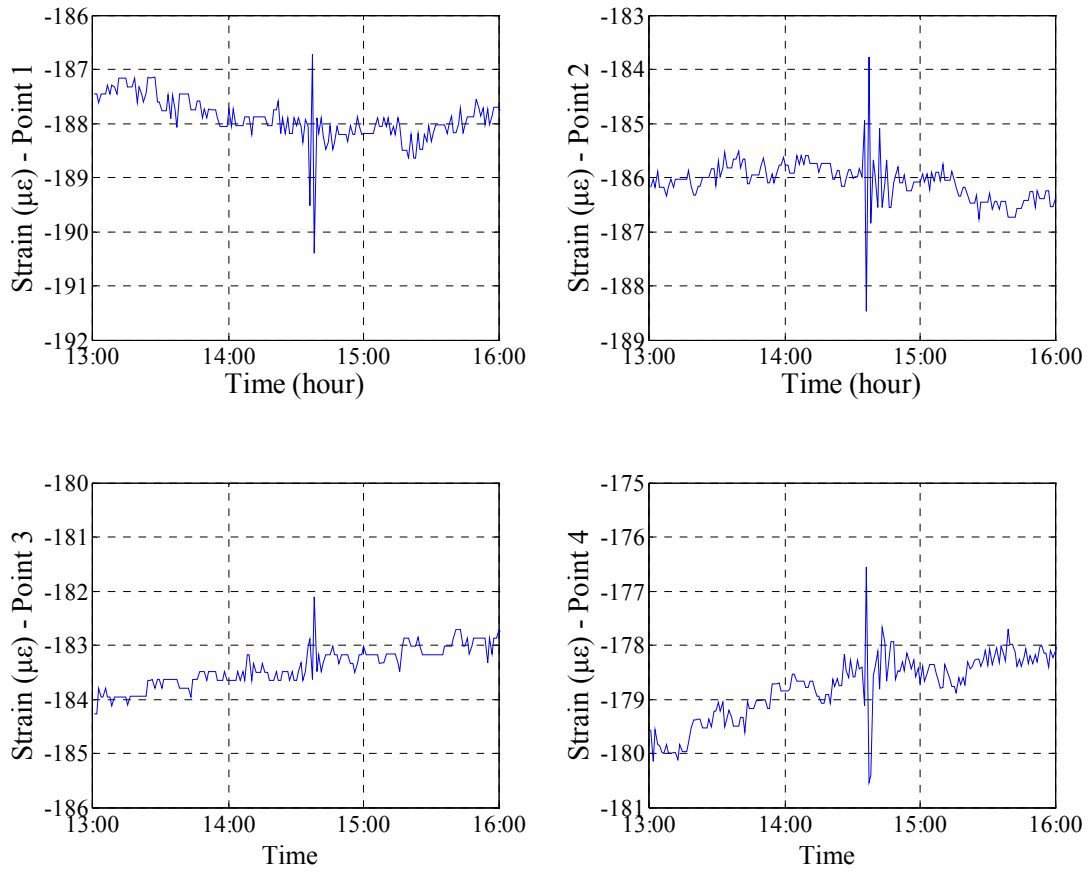
Fig. 12. Vertical strain responses in the 121.2 m section during the Wenchuan Earthquake on May 12, 2009

minutes after the earthquake struck. The distance between Wenchuan and Guangzhou is about 1,325 km and the wave propagation was calculated at around 3,150 m/s. Fig. 12 shows the vertical strains measured at the 121.2 m cross-section during the earthquake. It can be observed that the peak-peak variation in strain was less than $5 \mu\epsilon$. A comparison of difference levels shows that the maximum variation in the principal stresses at the middle section (173.2 m) was larger than those at the bottom and at the top of the tower as shown in Fig. 13. This indicates that the earthquake loading had a more significant effect on the middle than it did on the bottom and the top of the structure, which is different from the response pattern observed under the wind loading discussed in the last section. This may be due to different modes being excited under the two different types of loading.

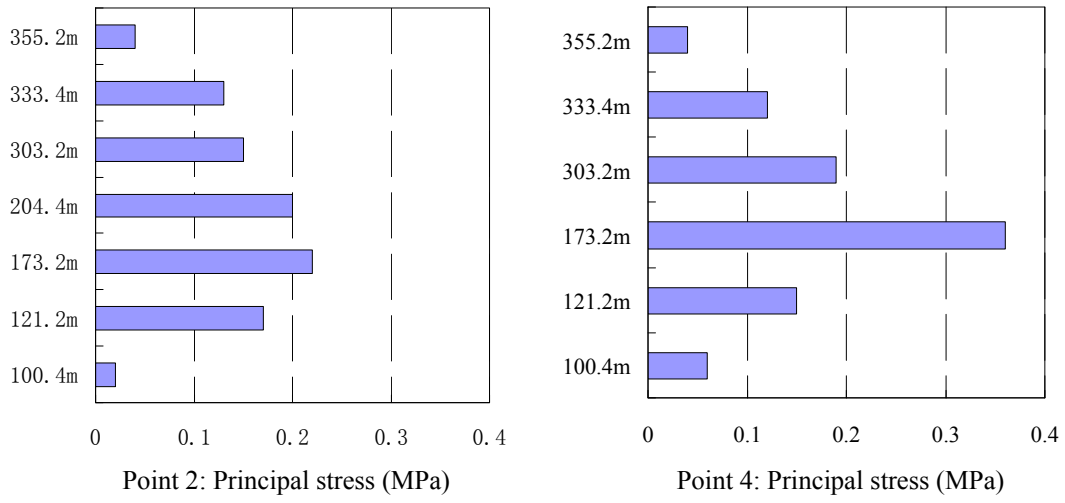
Fig. 13. Variation in the principal stresses in different sections during the Wenchuan Earthquake on 12 May 2009

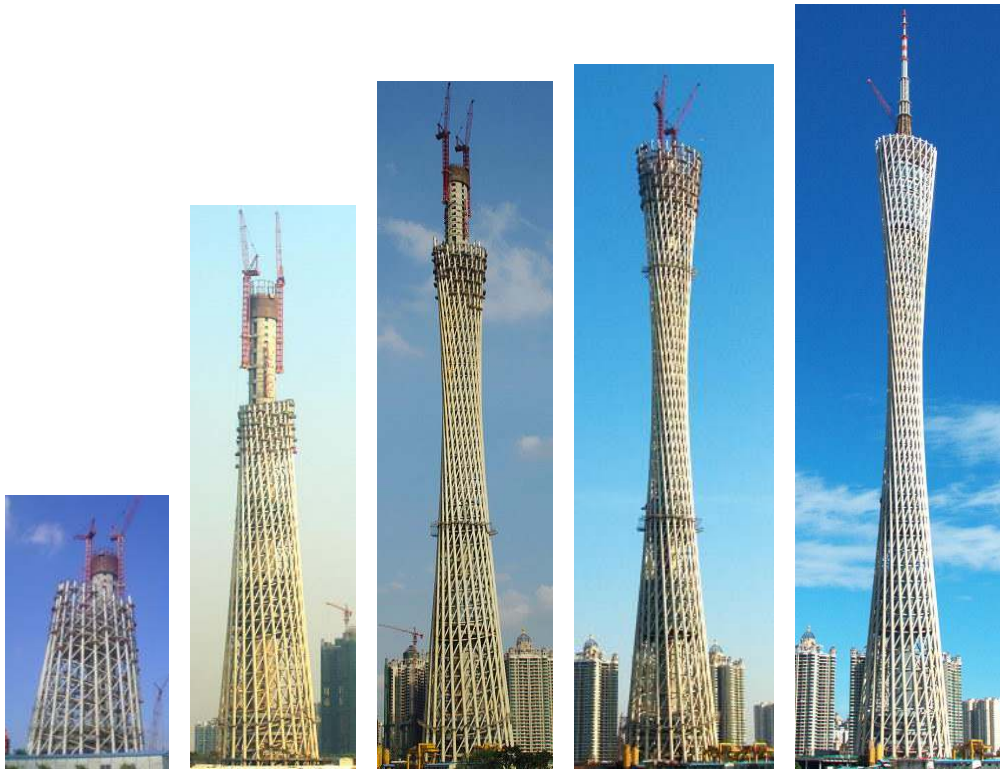
Fig. 14. Photographs of the tower and the corresponding FE models at different stages

FE models were constructed using SAP2000 Version 11.0 (SAP2000, 2006) according to the structural components under construction at the time (see Fig. 14). In these models, two-node three-dimensional Euler beam elements with six degrees of freedom (DOFs) at each node were employed to model the outer structure, the antenna mast, and the connection girders between the inner and outer structures. Four-node and three-node shell elements with six DOFs at each node were used to model the shear walls of the inner structure and the floor decks. All of the nodes in the basement were fixed in six directions. The full model at the final stage contains 122,476 elements, 84,370 nodes, and 505,164 DOFs in total. Only the dead load of the completed components and the mass of major construction facilities including cranes and the construction platform

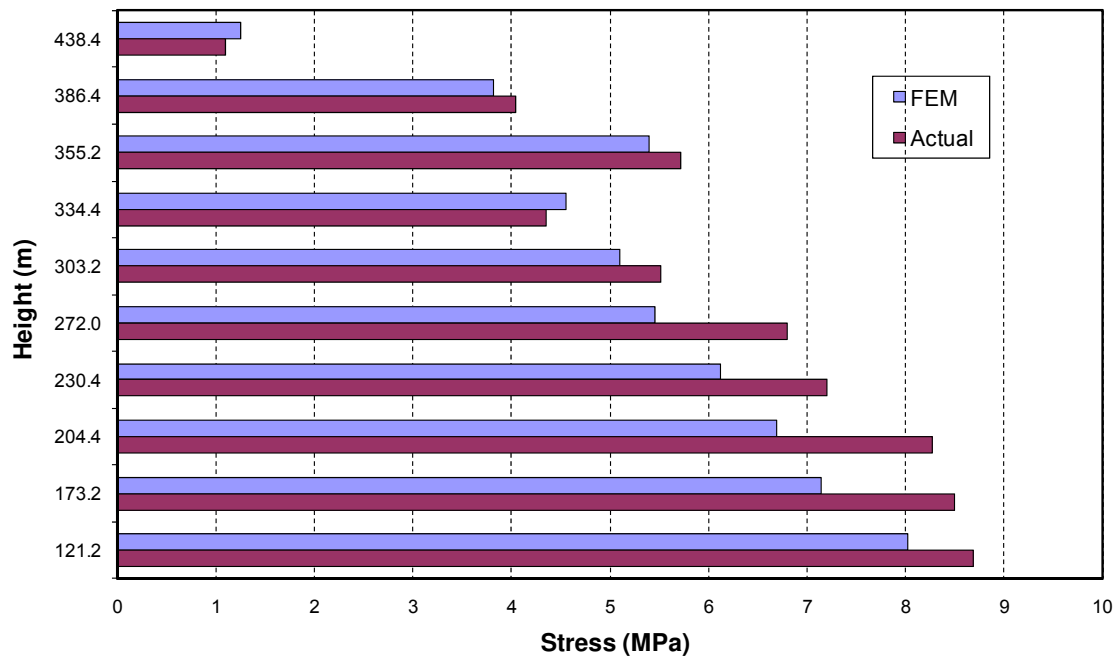
Fig. 15. Stress distribution in different sections: point 2 in July 2009

At different stages, the stresses of the structure are obtained via linear analysis and compared with the measurements. Fig. 15 compares the calculated stresses of point 2 at different heights in July 2009 with the measured counterparts. It can be seen that the model predictions and the field measurements are generally in good agreement although the average discrepancy is about 10%. The discrepancy may be due to the uncertainty of the measurement and the difference between the FE model and the actual structure constructed. For example, the construction error of the large-scale structure results in additional stresses that are difficult to model in the numerical analysis. Non-uniform temperature distribution throughout the structure also causes thermal stresses at components, which is not considered at the moment. In addition, inaccuracy in the material properties contributes to discrepancy of results. Considering these factors, the discrepancy is acceptable. It is also observed that the stress differences in the sections close to the connection girders were relatively large due to the concentration of stress in regions where the inner tube and the outer tube interact. This suggests that more sensors should have been installed in the regions. The stresses in the lower sections were generally larger than those in the upper sections, with the exception of those at 355.2 m. It is observed the thickness of the wall above 339.6 m decreased from 500 mm to 400 mm (a 20% reduction), whereas the dead load at 355.2 m decreased by less than 20% in comparison with that observed at 334.4 m. Consequently, the stress increased a little at 355.2 m.

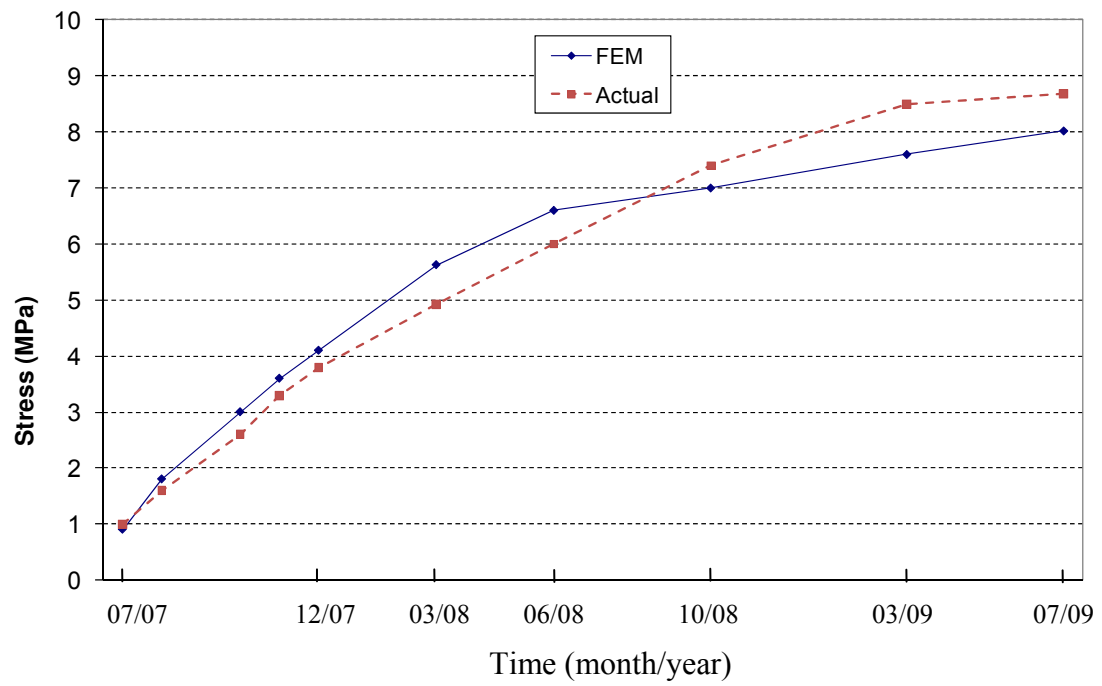
Fig. 16. Stress evolution at different stages of construction: Point 2 at the 121.2 m level

Fig. 16 illustrates the evolution of principal stress at point 2 at the 121.2 m level as construction activity progressed. Again, the model predictions match the measurement data well. It is observed that the principal stress increased monotonically as construction work proceeded.

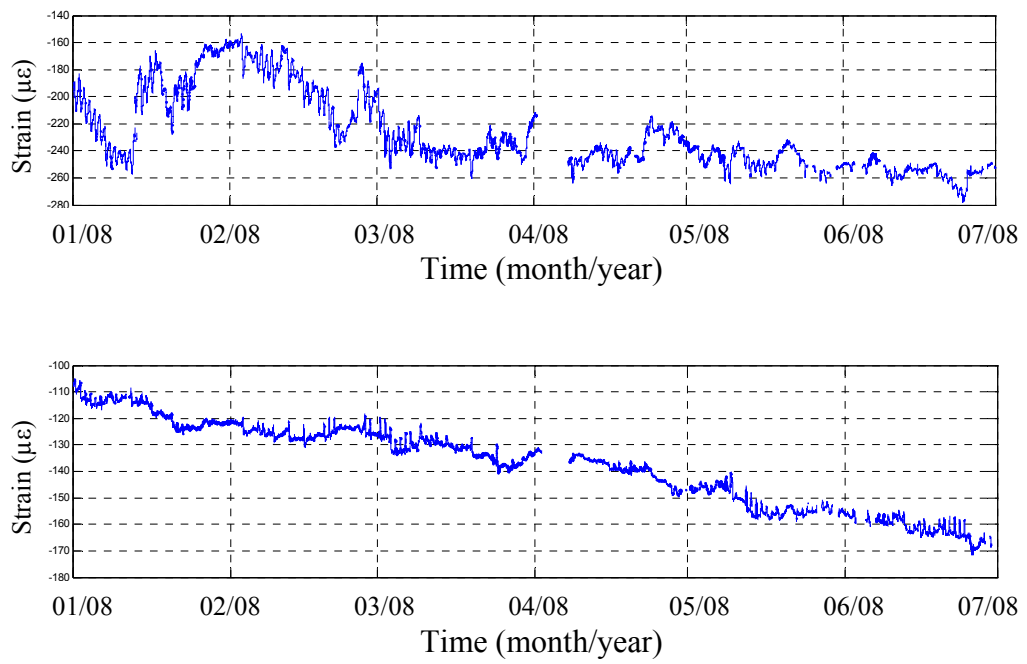
Fig. 17. Vertical strains measured at point 2 at the 32.8 m level (upper) and at point 2 at the 121.2 m level (lower)

Fig. 17 illustrates the vertical strains measured by the gauge at point 2 at the 32.8 m and 121.2 m levels. As noted previously, the strain gauges at the 32.8 m and 100.4 m sections were attached to the grouted mounting blocks on the exterior surface of the wall, while all the other strain gauges (above 121.2 m) were embedded inside the wall. The compressive strain data measured by the embedded sensor gradually rose from $-110 \mu\epsilon$ to $-170 \mu\epsilon$ over six months, thereby verifying the progress made in construction. However, the data measured by the surface sensor vary significantly and do not show a clear increasing trend during the study period. One reason for this is that the raw strain measured by the vibrating wire includes the strain due to temperature change measured by the thermocouple embedded in the vibrating wire. This thermocouple measured the ambient air temperature rather than the temperature of the concrete wall. This resulted in incorrect strain data when an incorrect temperature was employed to remove the temperature effect from the raw strain. Due to this reason, the strain data measured by the sensors at the two lowest levels are not reported in this paper.
