National Tsunami Hazard Mitigation Program

Surviving a Tsunami—Lessons from Chile, Hawaii, and Japan

Circular 1187

Actions that saved lives, and actions that cost lives, as recounted by eyewitnesses to the tsunami from the largest earthquake ever measured—the magnitude 9.5 earthquake in Chile on May 22, 1960.

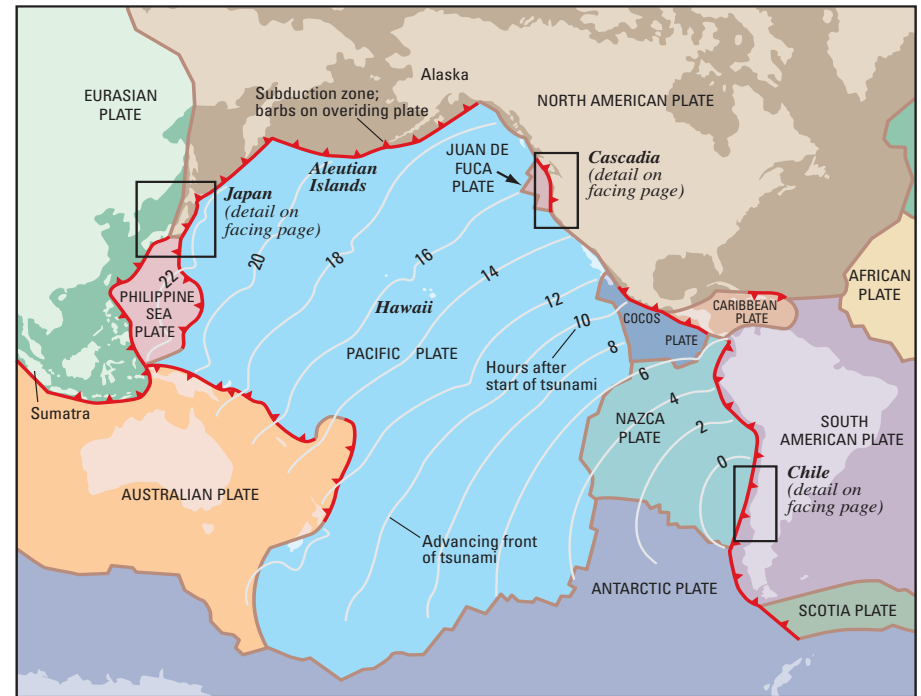
The 1960 Chilean tsunami radiated outward from a subduction zone along the coast of Chile. Its waves reached Hawaii in 15 hours and Japan in 22 hours.

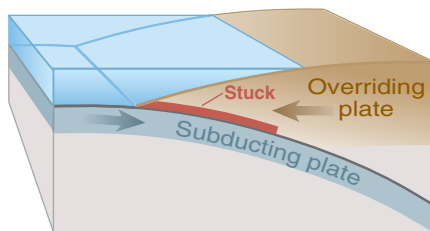
Vertical Slice Through a Subduction Zone

One of the many tectonic plates that make up Earth’s outer shell descends, or “subducts,” under an adjacent plate. This kind of boundary between plates is called a “subduction zone.” When the plates move suddenly in an area where they are usually stuck, an earthquake happens.

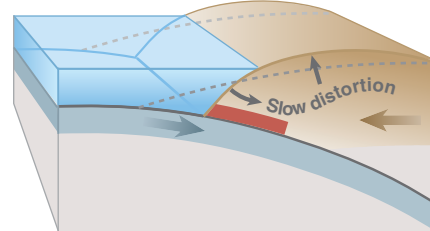
A. Between Earthquakes

Stuck to the subducting plate, the overriding plate gets squeezed. Its leading edge is dragged down, while an area behind bulges upward. This movement goes on for decades or centuries, slowly building up stress.

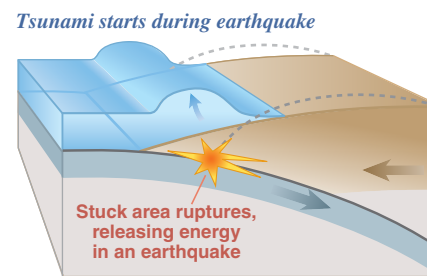
B. During an Earthquake

An earthquake along a subduction zone happens when the leading edge of the overriding plate breaks free and springs seaward, raising the sea floor and the water above it. This uplift starts a tsunami. Meanwhile, the bulge behind the leading edge collapses, thinning the plate and lowering coastal areas.

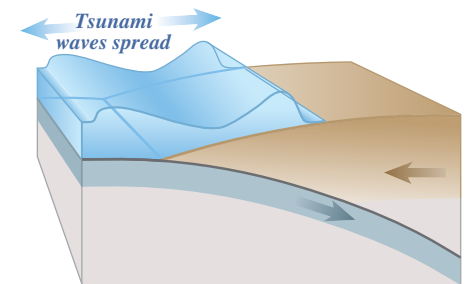
C. Minutes Later

Part of the tsunami races toward nearby land, growing taller as it comes in to shore. Another part heads across the ocean toward distant shores.

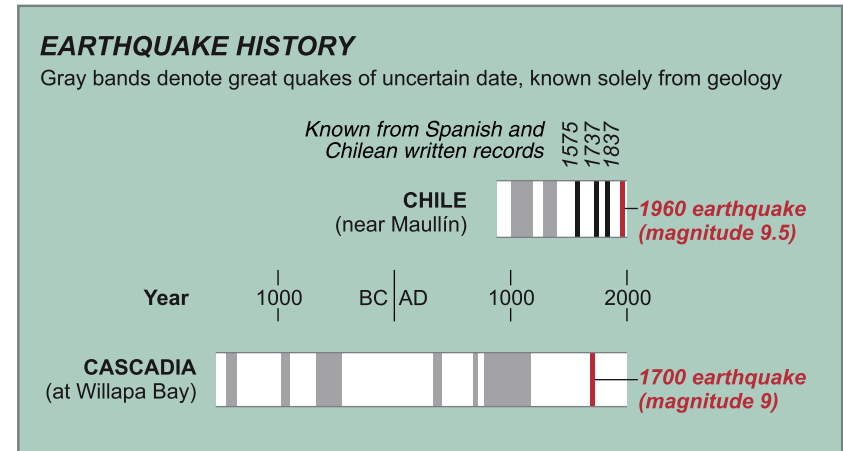
Both the 1960 Chile earthquake and the 1700 Cascadia earthquake were caused by sudden ruptures of long segments of subduction zones. Each of these quakes generated a tsunami that not only struck nearby coastal areas but also caused damage in coastal areas as far away as Japan.

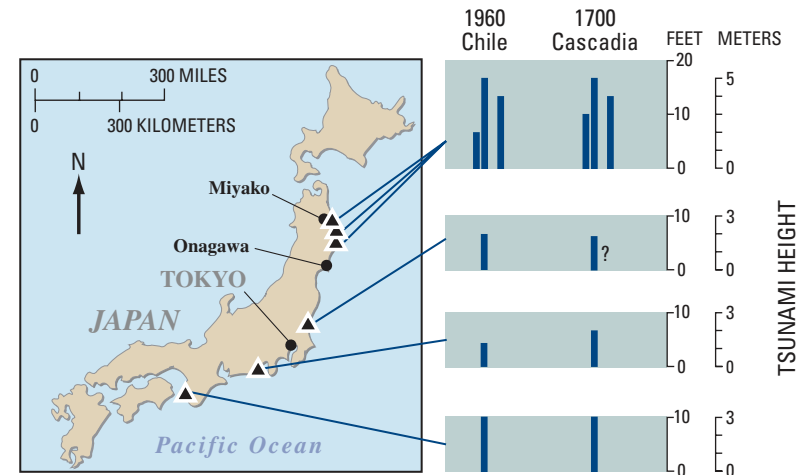
As shown by wave heights observed in Japan, subduction-zone earthquakes in Chile and Cascadia have caused tsunamis that were large even after crossing the Pacific Ocean.

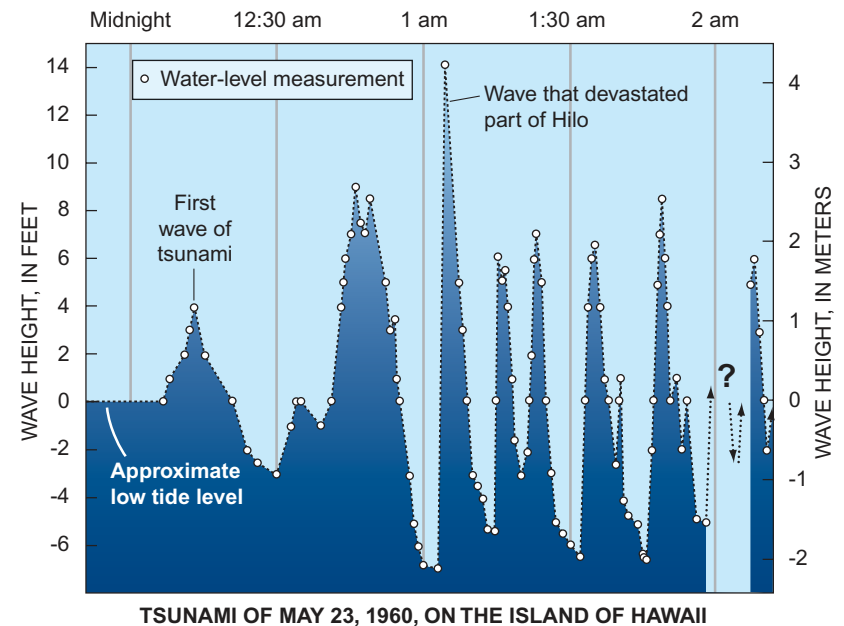
The 1960 Chile earthquake produced a series of tsunami waves that crossed the Pacific Ocean. This record shows measurements of water levels beneath the Wailuku River Bridge made by seismologist Jerry Eaton and his companions during the first few hours of the tsunami in Hilo, Hawaii.

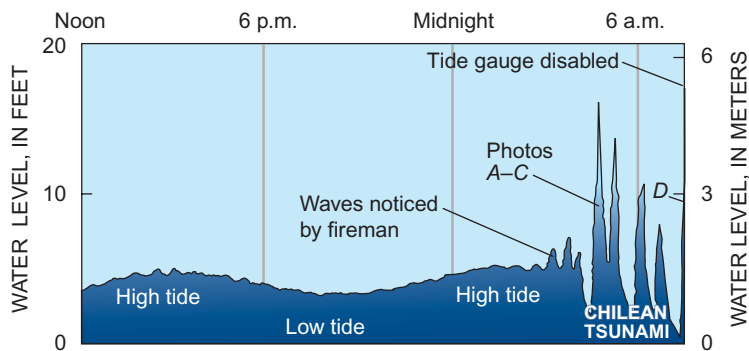
Tide-Gauge Record for May 23 and 24, 1960, at Onagawa, Japan

Endō Fukuei (left, in 1999) recalls the fireman's warning that spurred citizens of Onagawa, Japan, toward high ground as the 1960 Chilean tsunami reached the town's harbor. Some residents gathered on a hillside as the first large wave poured into town (photos A-C at right). Almost 3 hours later, crowds remained on this hillside as another wave arrived (D). Waves shown in the photos were recorded by a tide gauge in the Onagawa harbor (see below).

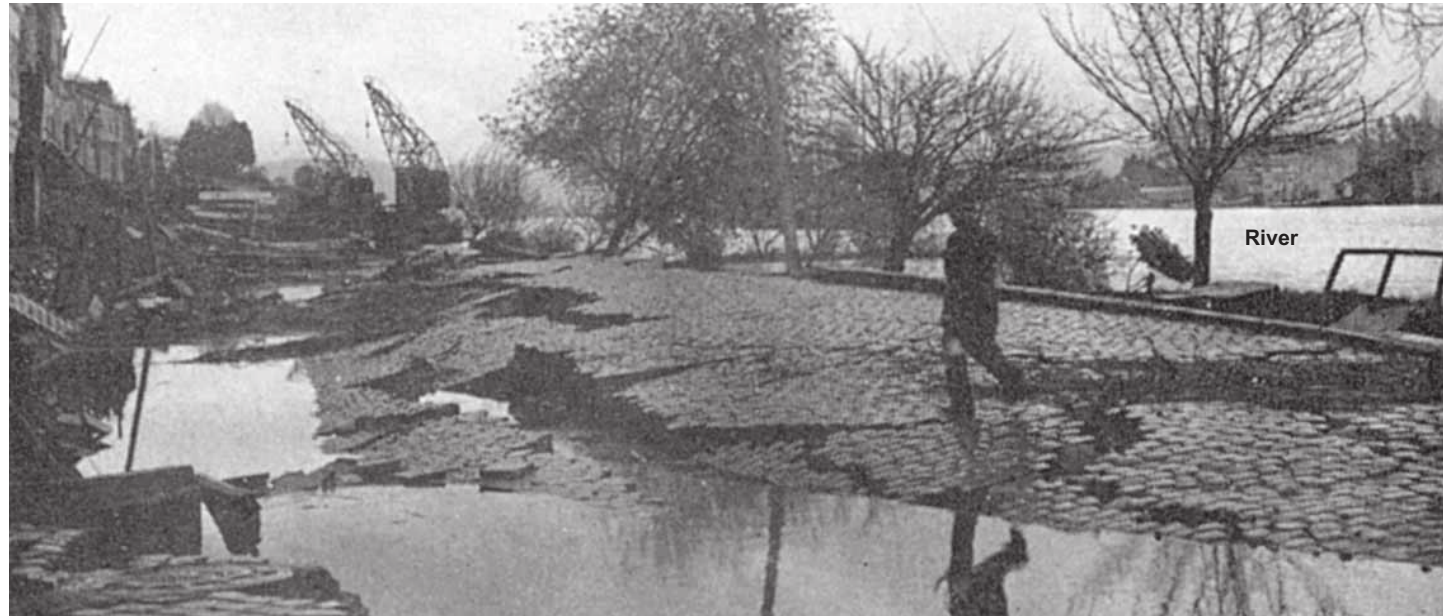
The 1960 Chile earthquake cracked a road near Maullín, Chile, used minutes later by René Maldonado. This road was soon cut by the waves of the tsunami that followed the quake. At left, Mr. Maldonado poses on horseback in 1989 beside his 1960 home. Below, a photo from 1960 shows a main street in Valdivia, Chile, that was damaged when shaking from the earthquake caused land to spread toward the adjacent river.

Minutes after the 1960 Chile earthquake, René Maldonado rode his horse on the road from Maullín, Chile (see locations on photo, p. 14). During the ride, Mr. Maldonado's horse had to jump newly formed cracks in the road. The weakened road was soon severed by the waves of the tsunami that followed the earthquake, leaving channels too wide even for a horse to jump.

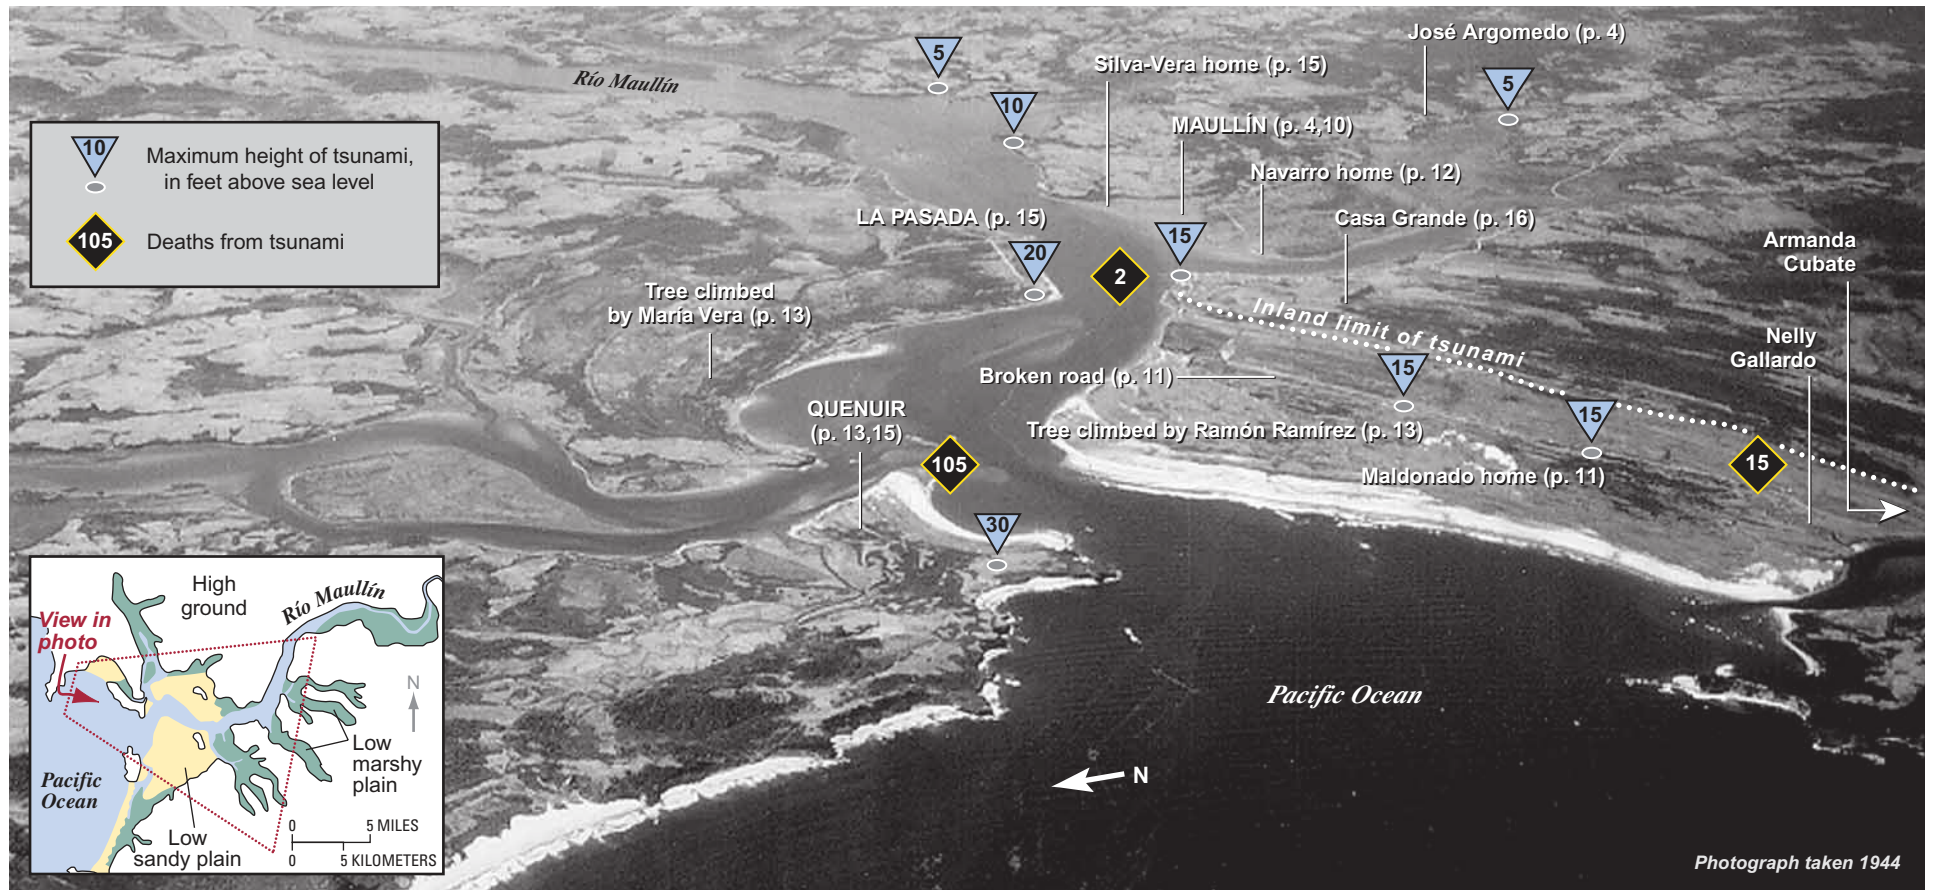
As marked on this 1944 photo of the mouth of the Río Maullín, Chile, the 1960 Chilean tsunami flowed 2 miles inland from the beach at right foreground. In much of this flooded area, the tsunami reached a height of 15 feet above sea level. After being swept up by the tsunami, Nelly Gallardo floated on a wooden rail and Armanda Cubate took refuge on a roof (see far right in photo below). They survived the tsunami, but 15 other people near them died.

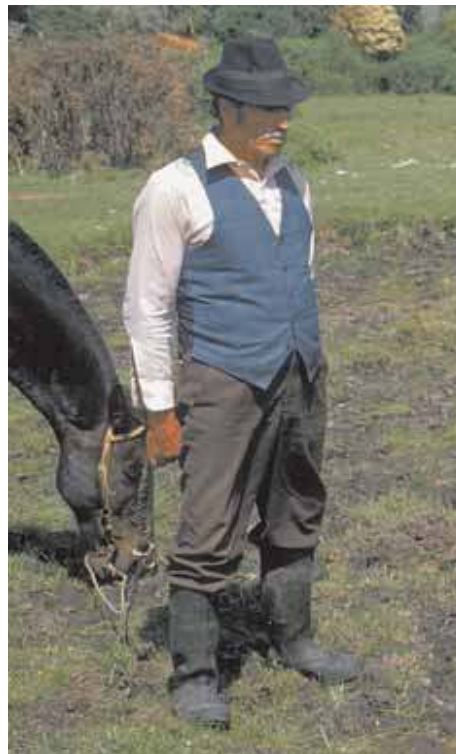
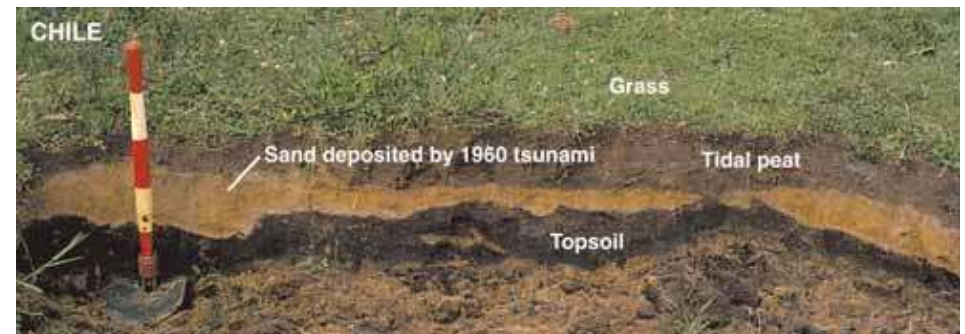
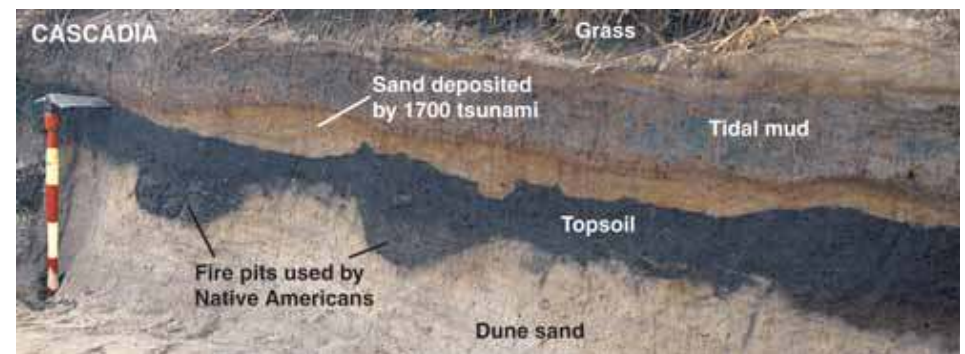
The 1960 Chilean tsunami deposited a sand layer on fields owned by Juan Vera near Maullín, Chile. When this picture of Mr. Vera was taken in 1989, the sand layer was still visible in a streambank (upper right photo). A similar sand layer from the 1700 Cascadia tsunami covers the remains of a Native American fishing camp exposed in a bank of Oregon’s Salmon River (lower right photo; see map, p. 3, for location).

The 1960 tsunami also deposited sand along the Río Maullín, some of it on land owned by Juan Vera. He and his wife, María Isolina Silva, lived on low ground 2 miles east of Maullín. The 1960 earthquake found Mrs. Silva at home and her husband on a nearby hillside. Their house collapsed, but Mrs. Silva escaped and soon joined her husband on high ground. Together they watched the tsunami overrun their fields and carry away the

remains of their house. The next day, Mr. Vera found a layer of sand several inches thick on much of the land the tsunami had overrun.

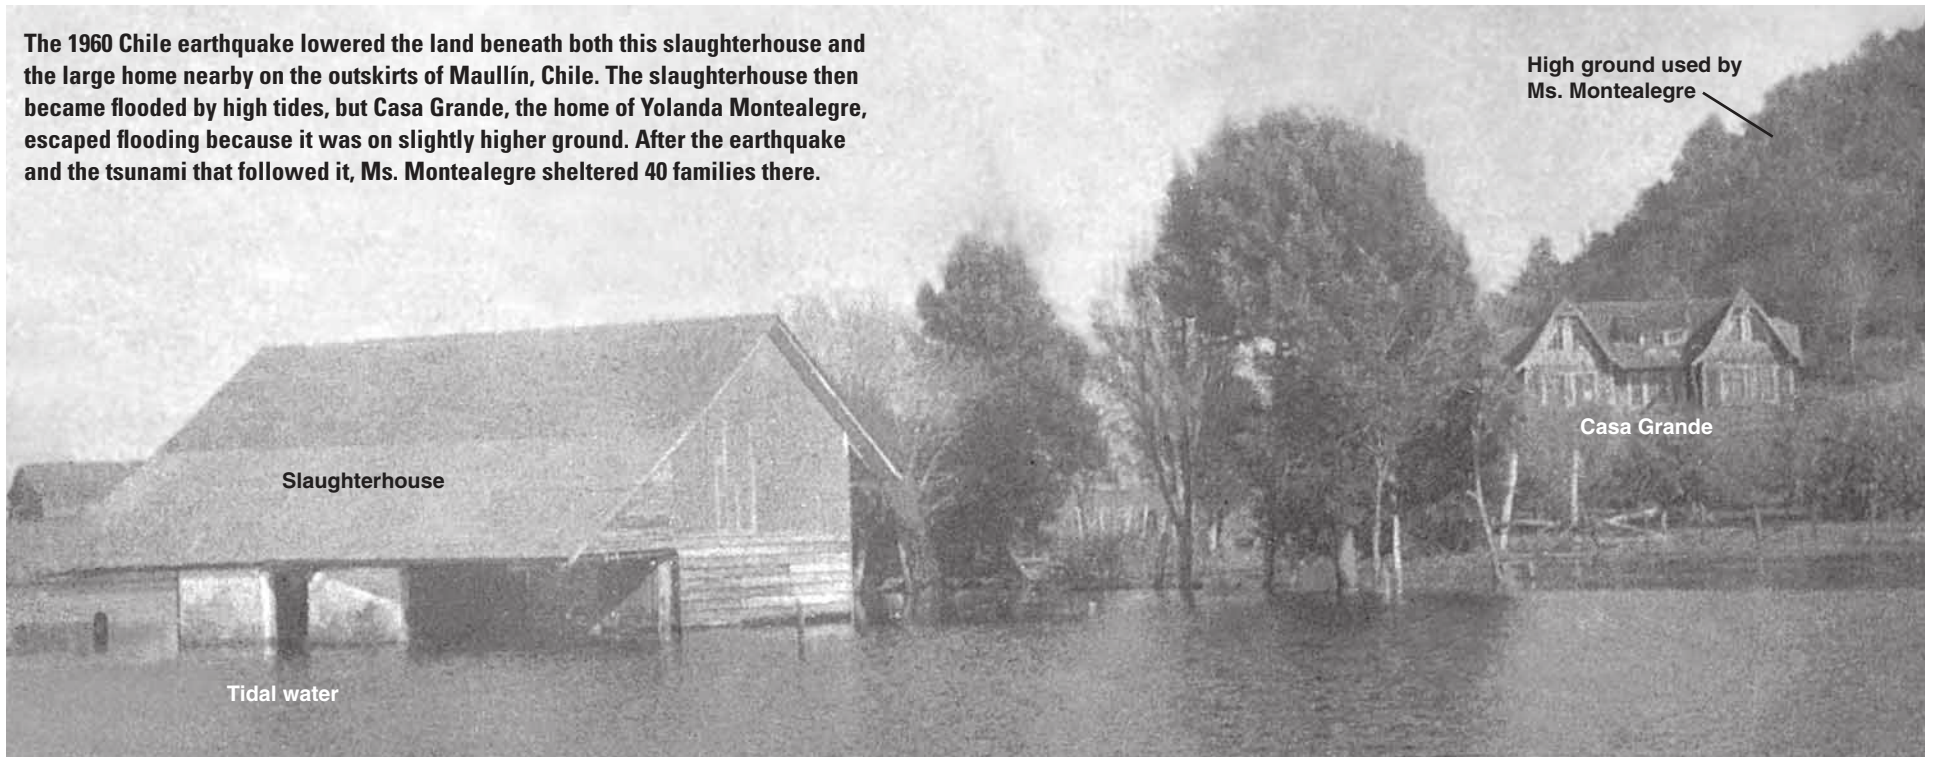
The 1960 Chile earthquake lowered the land beneath both this slaughterhouse and the large home nearby on the outskirts of Maullín, Chile. The slaughterhouse then became flooded by high tides, but Casa Grande, the home of Yolanda Montealegre, escaped flooding because it was on slightly higher ground. After the earthquake and the tsunami that followed it, Ms. Montealegre sheltered 40 families there.
