TESTING OF SPECIAL LYS STEEL PLATE SHEAR WALLS

Darren VIAN¹ and Michel BRUNEAU²

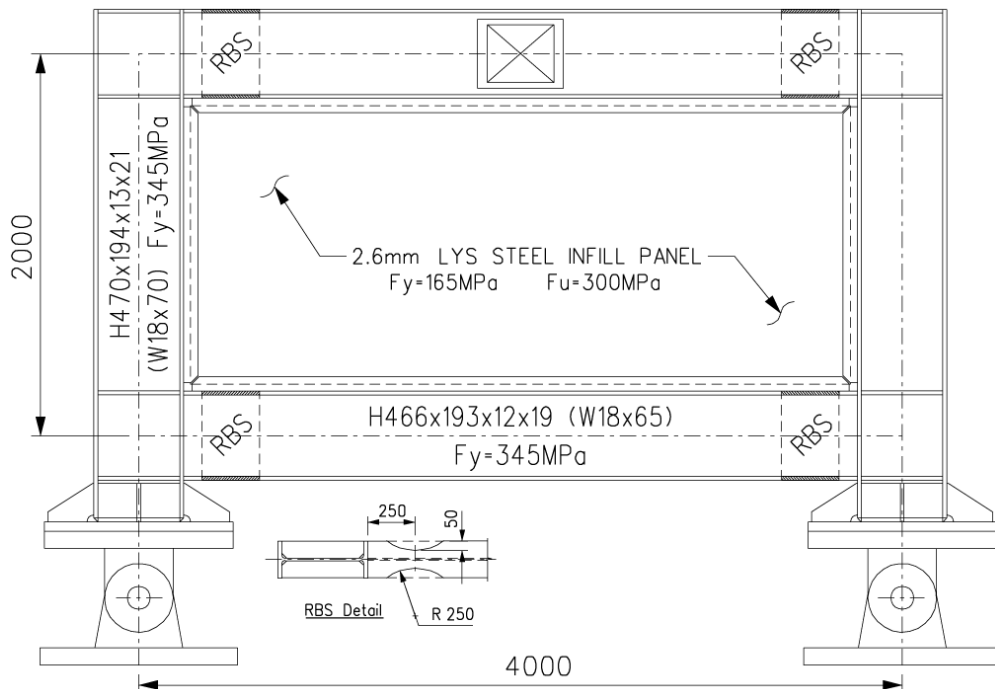
A total of three single bay, single story LYS SPSW specimens were designed by the researchers at UB, fabricated in Taiwan, and subjected to quasi-static cyclic testing in the NCREE laboratory at NTU. The frames measured 4000mm wide and 2000mm high between member centerlines, and consisted of 345MPa steel members. The infill panels produced by China Steel were 2.6mm thick, LYS steel plates with an initial yield stress of 165MPa, and ultimate strength of 300MPa, important properties that may aid in alleviating over-strength concerns mentioned above. All specimens also have a beam-to-column connection detail that includes reduced beam sections (RBS) at each end. This detail was designed to ensure all inelastic beam action would occur at these locations, with the intention of efficient anchoring of infill panel tension field forces, as required at the extremes (roof and basement level beams) of a multistory SPSW-retrofitted/designed steel frame. A solid panel specimen is shown schematically in Fig. 1.

Figure 1: Typical specimen dimensions

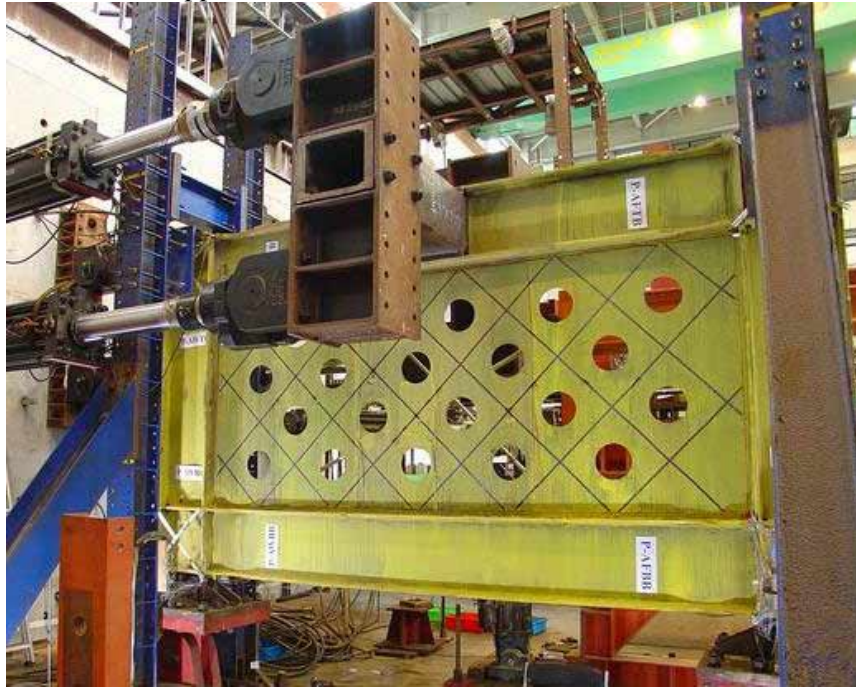
Two specimens tested had solid panels while the remaining two provide utility access through the panels using cutouts. One specimen consisted of a panel with a total of twenty 200mm-diameter holes, or perforations, in an arrangement shown in Fig. 2. Roberts and Sabouri-Ghomi [7] conducted research

Figure 2: Specimen P before testing

Specimen P performed well at the beginning of the test, behaving elastically at small displacements and exhibiting stable hysteretic behavior in the inelastic range. The stiffness and strength were both reduced, as anticipated, from the solid panel specimen values. Yielding in the panel spread between the perforations, remaining mainly in the narrow region between the holes. From a qualitative standpoint, the perforations reduced the audible sound produced by buckling of the panel, as the specimen was cyclically loaded. This would be beneficial in a building application, towards the negative perceptions of building occupants.

The perforated panel specimen shows promise towards alleviating stiffness and over-strength concerns using conventional hot-rolled plates, useful for markets in which LYS steel is not readily available. This option can also provide access for utilities to penetrate the system, important in a retrofit situation, where building use is pre-determined before SPSW implementation.

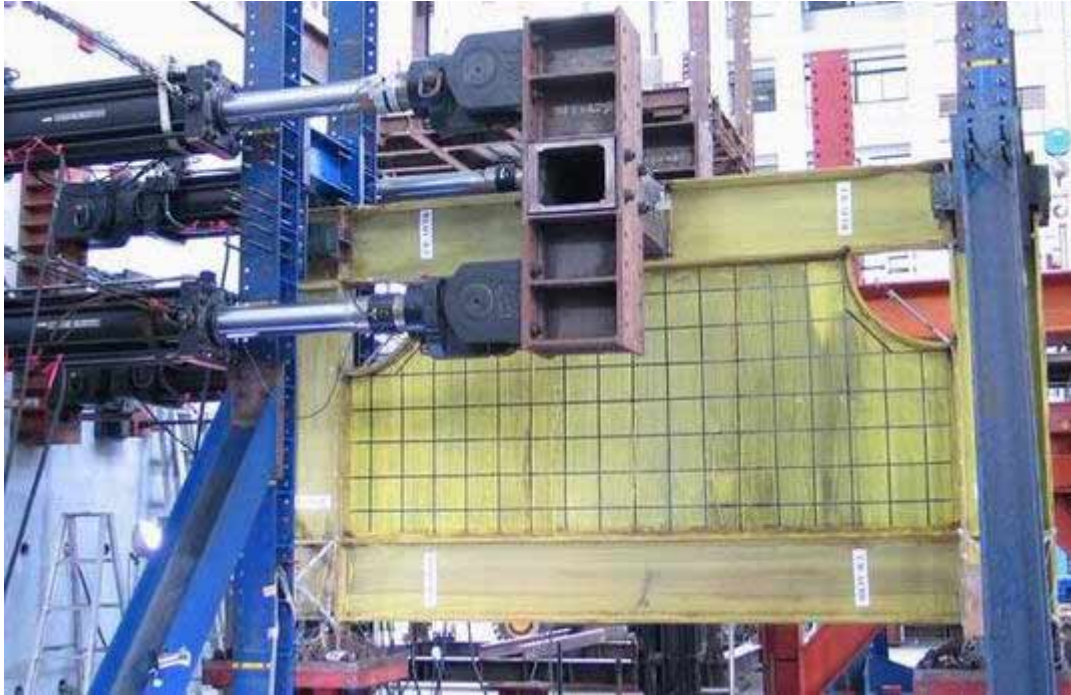
The other specimen allowing for utility penetration is a solid panel, with the top corners of the panel cutout and reinforced to transmit panel forces to the surrounding framing, as shown in Fig. 3 below. This specimen would allow utility access through the wall, while also transmitting forces near that of the solid panel counterpart.

Figure 3: Specimen CR before testing

The cutout reinforced corner specimen appears to be a design option that will allow a designer the option of sizing for a solid panel infill, but still have the benefit of access through the wall for utilities.

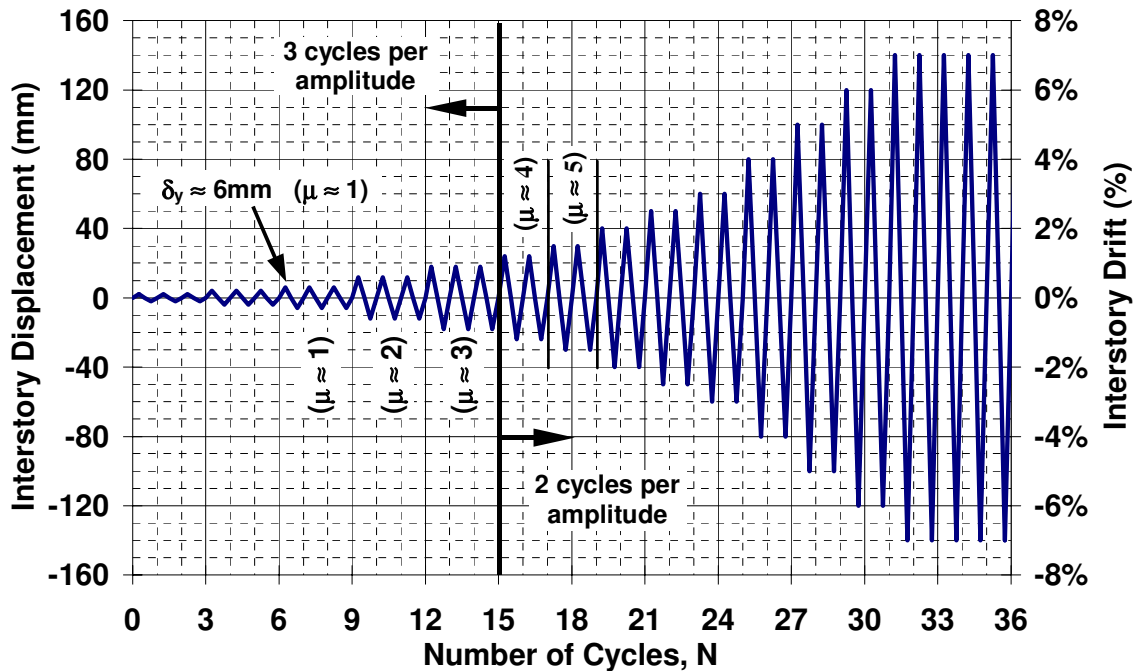
All specimens were tested using a cyclic, quasi-static loading protocol similar to ATC-24. In agreement with the typical testing procedure at NCREE, a displacement-controlled scheme was selected for the entire experimental program. Based on estimates of yield from SAP2000 pushover analyses, the displacement history shown in Fig. 4, was developed and applied horizontally to the center of the top beam using four actuators, as shown in the figures above. The same displacement loading history was used for actuator control of all the specimens tested.

Figure 4: Displacement Loading History

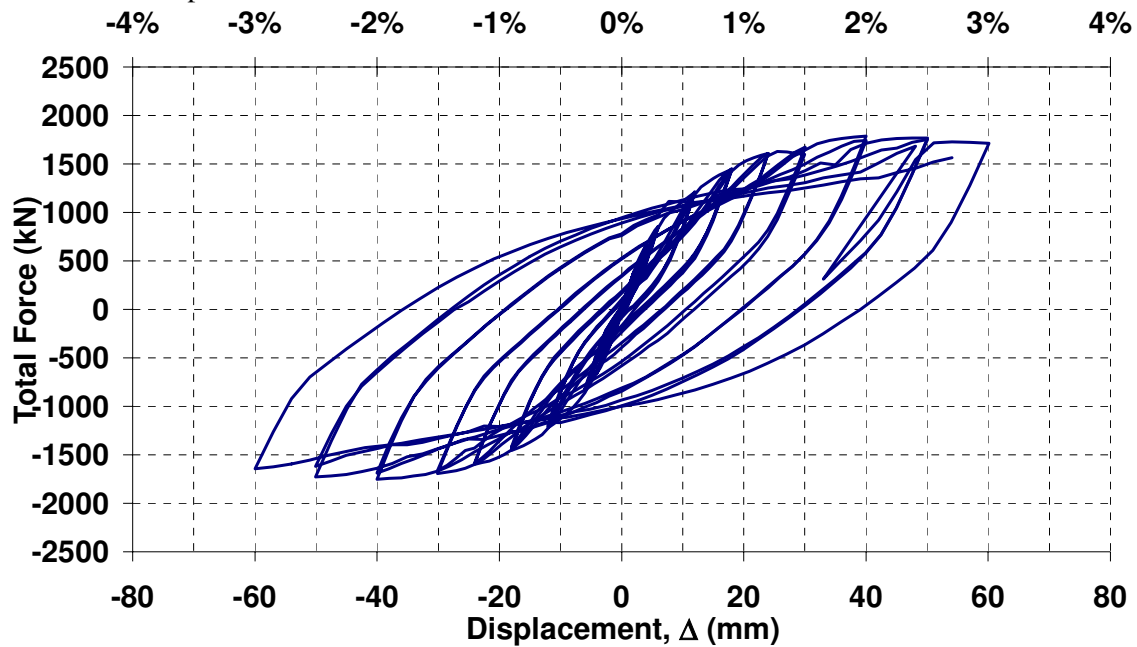
The hysteresis of specimen P is shown in Fig. 5. Small fractures were found at panel corners at the conclusion of the test. Panel welds splicing together the three pieces remained intact for the entire test. An instability with the loading scheme led to the H-shaped loading detail twisting at the center of the top beam. Two attempts were made to correct the problem, and though a visual inspection revealed no visible residual effect due to the H rotation, damage to the specimen incurred in the initial incident was too much for the specimen to handle at larger displacements. Columns rotated about their vertical axis with increasing severity as the test continued. The test was concluded after reaching a drift of 3%, when a weld failed in the continuity plate at the top of a column, and the other damage and distortions of the specimen made it impractical to continue.

Figure 5: Specimen P Hysteresis

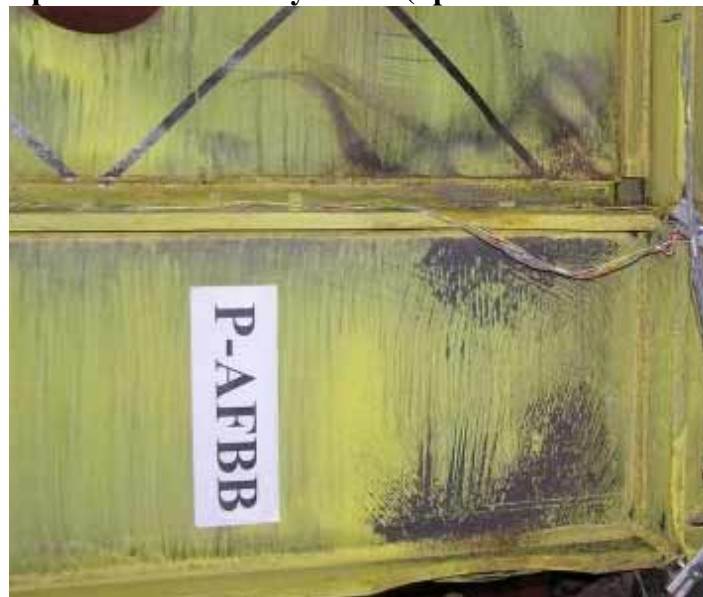
Photos of the buckled panel following the test, and a yielded RBS connection at 2.5% drift, are shown in Figs. 6 and 7, respectively. Fig. 6 also shows one of the methods used to reduce the rotation of the loading detail: two beams, placed parallel to the wall on both sides, which are then tied down into the strong floor using post-tensioning bars. Roller bearings between these beams and the loading detail reduced the horizontal friction, making this a fairly effective solution.

Figure 7: Yielding of bottom beam RBS (Specimen P: Cycle 23, $\gamma = 2.5\% \approx 8.333\delta_y$)

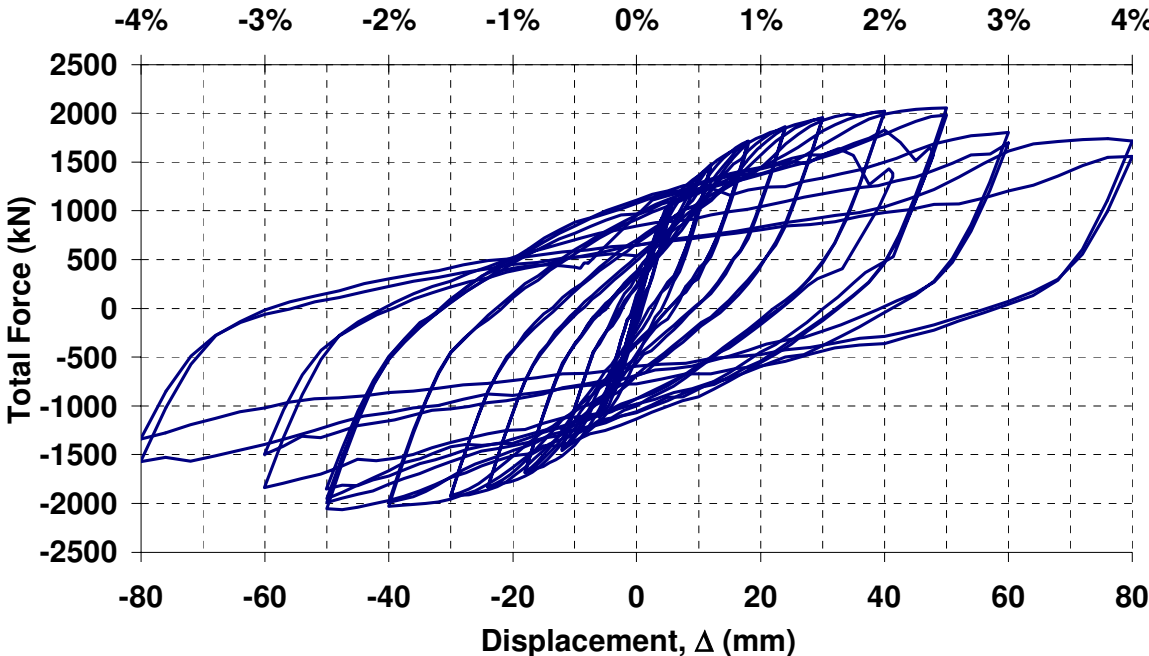
The specimen CR hysteresis is shown in Fig. 8 below, exhibiting stable behavior to relatively modest drifts. However, the problems in the loading scheme observed in other tests were also experienced in this test. The loading detail twisted the top beam (though not as severely, due to careful monitoring and prevention), and the columns twisted, severely distorting the top beam by the end of the testing. Web local buckling occurred in the bottom beam RBS connections after 1.5% drift, but the global behavior was not adversely affected until fracture and rupture of the bottom flange of the bottom beam in the RBS

Figure 8: Specimen CR Hysteresis

Specimen CR performed well, exhibiting stable hysteretic behavior until a drift of 2.5%, during which cycles, fractures, followed by ruptures occurred in the bottom flange of each bottom beam RBS connection. These events significantly changed the load path in the specimen, resulting in the 20% drop in strength by the termination of loading after two cycles at 4% drift.

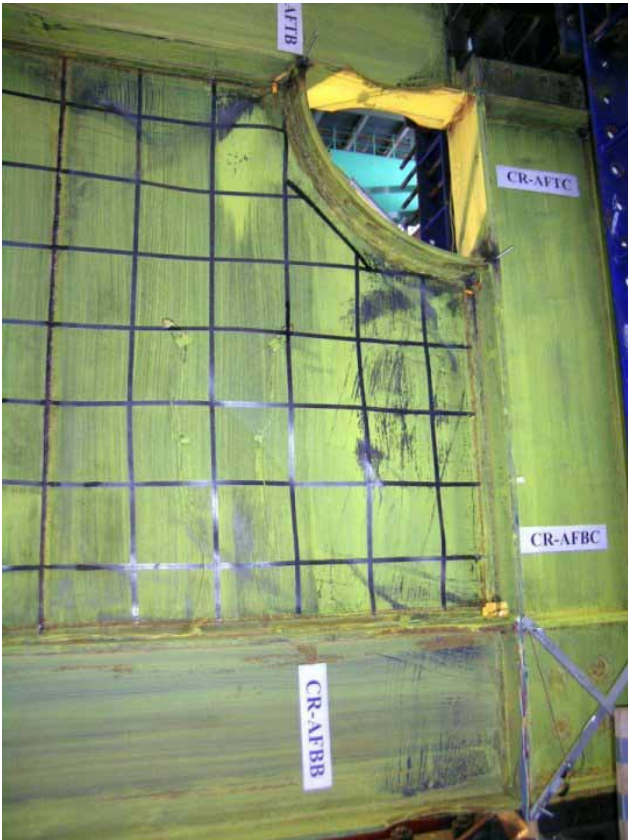
connections after cycling at 2.5% drift. Panel and bottom beam RBS connection yielding at 1.5% drift is shown in Fig. 9.

Figure 9: Infill panel and RBS yielding (Specimen CR: Cycle 19, $\gamma = 1.5\% \approx 5\delta_y$)
