The effect of low temperatures on the intermediate and high velocity impact response of CFRPs

J. López-Puente, R. Zaera, C. Navarro*

The influence of low temperature on the damage produced on CFRPs by intermediate and high velocity impacts is analyzed. Spherical projectiles were launched against different carbon fiber/epoxy laminates (tape and woven). Experimental tests were done at temperatures ranging from 25 to -150 °C. The extension of the damage was measured by C-Scan. Results show a clear dependence of damage on temperature, impact velocity and the type of the laminate.

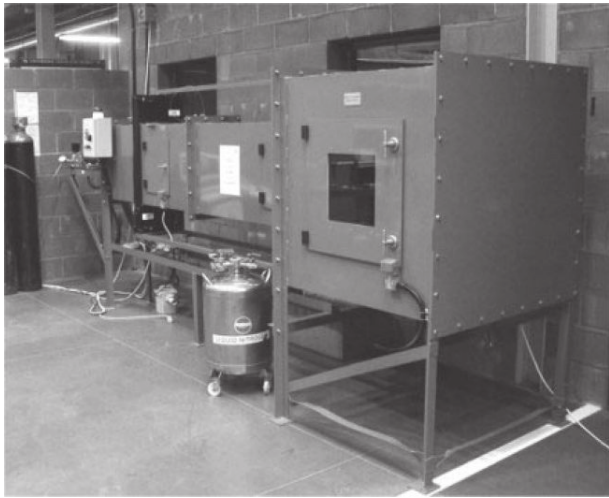
Fig. 2. Experimental device.

A SABRE gas gun was used to launch the spherical projectile. For the impact test at different temperatures a climatic chamber was specially designed to be coupled to the gas gun. The experimental device is shown in Fig. 1. Fig. 2 shows a photo of the whole device.

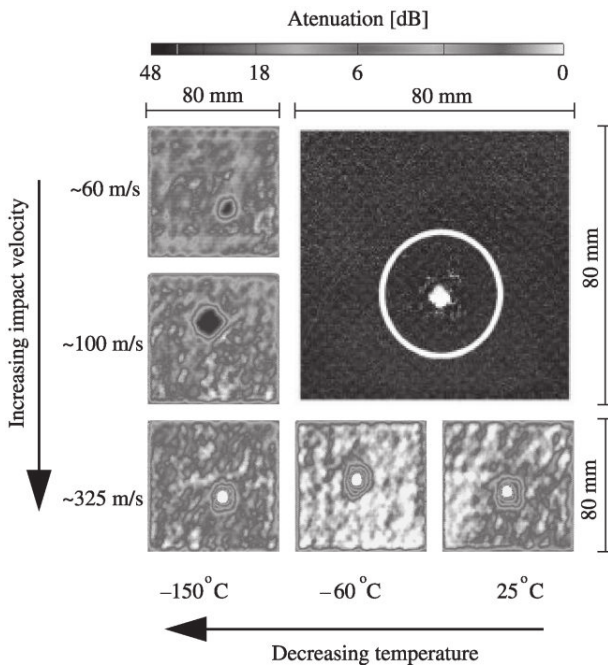
Fig. 4. C-Scan damage contours in woven laminates as a function of impact velocity and temperature. External aspect of the damage in a perforation case.

Fig. 4 shows the images obtained by C-scanning of the damaged areas around the impacts at different impact velocities and temperatures. The tests were made at velocities above and below the ballistic limit. Perforation cases may be easily identified looking at the hole in the laminate due to the projectile penetration. The attenuation of the ultrasonic signal becomes zero at that zone and thus a white area appears in the laminate. In the most damaged specimens, the delaminated area is less than four times the cross-section area of the projectile.

An image analyzer program was used to measure damage areas from C-Scan images, considering delamination when the signal attenuation was greater than 4 dB. Average values

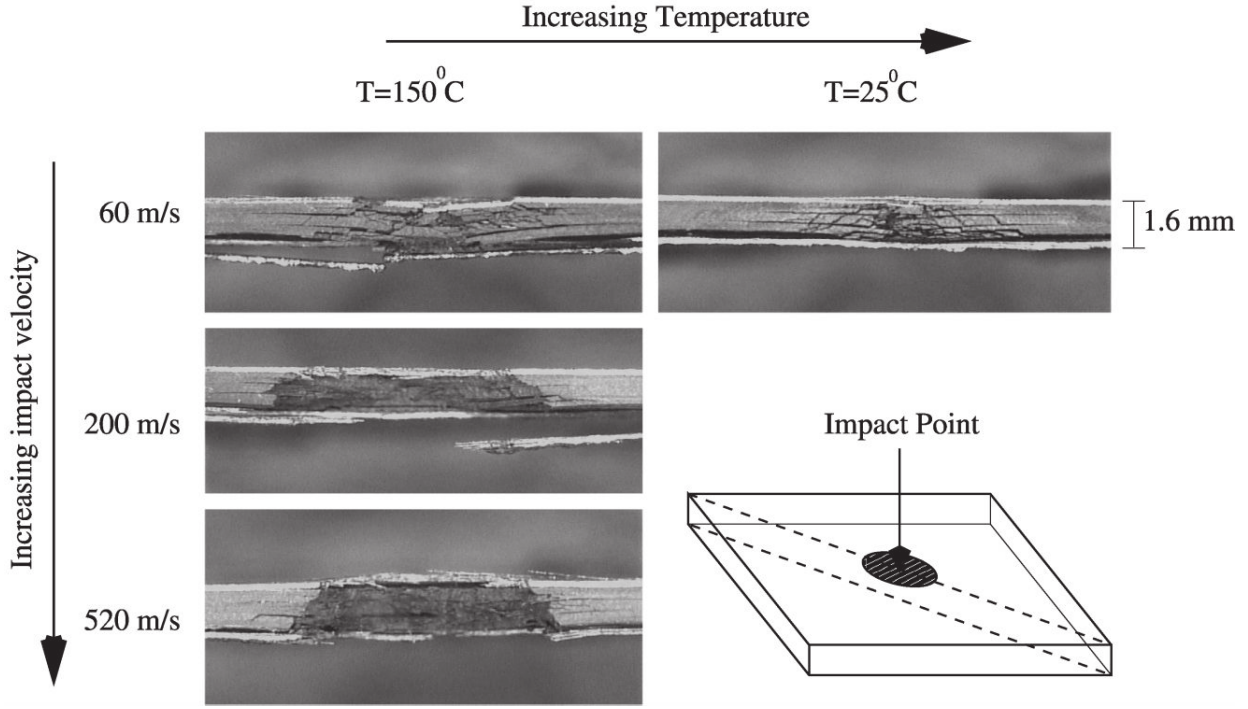
Fig. 10. Cross-sections of quasi-isotropic laminates at different impact velocities and temperatures.

Cross-section images of the tested laminates (Fig. 10) show the damage pattern in relation to temperature and impact velocity. Below the ballistic limit, matrix cracking and delamination are the modes of failure, and temperature significantly affects the damage extension. Above this limit, shear plugging of all the layers and delamination of the rear face.

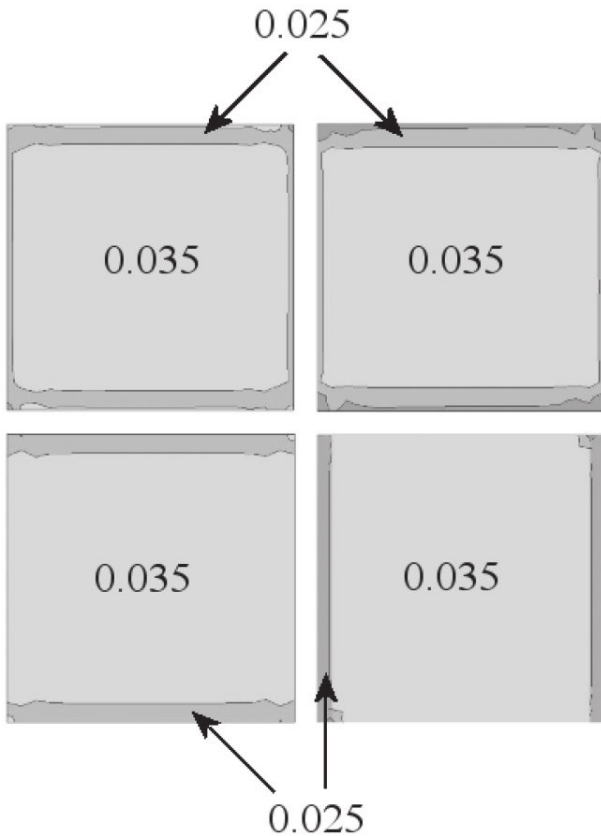
Fig. 12. Values of damage parameter e_m^2 in quasi-isotropic laminates at $25\text{ }^\circ\text{C}$ due to thermal stresses. Ply +45 (top left), ply -45 (top right), ply 0 (bottom left), ply 90 (bottom right).

It seems that matrix cracks contribute little to energy absorption or reduction of the residual properties. However, before delamination at the ply interfaces, the damage process is initiated by this matrix cracking failure mode. Large differences in contours of e_m^2 were observed between room and cryogenic temperatures [5]. The magnitude of this parameter at $T = 25\text{ }^\circ\text{C}$ is not significant in any ply (about 0.04, Fig. 12) but at $T = -150\text{ }^\circ\text{C}$ it rises to around 0.5 (Fig. 13), and produces a faster damage development on impact.

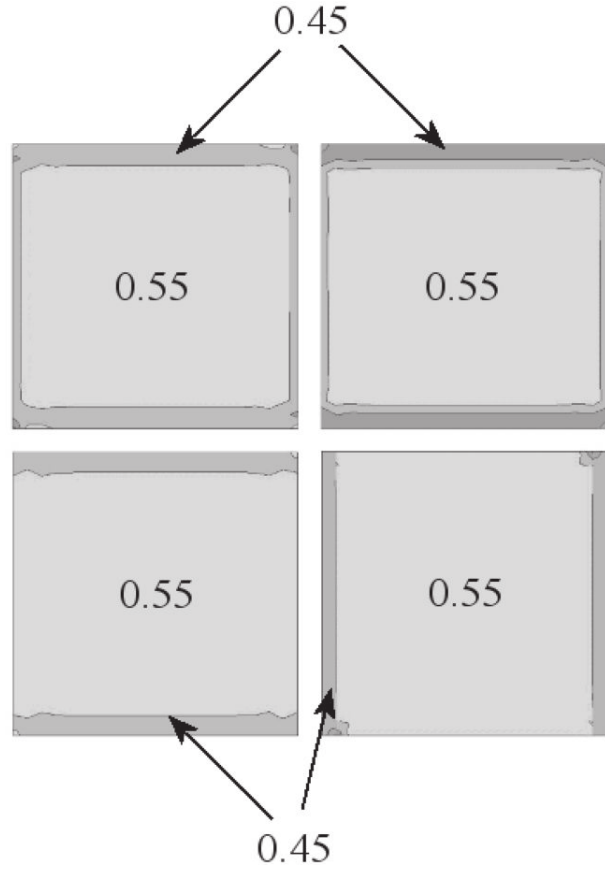
Fig. 13. Values of damage parameter e_m^2 in quasi-isotropic laminates at $-150\text{ }^\circ\text{C}$ due to thermal stresses. Ply +45 (top left), ply -45 (top right), ply 0 (bottom left), ply 90 (bottom right).
