EARTHQUAKE SPECTRA

Emilia Earthquake: the Seismic Performance of Precast RC Buildings

On 20th and 29th May 2012 two earthquakes of magnitude 5.9 and 5.8 (M_w) occurred in the Emilia region (Northern Italy), one of the most developed industrial centers of the country. A complete photographic report collected in the epicentral zone shows the seismic vulnerability of precast structures, the damage to which is mainly caused by connection systems. Indeed, the main recorded damage is either the loss of support of structural horizontal elements, due to the failure of friction beam-to-column and roof-to-beam connections, or the collapse of the cladding panels, due to the failure of the panel-to-structure connections. The damage can be explained by the intensity of the recorded seismic event and by the exclusion of the epicentral region from the seismic areas recognized by the Italian building code up to 2003. Simple considerations related to the recorded acceleration spectra allow motivating the extensive damage due to the loss of support.

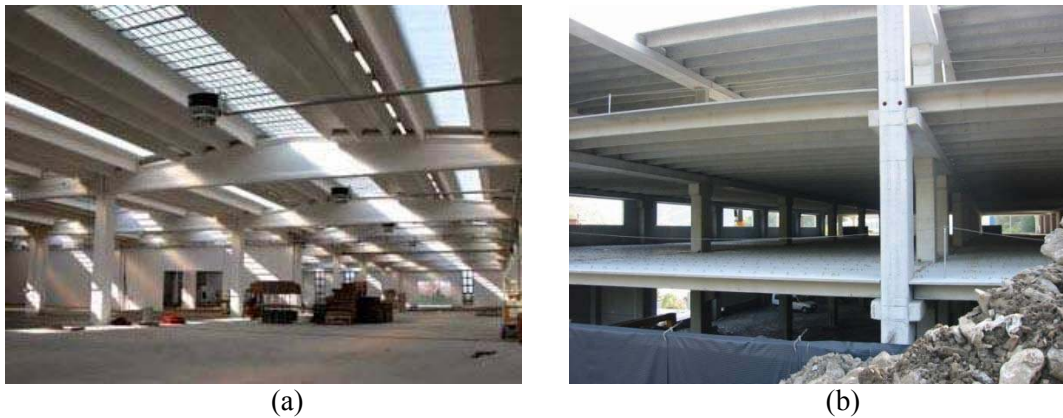
Figure 1. Examples of (a) single-story and (b) multi-story precast buildings

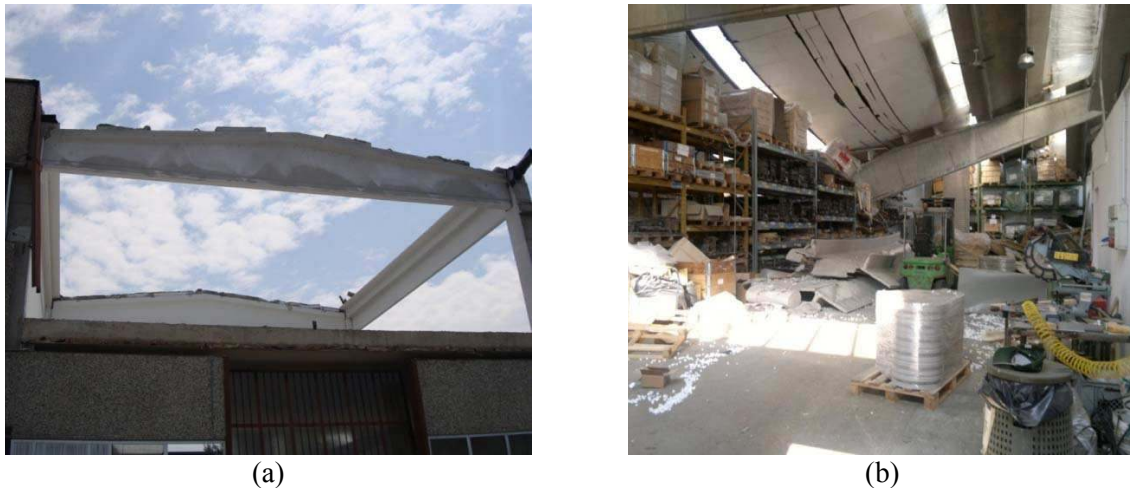
Most of the damaged precast buildings provides friction connections between horizontal elements (beams and roof elements) or between horizontal (beam) and vertical (columns) members. The lack of connection devices is the main cause of damage in precast structures, in which the low strength given by friction mechanism causes the loss of support of both roof elements from beams and beams from columns. The consequences are disastrous: Figure 5a shows the loss of support of the roof elements from the main beam due to the use of friction connections and a very limited support width. Figure 5b shows the loss of support of a beam from the column and the consequent collapse of the roof elements, causing the failure of the whole structure.

Figure 5. (a) Roof elements collapse due to the loss of support from main beam. (b) Loss of support of beam from column.

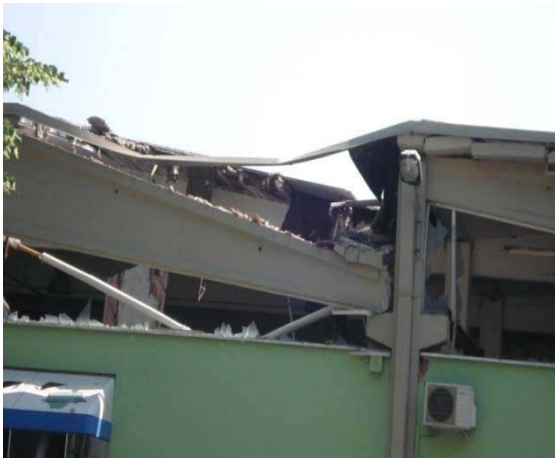
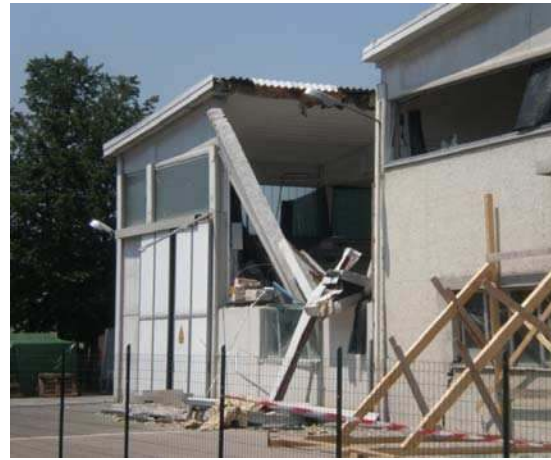
The lack of mechanical devices causes the loss of support of the beams from the columns also in Figure 6a. In other cases the loss of support causes the change of the beam restraints, that let the beam act as a cantilever, and make it collapse under the weight of the roof elements (Figure 6b). The vulnerability recorded in precast structures is certainly larger than the vulnerability exhibited by similar precast structures in Turkey after 1999 Kocaeli earthquake (Saatcioglu et al. 2001, Sezen et al. 2000); the main reason is the common presence of connections relying on friction in Emilia region, contrasting with the doweled connections used in Turkey.

Figure 6. (a) Loss of support of beam from column. (b) Collapse of main beam due to the loss of support on column.

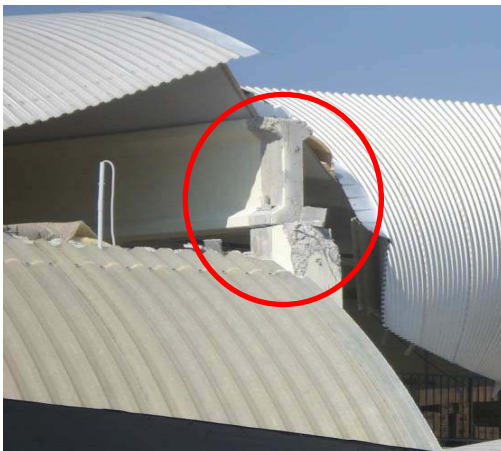
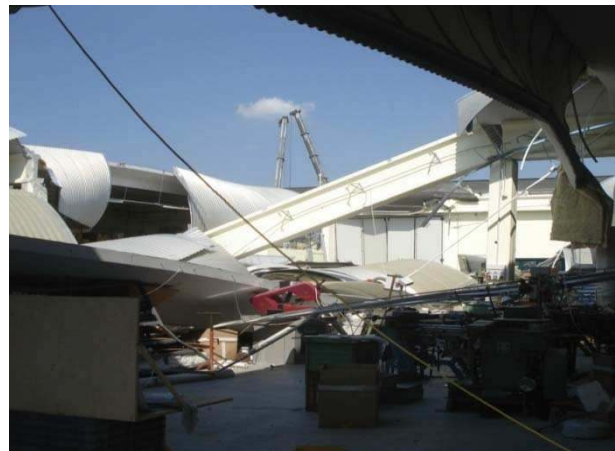
Some precast structures show the failure of the connections even in cases in which pin beam-to-column connections are used, due to the inadequacy of the connection design. Figure 7 represents a significant example of unsuitable design of the connection. The strength of the pin connection is evaluated in correspondence to the failure of the dowel; instead in Figure 7a, the spalling of concrete cover occurs before the yielding of the dowel, due to the small size of the cover and to the lack of dense stirrups close to the supporting zones. Consequently, it causes the collapse of the beam and roof elements which are supported by the beam (Figure 7b).

Figure 7. (a) Pinned beam-to-column connection failure and (b) consequent loss of support of the beam from column.

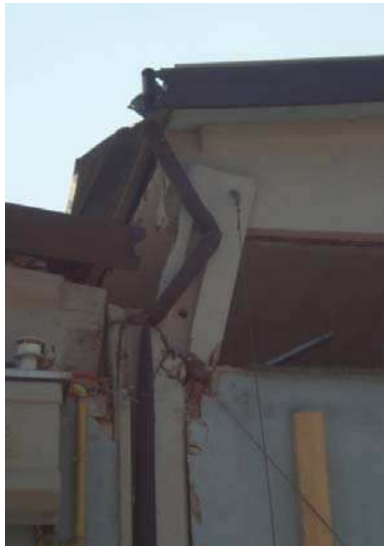
Figure 9. Shear collapse of column due to the interaction with infill masonry panel.

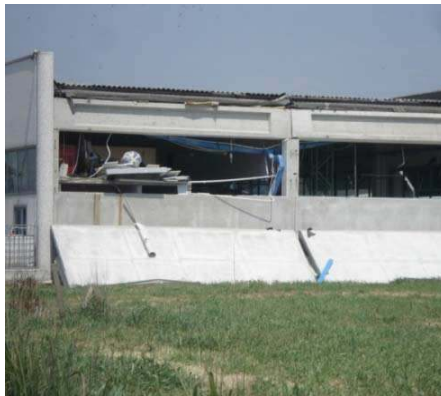
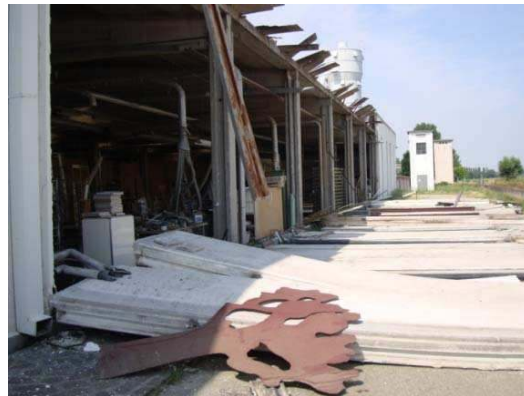
Precast buildings infill systems in Emilia region are mostly constituted by precast cladding panels. Horizontal (Figure 10a) and vertical (Figure 10b) panels collapse is the most frequent damage in precast buildings.

- a) the lack of seismic design in cladding panel-to-structural element connection devices;
- b) the pounding of roof elements, columns or other precast panels;
- c) the panel-to-structure interaction that causes additional lateral forces in the connection devices, not considered during the design process.

Figure 10. (a) Collapse of horizontal precast panels. (b) Collapse of vertical precast panels.

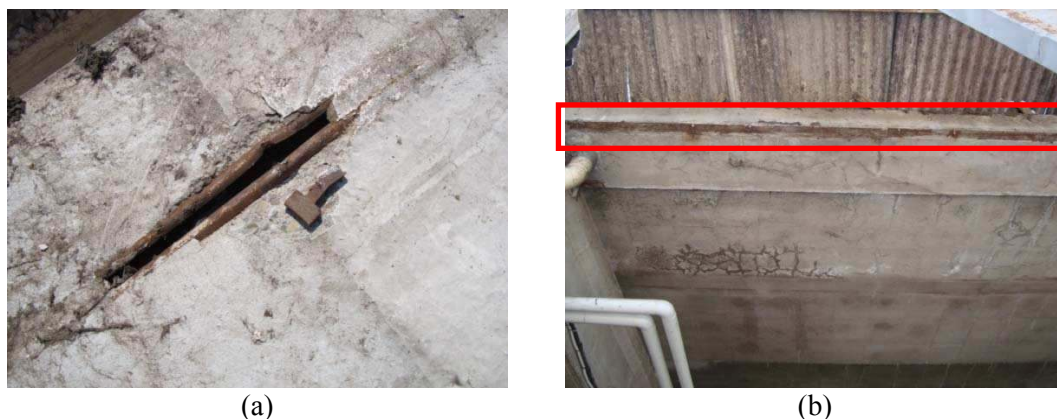
the steel angle plate that joints the panel to the structure (Figure 11b); details of the hammer head screw can be observed in Figure 11c. Figure 12 shows the collapse of a vertical panel-to-beam connection: in this case a particular connection device is used, i.e. a steel profile is embedded in the beam (highlighted in Figure 12b) and some hammer head elements are welded to the profile and inserted into the anchor channel of the vertical precast panels (Figure 12a). Under the seismic action the screw-to-profile welding fails and causes the collapse of the panels.

Figure 12. Collapse of vertical precast panel connection: (a) the anchor channel embedded in the panel and the failed hammer head element; (b) profile located in the beam which the hammer head elements are welded to.

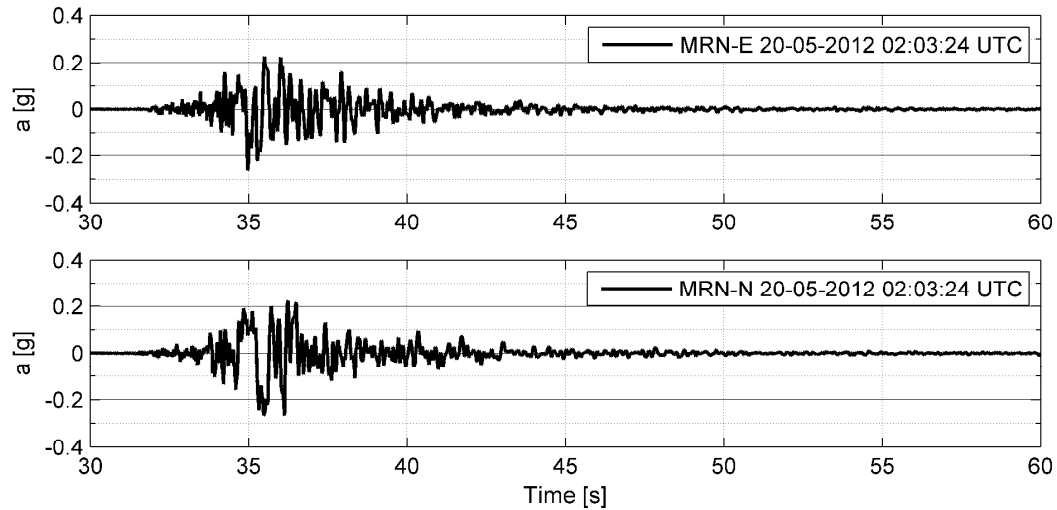
The acceleration time histories recorded (Figure 14) by the station MRN of the Italian National Accelerometric Network yields a maximum acceleration equal to 0.264g and 0.261g for the N-S and E-W components, respectively; the spectral ordinates reach values up to 1g (Figure 15). It should be noted that the recorded accelerograms include seismic site effects; indeed, MRN station is placed on a “C” class soil site (shear wave velocity ranging from 180m/s to 360m/s), based on geological data, and T1 category according to EC8 (flat surface), as reported in the *Italian Accelerometric Archive* (Luzi et al. 2008).

Figure 14. Accelerograms recorded in the station of Mirandola (Modena, Italy) (the origin of time is set at 20-05-2012 02:03:24 UTC).

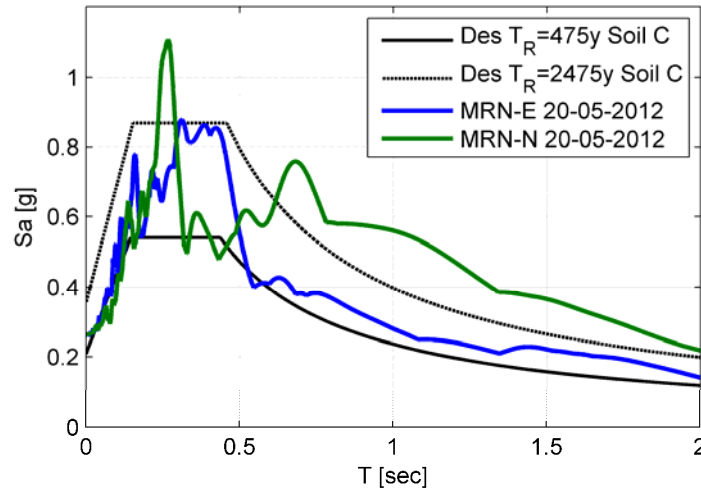
In Figure 15 the recorded spectra are compared with the design spectra in the epicentral zone for return periods equal to 475 and 2475 years (C soil and T1 surface). The comparison demonstrates the rarity of the event, according to the actual Italian seismic hazard maps and the historical data they are based on; the NS component spectrum is generally included between the two considered design spectra for low period range, i.e. before 0.6sec, and it exceeds the spectrum with the higher return period for high period range, i.e. beyond 0.6sec.

In order to establish the spectral accelerations in the precast structures during the investigated Emilia seismic events, two period ranges can be distinguished in the spectrum of Figure 15, according to the extensive parametric study provided by Magliulo et al. (2013) on single-story precast structures designed according to the current Italian code in low-to-high seismic zones. The bare precast structures exhibit an elastic fundamental period ranging from 0.54sec to 1.45sec, while infilled precast structures range from 0.09sec to 0.40sec, due to the presence of cladding panels. No significant difference between the spectral ordinates for bare

Figure 15. Elastic response spectra recorded on 20 May 2012 in Mirandola NS (green) and EW component (blue) compared to elastic response spectra for return period equal to 475y (black) and 2475y (dashed black) provided by Italian building code (DM 14/01/2008) for soil class C. A damping ratio equal to 5% is assumed.

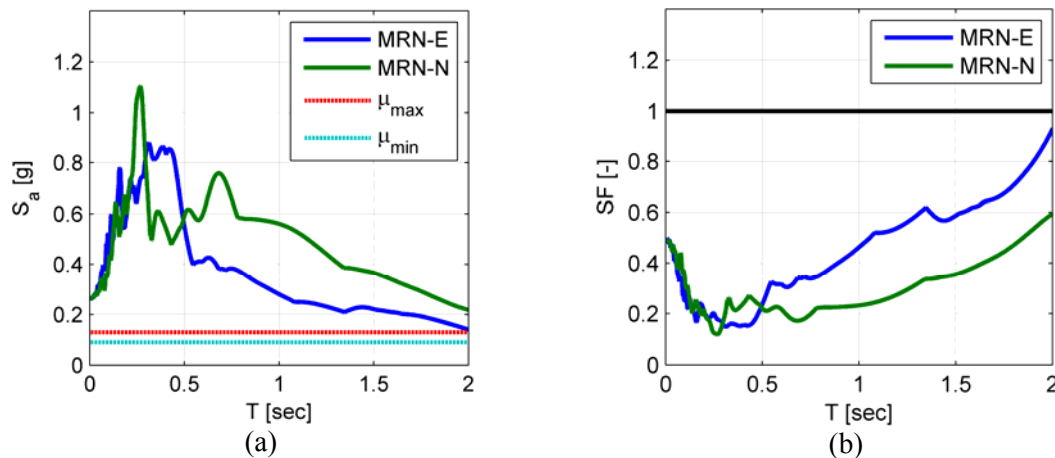
The strength of a friction connection V_{Rd} can be evaluated multiplying the vertical force acting on the connection and the friction coefficient μ . Based on these considerations, the loss of support mechanism is immediately checked comparing the friction coefficient with the acceleration spectral ordinates in g, as shown in Figure 16. Indeed, a safety factor SF can be evaluated and plotted (Figure 16b) versus the fundamental period for the recorded spectra.

According to the experimental studies conducted by Magliulo et al. (2011) on neoprene-to-concrete connections, the friction coefficient varies in the range $0.09 \div 0.13$ for compressive stress varying between 1.7 MPa and 5.3 MPa. In Figure 16a these limits are compared to the recorded spectral ordinates. Figure 16b shows the safety factor SF, evaluated considering μ equal to 0.13. The safety factor SF is much below 1 for a wide range of periods and confirms the vulnerability recorded in friction connection of precast structures in Emilia region.

Figure 16. (a) Acceleration spectral ordinates recorded in Mirandola compared to the friction coefficient upper and lower bounds evaluated by Magliulo et al. (2011); (b) loss of support safety factor plotted versus fundamental periods for the recorded accelerograms, assuming $\mu=0.13$.

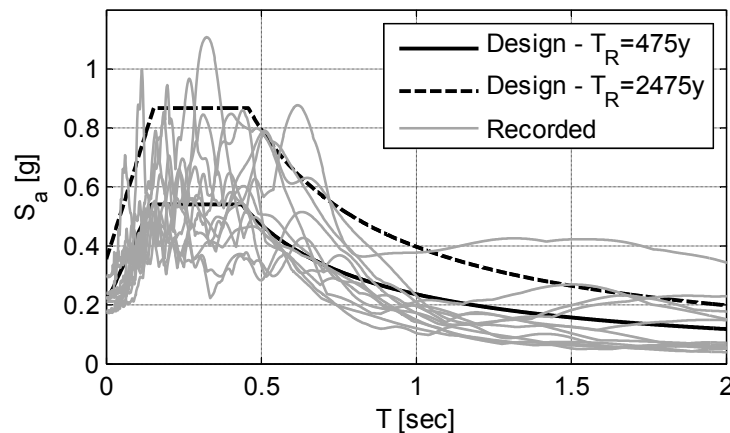
The mainshock occurred on the 29th May 2012 is well recorded, due to the installation of temporary seismic stations around the epicentral area. The considerations above presented for the 20th May mainshock can be extended to the 29th May mainshock as well, based upon the horizontal acceleration spectra recorded in the area close to the epicenter (Figure 17).

Figure 17. Elastic response spectra recorded on 29 May 2012 in Cento (CNT), Finale Emilia (FIN0), Moglia (MOG0), Mirandola (MRN), San Felice sul Panaro (SAN0) and San Martino Spino (SMS0) compared to elastic response spectra for Mirandola for return period equal to 475y (black) and 2475y (dashed black) provided by Italian building code (DM 14/01/2008) for soil class C.
