Renewable and Sustainable Energy Reviews

The increasing importance of leading edge erosion and a review of existing protection solutions

Robbie Herring^{a,*}, Kirsten Dyer^b, Ffion Martin^c, Carwyn Ward^a

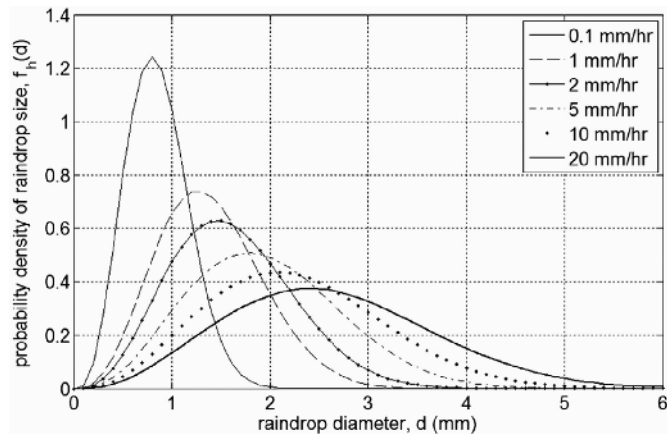
Fig. 3. Probability distribution of raindrop size for various rainfall rates. Reprinted from Ref. [39] with permission from Elsevier.

Keegan explored the damage threshold velocity (DTV) of epoxies with various values of fracture toughness; where the DTV is defined as the lowest impact velocity at which damage is observed. The analysis found that for droplet sizes with a diameter greater than 2 mm, the DTV could be as low as 50 m/s for low fracture toughness values, and even for higher toughness values, the DTV is still lower than the current 100 m/s tip speed limit. An examination of Fig. 3 in combination with

the average rainfall across the globe (Fig. 2) shows that raindrop diameters greater than 2 mm occur with increasing frequency in areas with high rainfall rates, such as the coastal areas of Asia. This implies that the DTV in these regions could be far lower than current tip speeds.

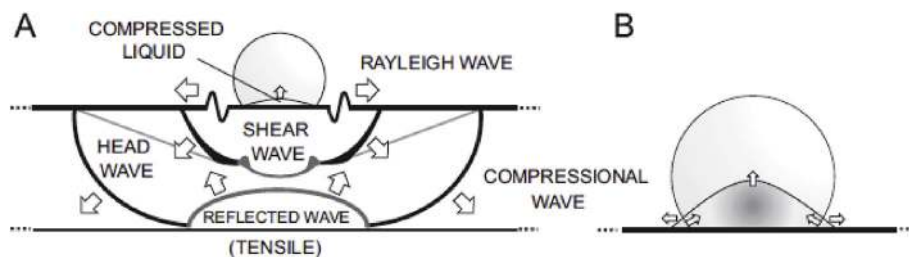
Fig. 4. a) Shock wave propagation occurring upon raindrop impact on a solid surface, b) compressed liquid wave front spreading past the contact periphery. Reprinted from Ref. [43] with permission from Elsevier.

A compressed liquid wave front travelling upwards in the droplet is also created upon impingement [43]. Once the wave front spreads past the contact periphery between the droplet and surface (Fig. 4b), the droplet collapses in on itself and lateral jets, with a speed up to 40 times the original impact speed [47], spread radially outwards from the impact location over the surface. The proportion of the initial impact energy that is reflected into the droplet or transferred to the material is dependent on the surface hardness. A hard material will reflect a greater proportion of the initial impact energy back into the droplet causing a large amount of jetting across the surface. Conversely, a soft material will deform upon impact to absorb the impact energy, reducing the proportion of energy reflected into the droplet and therefore reducing the surface splashing [48]. This leads to the formation of pits on the surface. The level of surface deformation is dependent on the short and long term recovery of the material, which is defined by the elasticity and viscoelasticity of the material, respectively [49].

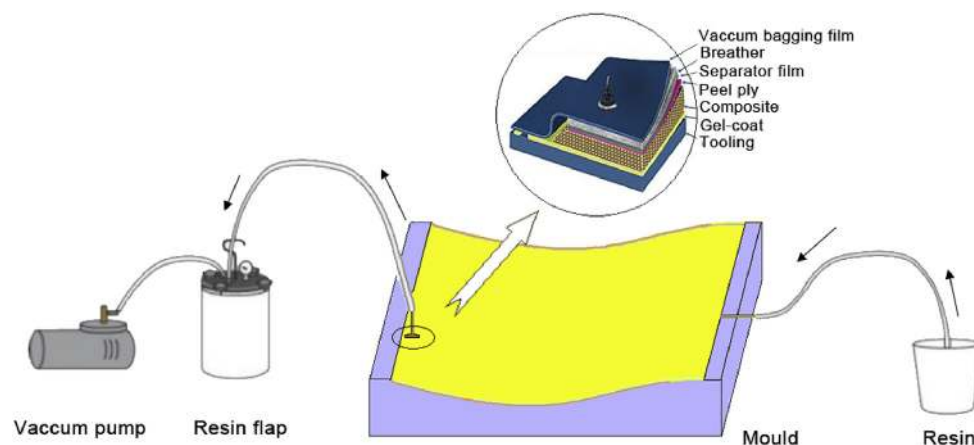
Fig. 5. Applying the gelcoat in the in-mould technique. Reprinted from Ref. [52] with permission.

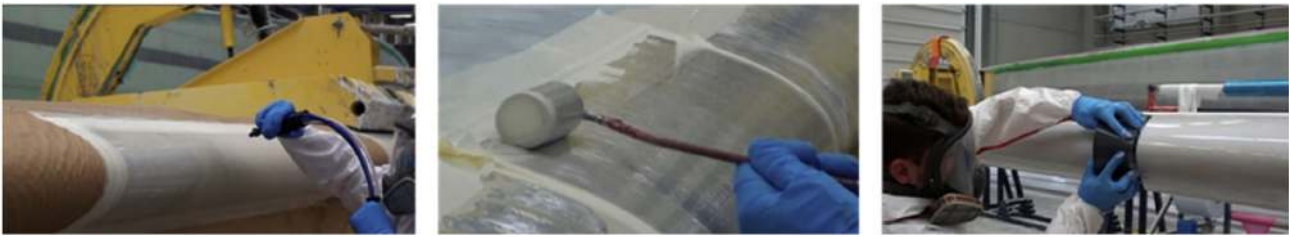
Fig. 6. Post-mould application methods, from left to right: spray, roller, trowel. Reprinted from Ref. [45] with permission.

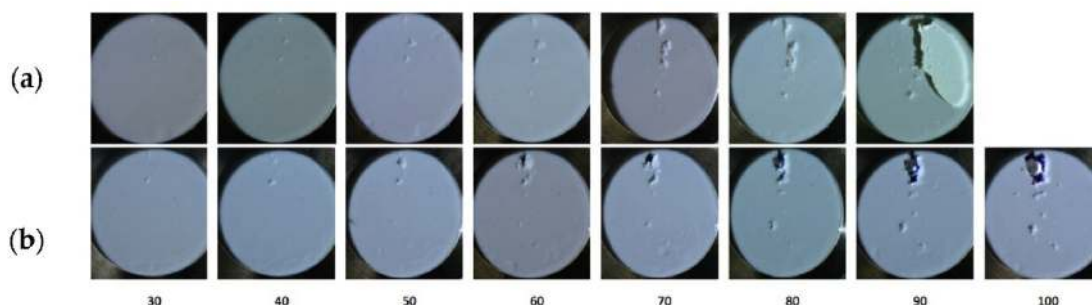
Fig. 7. Rain erosion testing results for flexible coatings a) without a primer layer and b) with a primer layer. Reprinted from Ref. [67] with permission.

Further investigation from Cortés [67,68] looked at the effect of adhesion on the rain erosion performance of flexible coatings. Two setups were compared; the first consisted of a filler applied to a biaxial laminate, with a flexible coating applied over it, and the second

included a primer layer between the filler and the coating to aid adhesion. The mechanical testing found that the inclusion of a primer significantly improved the adhesion of the coating to the filler. Subsequent rain erosion testing found similar incubation times for each setup. However, Fig. 7a shows that delamination occurs only in the first configuration causing a large section of the coating to be removed.

The results from Cortés demonstrate the importance of achieving a strong adhesive bond between the coating and the substrate. The low impedance of the coating transmits the impact stress and causes the first setup to fail at the interface due to its worse adhesion. This is illustrated by the severe delamination. The inclusion of a primer layer improves the adhesion, preventing failure at the interface, and moves the failure mode back into the coating as demonstrated by pitting in Fig. 7b. The results of the studies prompted Cortés to conclude that the adhesion of the coating to the substrate is of paramount importance to the rain erosion resistance of the system.

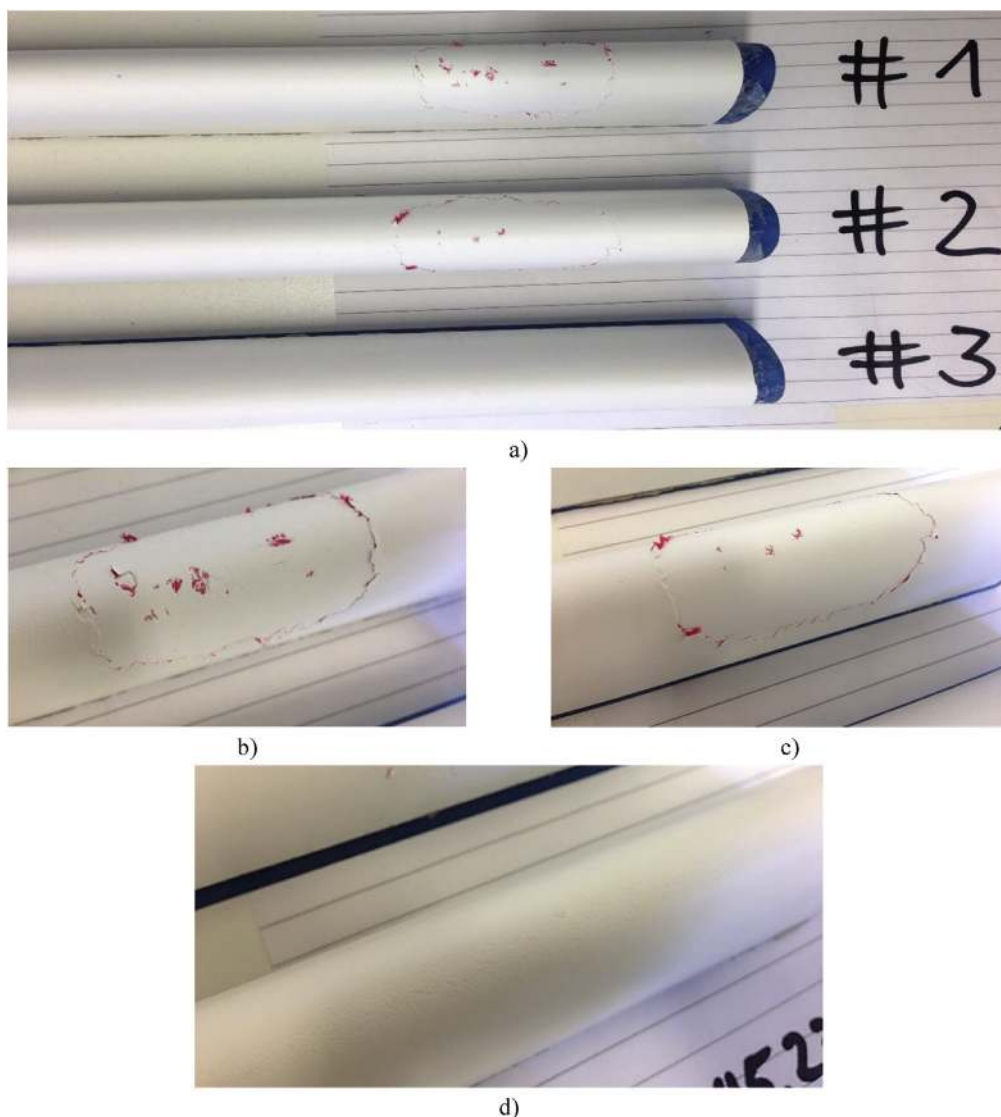
Fig. 8. a) Results of flexible coatings rain erosion performance: b) sample 1 exhibited large areas of debonding, c) sample 2 also exhibited large areas of debonding, d) sample 3 exhibited pitting and surface degradation.

ORE Catapult uses aerodynamic profiles in its whirling arm erosion test rig. Aerodynamic profiles can make it challenging to apply coatings to the substrate, and so coatings can be prone to fail early if application cannot be performed effectively. However, the stark contrast in performance between samples 1 and 2, and sample 3 highlight the effect of poor adhesion on the rain erosion properties of flexible coatings.

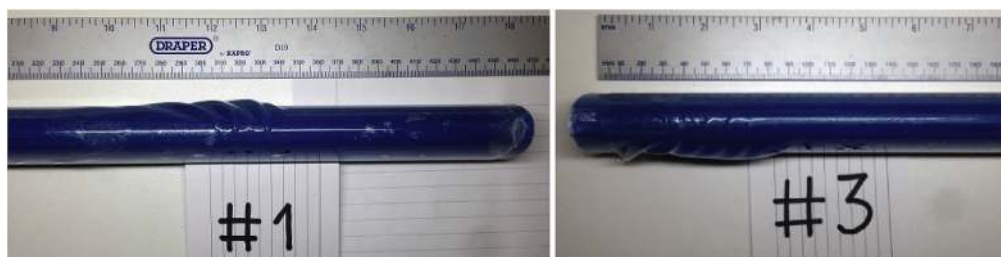
Fig. 9. Significant tape detachment and water entrapment in sample 1 after 8 h (left) and in sample 3 after 5 h (right) of rain erosion testing.

Rain erosion testing on an industrial leading edge tape was performed by ORE Catapult. As with the previous ORE Catapult tests, three samples were used. Inspection of the samples prior to testing revealed several air bubbles across the whole surface area of samples 1 and 3, whilst sample 2 was firmly attached. Inspection every hour revealed that the trapped air bubbles acted as pressure points and cut through the tape, allowing water to enter and become entrapped underneath the tape (Fig. 9). The trapped water then caused severe tape detachment and the samples failed. Samples 1 and 3 failed after 8 h and 5 h, respectively. The well attached sample 2 failed after 11 h. The failure mode for sample 2 was surface damage, again demonstrating that strong adhesion moves the failure mode from the bond back into the protection solution.

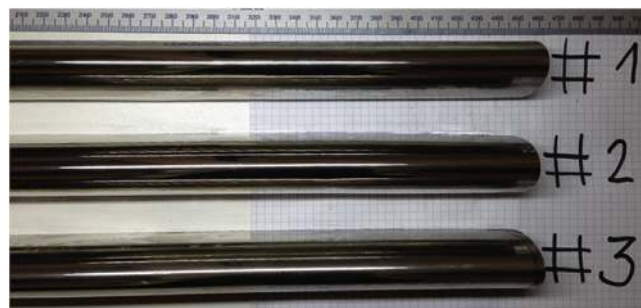
Fig. 10. A nickel alloy sample after 85 h of rain erosion testing at a rotational speed of 173 m/s.

Metals have substantially higher impedances than typical gelcoats [56]. Therefore, upon droplet impingement the metal reflects a large proportion of the droplet impact energy, resulting in high energy jetting across the surface. However, a smooth surface and a high hardness that resists plastic deformation mitigates the damaging nature of the jetting. The dominant damage form of metals is still surface degradation. The high impedance ensures a smaller proportion of droplet energy is transferred and subsurface degradation and damaging of the bond is reduced. This resistance allows certain metallic shields to have excellent rain erosion performance at higher tip speeds than seen for polymeric materials. Fig. 10 presents rain erosion tests on a nickel alloy sample, showing no surface degradation after 85 h at rotational speeds of 173 m/s, estimated to give a 30 + year lifetime on wind turbine blades operating at tip speeds of 120 m/s.
