The Mycenaean Entrance System at the West End of the Akropolis of Athens

James C. Wright

Wright, James C. 1994. The Mycenaean Entrance System at the West End of the Akropolis of Athens. *Hesperia* 63:323-360.

THE MYCENAEAN ENTRANCE SYSTEM AT THE WEST END OF THE AKROPOLIS OF ATHENS

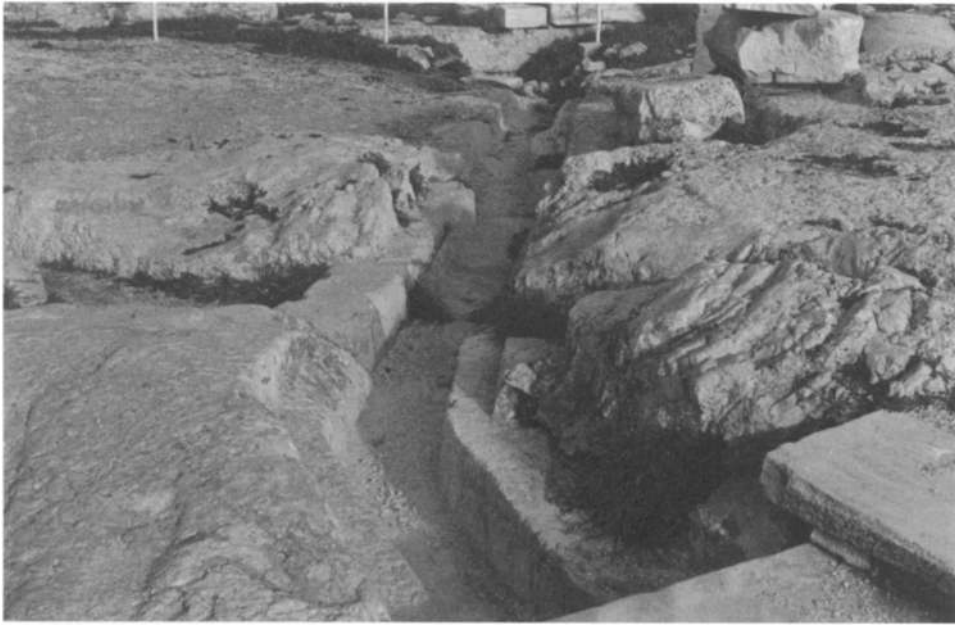
a. Drain cutting leading from the east porch of the Propylaia towards the Archaic cistern.
From south

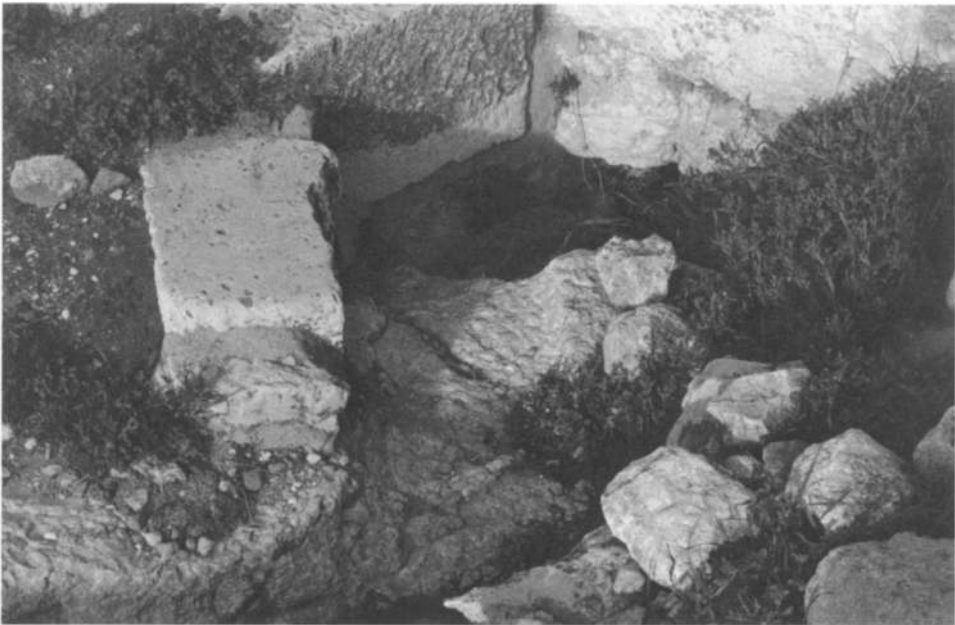
b. Drain leading into the Archaic cistern, north face

The northwest corner is the natural collection point for the drainage of the Akropolis. The lowest surface in this area (*ca.* +137 m.) is directly over the caves of the North Slope; indeed, the continuous runoff of water there over the millennia has caused the hollowing out of these caves. Approaching this area is a drain cut into the rock in front of the east façade of the Propylaea. It continues northwards to the Northwest Building (Fig. 10, Pl. 77:a) and is the original drain that led to the Archaic cistern.¹¹¹ This drain can be identified by a reveal cut into the bedrock on each side of the upper drain walls to receive cover slabs, now missing. A second, later channel forks to the northwest from the primary one (see p. 357 below). At the north end the original course has been marred by erosion and damage to the rock face, perhaps due partly to making the foundation bedding for the southern wall (Figs. 10, 11: wall 8) of the Northwest Building. Close examination shows that the drain ran under this wall into the Archaic cistern (Pl. 77:b).

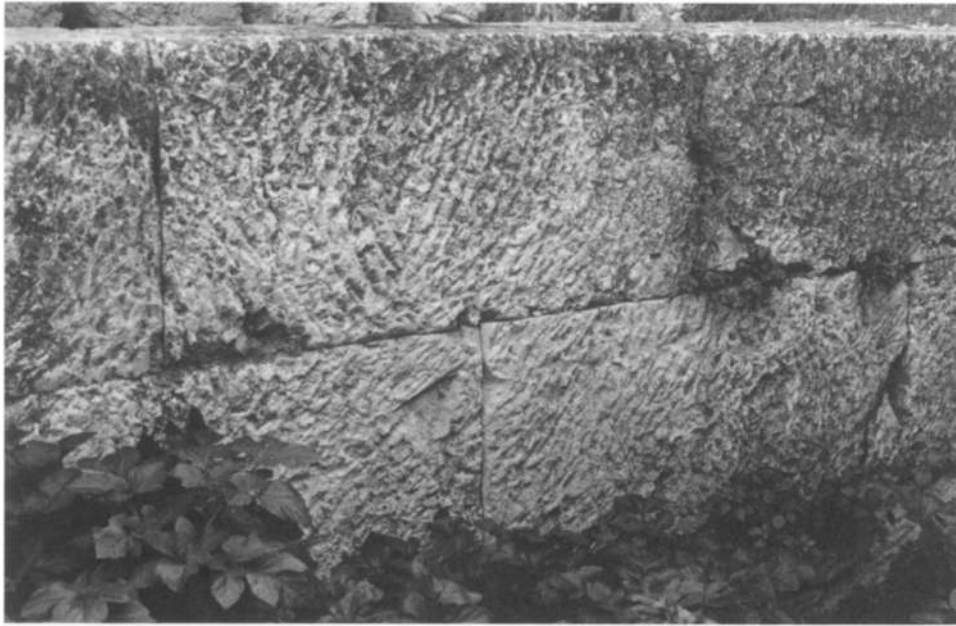
a. East-west wall 2 of the Archaic cistern, north face

The east–west wall 2 forms the preserved north wall of the cistern. The wall can still be inspected in the northwestern room of the Northwest Building (Fig. 11; Pl. 78:a). There it is preserved two courses high and is built of poros ashlar blocks. The lowest course is set into the bedrock, which was dressed down to receive it. (In Kawerau’s plan of the now buried northeastern room this cutting is shown to have been carried farther behind the inner face of the wall to form a kind of channel [Fig. 11, south of wall 2 up to wall 1].¹¹⁴) Just east of the crosswall (3) that abuts wall 2, one of the blocks of the lowest course has a square cutting on its underside which forms a channel through the wall (Fig. 11; Pl. 78:b). At the west, wall 2 continues up to the western foundation wall of the Northwest Building, which cuts it off.

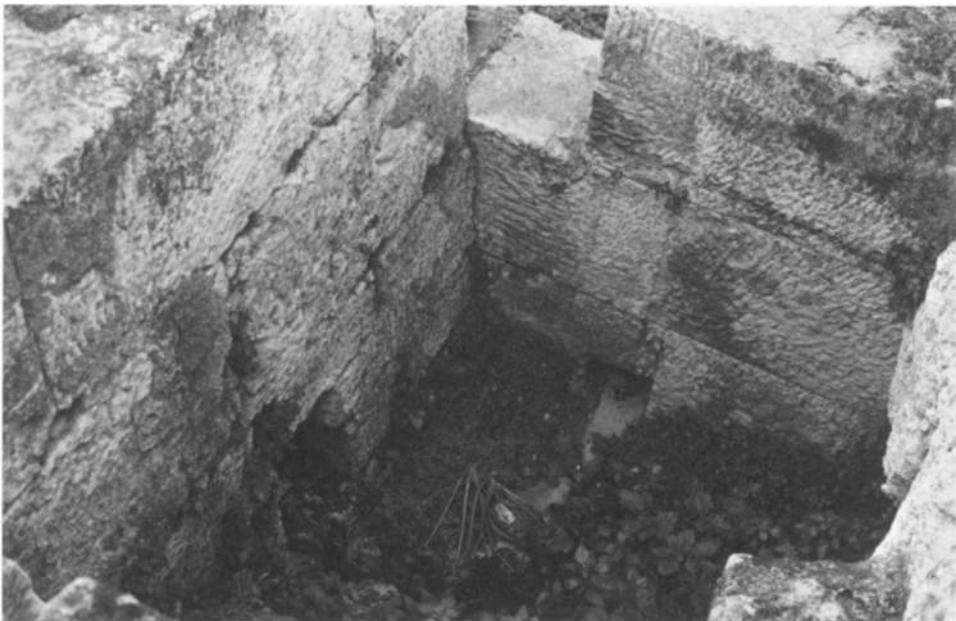
b. Drain channel in north wall 2 (right) and crosswall 3 of the Archaic cistern. From south

the bedrock on the other side of the central east–west foundation of the Northwest Building. This wall is built like walls 1 and 2. Like the northern wall it has a channel cut through the lowest course (Pls. 78:b, 79:a). In this channel Kawerau reported finding two marble tiles set together to form a kind of drain.¹¹⁷

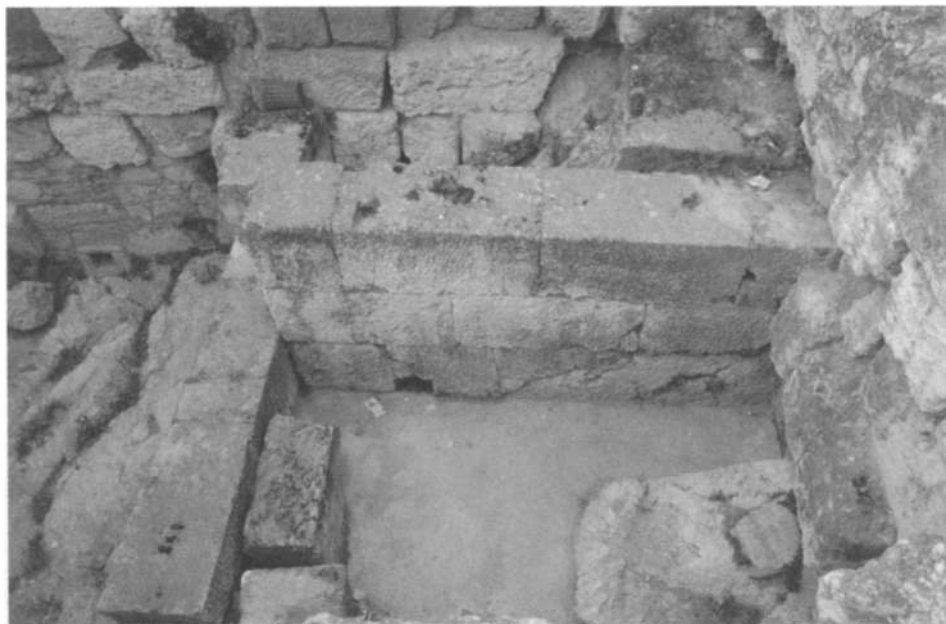
a. North-south crosswall 3 of the Archaic cistern. From west

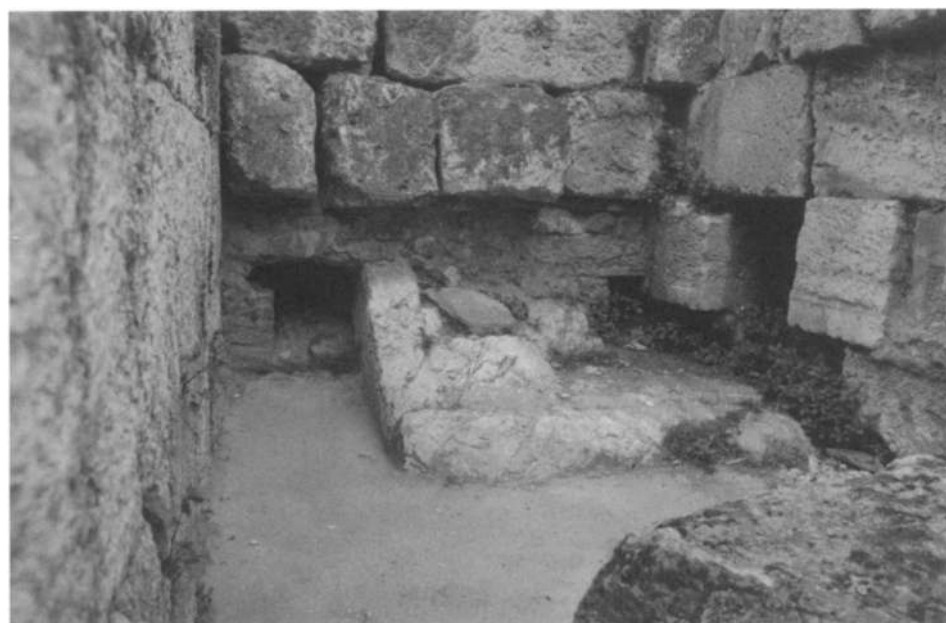
b. Later drains and worked bedrock in the northwest room of the Archaic cistern. From north

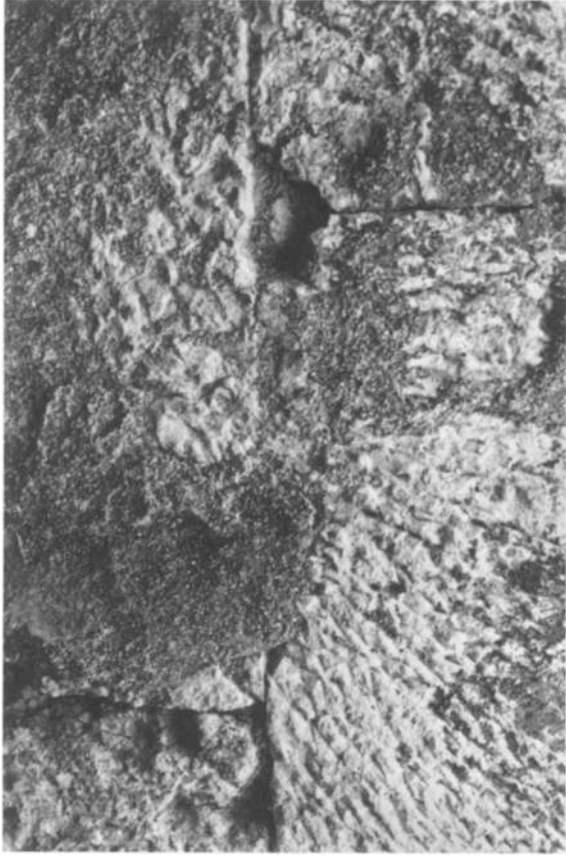
b. Detail of plaster adhering to the cistern wall

¹²² Kavvadias and Kawerau 1906, where Kawerau observed this plaster, as did Middleton (1900, p. 8 [H], pl. V at ‘H’ and ‘R’). Roland Martin (1965, p. 432) notes that especially hard plasters used for hydraulic installations tended to be made partly from volcanic powders. The plasters from this cistern have not been analyzed.

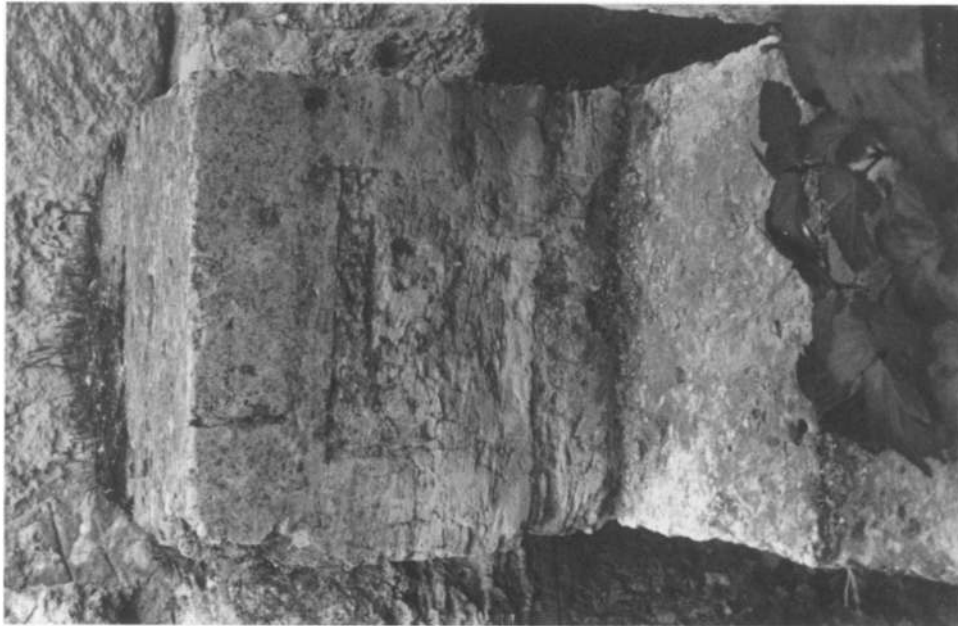
a. Anathyrosis on block of north wall 2 of the Archaic cistern. From west

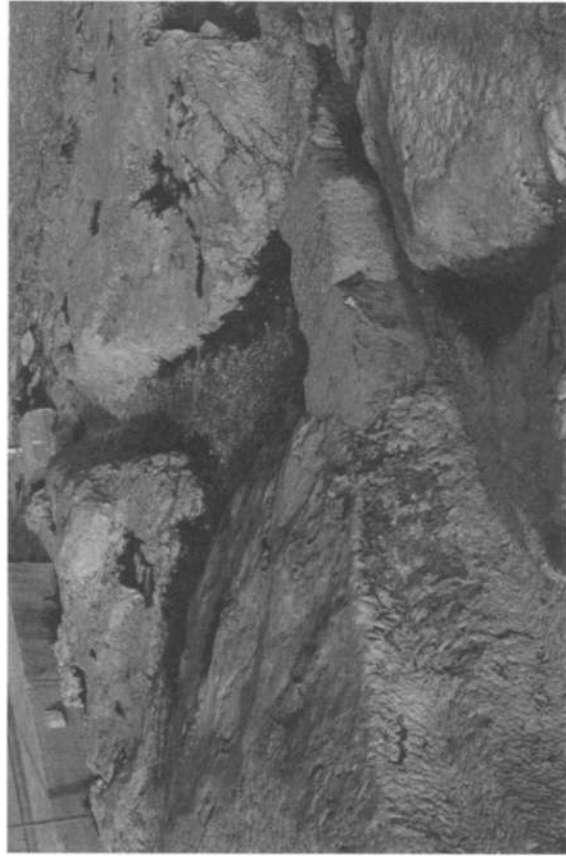
c. Secondary drain branching from the Archaic drain channel and running to the northwest around the Northwest Building. From southeast

¹¹⁶ A late (Byzantine? Turkish?) drainage system was cut through the lowest foundation courses of the east–west crosswall 9 of the Northwest Building (Pl. 80:c) and then turned to the west, where another hole was mined through the west foundation 14 of the Northwest Building, presumably to link the drain with either the Roman cistern or the Classical drain. These constructions are easily recognized today by the use of tiles and cement to help support them under the foundations and, probably, by crude cuttings in the bedrock apparently following the course of the drain (visible as the hatched bedrock corner between walls 9 and 14 in Kawerau’s sketch, reproduced here as Figure 11, and in Plate 79:a). This area may have been partially excavated in 1864 (Bundgård 1974a, p. 9), which may explain why Kawerau was unable to make any stratigraphic notes when work continued in this area in 1886 (cf. Bundgård 1974a, p. 12).
