**NASA TECHNICAL
MEMORANDUM**

NASA TM-78876

THE ROLE OF THERMAL SHOCK IN CYCLIC OXIDATION

by Carl E. Lowell and Daniel L. Deadmore
Lewis Research Center
Cleveland, Ohio 44135

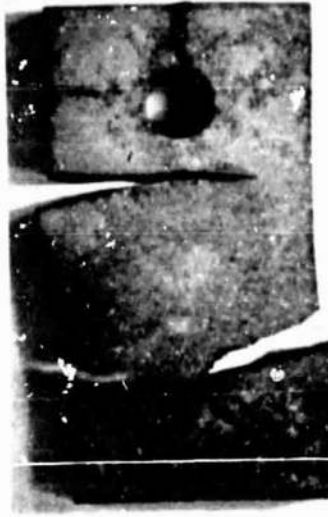
(a) BRITTLE ALLOY TD NiCrAl.

(b) DUCTILE ALLOY HOSKINS 875.

Figure 4. - Deformation modes of thermal shock after 80 one hour cycles.

One thing that was apparent in the fast cooling tests was that the alloy coupons became more and more distorted as the tests progressed. Examples of such distortion are shown in figure 4. The wrought alloys HOS-875, TD-Ni, IN-702, and IN-601, all plastically deformed extensively, while cast B-1900+Hf had considerably less, but measurable plastic deformation. These alloys all tended to elongate and assume a dogbone shape, although the HOS-875, the weakest alloy, also curled (fig. 4(b)). In contrast, the alloy with very limited ductility (TD-NiCrAl) had little plastic deformation, and cracked extensively (fig. 4(a)).

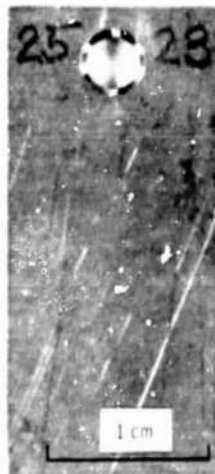
(a) AS MACHINED.

(b) 40 ONE MINUTE CYCLES
WATER QUENCHED.

Figure 5. - Metal flow from thermal shock IN-601.

It was assumed that the cause of the deformation was the rapid cooling and not oxidation. To test this assumption, a coupon of IN-601 was put into a 1100^o C furnace just long enough to reach temperature (~1 minute), removed, and plunged into water. After a few such thermal cycles, thermal growth was noted. By the end of 40 cycles, the change was quite obvious as can be seen in figure 5.

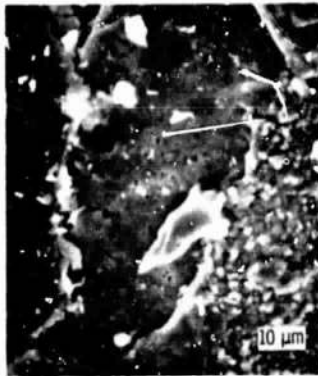
(a) IN-702 AIR COOLED.

(b) IN-702 WATER QUENCHED.

Figure 6. - Effect of cooling rate on oxide surface structure of a ductile alloy.

A comparison of the slow cooled oxide surface morphologies with those of rapidly cooled oxides was made using scanning electron microscopy. Of particular interest were the surfaces on IN-702, IN-601, and B-1900+Hf. Figure 6 shows the comparison for IN-702. The oxide morphology of the air cooled sample is typical of the type of spalling which normally occurs on cooling. It results from CTE mismatch induced compressive stresses in the oxide exceeding the strength of the oxide. When this happens, large flakes of oxide part from the scale, often explosively. In the case of the rapidly cooled sample, the oxide appears to have failed by cracking, but there is no evidence of the loss of large oxide flakes of oxides. Furthermore, the crack pattern is nearly a regular array much as one might expect from a biaxial tensile failure.

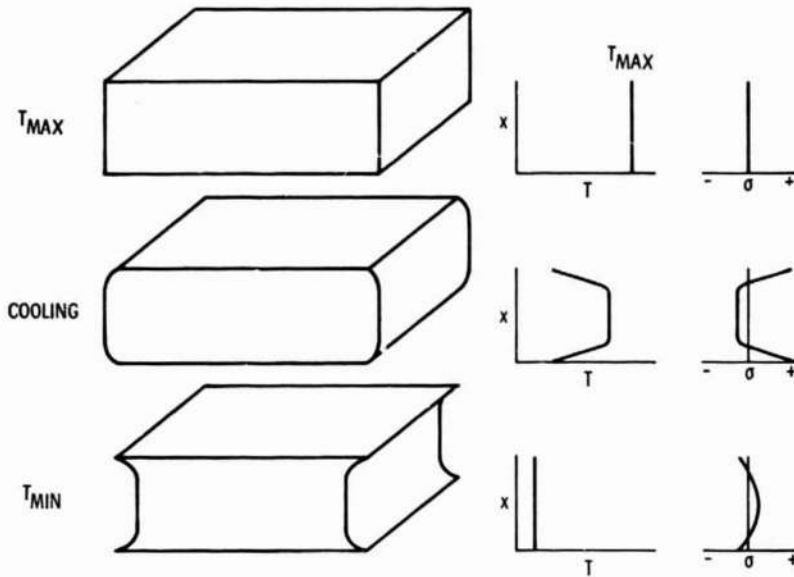
Figure 8. - Thermal shock in a ductile alloy-schematic.

It is quite clear that, aside from the effects on spalling, thermal shock has a major effect on the metal itself: deformation. The source of this deformation can be seen schematically in figure 8. At temperature, the sample is a parallelepiped under no

stress. As the sample is rapidly cooled, it cools from the surface inward and a temperature gradient is induced. The outer surface tries to contract but is constrained by the hotter interior; this sets up a tensile stress in the surface layers with a compressive stress inside. If the tensile stress is great enough, the surface will deform. With time, the thermal gradient disappears as the entire sample reaches ambient temperature. Then with plastic flow, the stresses are reversed. Depending on the size of the stresses and the strength of the alloy, this can result in either the eared sample shape shown in figure 8 or a more uniform increase in length and width. In either case, this must obviously be accompanied by a reduction in thickness. The length change has the effect of apparently reducing the CTE of the sample. It should also be pointed out that this phenomenon, depending on its extent, may adversely affect attempts to use thickness change as a measure of the extent of oxidation. In some cases one might even measure thickness increases.
