VARIABILITY OF MODAL PARAMETERS MEASURED  
ON THE ALAMOSA CANYON BRIDGE

XV International Modal Analysis Conference  
Orlando, FL  
February 1997

# VARIABILITY OF MODAL PARAMETERS MEASURED ON THE ALAMOSA CANYON BRIDGE

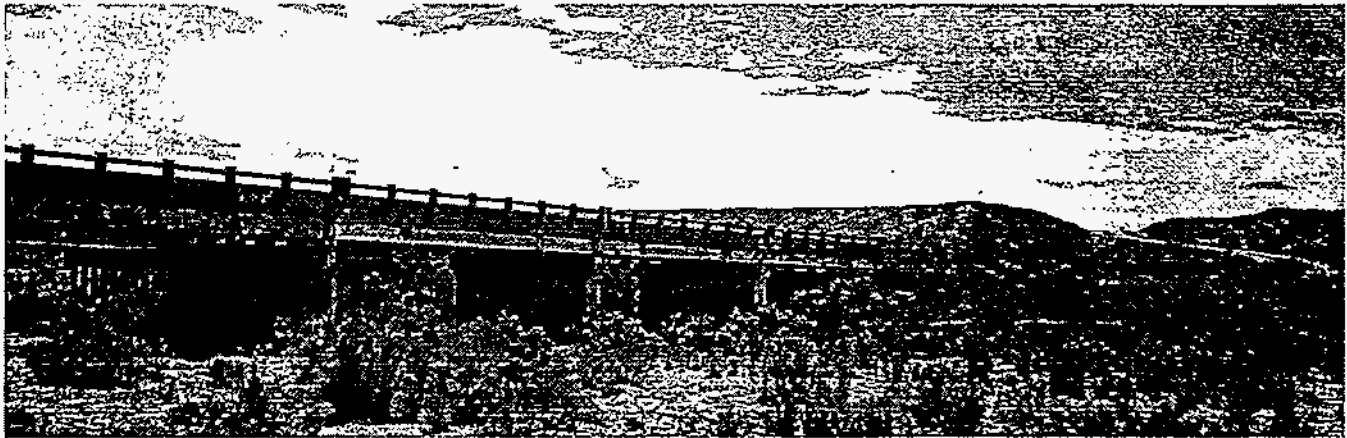
Figure 1. Elevation View of the Alamosa Canyon Bridge

The Alamosa Canyon Bridge has seven independent spans with a common pier between successive spans. An elevation

view of the bridge is shown in Fig. 1. Each span consists of a concrete deck supported by six W30x116 steel girders. The roadway in each span is approximately 7.3 m (24 ft) wide and 15.2 (50 ft) long. A concrete curb and guard rail are integrally attached to the deck. Plans for the bridge do not show shear studs on the top flanges of the girders. Inspection of the bridge showed that the upper flanges of the girders are imbedded in the concrete. Four sets of cross braces are equally spaced along the length of the span between adjacent girders. The cross braces are channel sections (C12x25). A cross section of the span at a location showing the interior cross braces is shown in Fig. 2. At the pier the girders rest on rollers as shown in Fig. 3. Also shown in Fig. 3 is the connection detail at the abutment where the beams are bolted to a half-roller to simulate a pinned connection. The bridge is aligned primarily in a north-south direction.

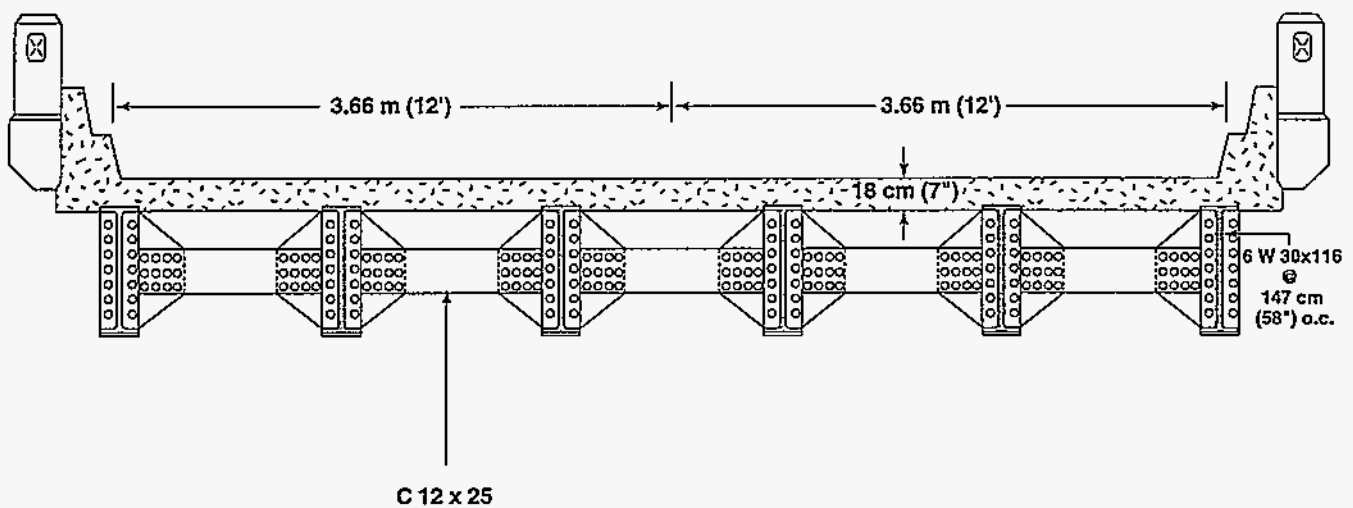
Figure 2. Cross-section view of the Alamosa Canyon Bridge.

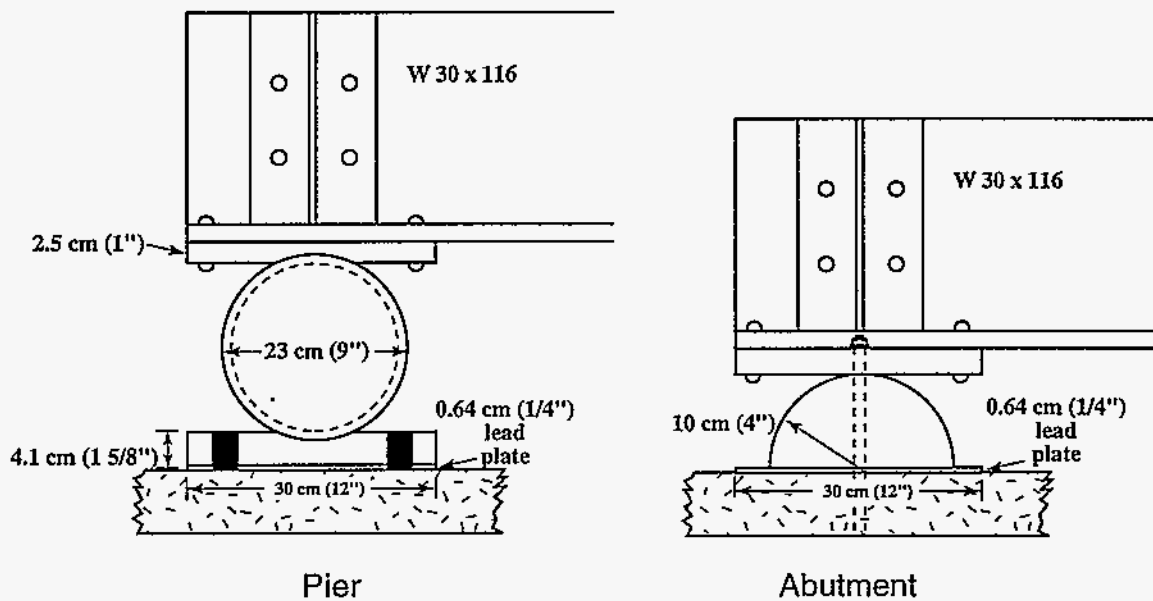
Figure 3. Support details at the pier and abutment.

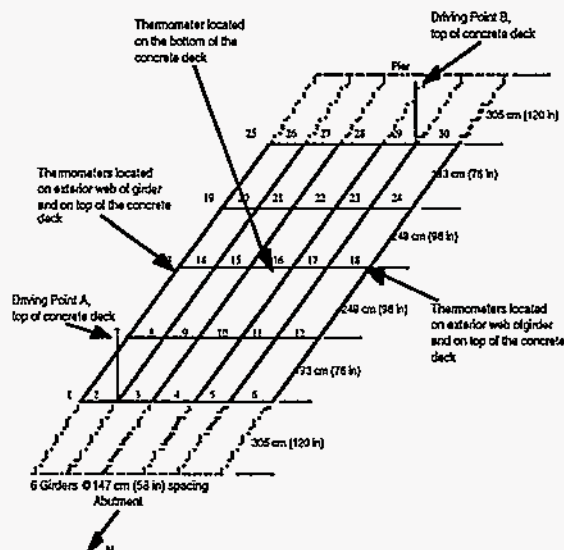
Figure 4. Accelerometer, impact, and thermometer locations.

A total of 31 acceleration measurements were made on the concrete deck and on the girders below the bridge as shown in Fig. 4. Five accelerometers were spaced along the length of each girder. Because of the limited number of data channels measurements were not made on the girders at the abutment or at the pier. Two excitation points were located on the top of the concrete deck. Point A was used as the primary excitation location. Point B was used to perform a reciprocity check. The force-input and acceleration-response time histories obtained from each impact were subsequently transformed into the frequency domain so that estimates of the PSDs, FRFs, and coherence functions could be calculated. Thirty averages were typically used for these estimates. With the sampling parameters listed above and the overload reject specified, data acquisition for a specific test usually occurred over a time period of approximately 30 - 45 minutes.

Five indoor-outdoor thermometers were located across the center of the span. Two thermometers were positioned such that their outdoor sensor was taped to the outside web surface at midheight of the exterior girders. The indoor readings from these two thermometers were made on the inside, bottom flange of the exterior girders. A third thermometer was taped to the underside of the concrete deck at the middle of the span. The outside sensor for this thermometer was located adjacent to the indoor sensor yielding almost identical temperature readings. The two remaining thermometers were located on the top side of the bridge. Their outside sensors were taped to the bridge deck immediately adjacent to the concrete curbs. The indoor sensor was located on the top of the guard rail. All sensors were shaded from direct sun light either by the bridge itself or by shades made from duct tape and cups. All temperature readings were made by visual inspection of the thermometers.

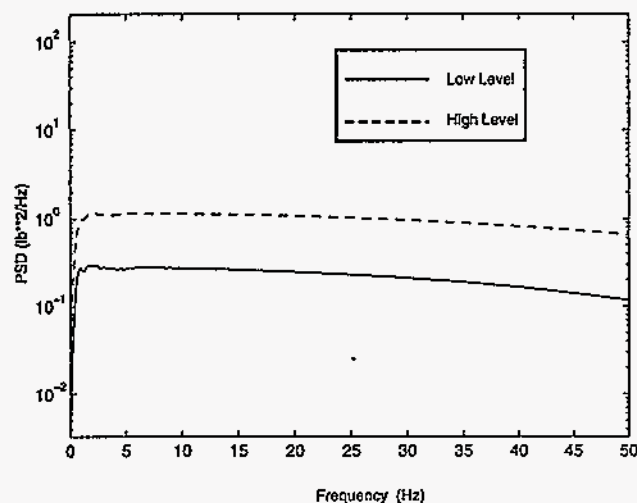
Figure 5. PSDs of impact excitations used in the linearity check at driving Pt. A.

First, measurements were made using two impact levels, whose PSD amplitudes are approximately a factor of 5 different, to test the linearity of the response over this range of loading. Figure 5 shows an overlay of the input PSDs and Fig. 6 shows the corresponding overlay of FRF magnitudes when these inputs were applied at Pt. A and response measurements were made at location 6 (See Fig. 4). These tests were performed sequentially between 4:00 and 6:00 AM when temperature differences across the bridge were negligible. Coherence functions for these measurements yielded values of 0.9 or greater across the entire spectrum. Figure 6 shows that the structure was exhibiting linear response in the range of 5 to 25 Hz. Above 30 Hz there is a noticeable difference in the two measurements suggesting the possibility that nonlinearities were excited in this frequency range or that signal-to-noise-ratios were poor thus providing the appearance of nonlinear response. This frequency range also corresponds to the lowest coherence in the measurements.

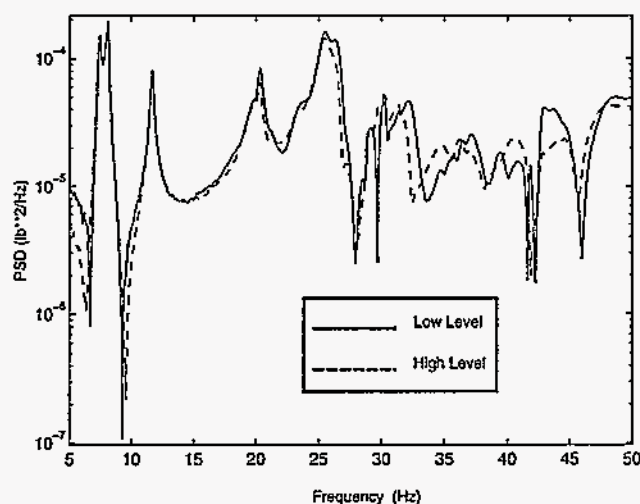
Figure 6. FRF magnitudes measured at location 6 (impact applied at point B)

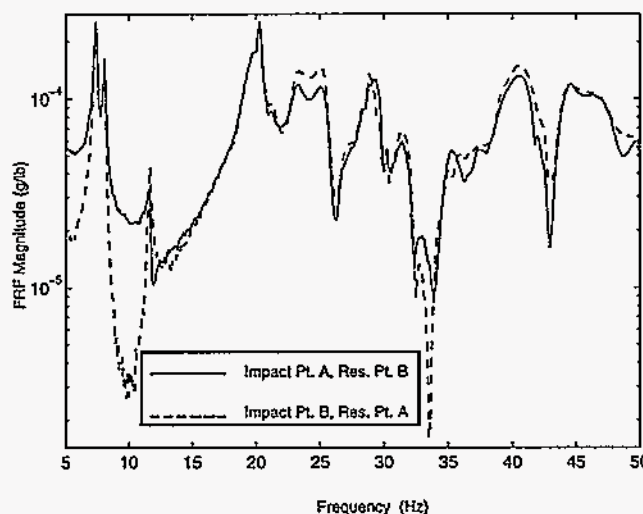
Figure 7. FRF magnitudes used to check reciprocity of the structure and the electronics.

Figure 7 shows the FRF magnitudes for an impact applied at Pt. A (See Fig. 4) and a response measured at Point B. Also shown in this figure is the FRF magnitude for an impact applied at Pt. B and a response measured at Point A. A similar plot is shown in Fig. 8, but here the accelerometers at Pts. A and B have been switched. By switching the accelerometers the reciprocity being measured is that of the structure alone. From Figures 7 and 8 it is evident that the structure itself is exhibiting reciprocity in the 5 to 25 Hz region. Above thirty Hz one could not make this claim. Also, when Fig. 7 is compared to Fig. 8 it is evident that the electronics are contributing to the loss of reciprocity, particularly at the third natural frequency near 11.5 Hz.

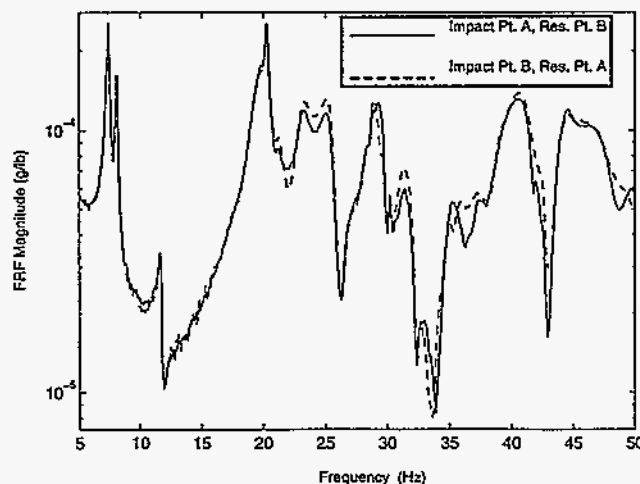
Figure 8. FRF magnitudes used to check reciprocity of the structure only.

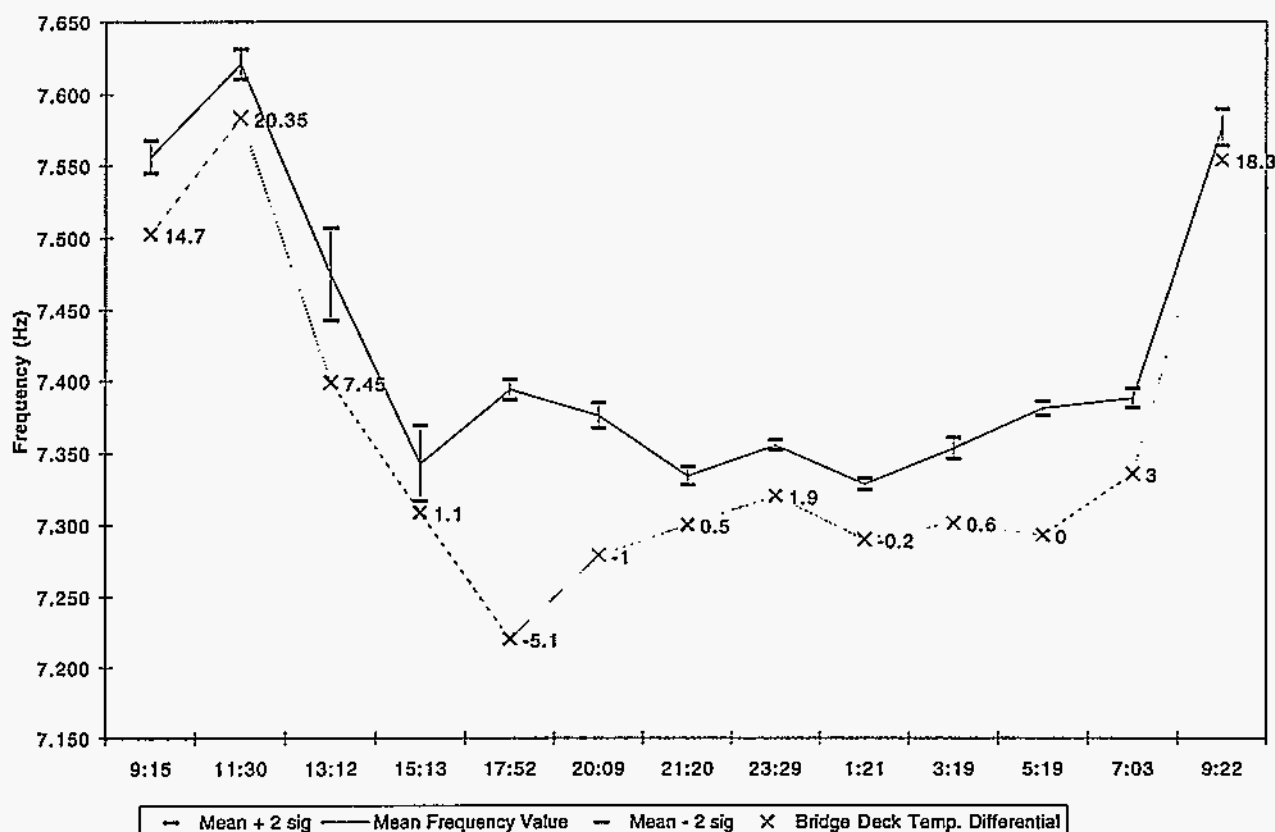
Figure 9. Change in the first mode frequency during a 24 hr time period.

Figure 9 shows the first mode frequencies along with their 95% confidence limits plotted as a function of the measurement completion time. Also plotted on Fig. 9 is the change in temperature between the two thermometer readings made on the concrete deck (east - west). This figure clearly shows that the change in modal frequencies are related to the temperature differentials across the deck. The first mode frequency varies approximately 5% during this 24 Hr time period. Similar variations and correlation with deck temperature differentials were observed for the other modes of the structure.
