Vibration monitoring and condition assessment of the University of Sheffield Arts Tower during retrofit

Abstract

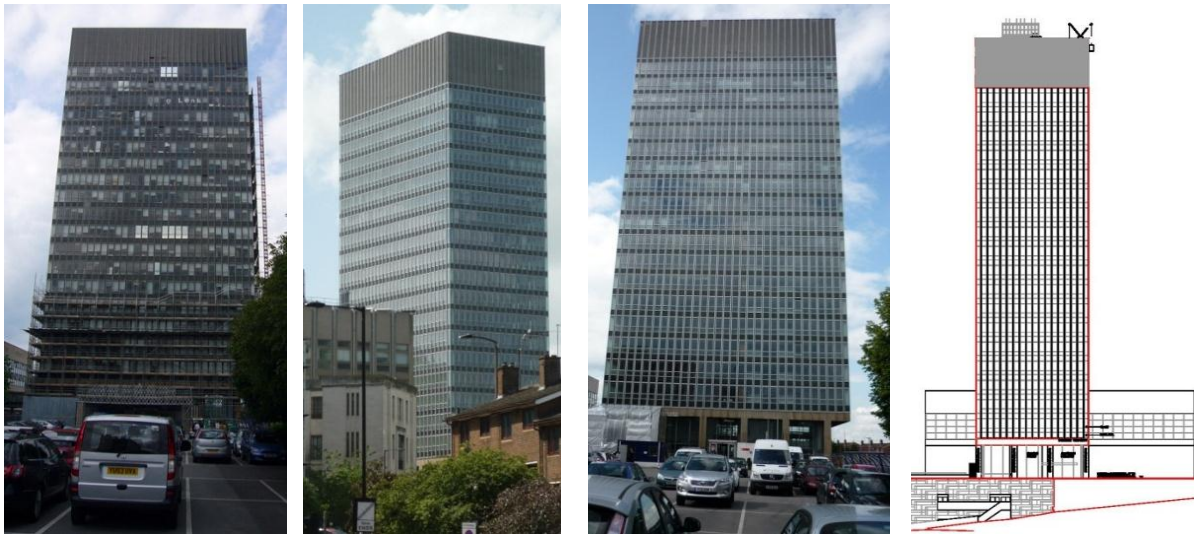
Figure 1: Views of Arts Tower: during retrofit (left), after retrofit (middle pair) and east elevation.

The building (Figure 1) has 21 storeys above ground floor (level 0), 2 basement levels, and is approximately 80m high, 36m wide and 20m deep. The basement houses lecture theatres and plant rooms which extend outside of the tower footprint and level 1 is 8.54m above level 0, with a mezzanine level. Normal floors are spaced at 3.55m intervals and as built were sub-divided by non-load bearing 75mm thick 'breezeblock' masonry partitions

Figure 1 shows the building at various stages of the operation; with original façade and following its replacement, while Figure 2 shows the internal floor plan before and after the retrofit and Figure 3 shows the original and replacement partitions. The original heavy masonry partitions have been largely demolished in the lower left view in Figure 3 which shows the narrow side of the floor. The middle view shows a totally cleared floor on the wider side with the two cores on the left, and the lower right view shows one of the many partition arrangement in the new configuration. Some floors now have a combination of the fixed and sliding partitions, while open plan areas have half-height 'cantilever' partitions and offices with glass partitions.

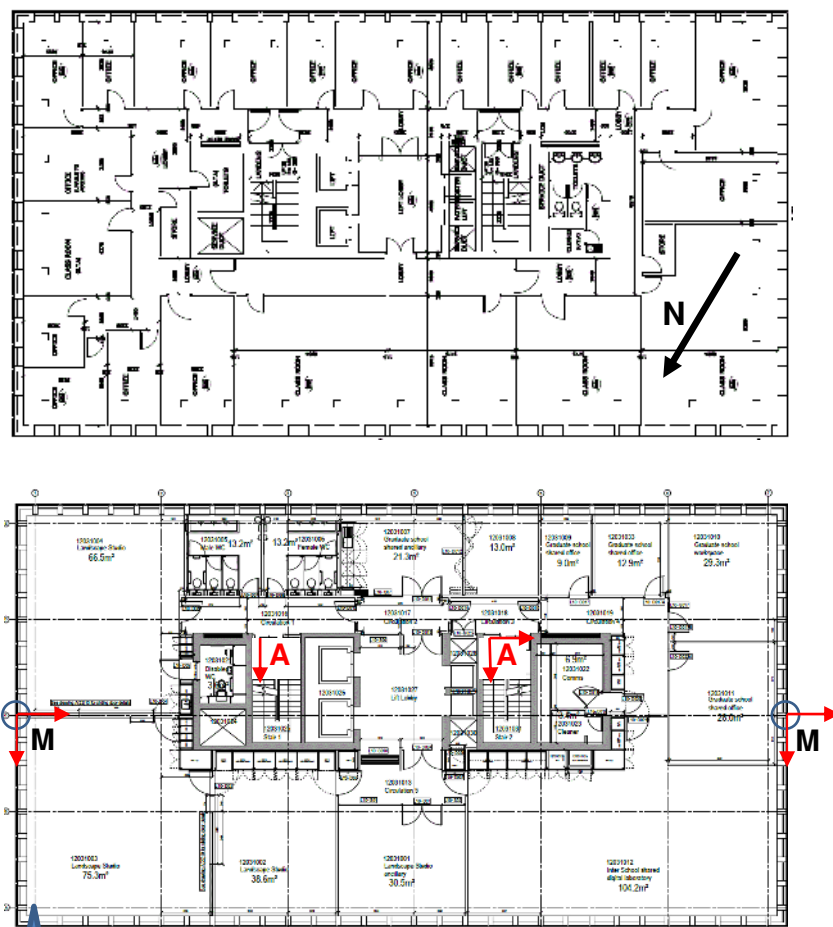
Figure 2: Typical floor plan (example for level 10) showing two cores and partitioned office spaces before (upper) and after (lower) retrofit. Triangle (lower left) matches origin of measurement grid (Figure 11). 'M' marks location in plan and orientation of rooftop-mounted accelerometers used for long term monitoring, 'A' marks location in plan and orientation in plan of accelerometers used for ambient vibration testing.

The structural frame comprises 250mm reinforced concrete (RC) flat slabs spanning between two closely spaced RC cores and RC columns arranged around the perimeter of the floors (Figure 2). There are two frame arrangements; below level 1 there are 16 perimeter rectangular columns of 965mm by 965mm, with a transfer slab to the 94 rectangular upper columns of 203mm by 406mm at 1.8m centres in the long direction and 1.12m in the short direction.

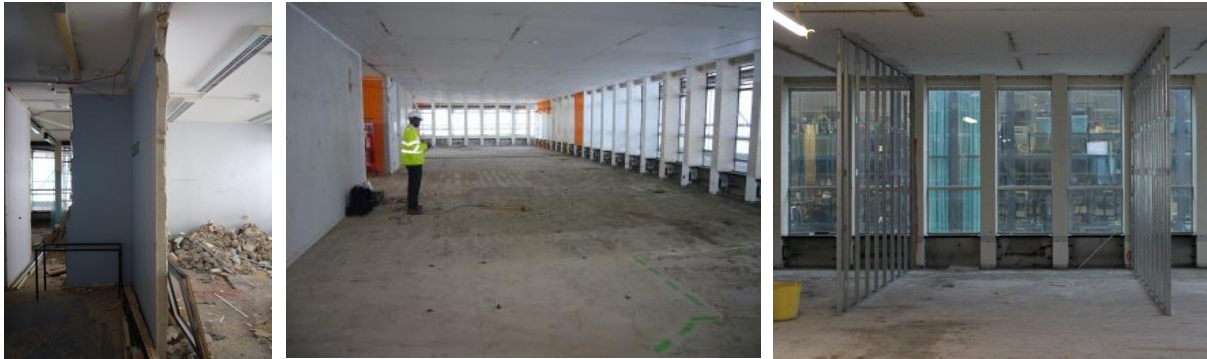
Figure 3: Half-demolished masonry partitions, cleared floor and lightweight steel frames for new fixed partitions.

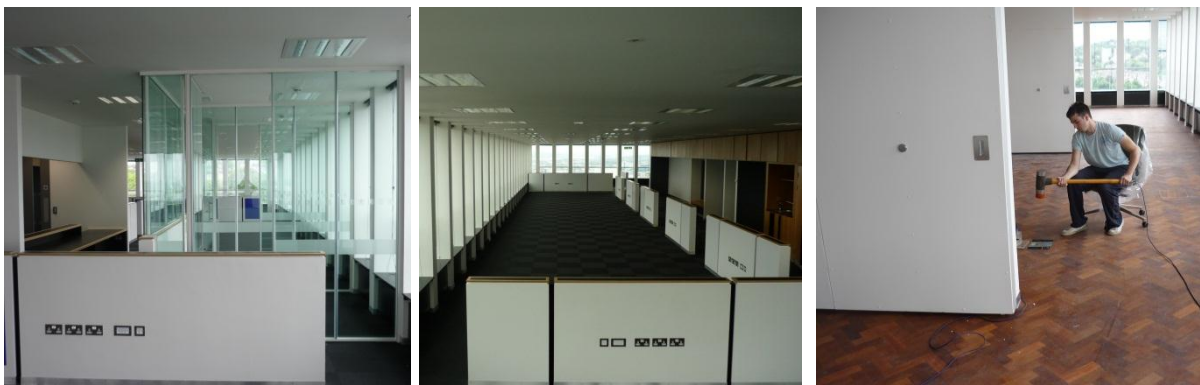
Figure 4: Post-retrofit partition arrangements. Level 7 (left) full-height glass and half-height cantilever, level 8 (middle) half-height only and level 18 (right) movable partitions retracted, with hammer test in progress.

- The wide bay of the post-retrofit re-partitioned level 8 (Figure 4 middle) was tested (using an electro-dynamic shaker) in June 2011. The area tested included the area tested in 2009, but at lower resolution i.e. twice the spacing of measurement points. This area is referred to as L8_2011.

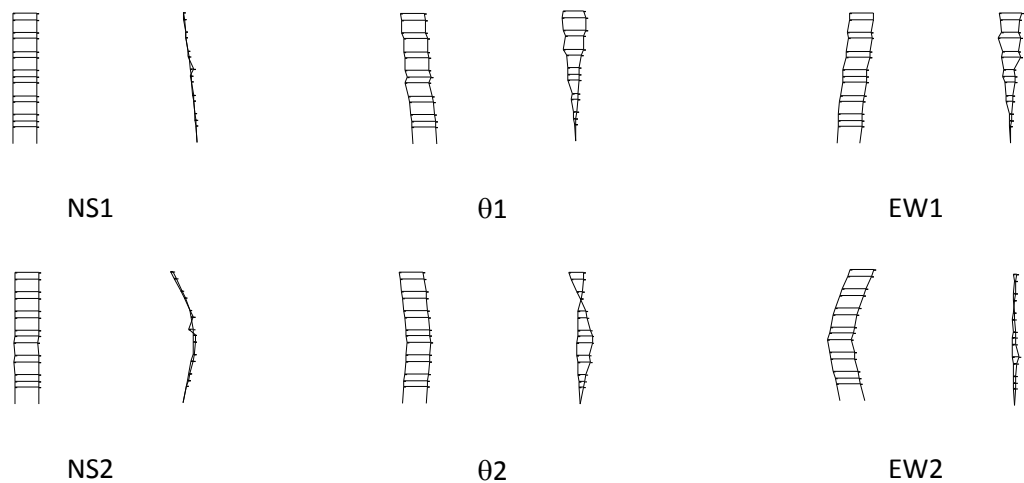
Figure 5: Mode shapes from AVS, June 2011 for orthogonal elevations in long axis and short axis.

Subsequent OMA using the eigen-system realisation algorithm (ERA) implemented in MODAL software (Brownjohn et al. 2001, Brownjohn 2003) identified the 2D characteristics of modes up to 15Hz. As the mode shapes are not expected to have varied significantly during the retrofit they are presented as a reference set in Figure 5, for the first six modes viewed in the E-W and N-S directions, with the frequency estimates for 10th June 2011 given in the last row of Table 1. NS1 and NS2 are pure bending due to the symmetry of the building whereas EW modes are less well aligned and involve torsion due to the asymmetry of the core locations.

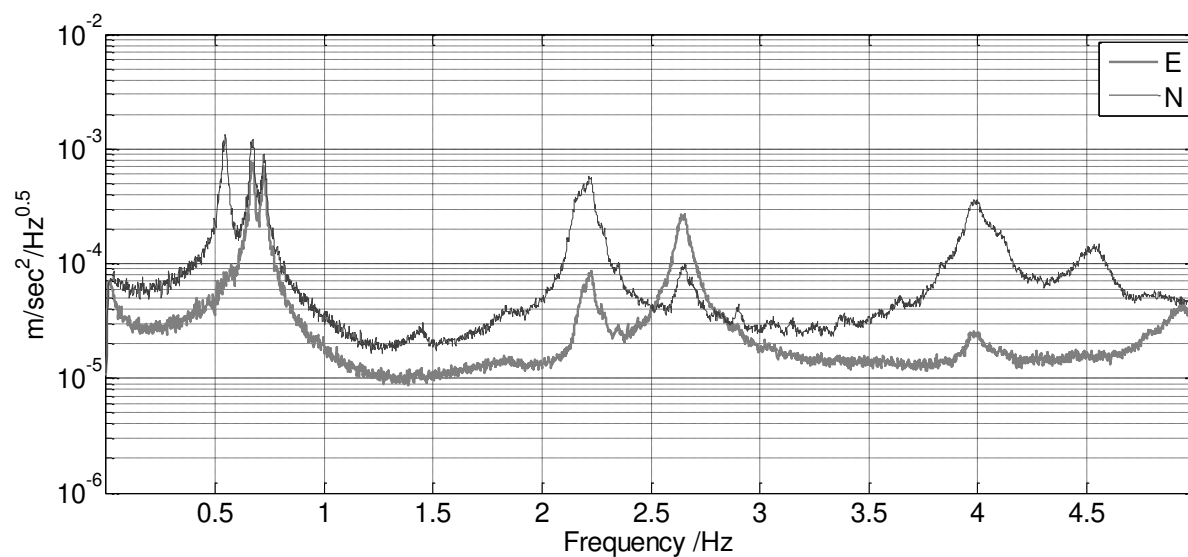
Figure 6: Broadband displacement power spectra for one hour of monitoring, 4th January 2011.

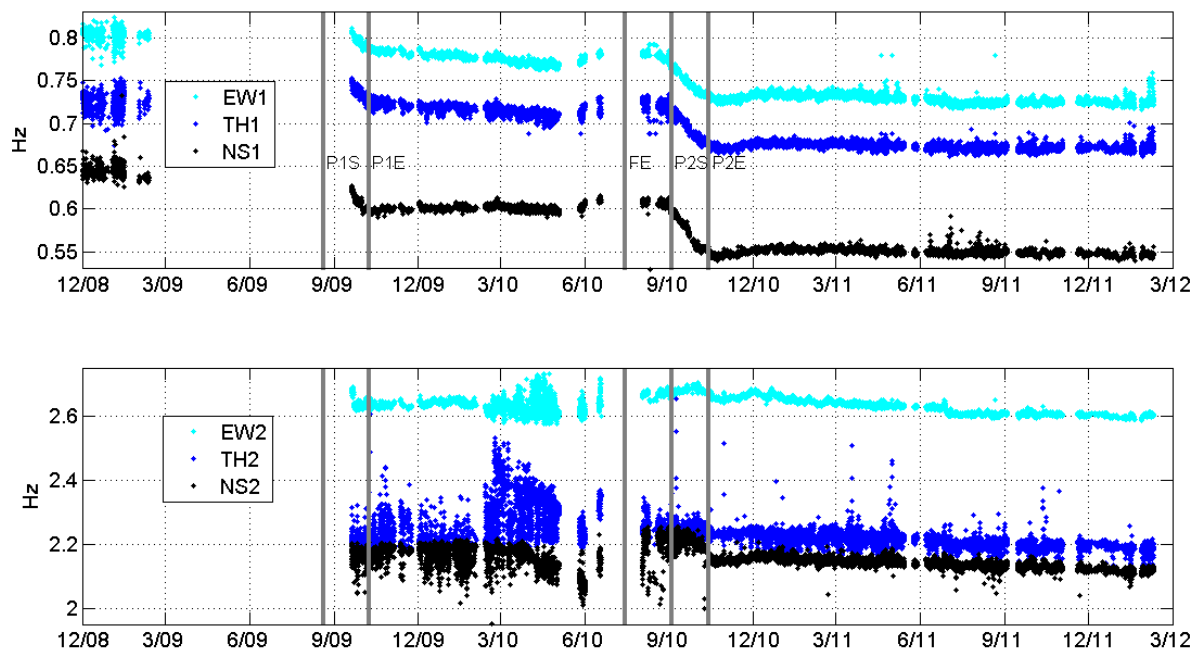
Figure 7: Frequency variation in sway modes.

P1S and P1E mark start/end of Phase 1 partition removal, FE marks end of removal and replacement of facades, P2S, P2E mark start/end of Phase 2 partition removal.

Figure 7 shows variation in natural frequencies for the lowest six modes for the duration of the FSDL monitoring. Frequencies for the first three modes were also estimated from the Straininstall monitoring data corresponding to several months before the retrofit, and due to the short event-triggered recordings the same SSI process results in larger variation than the later estimates. There are several notable features in the data which are discussed in a later section.

The most remarkable feature demonstrated from the monitored frequencies in Figure 7 is the two periods during which the frequencies of the first three horizontal vibration modes (NS1, θ 1, EW1) dropped rapidly. These correspond to the two distinct phases of partition removal.

Phase 2 removal of masonry partitions (levels 8 down to level 1) began in the first week of September 2010, with one week per floor. This period corresponds to the fastest and most significant drop in frequencies visible in Figure 7.

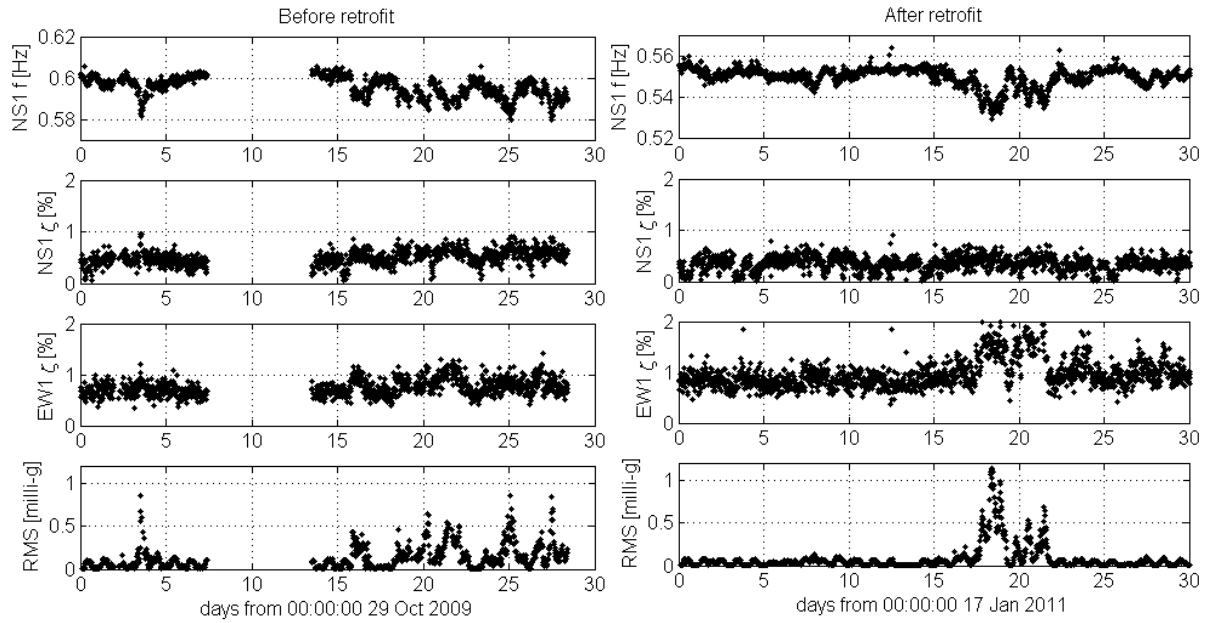
Figure 8: Modal properties and response levels before and after Phase 2.

Figure 8 zooms in on one month periods before and after Phase 2 showing variation in NS1 frequency, of NS1 and EW1 damping and of 30-minute RMS acceleration, for vector sum of broadband E and N components from a single a roof level accelerometer. In both cases maximum 30-minute RMS response exceeded 1 milli-g (9.81 mm/sec^2), which corresponds to 0.5mm for a frequency of 0.7Hz. Instantaneous values, estimated by double integration of acceleration data, reached 5mm, larger than (1.2mm) single mode amplitudes generated by BRE shakers.

NS1 frequency shows approximately 0.02Hz reduction per milli-g of response, EW1 similar, but the damping variation is more interesting. Before Phase 2 EW1 and NS1 show similar ranges consistent with the BRE results and modest increase with stronger response. After Phase 2 NS1 damping range has dropped while EW1 shows very clear dependence on amplitude. Histograms for the full durations of FSDL monitoring before and after Phase 2 are shown in Figure 9, clarifying the changes.

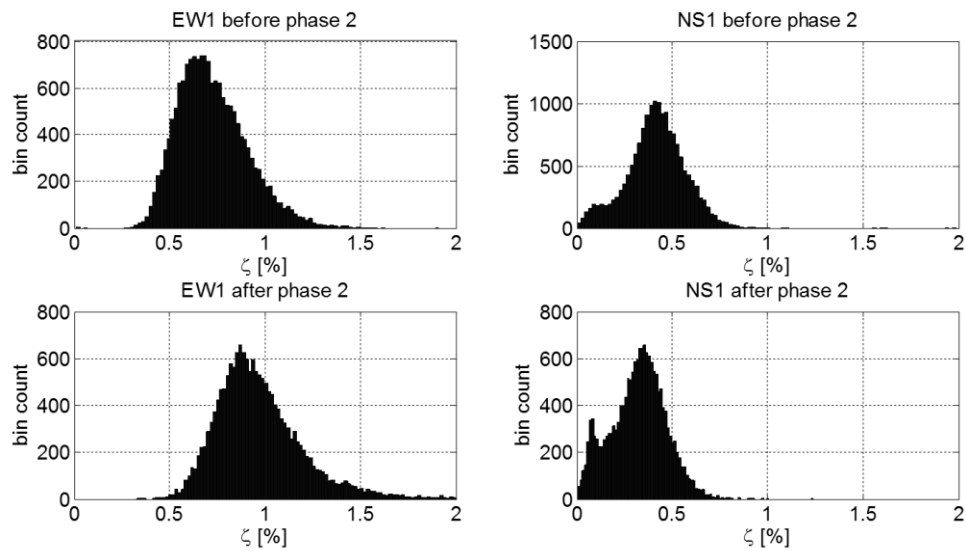
Figure 9: Damping ratios before and after Phase 2.

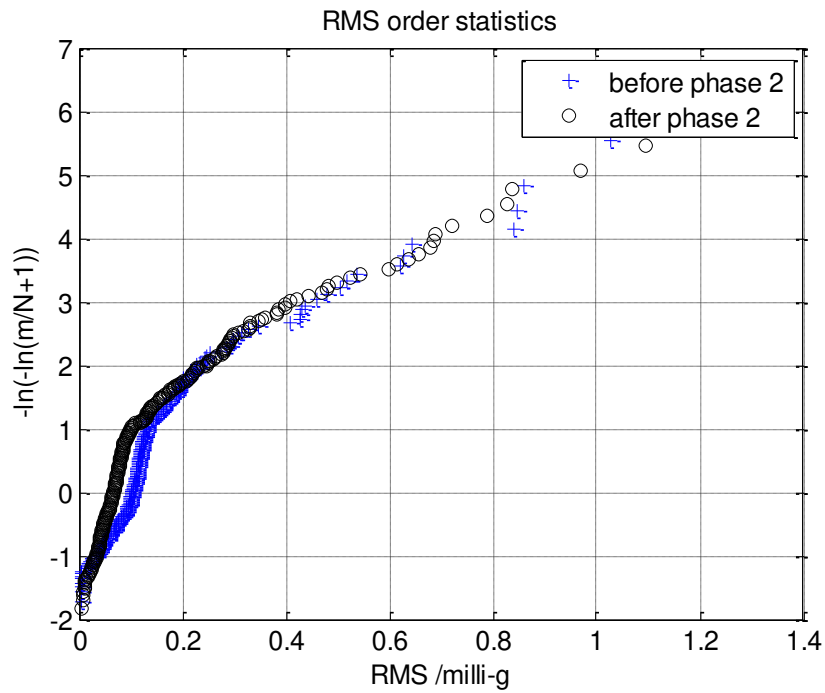
Figure 10: Gumbel plot of rank (m) of daily maximum RMS values before and after Phase 2.

With reduced frequency –implying reduced stiffness and altered damping ranges, what is the impact on response levels? There are too few reliable data points from processed 30-minute records to demonstrate convincing correlations, so the alternative approach of extreme value statistics is applied. The daily RMS maxima are obtained and their rank plotted as ‘reduced variates’ against corresponding response level as a Gumbel plot in Figure 10. While the maxima do not follow a linear trend (which would indicate a Gumbel distribution), the distributions are remarkable similar strongly suggesting that Phase 2 alterations had no significant effect on response levels.

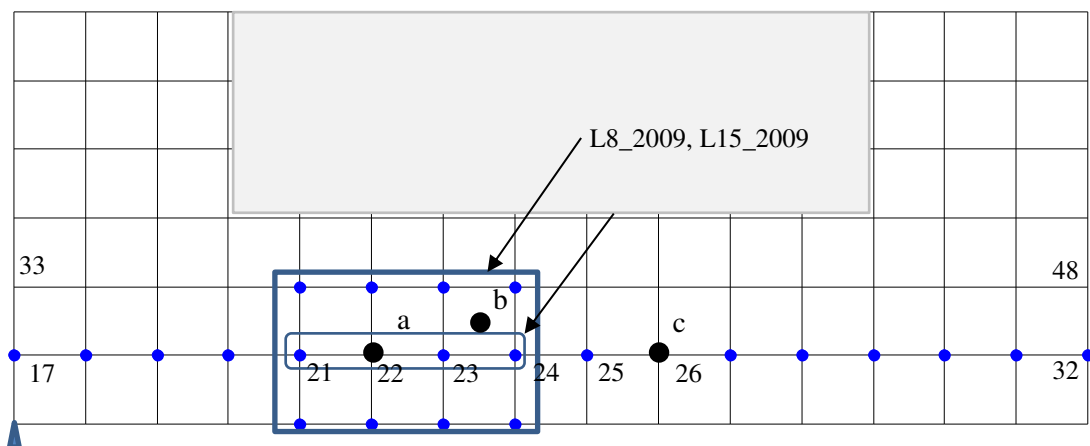
Figure 11: Floor vibration test grids. Larger grid represents level L8_2011 test grid (points spaced in line with every second column), line of dots represents L18_2011.

Large dots represent reference points for (left to right) measurements on: (a) level 18; (b) level 15 and level 8 (during retrofit); (c) level 8 (post-retrofit).

Figure 11 summarises the measurement areas for the various floor conditions, with the grid covering the wide bay of the floor and areas adjacent to the cores. The rectangular grid of dots represents the measurements points used in L8_2009 and L15_2009 testing resampled to match the L8_2011 measurement grid. The line of dots represents the L18_2011 measurement poi. The measurement point numbers are referred to in the figures that follow, particularly points 21-24.

From L8_2009 and L15_2009 it is possible to compare modal frequencies of different partitioned and un-partitioned levels, but as the floor slabs are only nominally similar the value of the comparison may be limited. Comparison is made using frequency response functions (FRFs) representing the ratio of harmonic acceleration response at a point *j* to harmonic force at a point *i*. Rather than attempting comparison of like-for-like FRFs (same *i-j* pairs, not possible across the full set of measurements at all stages and floors), the strengths and peak frequencies of the FRF peaks are compared for points 21-24 and other nearby points as indicated in Figure 11. For these two measurements the response points were fixed and the hammer roved (labeled 'b' in Figure 11).

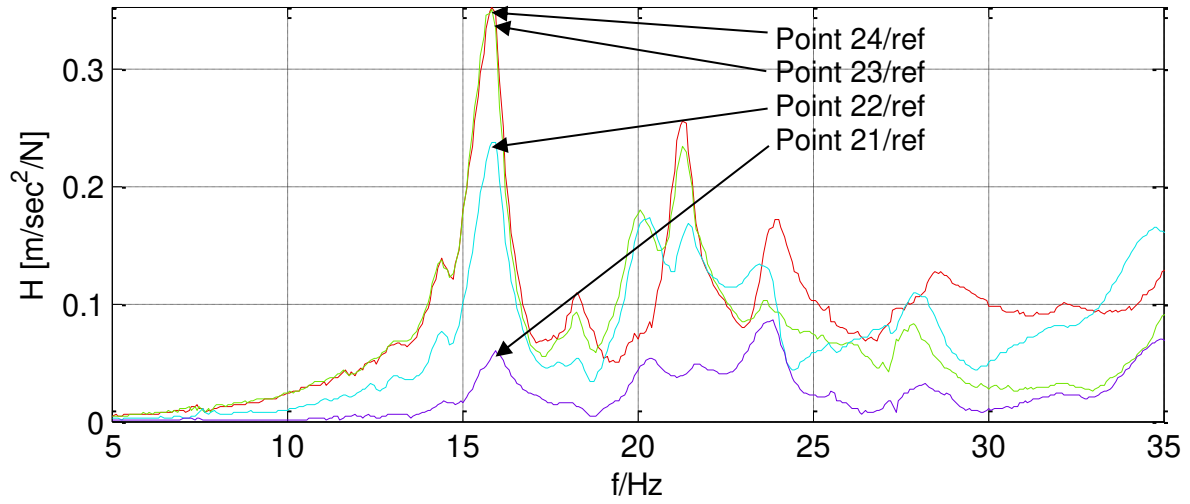
Figure 12 L8_2009: Un-cleared level 8 points 21-24. Note three modes up to 16Hz.

Figure 12 shows the FRFs for L8_2009, while Figure 13 shows FRFs for L15_2009, using the same reference point. Two things are immediately obvious when comparing the two floors.

First the peaks for (cleared) L15_2009 are much sharper than those of L8_2009, which shows a lower damping, and the strongest FRF below 20Hz is 50% stronger for the cleared floor. Hence the partitions have provided additional damping.

Second the first two clear frequencies for L15_2009 are shifted down compared to L8_2009, the obvious conclusion being that the partitions provide considerable stiffness but relatively little mass.

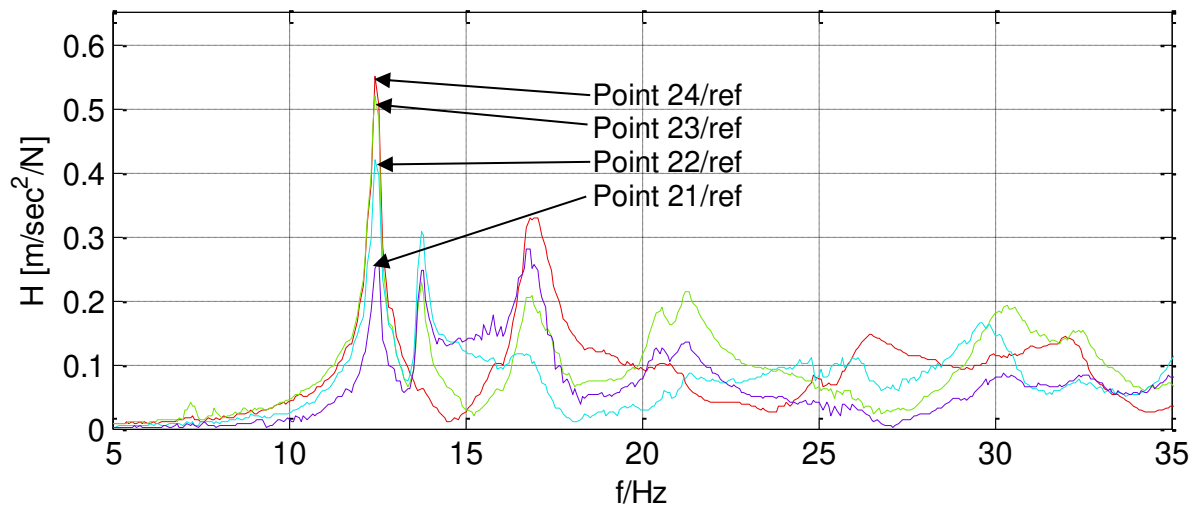
Figure 13: L15_2009: cleared level 15 points 21-24; ref point is closes to points 21 and 22

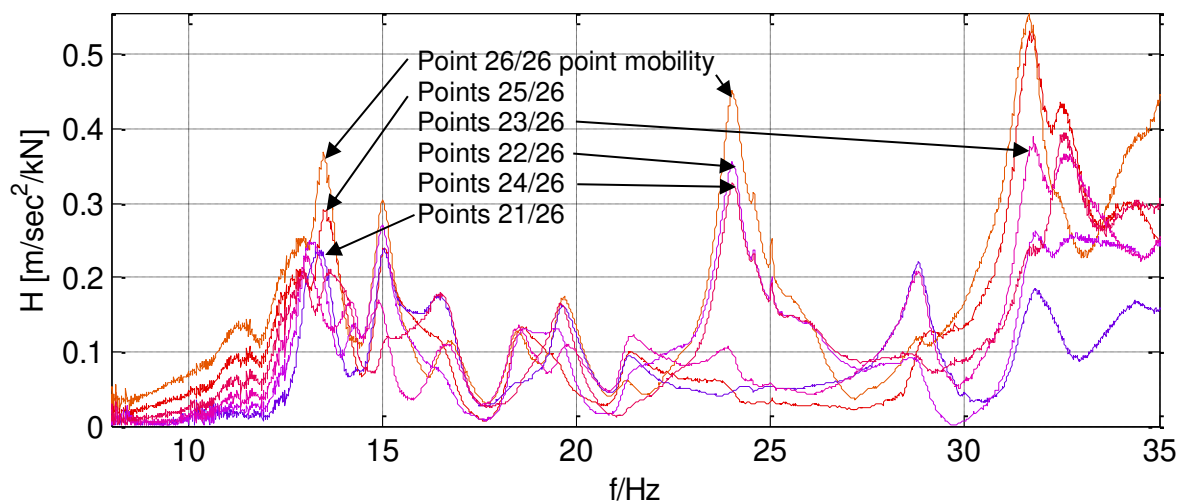
Figure 14: L8_2011: cleared level 8 (points 21-26 including point mobility). Note three modes up to 14Hz.

Due to the sequence of partition removal it was not possible to investigate level 8 in the same condition as level 15 i.e. completely cleared *during the retrofit*. However for this level post-retrofit there are no full-height partitions above and below the area tested (only the cantilever partitions) so it might be expected to behave as if cleared above and below. Only partial mode shapes were obtained in 2009, compared with the detailed shapes obtained in 2011, and the reference measurements points were different but it is still possible to make valid comparisons via the composite FRFs of Figure 12 and Figure 14. There appears to be a downward shift of mode frequencies from L8_2009 to L8_2011 but the character of the two FRF sets are rather different. Probably the first three modes (to 16Hz in L8_2009 and to 14Hz in L8_2011) correspond but beyond that the few matching point measurements are not enough to make a convincing comparison using for example modal assurance criterion. Unlike

the L8_2009 to L15_2009 (uncleared vs. cleared, but different levels) there is no obvious change in either sharpness of the peaks or FRF maxima before and after retrofit for level 8, i.e. no conclusive effect on damping.

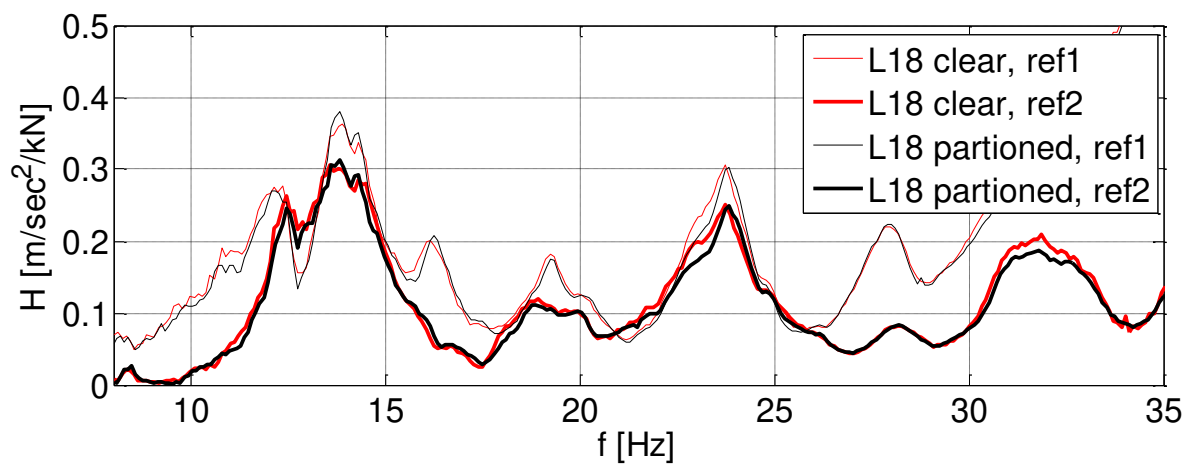
Figure 15: L18_2011: Point 22 and 26 driving point mobility FRFs with or without extended partitions.

From the level 18 measurements, the effects of the movable partitions could be observed. Figure 15 shows point mobility FRFs ($i=j=22,26$) for two locations with and without partitions engaged over the remaining half of the floor above level 18. The engagement is effected by forcing out a set of locking pins to push up and down but there is negligible effect on the FRFs; for both locations the FRFs overlay perfectly with or without partitions extended.

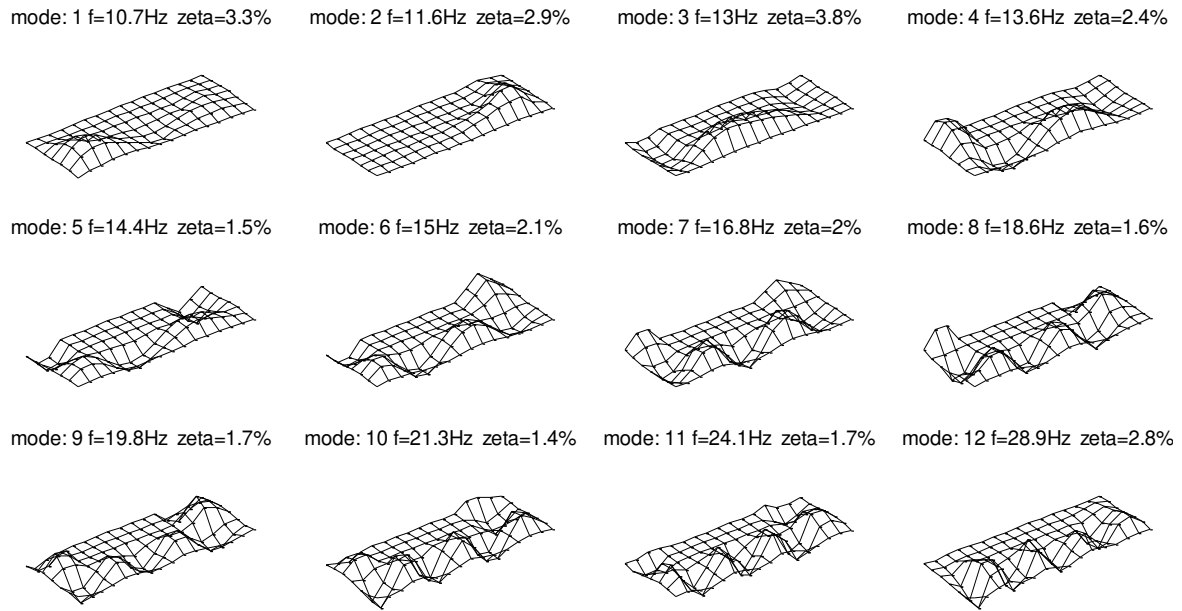
Figure 16: Mode shapes for L8_2011 i.e. level 8 after retrofit.

Mode shapes estimated for the comprehensive post-retrofit level 8 measurements are shown in Figure 16. The first three modes follow an expected pattern of global deformation with increasing order along the bay and all except the first mode are clearly visible in the FRFs of Figure 14. There is no second order mode in the short direction (across the wide bay) below 30Hz.

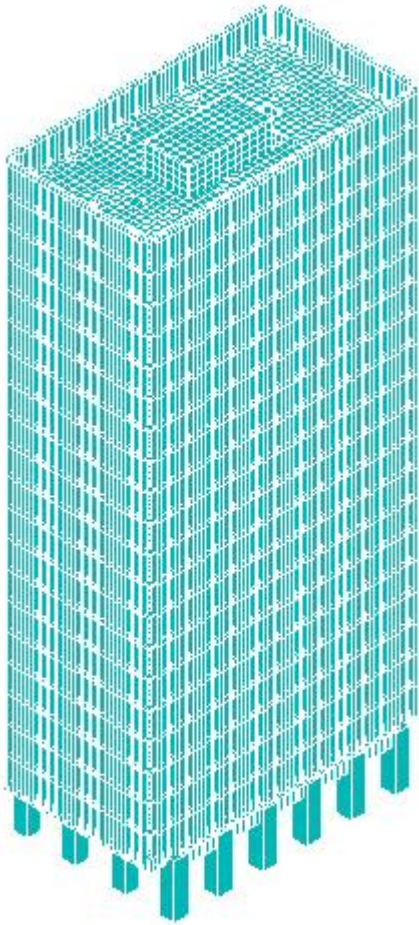
Figure 17: Finite element model for sway, slice at level 8 and partitions with openings at level 1.

Model 1: shown in Figure 17 representing the final state of the Arts Tower after removing partitions and including main structural elements (columns, slabs and core walls).

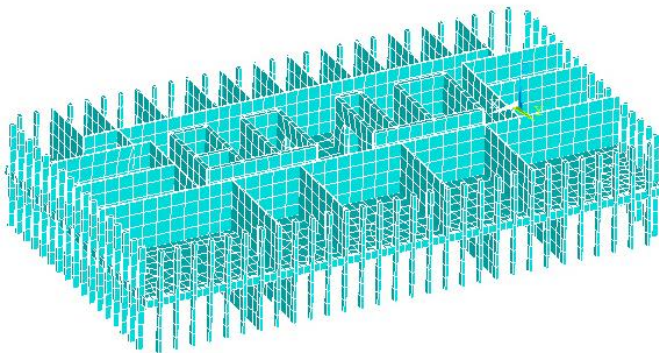
Figure 18: Finite element model for floor vibration at level 8.

Model 4: a slice of the building at level 8 with structural components above and below to model the behavior of this level in detail.

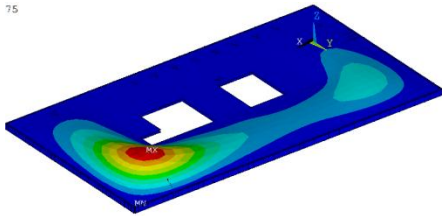
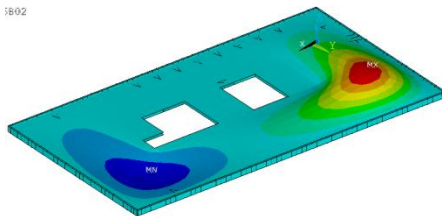
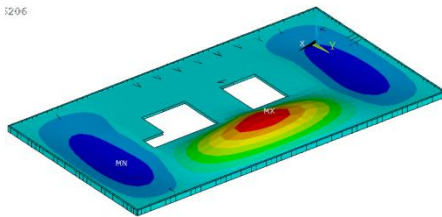
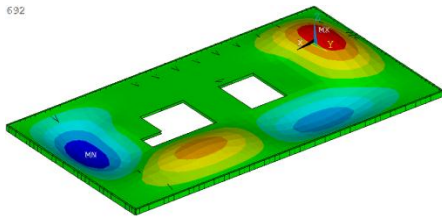
Figure 19: Matching of Model 4 (without partitions) with L8_2011 measured modes. FEM modes on left, experimental modes on right.d

Figure 19 compares Model 4 with no partitions with L8_2011 floor mode shapes. The agreement is acceptable; except for the first mode, the model underestimates the frequencies by an average 6%. The first two modes observed in L8_2011 measurements (10.7Hz and 11.5Hz) are relatively weak in Figure 14 as they involve motion of the slab at the ends of the long bays with little motion in the area of the shaker. Higher modes are stronger and the agreement is more convincing. This all points to Model 4 being able to represent the behavior of the bare slab reasonably, hence providing a good basis for studying the effect of partitions.

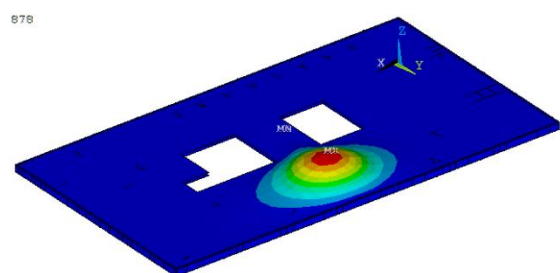
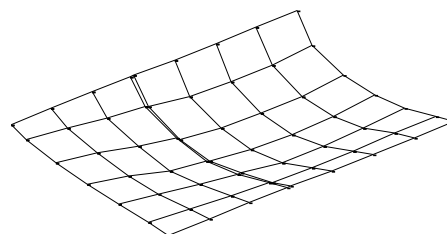
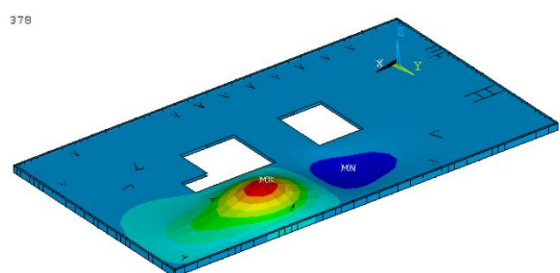
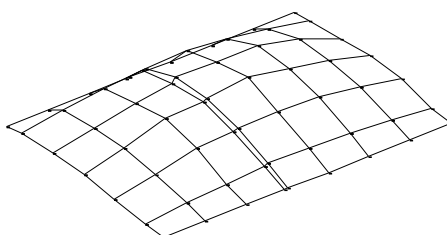
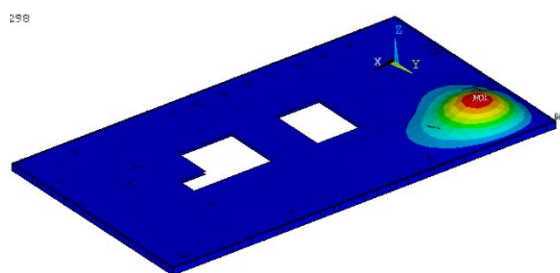
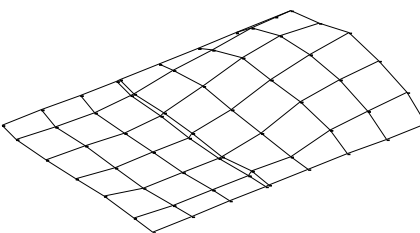
Figure 20: Matching of Model 4 (with partitions) with L8_2009 measured modes.
