# VIBRATION STUDIES OF THE STANFORD LINEAR ACCELERATOR<sup>†</sup>

### ABSTRACT

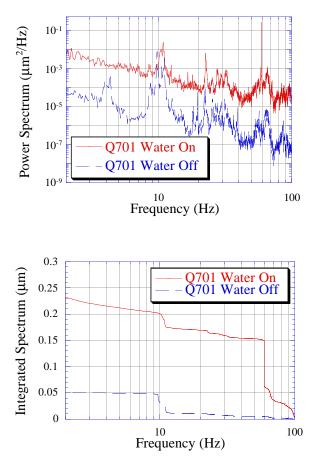
Figure 2. Quadrupole motion spectrum (top) and integrated spectrum (bottom) with accelerator cooling water on and off.

Turning off water to the quadrupoles themselves had little affect, but turning off the water to the adjacent accelerator structures lowered vibration of the quadrupoles from about 250 nanometers rms to about 60 nanometers rms (see figure 2). Thus most of the quadrupole motion is due to the vibrations that are caused by the cooling water. Much of the motion is at 59 Hz (see figure 2 bottom plot) which can be seen in the jitter of the beam orbits [3]. The 59 Hz motion is believed to be due to the accelerator water pump impeller rotating at 59 Hz. The quadrupole motion in the 8-14 Hz

range, however, was not reduced dramatically with the water off (see figure 2).

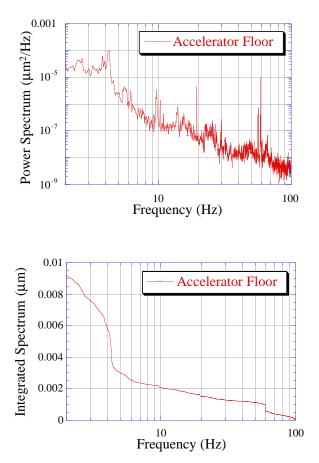
Figure 6. Spectrum and integral of vertical motion on the floor of the accelerator tunnel (about 35' below ground [4]).

Finally, measurements of the accelerator floor motion were made. Figure 6 shows an example. Integrated values (>2 Hz) between 9 and 35 nanometers were observed on different days.
